Contract No. HY/2010/02

## Hong Kong – Zhuhai – Macao Bridge Hong Kong Boundary Crossing Facilities – Reclamation Works

Monthly EM&A Report for September 2014

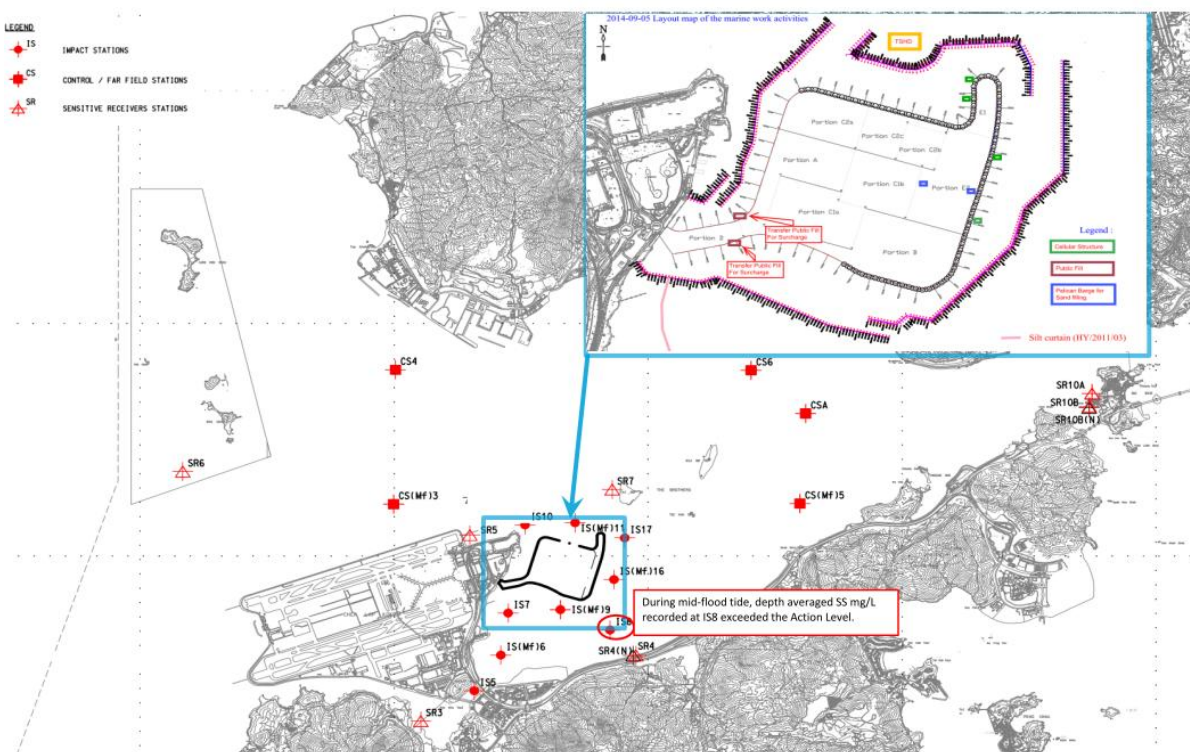
4.7.3 (1) One Action Level Exceedance of SS (27.4mg/L) was recorded at IS8 during flood tide on 5 September 2014.

4.7.3.1 For marine works, marine filling was conducted at portion E2 during flood at area behind cellular structures on 5 September 2014. Also refer to layout map above.

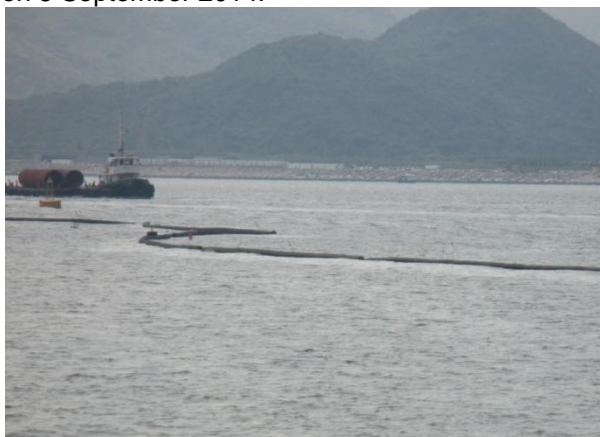
4.7.3.3 As informed by the Contractor, filling was conducted on 3, 5 and 8 September 2014 at Portion E2, but with referred to monitoring record and photo record attached, no sediment plume has been observed to flow from the inside of the perimeter silt curtain to the outside of the perimeter silt curtain and no discoloration of sea water has been observed.

4.7.3.4 Photo record of sea condition taken during flood tide at north of HKBCF Reclamation Works near IS8 on 5 September 2014.

- 4.7.3.12 Nevertheless, the Contractor was reminded to ensure provision of ongoing maintenance to the silt curtains and to carry out maintenance work once defects were found.

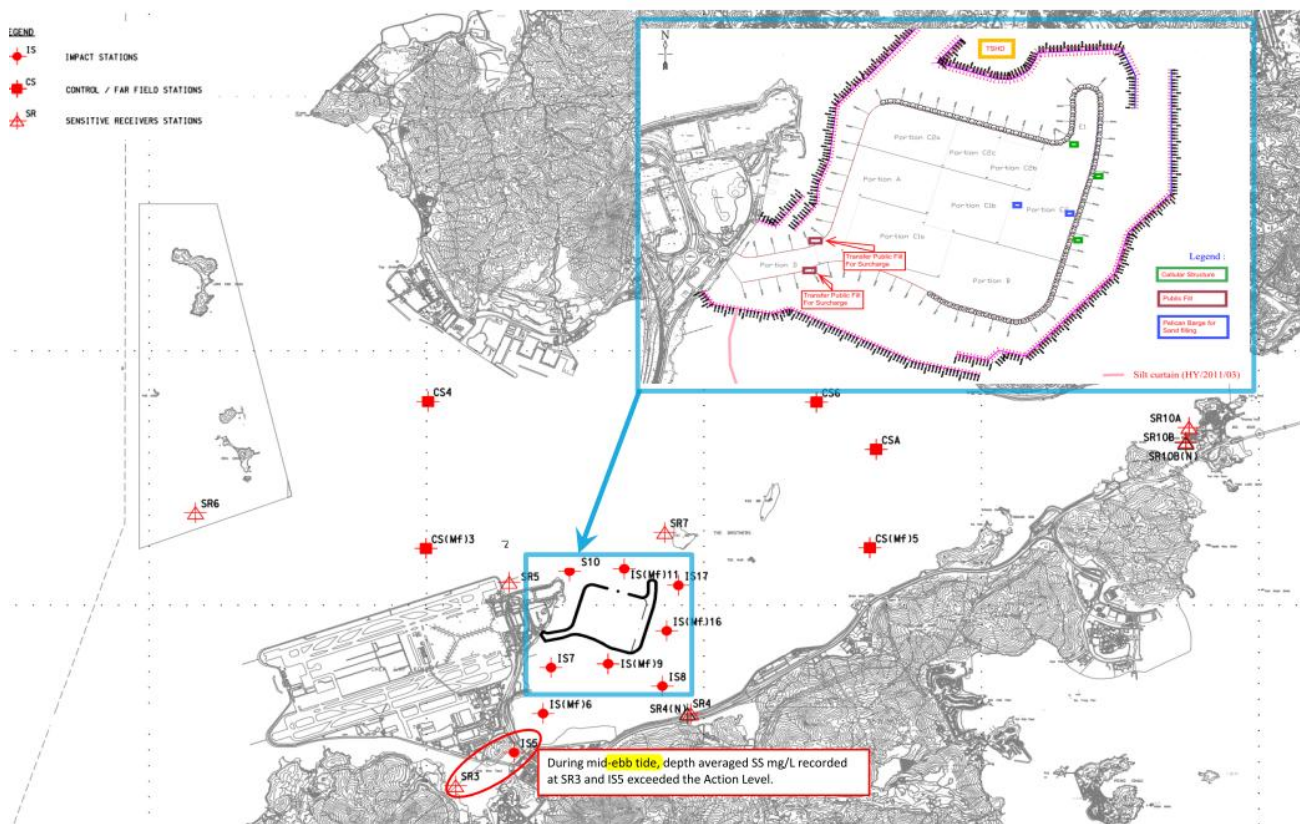
4.7.4 (2) Two Action Level Exceedances of SS (26mg/L and 32.3mg/L) were recorded at IS5 and SR3 during ebb tide on 5 September 2014.

4.7.4.1 For marine works, marine filling was conducted at portion E2 during ebb tide at area behind cellular structures on 10 September 2014.

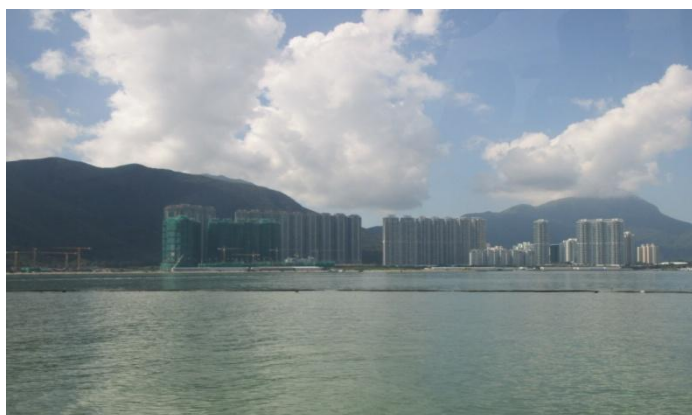
4.7.4.3 As informed by the Contractor, filling was conducted on 8, 10 and 12 September 2014 at Portion E2, but with referred to monitoring record and photo record attached, no sediment plume has been observed to flow from the inside of the perimeter silt curtain to the outside of the perimeter silt curtain and no discoloration of sea water has been observed.

4.7.4.4 Photo record of sea condition taken at South of HKBCF Reclamation Works near IS5 and SR3 on 10 September 2014.

4.7.4.10 Nevertheless, the Contractor was reminded to ensure provision of ongoing maintenance to the silt curtains and to carry out maintenance work once defects were found.

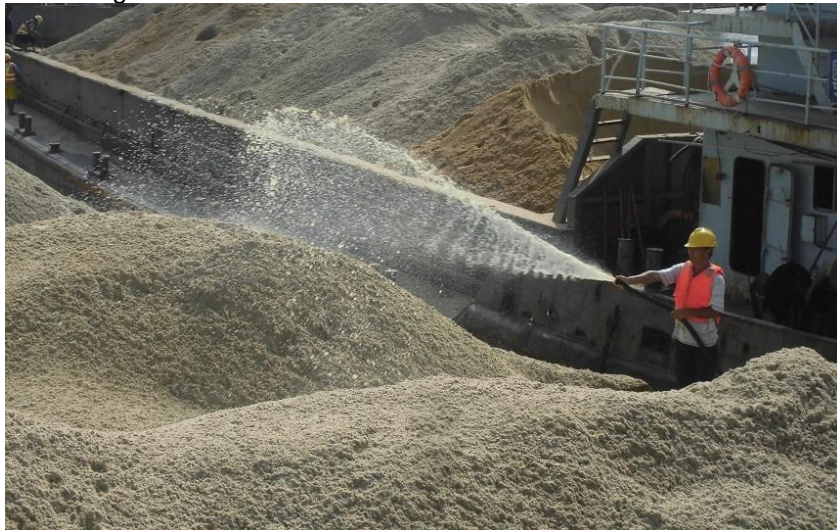
- Photo record below shows that sand barges were not covered but they are equipped with watering equipment and in order to prevent generation of fugitive dust, watering equipment was used to keep the sand filling material wet.

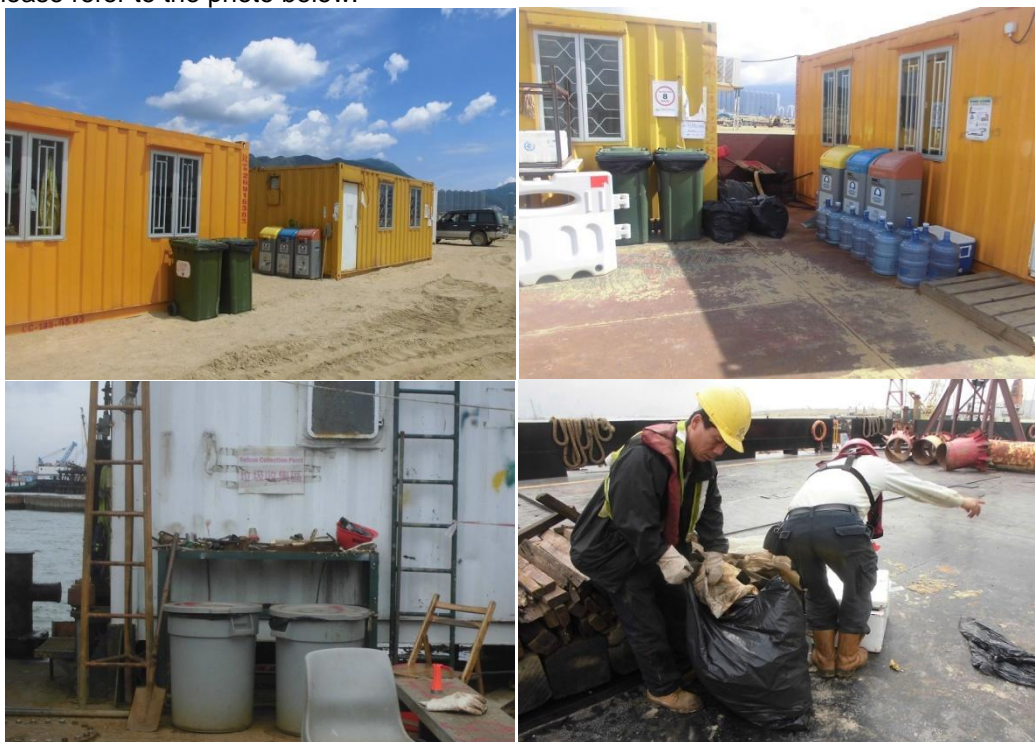
- There is no sufficient information provided by the complainant to make sure that the general refuse such as food container and plastic bottles are related to this project.
- Photo of site condition was reviewed, temporary refuse collection facility/ appropriate containers such as rubbish bins were provided by the Contractor on reclamation and vessel to collect general refuses, please refer to the photo below:

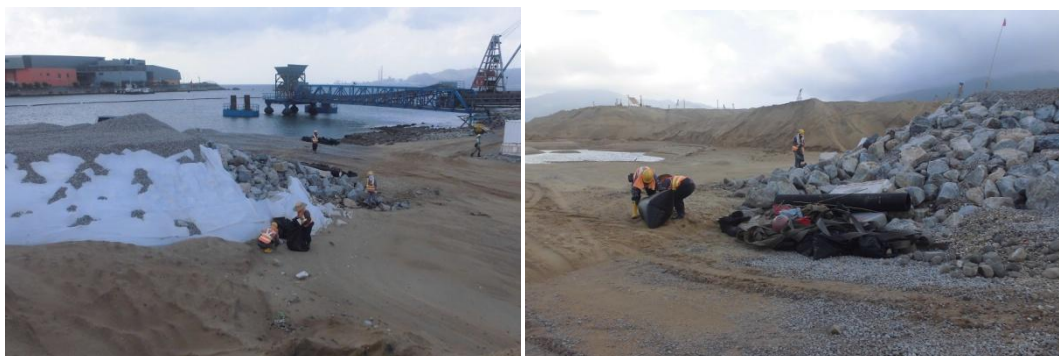
- Photo records shows collection of general refuse by workers on a regular basis:

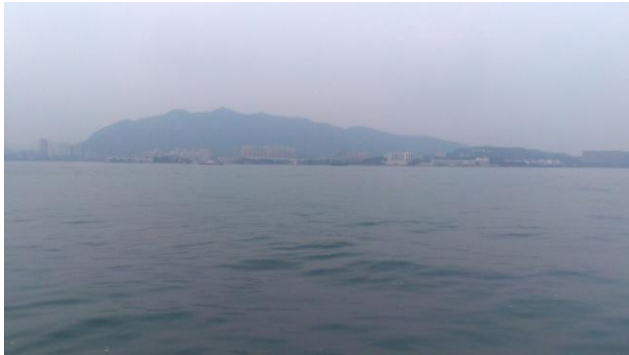
6.6.4.3 Below photo shows condition of the sea area facing Tuen Mun on 22 September 14.

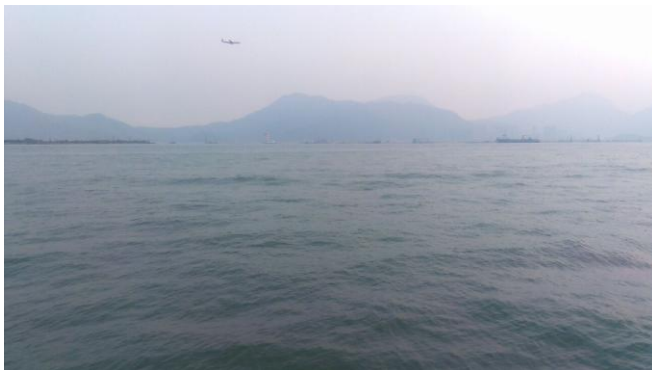
6.6.4.4 Below photo shows condition of the sea area facing HKBCF Reclamation Works on 22 September 14.

- 6.6.4.5 After investigation, there is no adequate information to conclude the observed impact is related to this Contract.
- 6.6.4.6 The Contractor was advised to ensure to continue the provision of waste mitigation measures to barges on reclamation land and vessels.
- 6.6.4.7 The Contractor was recommended that the site and surroundings shall be kept tidy and litter free. General refuse generated on-site should be stored in enclosed bins or compaction units separately from construction and chemical wastes.

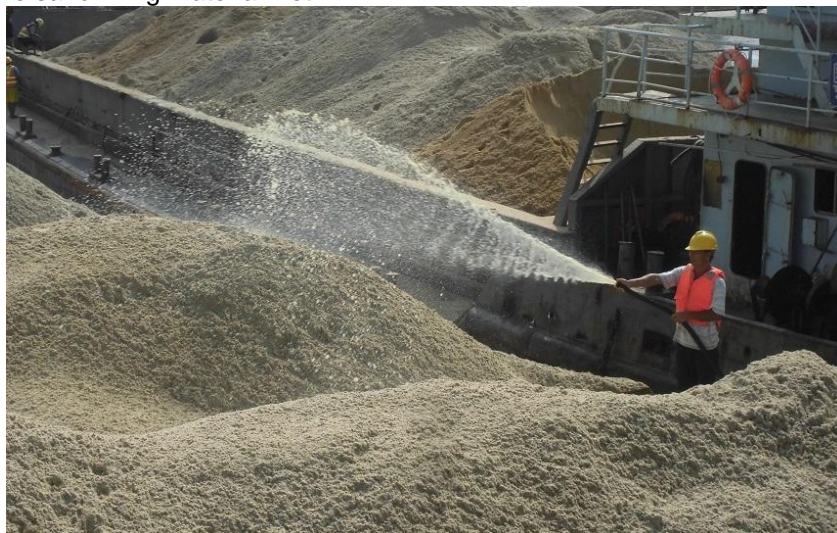
- There is no sufficient information provided by the complainant to make sure that the concerned barges are related to this project.
- Date of the observed impact was not specified by the complainant so the impact air quality monitoring (IAQM) results available for September 2014 for monitoring stations close to the concerned area – AQMS1, ASR1, ASR5, ASR6 and ASR10 have been reviewed and there was no impact air quality monitoring result that shows 1-hour TSP or 24-hour TSP exceeded the action (AL)/limit level (LL).
- Photo record below shows that sand barges were not covered but they are equipped with watering equipment and in order to prevent generation of fugitive dust, watering equipment was used to keep the sand filling material wet.

- 6.6.5.5 The Contractor was advised to ensure to continue the provision of fugitive dust mitigation measures to barges loaded with filling material such as watering to sand filling material on sand barges to keep the surface of stockpile of filling material wet.
- 6.6.6 No notification of summons and successful prosecutions was received in the reporting period.
- 6.6.7 Statistics on complaints, notifications of summons and successful prosecutions are summarized in Appendix N.
