Contract No. HY/2010/02

**Hong Kong – Zhuhai – Macao Bridge
Hong Kong Boundary Crossing
Facilities –
Reclamation Works****Quarterly EM&A Report for
March 2013- May 2013**

Version: Rev. 0 Date: Sept 2013

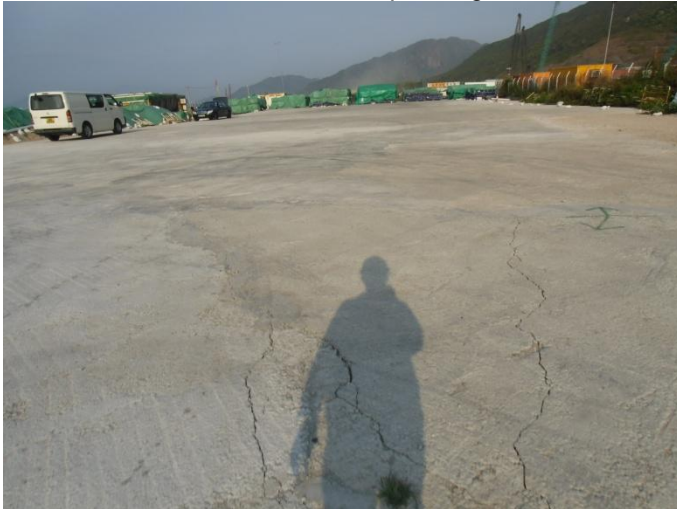
- 3.1.7 For the one (1) 24-hour TSP result exceeded the Limit Level on 04 March 13 at monitoring station AMS3A, according to information provided by the Contractor, land-based construction activity such as transloading and delivery of geotextile and installing sand bags were undertaken at Works Area WA2 during the monitoring period which is unlikely to cause fugitive dust emission.

View of Works Area WA2 : Hard paved ground next to monitoring station AMS3A (View A)

3.1.7.10 The Contractor was recommended to continue implementing existing dust mitigation measures.

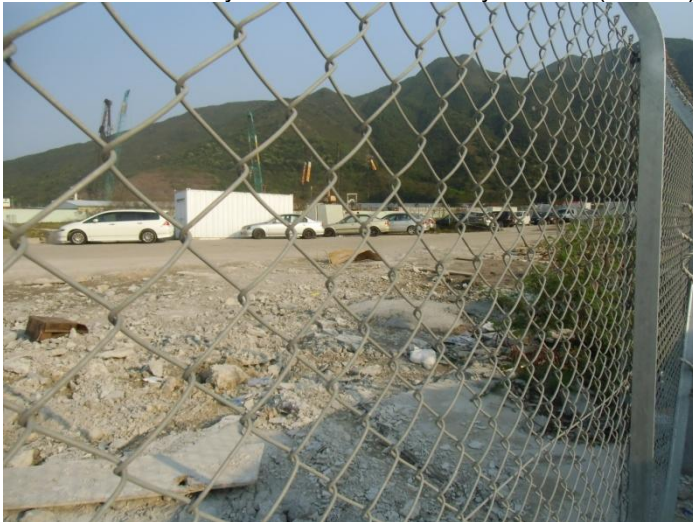
- 3.1.7.2 Construction activities, like sheet piling and percussive piling, were carrying out by nearby private development project during the course of monitoring, which are close to the monitoring station AMS3A but beyond the site boundary of Works Area WA2. Trucks were observed passing exposed soil surfaces at those construction sites of nearby private development project.

View on Site B: Beyond the site boundary of WA2 (View B)

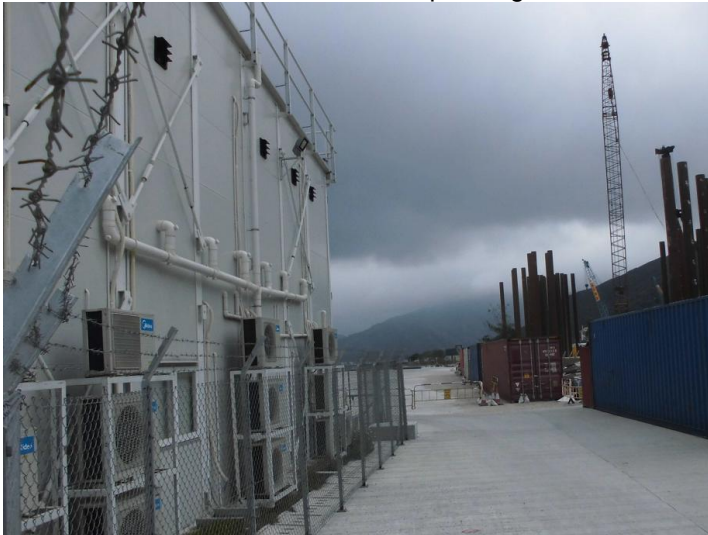
View of Works Area WA2 : the hard paved ground next to monitoring station AMS3A (View A)

3.1.8.10 The Contractor was recommended to continue implementing existing dust mitigation measures.

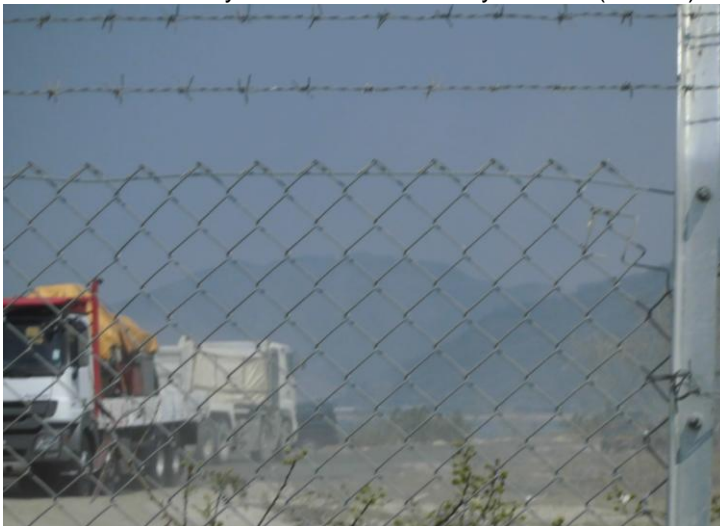
3.1.8.2 As informed by the Contractor, construction activities like sheet piling and percussive piling, were carrying out by nearby private development project during the course of monitoring, which are close to the monitoring station AMS3A but beyond the site boundary of Works Area WA2. Traffics were observed passing exposed soil surfaces at those construction sites of nearby private development project.

View on Site B: Beyond the site boundary of WA2 (View B)

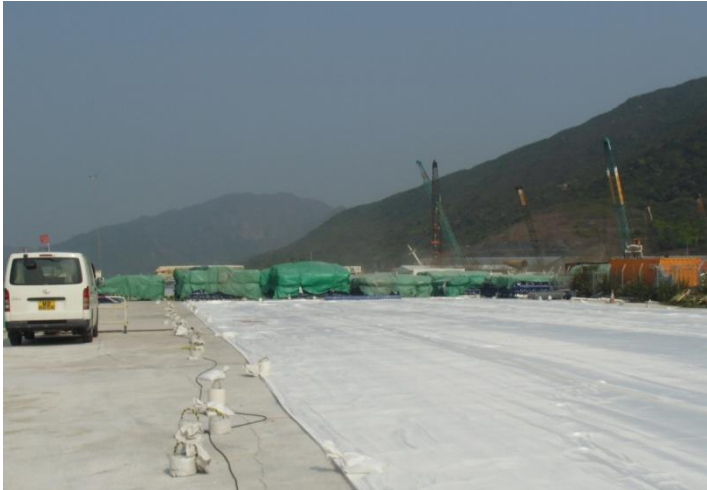
View of Works Area WA2 : the hard paved ground next to monitoring station AMS3A (View A)

- 3.1.9.10 The Contractor was recommended to continue implementing existing dust mitigation measures.

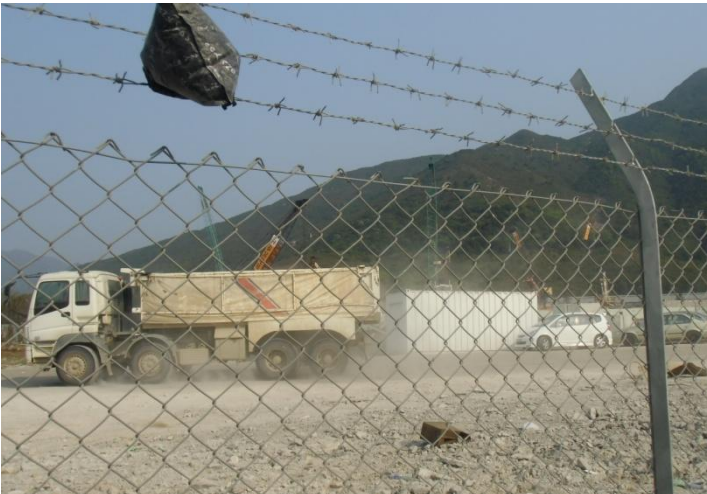
3.1.9.2 As informed by the Contractor, construction activities like sheet piling and percussive piling, were carrying out by nearby private development project during the course of monitoring, which are close to the monitoring station AMS3A but beyond the site boundary of Works Area WA2. Traffics were observed passing exposed soil surfaces at those construction sites of nearby private development project.

View on Site B: Beyond the site boundary of WA2 (View B)

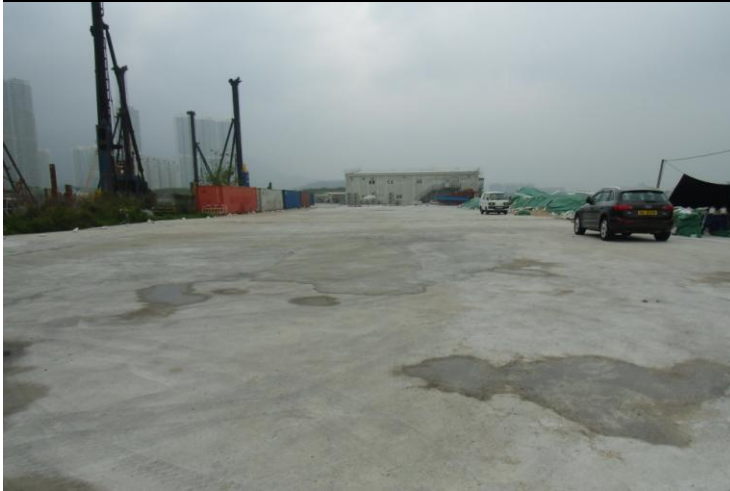
View of Works Area WA2 : Hard paved ground next to monitoring station AMS3A (View A)

3.1.10.9 The dust exceedance was therefore considered not to be due to the Project works.

3.1.10.10 The Contractor was recommended to continue implementing existing dust mitigation measures.

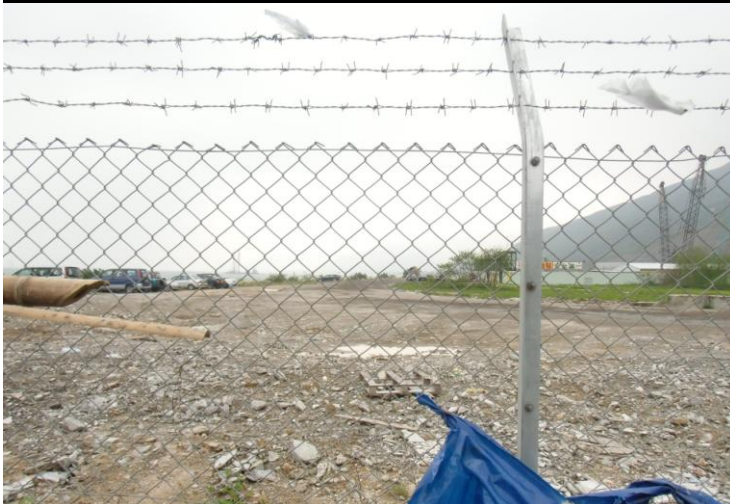
- 3.1.10.2 As informed by the Contractor, construction activities like sheet piling and percussive piling, were carrying out by nearby private development project during the course of monitoring, which are close to the monitoring station AMS3A but beyond the site boundary of Works Area WA2. Traffics were observed passing exposed soil surfaces at those construction sites of nearby private development project. Please also see photo and layout map attached for reference of site conditions.

View on Site B: Beyond the site boundary of WA2 (View B)

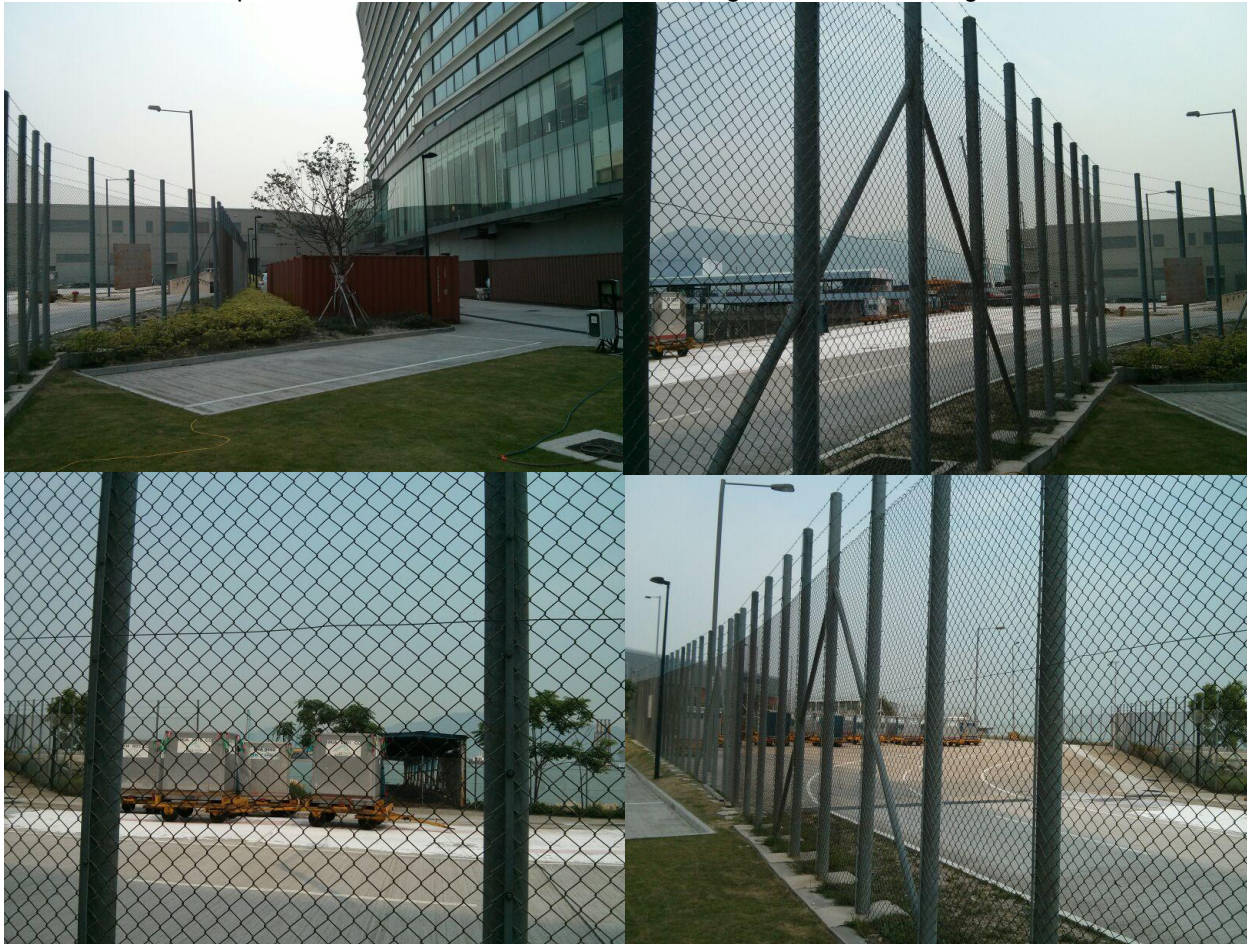
- 3.1.11.5 On the other hand, according to observation made at the monitoring station AMS7, there was no non-project potential cause/activity at the surrounding of monitoring station AMS7 which might potentially contribute to the dust action level exceedance.

3.1.11.10 Please see photos of the conditions of the surrounding near the monitoring station AMS7:

3.1.11.11 The dust exceedance was therefore considered not to be due to the Project works.

3.1.11.12 The Contractor was recommended to continue implementing existing dust mitigation measures.

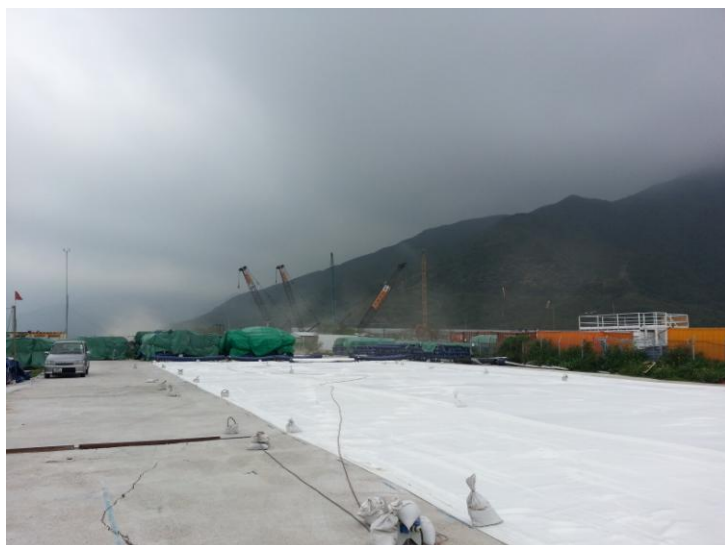
View of Works Area WA2 : the hard paved ground next to monitoring station AMS3A (View A)

3.1.12.10 The dust exceedance was therefore considered not to be due to the Project works.

3.1.12.11 The Contractor was recommended to continue implementing existing dust mitigation measures.

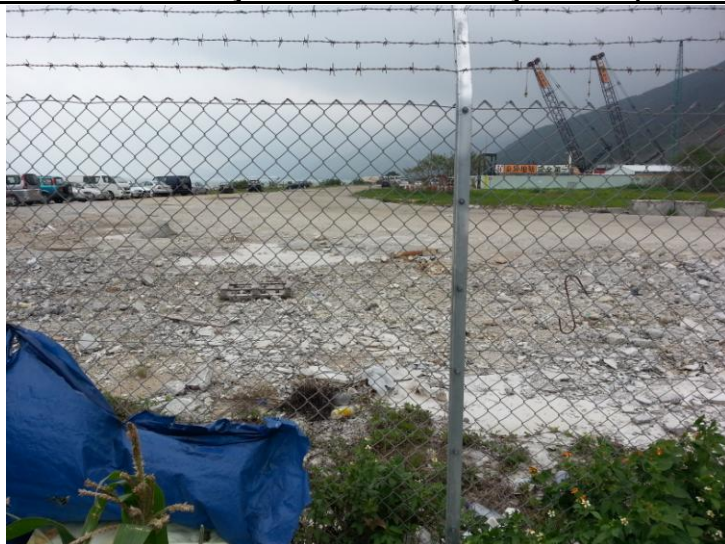
3.1.12.2 As informed by the Contractor, construction activities like sheet piling and percussive piling, were carrying out by nearby private development project during the course of monitoring, which are close to the monitoring station AMS3A but beyond the site boundary of Works Area WA2. Traffics were observed passing exposed soil surfaces at those construction sites of nearby private development project. Please also see photo and layout map attached for reference of site conditions.

View on Site B: Beyond the site boundary of WA2 (View B)
