China Harbour Engineering Company Limited

Contract No. HY/2010/02

**Hong Kong – Zhuhai – Macao Bridge
Hong Kong Boundary Crossing
Facilities –
Reclamation Works****Quarterly EM&A Report for
December 2013- February 2014**

Version: Rev. 0 Date: 26 June 2014

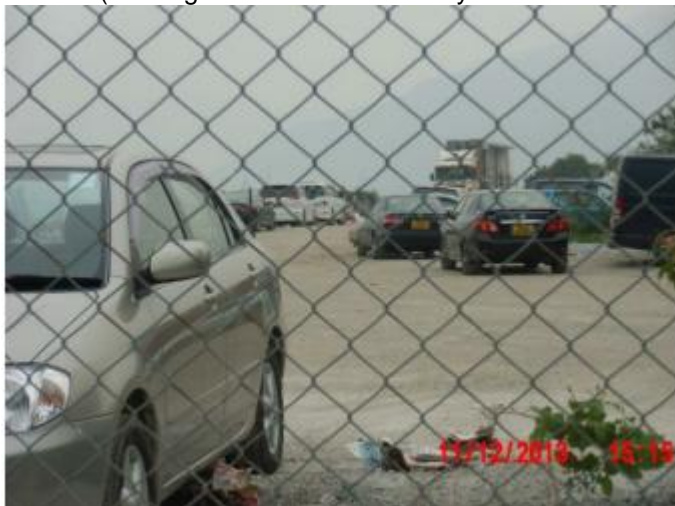
- 3.1.6.3 Photo records shows vehicle parking activities were observed inside an area at construction sites of nearby private development project which are close to the monitoring station AMS3A but beyond the site boundary of Works Area WA2. (Please also see photo and layout map attached for reference of site conditions (View A.))

View A: (Parking lot observed at nearby construction site which do not belongs to this Contract):

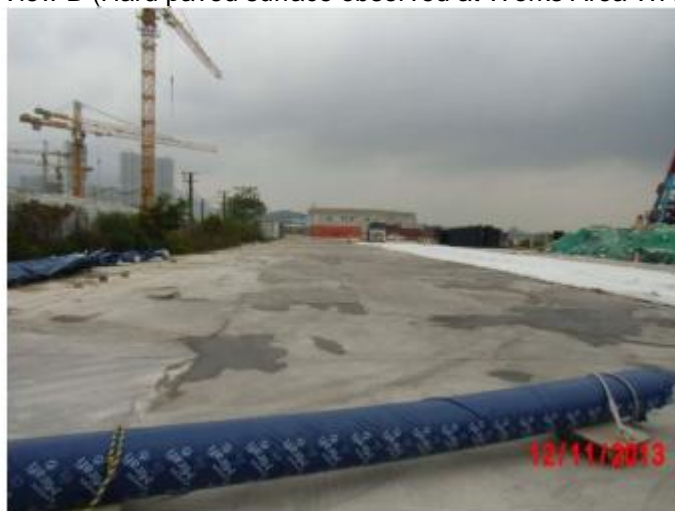
View B (Hard paved surface observed at Works Area WA2)

- 3.1.6.8 The dust exceedance was therefore considered not to be due to the Project works.
- 3.1.6.9 The Contractor was recommended to continue implementing existing dust mitigation measures.

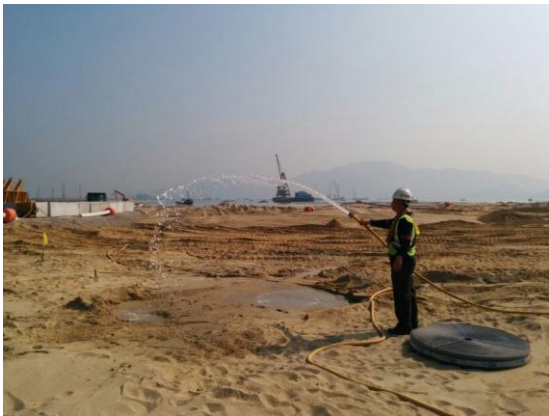
- 3.1.7.5 Photo record below shows that the Contractor implemented dust control measures on works area of Portion A:

- 3.1.7.11 The Contractor was recommended to continue implementing existing dust mitigation measures and the Contractor was reminded ensure to undertake watering at least 8 times per day on all exposed soil within the Project site and associated work areas throughout the construction phase.

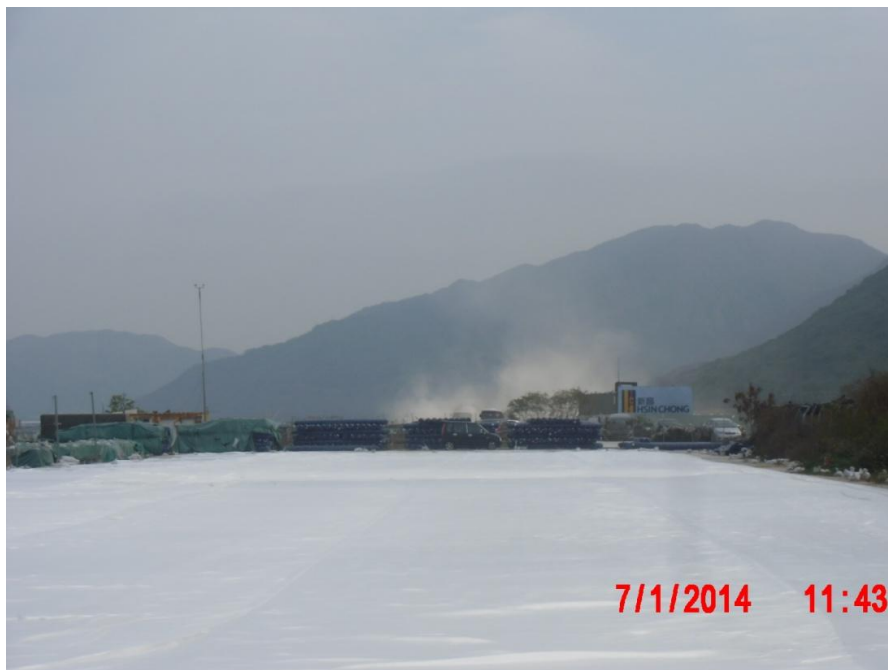
- 3.1.8.3 Photo records shows fugitive dust were generated by vehicle activities observed inside an area at construction sites of nearby private development project which are close to the monitoring station AMS3A but beyond the site boundary of Works Area WA2. (Please also see photo and layout map attached for reference of site conditions (View A.))

View A (fugitive dust were observed at the parking lot of the nearby construction site which do not belongs to this Contract)

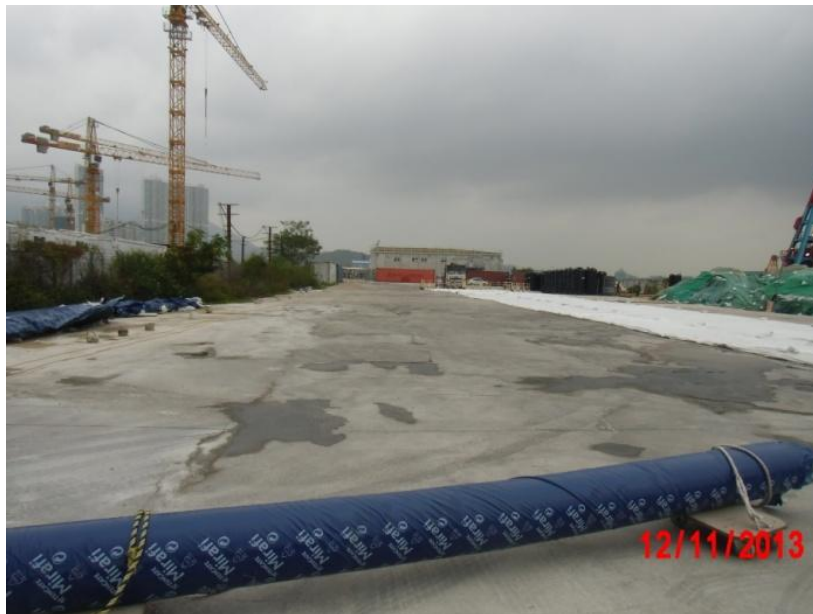
- 3.1.8.8 The following dust mitigation measures have been implemented at Works Area WA2:
1. Works Area WA2's surface was hard-paved, compacted or hydro-seeded (Please refer to attached layout map and photo record (View B))
 2. Vehicle washing facility was provided at vehicle exit points,
 3. Measures for preventing fugitive dust emission are provided, e.g. canvas/tarpaulin covers.
- 3.1.8.9 The Contractor was recommended to continue implementing existing dust mitigation measures.

View B (Hard paved surface observed at Works Area WA2)

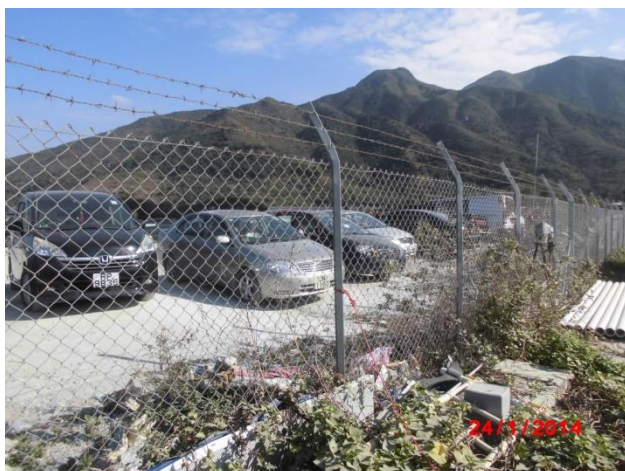
- 3.1.10.3 Photo records shows vehicle parking activities were observed inside an area at construction sites of nearby private development project which are close to the monitoring station AMS3A but beyond the site boundary of Works Area WA2. (Please also see photo and layout map attached for reference of site conditions (View A.))

View A (parking lot observed at nearby construction site which do not belongs to this Contract)

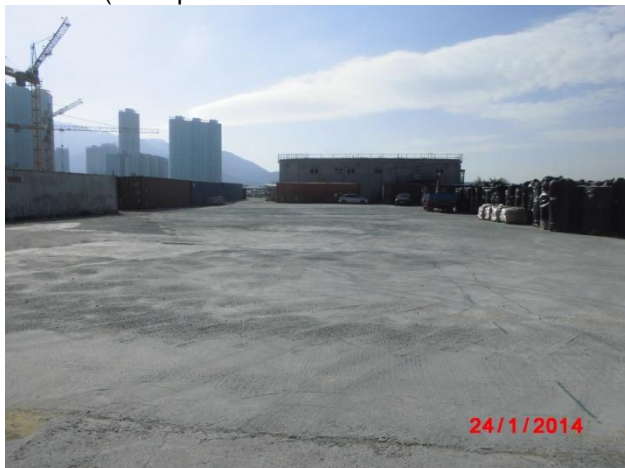
View B (Hard paved surface observed at Works Area WA2)

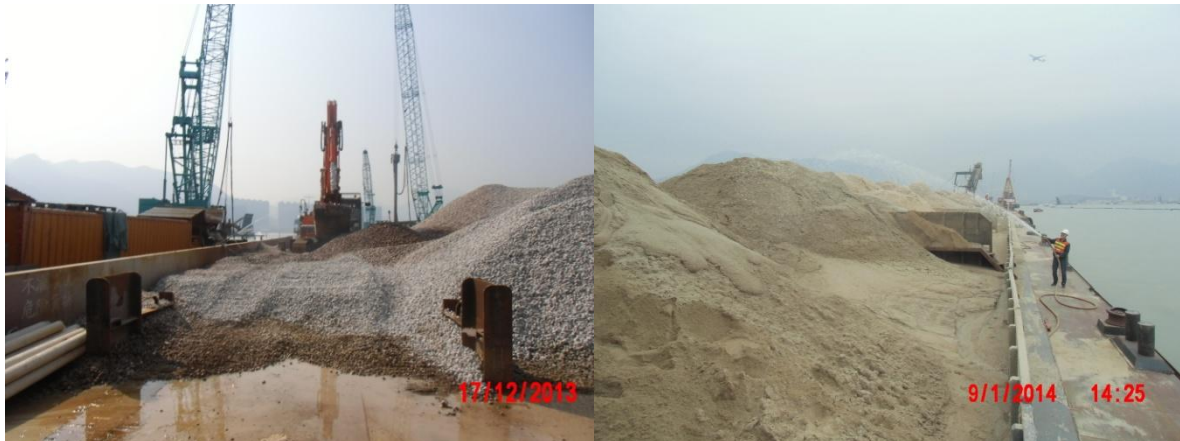
Photo record showed that the Contractor implemented dust control measures on pelican barge loaded with rock/sand. The Contractor was reminded to continue to provide dust control measures on pelican barge loaded with rock/sand.

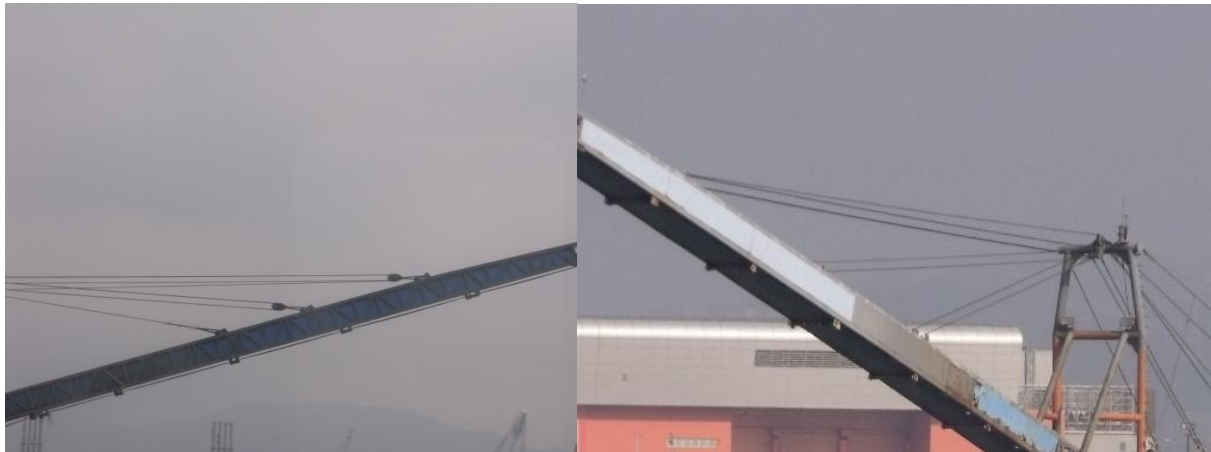
Photo record showed that the Contractor implemented dust control measures such as wind-board installed on pelican barge. The Contractor was reminded to continue to provide such dust control measure.

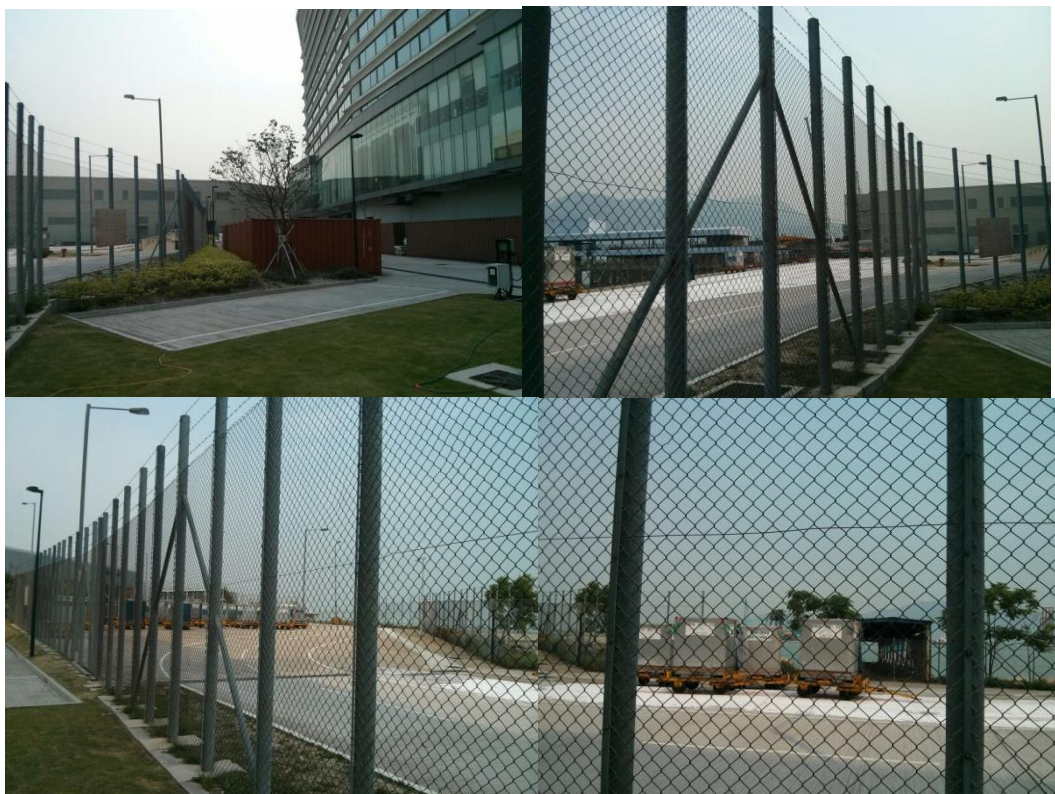
- 3.1.11.11 On the other hand, according to observation made at the monitoring station AMS7, there was no non-project potential cause/activity at the surrounding of monitoring station AMS7 which might potentially contribute to the dust action level exceedance.

Photo shows the conditions of the surrounding near the monitoring station AMS7:

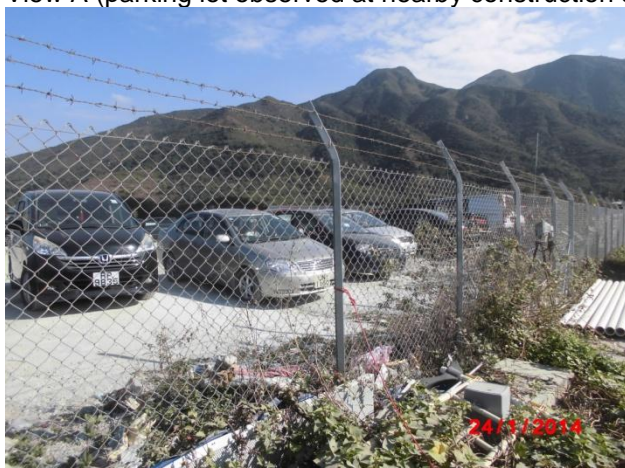
- 3.1.12.3 Photo records shows vehicle parking activities were observed inside an area at construction sites of nearby private development project which are close to the monitoring station AMS3A but beyond the site boundary of Works Area WA2. (Please also see photo and layout map attached for reference of site conditions (View A.))

View A (parking lot observed at nearby construction site which do not belongs to this Contract)

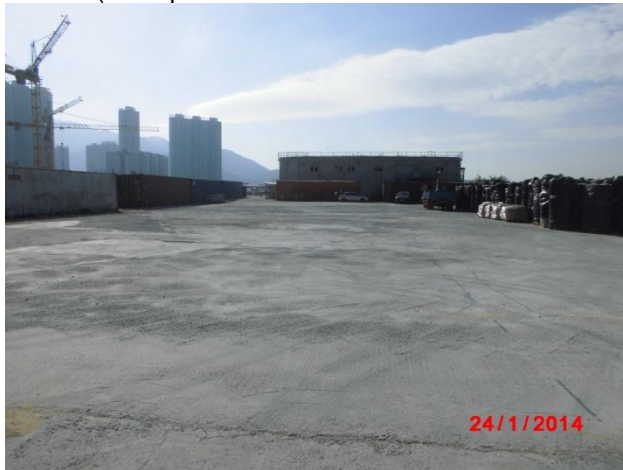
View B (Hard paved surface observed at Works Area WA2)

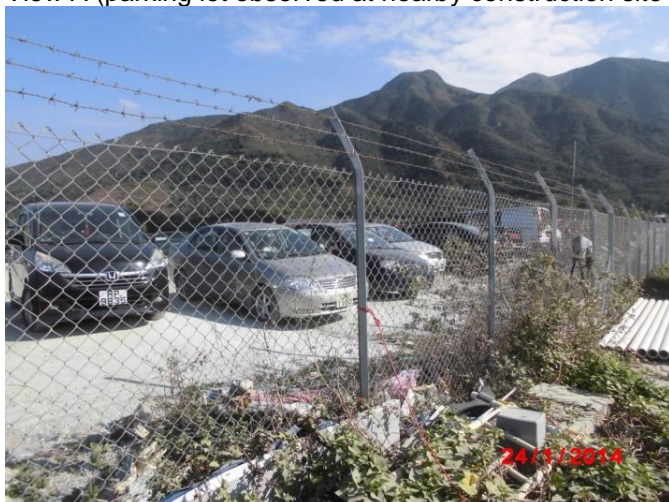
- 3.1.13.3 Photo records shows vehicle parking activities were observed inside an area at construction sites of nearby private development project which are close to the monitoring station AMS3A but beyond the site boundary of Works Area WA2. (Please also see photo and layout map attached for reference of site conditions (View A.))

View A (parking lot observed at nearby construction site which do not belongs to this Contract)

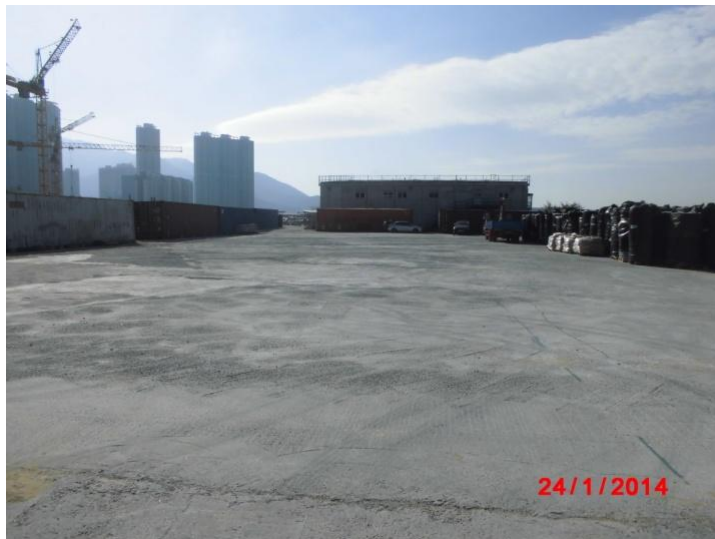
View B (Hard paved surface observed at Works Area WA2)

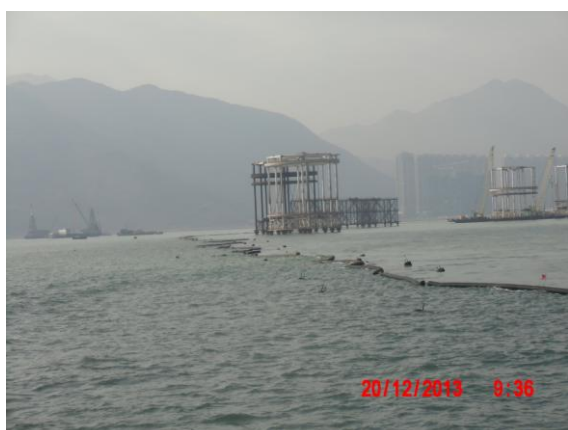
- 3.3.6.4 When impact water quality monitoring was carried out during mid flood tide at monitoring location IS8 on 20 Dec 13, no defects of the perimeter silt curtain was observed and no silty plume were observed to flow from the inside to the outside of the site boundary. (For reference, please see attached photo):

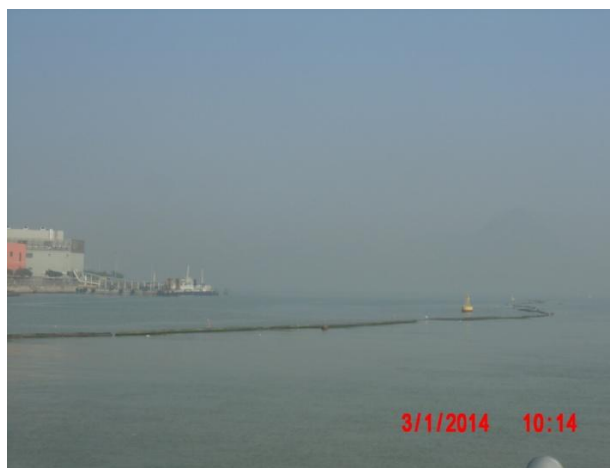
- 3.3.7.1 For locations and type of active works carried out on 03 Jan 14, please refer to the above layout map.
- 3.3.7.2 When impact water quality monitoring was carried out during mid flood tide at monitoring location IS10, SR5 and SR6 on 3 Jan 14, no silty plume were observed to flow from the inside to the outside of the northwestern part of the perimeter silt curtain.
- 3.3.7.3 IS10, SR5 (located outside northwest part of the perimeter silt curtain) and IS(Mf)11 (located outside north part of the perimeter silt curtain) which are closer to the active works than monitoring station SR6. Depth Averaged Suspended Solids (SS) values (in mg/L) recorded during the flood tide on the same day at IS10, SR5 and IS(Mf)11 were below the Action and Limit Level which shows that the water quality closer to active works was not adversely affected.

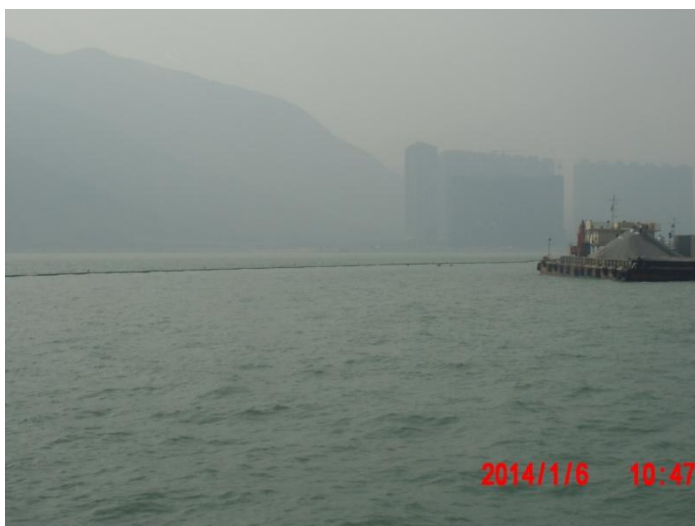
3.3.8.3 The turbidity level (in NTU) at IS(Mf)9, IS8, IS7 and IS(Mf)16 were below the action and limit level and no silt plume was observed when monitoring was conducted IS(Mf)9 and IS8, this indicates that the turbidity level (in NTU) at IS(Mf)9, IS8, IS7 and IS(Mf)16 were not adversely affected.

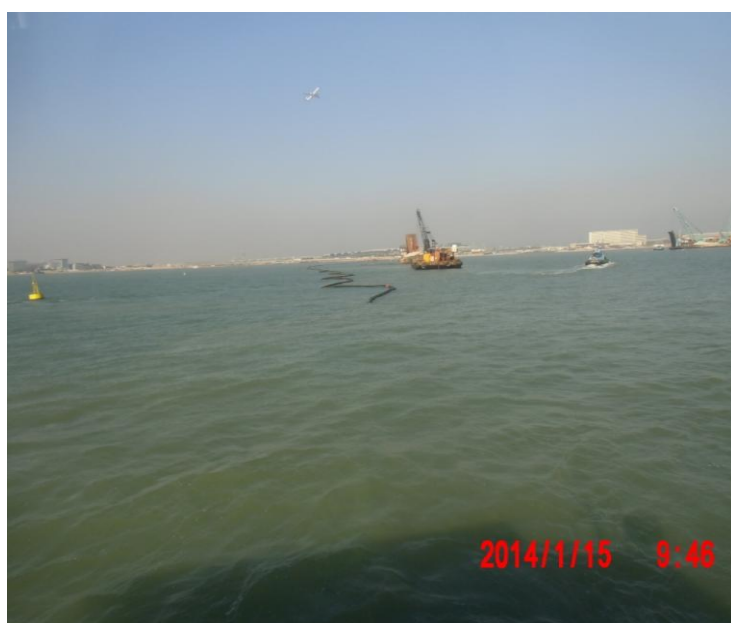
- 3.3.10.2 Since the turbidity level (in NTU) at IS(Mf)9, IS8, IS7 and IS(Mf)16 were below the action and limit level and no silt plume was observed when monitoring was conducted IS(Mf)9, this indicates that the turbidity level (in NTU) at IS(Mf)9, IS8, IS7 and IS(Mf)16 were not adversely affected. Please refer to the photo record attached for sea condition recorded on 15 Jan 14 at southeast vessel entrance of the perimeter silt curtain (near monitoring station IS(Mf)9).

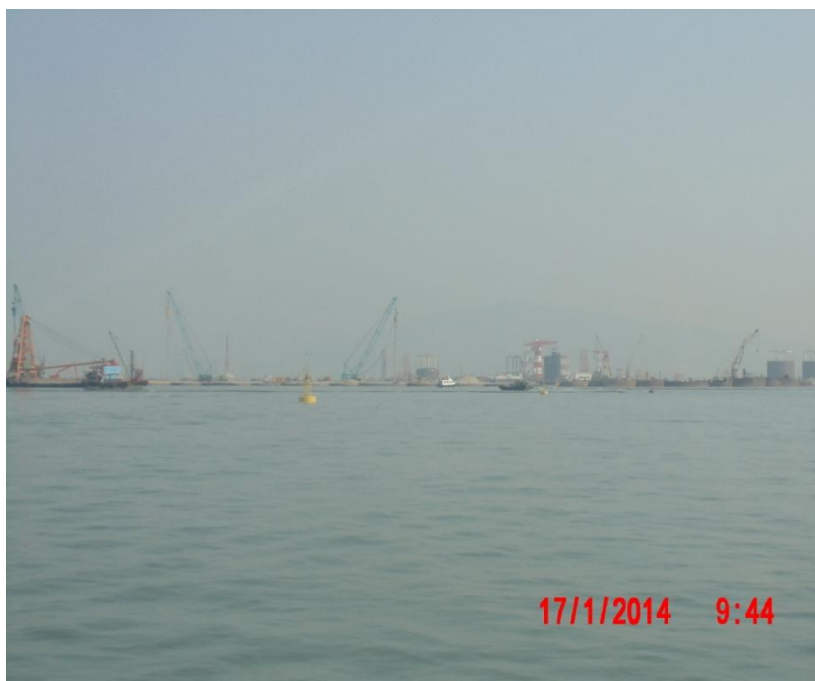
- 3.3.11.1 The Depth averaged turbidity (in NTU) and depth averaged SS (in mg/L) of nearby monitoring station, such as IS8, IS7 and IS(Mf)16 were below the action and limit level, indicating the water quality at area nearby IS(Mf)9 was not adverse affected.
- 3.3.11.2 Since the turbidity level (in NTU) at IS(Mf)9, IS8, IS7 and IS(Mf)16 were below the action and limit level and no silt plume was observed when monitoring was conducted at IS(Mf)9. Please refer to the photo record below for sea condition near IS(Mf)9 on 17 Jan 14.
