Hong Kong- Zhuhai- Macao Bridge Hong Kong Boundary Crossing Facilities (Superstructure and Infrastructure Contracts) Notifications of Environmental Quality Limits Exceedances					Notification No.: 20180302SS	
Date of Notification: 8 March 2018				Date of Investigation Report: 9 April 2018		
Works Inspected: Data collected from water sampling works on 2 March 2018 and the results were issued on 7 March 2018						
Monitoring Location: Water Quality Monitoring Station						
Parameter: Dissolved Oxygen (DO) / Suspended Solid (SS)/ Turbidity (TURB)						
Action & Limit Level (AL & LL) / Measured Level:						
PARAM	STATION	DEPTH	AL (mg/L)	LL (mg/L)	MEASURED AT MID-EBB TIDE (mg/L)	MEASURED AT MID-FLOOD TIDE (mg/L)
SS	SR6	Depth Average	23.5 and 120% (i.e. 8.3 for mid-ebb/6.6 for mid-flood) of upstream control station's SS at the same tide of the same day	34.4 and 130% (i.e. 9.0 for mid-ebb/7.1 for mid-flood) of upstream control station's SS at the same tide of the same day and 10mg/L for WSD Seawater intakes	10.4	24.6

Contract No.: HY/2013/01

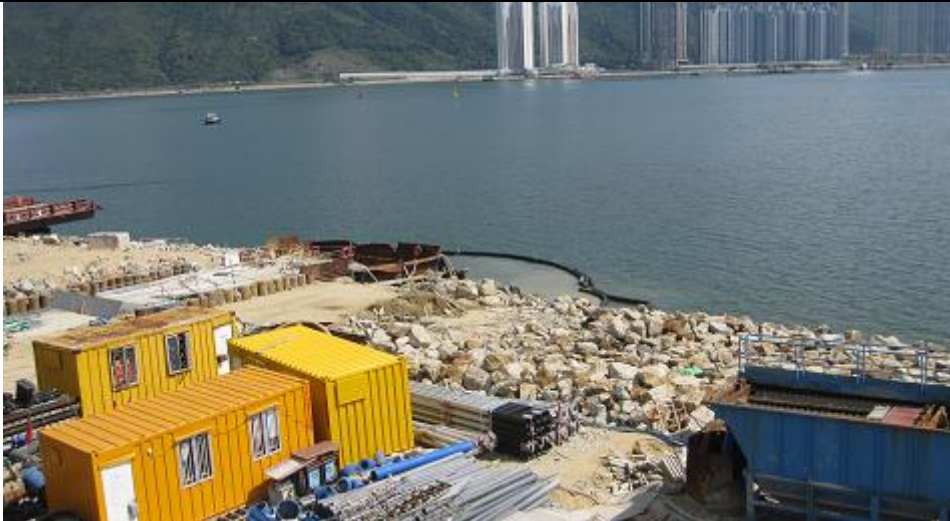
Attachment 1

Silty water was observed outside silt curtain at Box Culvert D. The Contractor was reminded to check the integrity of silt curtain.

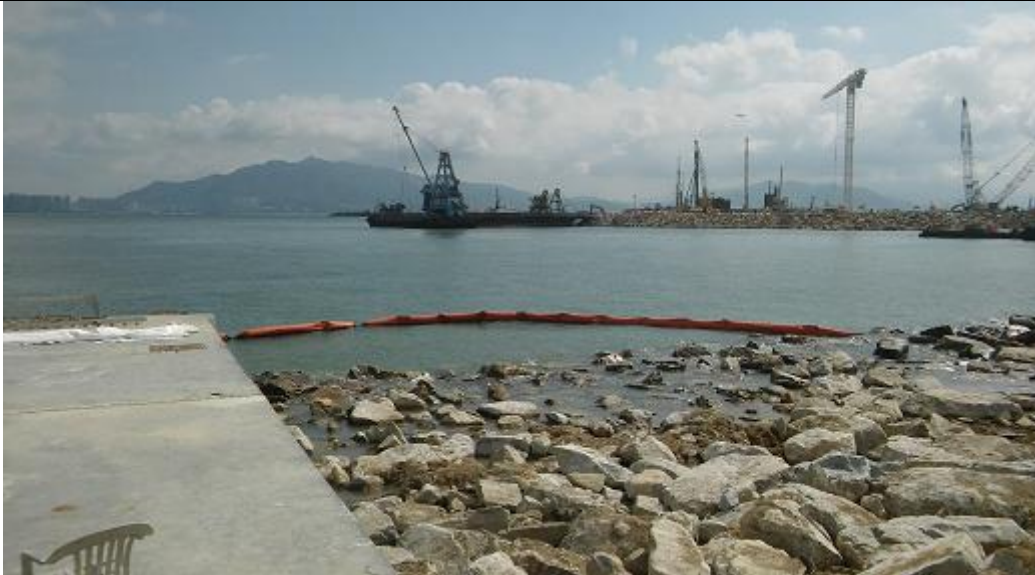
Photo 1

As confirmed with RSS of Contract No. HY/2013/03, there was no marine transportation on the date of exceedance. The marine-based works in Box Culvert B had been completed. Silt curtain was also maintained to enclose the work area of the outlet of the box culvert fully. For turbidity exceedance recorded at the WQM station IS(Mf)11 and SR5(N) closer to the marine delivery route, there was no turbidity exceedance recorded at WQM station IS10(N) which also close to the marine delivery route. It was unlikely that the works undertaken by Contract No. HY/2013/03 caused turbidity exceedance recorded at the concerned WQM station during mid-flood tide on 13 May 2018. The photos of site situation at box culvert are shown in Attachment 2.

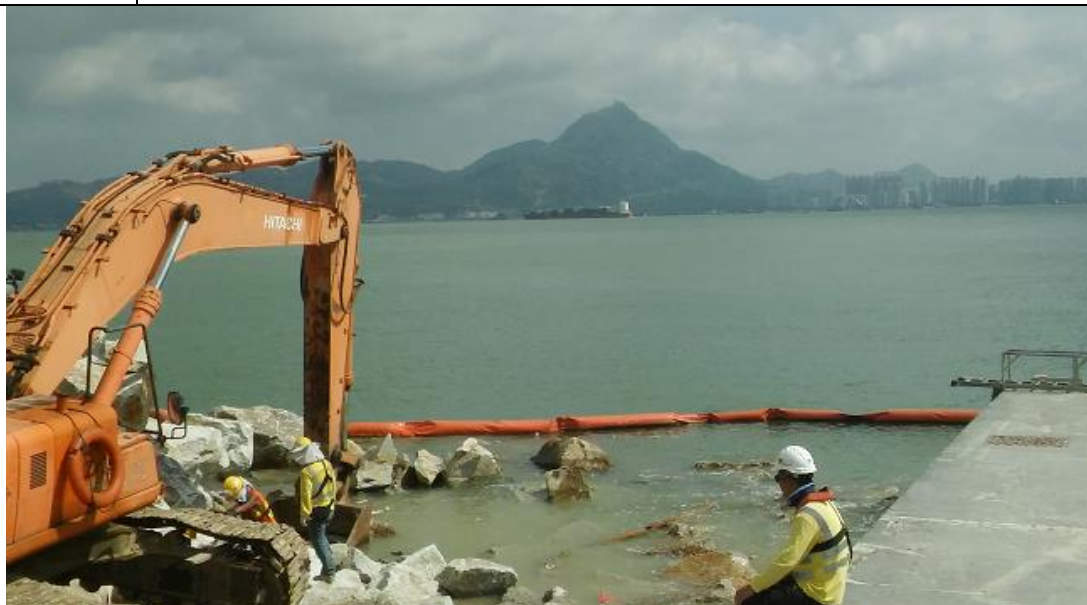
Photo 3 | Construction of seawall
