### Environmental Complaint Form

<b>RECEIPT OF COMPLAINT</b>		<b>Ref: ENPO-C0128</b>
Date:	23 November 2017	
Time:	N/A	
Via:	EPD (ref: NCF-N09/RS/00038038-17)	
<b>COMPLAINANT</b>		
Name:	N/A	Address: N/A
Contact no.:	N/A	
<b>DETAILS OF COMPLAINT</b>		
Date:	Not specified in complaint	
Time:	Not specified in complaint	
Parameter:	Air Quality	Other (specify): N/A
Description:	The complaint was about dust dispersion from HZMB BCF Island works site. According to the complainant, a large amount of dust was generated due to water spray not being provided at every part of the site and was most serious near the toll gate.	
<b>INVESTIGATION RESULT &amp; RESPONSE</b>		
IEC and ER notified on:	23 November 2017	
Investigation conducted on:	23 & 29 November 2017	
Result of investigation:	<p>As informed by the Contractor of HY/2013/04, watering of all main haul roads was provided in accordance with the HY/2013/04 site watering plan (as presented in <b>Attachment 1</b>). This plan schedules water spraying for 8 times per day which follows the recommended mitigation measures in the EM&amp;A Manual.</p> <p>During ET's regular weekly site inspection on 20 November 2017 (between 14:00 and 15:00) and

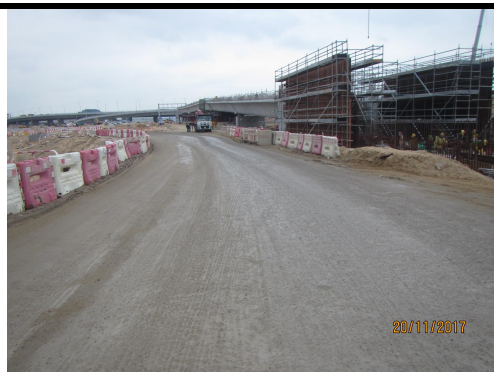
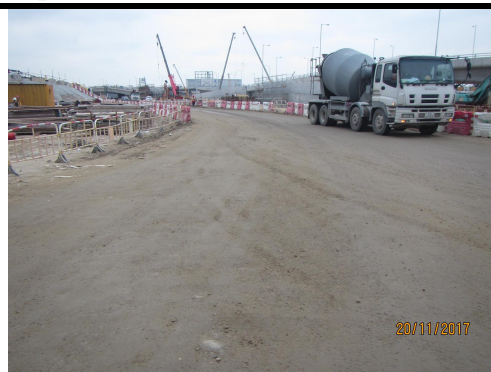
1a. Water spray provided for haul roads in the HY/2013/04 site area (near Box Culvert C). No fugitive dust generation was observed.

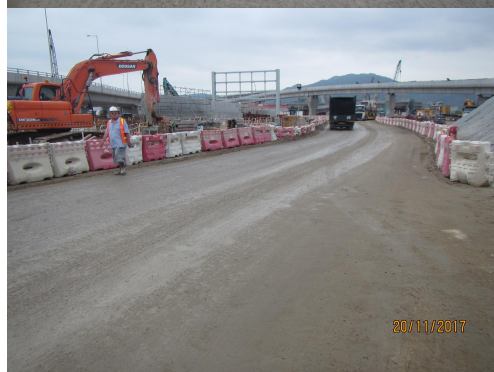
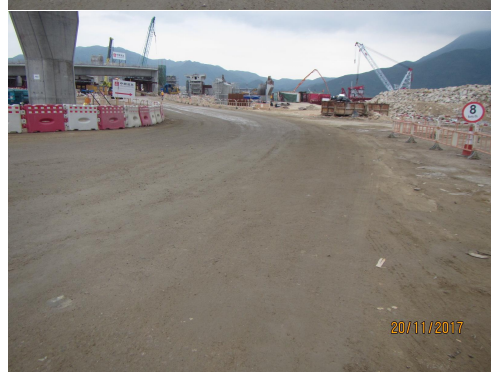
1b. Water spray provided for haul roads in the HY/2013/04 site area (near Box Culvert D). No fugitive dust generation was observed.

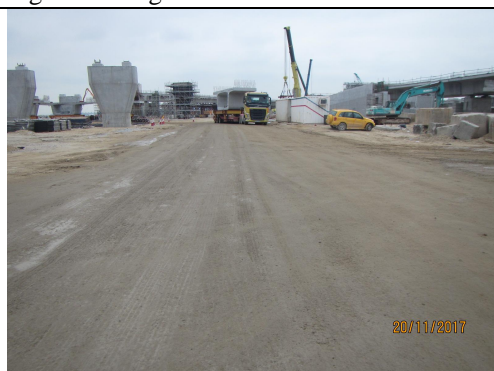
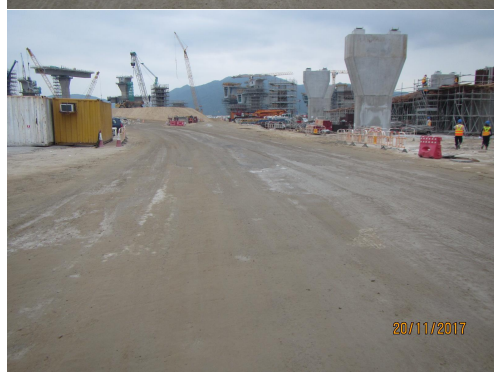
1c. Water spray provided for haul roads in the HY/2013/04 site area (near Bridge D12). No fugitive dust generation was observed.

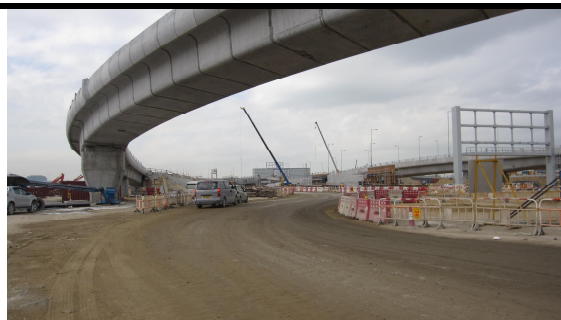
1a. Water spray provided for haul roads in the HY/2013/04 site area (near Box Culvert C). No fugitive dust generation was observed.

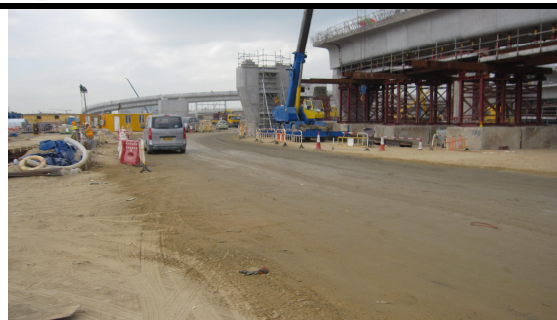
1b. Water spray provided for haul roads in the HY/2013/04 site area (near Box Culvert D). No fugitive dust generation was observed.

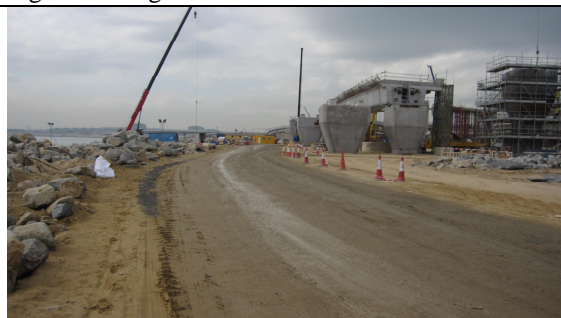
1c. Water spray provided for haul roads in the HY/2013/04 site area (near Bridge D12). No fugitive dust generation was observed.
