### Environmental Complaint Form

<b>RECEIPT OF COMPLAINT</b>		<b>Ref: ENPO-C0129</b>
Date:	29 December 2017	
Time:	N/A	
Via:	HyD (ref: CASE#2-4404344922)	
<b>COMPLAINANT</b>		
Name:	N/A	Address: N/A
Contact no.:	N/A	
<b>DETAILS OF COMPLAINT</b>		
Date:	Not specified in complaint	
Time:	Not specified in complaint	
Parameter:	Air Quality and Water Quality      Other (specify): N/A	
Description:	<p>The complaint was about effectiveness of mitigation measures implemented for dust and mud (namely, street washing vehicles and dust collecting vehicles) on East Coast Road to handle dust problems associated with HZMB BCF Island site works, which according to the complainant, was not as effective as they should. Specifically, the complainant said that water spray from street washing vehicles had turned the dust on the road into mud, and furthermore dust was still present on the road despite the use of dust collecting vehicles, causing the problem to persist.</p>

HY/2013/04  
HONG KONG-ZHUHAI-MACAO BRIDGE  
HONG KONG BOUNDARY CROSSING FACILITIES  
- INFRASTRUCTURE WORKS STAGE II  
(SOUTHERN PORTION)

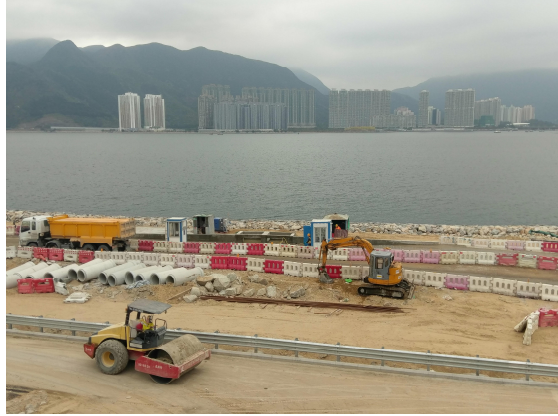
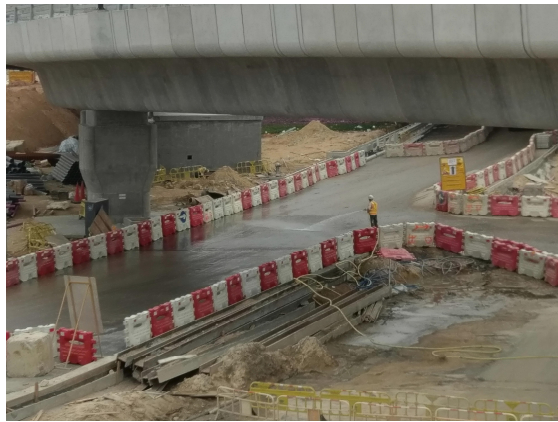
1. Wheel wash facility and water spray provided at HY/2013/04 site boundary for vehicles leaving HY/2013/04 site towards BCF Island site exit.

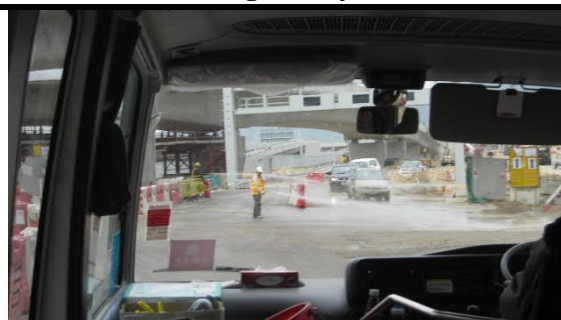
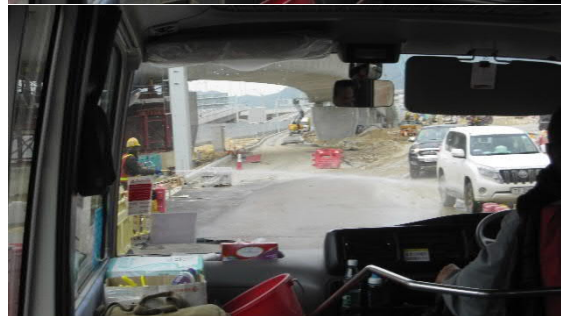
1. Water spray provided at HY/2013/04 site boundary for vehicles leaving HY/2013/04 site towards BCF Island site exit. No adverse observation was observed.

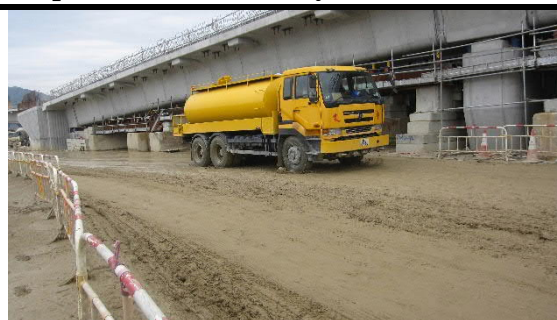
2. Water spray provided for haul roads in the HY/2013/04 site area (near Bridge D10).

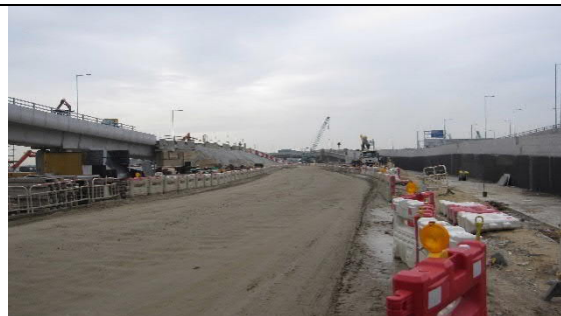
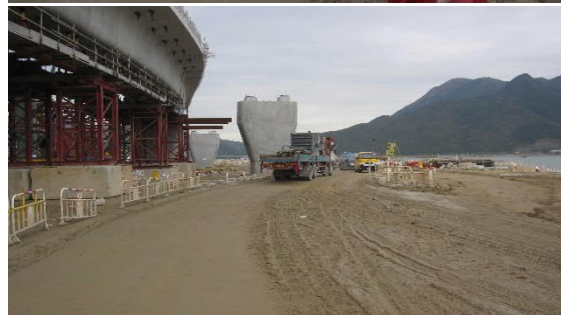
3. Haul roads were wetted in the HY/2013/04 site area (between Box Culvert C and Box Culvert D).

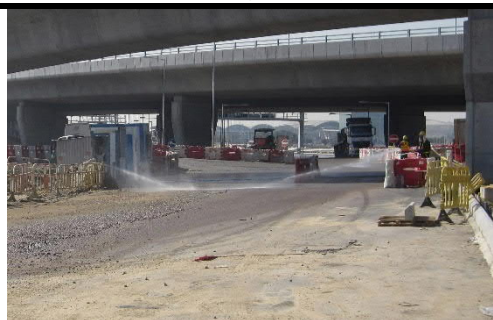
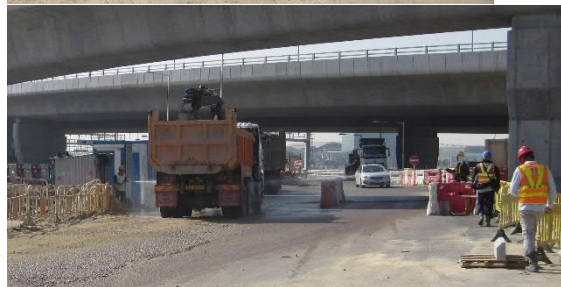
1a. Water spray provided for site vehicles leaving the HY/2013/04 site area towards BCF Island site exit.

Air quality observation: The Contractor was reminded to display a sign of temporary stop in the vicinity of wheel washing facilities.

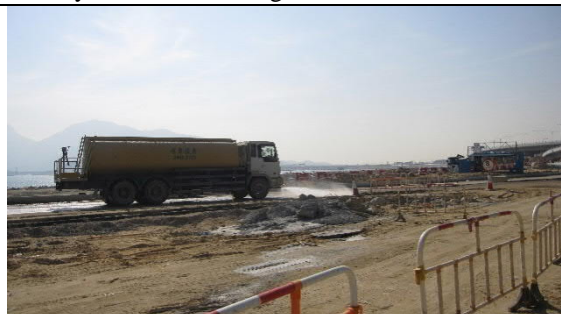
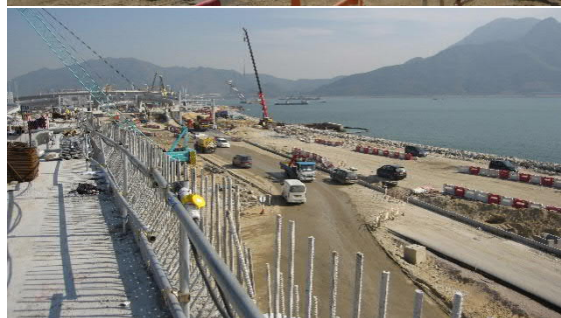
2. Water spray provided for haul roads in the HY/2013/04 site area (near Box Culvert C). No fugitive dust generation was observed.

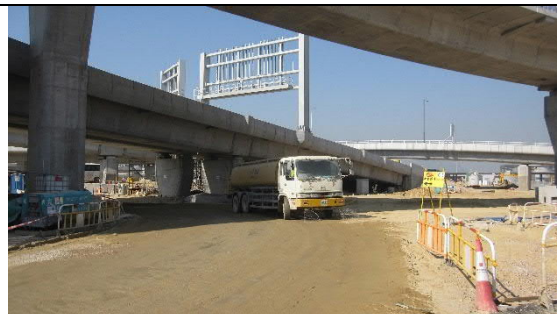
3. Water spray provided for haul roads in the HY/2013/04 site area (near Bridge D14a). No fugitive dust generation was observed.

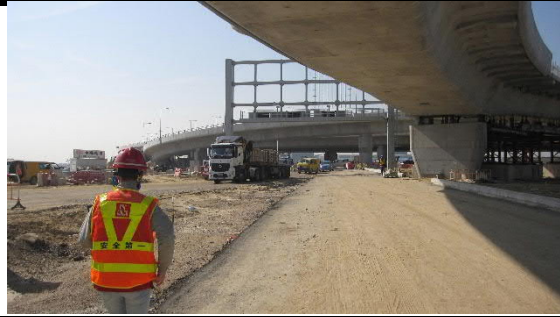
- 15 January 2018 (14:30-15:30): Water spray was provided for haul roads in the HY/2013/04 site area. Water spray from two hoses was provided by the Contractor to wash the wheels of vehicles leaving HY/2013/04 and entering HY/2013/02 site towards HZMB BCF Island site exit. An air quality observation regarding effectiveness of water spray was made; subsequently the Contractor displayed a temporary stop sign to ensure vehicles were being properly washed at this location and the observation was closed. Also, an air quality observation regarding dry haul road at Bridge D1 was observed; subsequently, the Contractor provide water spray.

4a. Air quality observation: Dry haul road at Bridge D1.

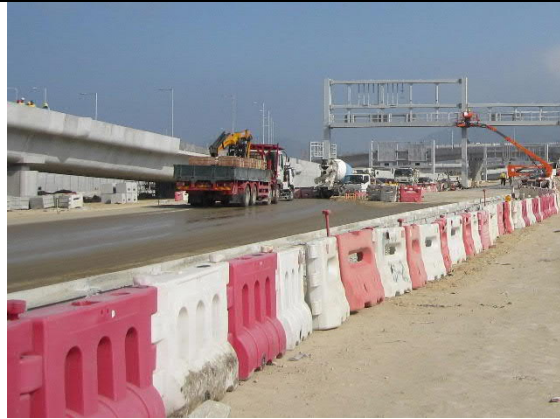
1. Water spray provided for haul roads in the HY/2013/04 site area (near Box Culvert C). No fugitive dust generation was observed.

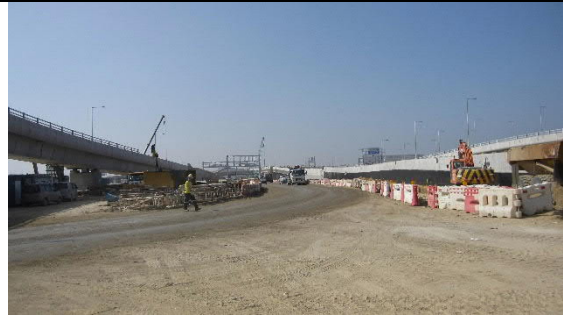
2. Water spray provided for haul roads in the HY/2013/04 site area (near Bridge D13). No fugitive dust generation was observed.

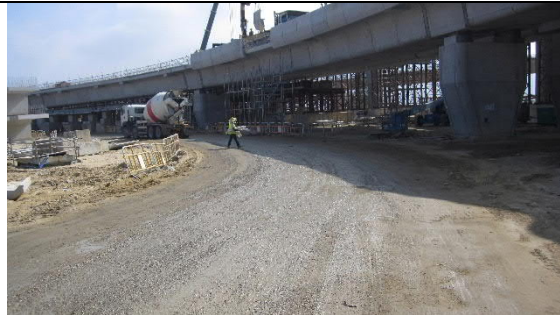
3. Water spray provided for haul roads in the HY/2013/04 site area (near Bridge D10). No fugitive dust generation was observed.

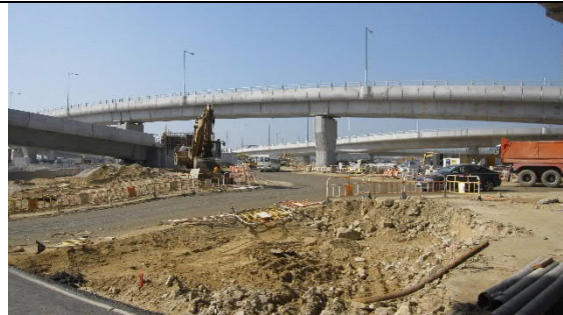
4. Water spray provided for haul roads in the HY/2013/04 site area (near Bridge D9a). No fugitive dust generation was observed.

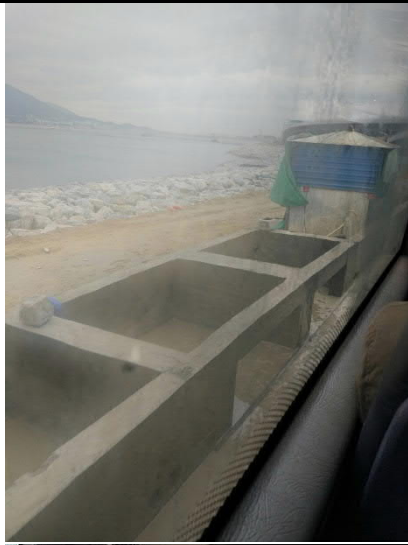
1. Wheel wash facility was in operation at HY/2013/04 site boundary for vehicles leaving HY/2013/04 site towards BCF Island site exit. No specific observation referring to air or water quality mitigation measures associated with access roads was observed.

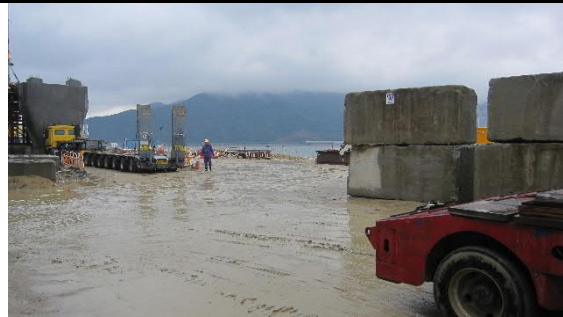
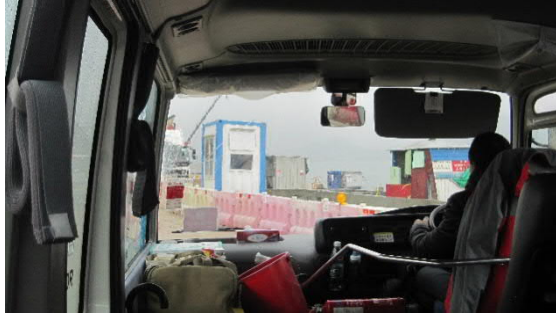
2. Water spray provided for haul roads in the HY/2013/04 site area (near Box Culvert D). No fugitive dust generation was observed.

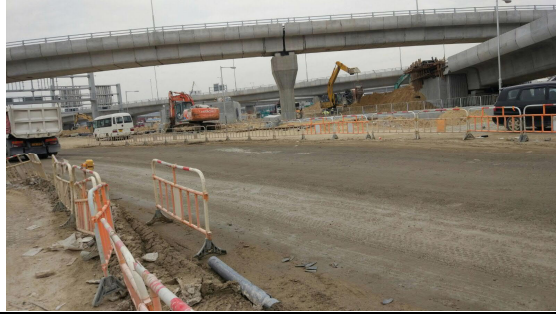
1. Haul roads were wetted in the HY/2013/04 site area (between Box Culvert C and Box Culvert D). No specific observation referring to air or water quality mitigation measures associated with access roads was observed.

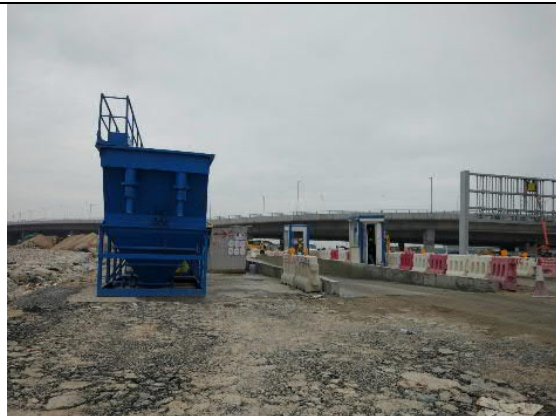
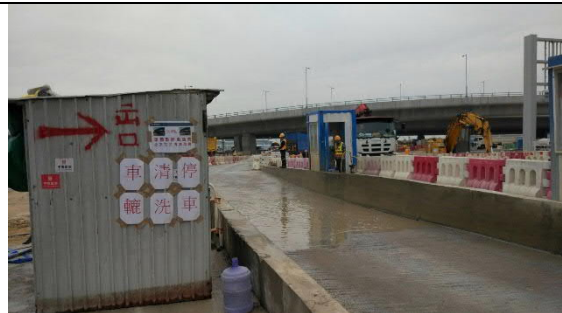
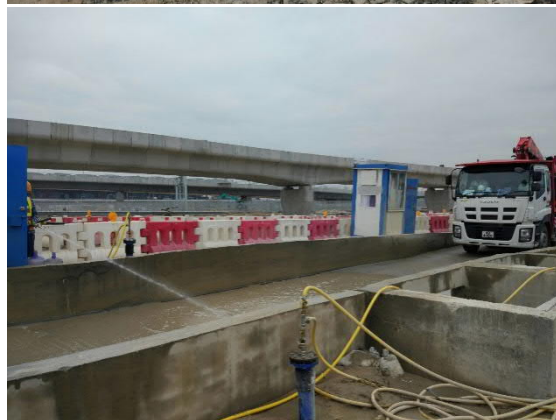
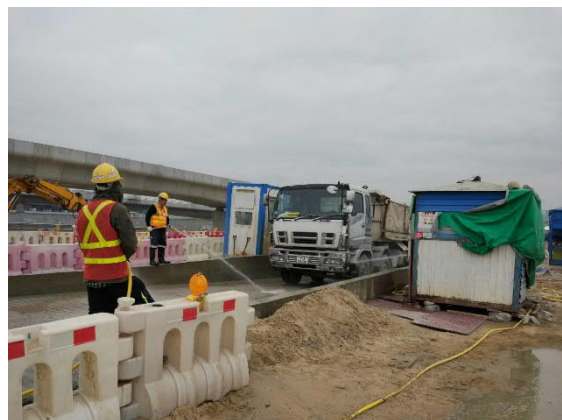
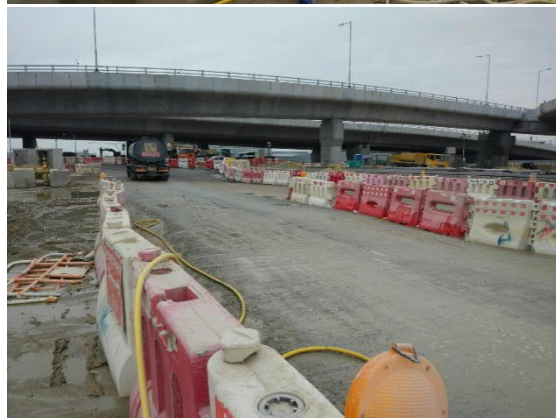
2. Wheel wash facility was in operation at HY/2013/04 site boundary for vehicles leaving HY/2013/04 site towards BCF Island site exit. No specific observation referring to air or water quality mitigation measures associated with the wheel wash facility was observed.

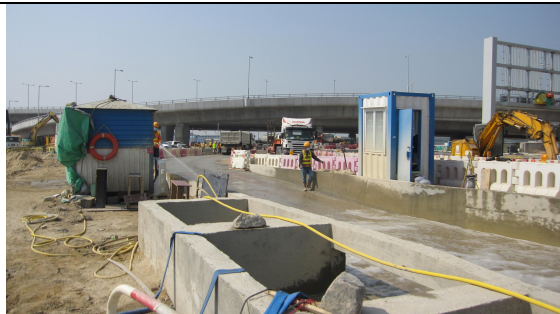
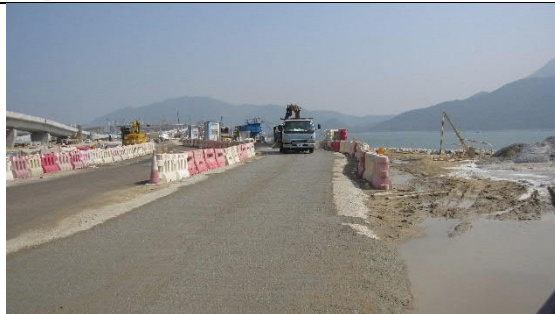
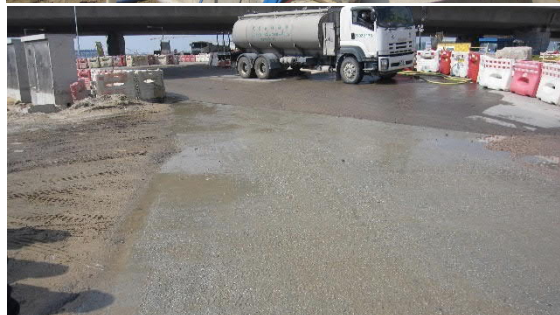
1. Wheel wash facility was in operation at HY/2013/04 site boundary for vehicles leaving HY/2013/04 site towards BCF Island site exit. No specific observation referring to air or water quality mitigation measures associated with the wheel wash facility was observed.

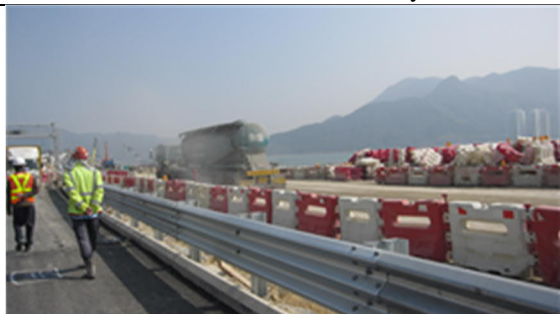
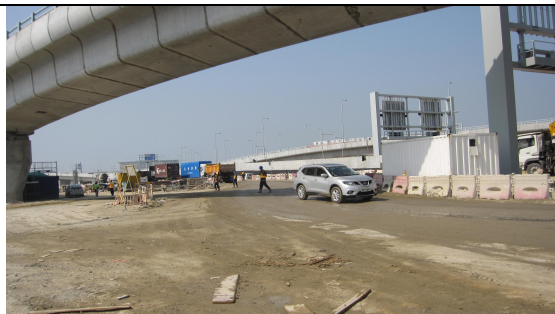
- 12 February 2018 (14:00-15:00): Wheel wash facility was in operation; no specific observation referring to air or water quality mitigation measures associated with the wheel wash facility was observed. Water spray was provided for haul roads in the HY/2013/04 site area. An air quality observation regarding fugitive dust generated when vehicles passed through the haul road between wheel washing facilities and Box Culvert C was observed. The Contractor was reminded to provide watering on haul road frequently.

2. Air quality observation: Fugitive dust was generated when vehicles passed through the haul road between wheel washing facilities and Box Culvert C. The Contractor was reminded to provide watering on haul road frequently.

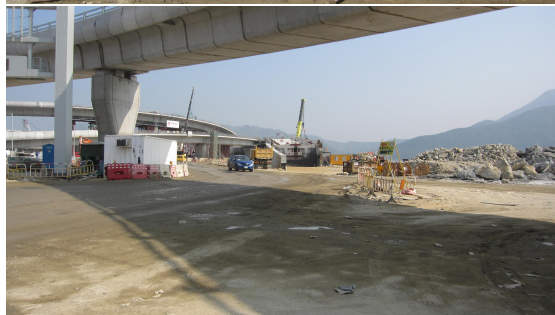
3. Haul roads were wetted in the HY/2013/04 site area (between Box Culvert C and Box Culvert D).
