### Environmental Complaint Form

<b>RECEIPT OF COMPLAINT</b>		<b>Ref: ENPO-C0135</b>
Date:	22 June 2018	
Time:	N/A	
Via:	HyD	
<b>COMPLAINANT</b>		
Name:	Not specified in complaint	Address: N/A
Contact no.:	N/A	
<b>DETAILS OF COMPLAINT</b>		
Date:	-	
Time:	13 June 2018	
Parameter:	Water Quality	Other (specify): N/A
Description:	The complaint was about discharge of muddy water from HKBCF. According to site photos provided by HyD (see <b>Attachment 1</b> ), it is noticed that there was muddy water discharged via as-constructed box culverts/outfall structures at various parts of seawall on 13 June 2018. An opening in the silt curtain at Box Culvert C was also observed.	
<b>INVESTIGATION RESULT &amp; RESPONSE</b>		
IEC and ER notified on: 25 June 2018		
ET inspected site on: 27 June 2018		
Result of investigation:		
<p>This investigation reports the findings with respect to Box Culverts C and D which are located inside HY/2013/04 works site. It is noted that more than one HKBCF contract site was subject to the present complaint.</p> <p>It is noted that the construction of Box Culverts C and D is divided into two parts, with HY/2013/04 and the adjacent BCF contract each responsible for

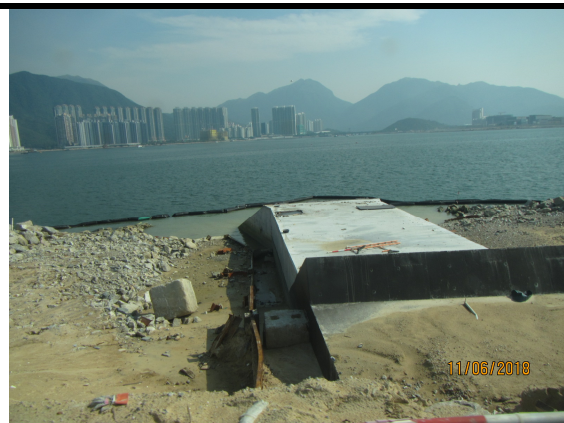
1. Silt curtain at Box Culvert C was observed as secured. No leakage of muddy water into the open waters was observed.

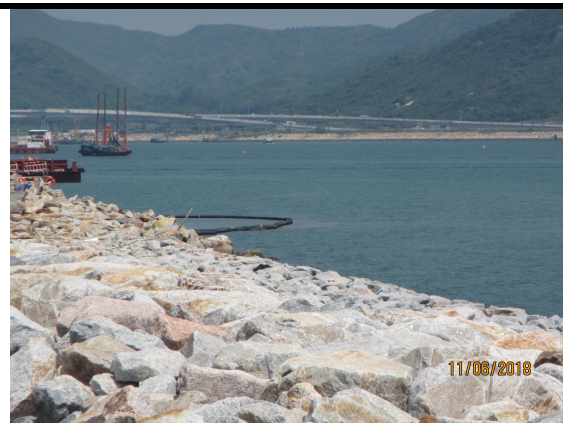
2. Silt curtain at Box Culvert D was observed as secured. No leakage of muddy water into the open waters was observed.

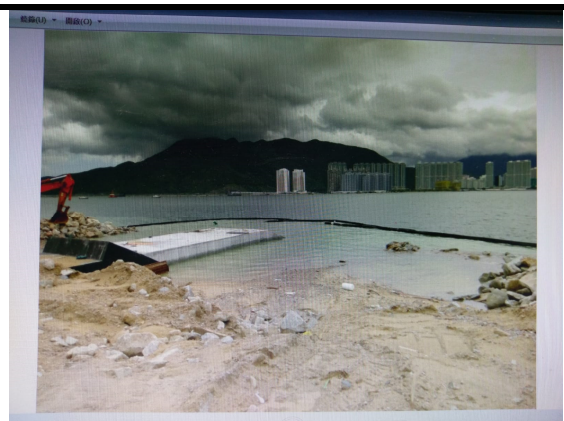
1. 13 June 2018 (daytime): Silt curtain at Box Culvert C was observed as secured. No leakage of muddy water into the open waters was observed.

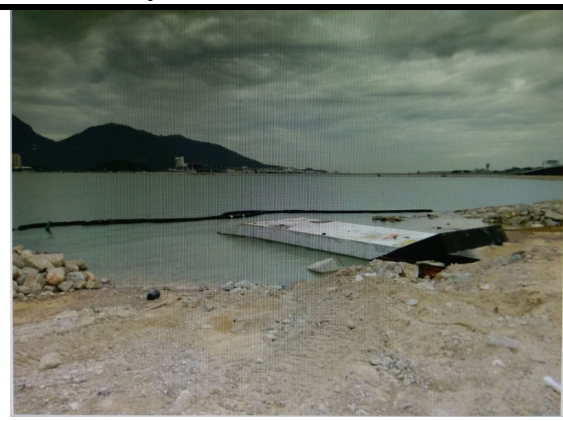
After the heavy rain, the silt curtains were inspected and readjusted to ensure no leakage of site runoff into the open waters. Photo taken by the Contractor on 16 June 2018 is also presented in **Attachment 3**.

2. 16 June 2018: Silt curtain at Box Culvert C was observed as secured. No leakage of muddy water into the open waters was observed.

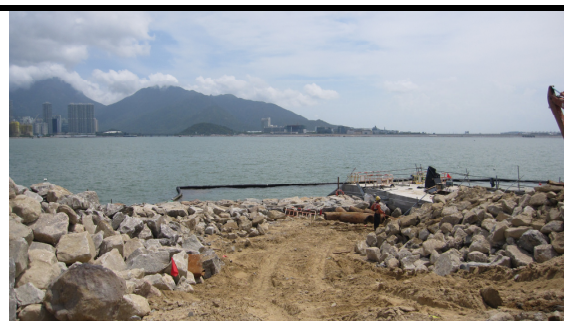
ET conducted weekly site inspection on 20 June 2018, during which the HY/2013/04 site shoreline interfacing with open waters was inspected. There was no observation regarding any overflow of site runoff or presence of silty water in the open waters associated with that shoreline. Silt curtains at Box Culverts C and D were observed as secured with no leakage of muddy water into the open waters. According to the Contractor, the opening in the silt curtain at Box Culvert C was repaired by 20 June 2018. Relevant photos are presented in **Attachment 3**.

1. Silt curtain at Box Culvert C was observed as secured. No leakage of muddy water into the open waters was observed.

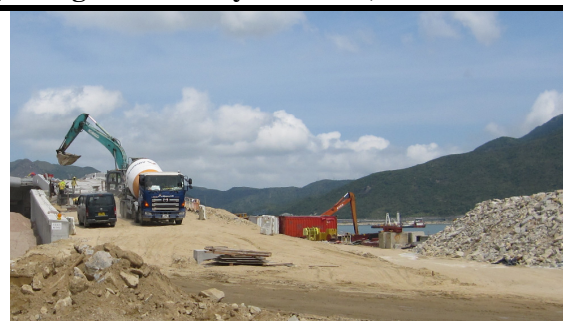
2. Silt curtain at Box Culvert D was observed as secured. No leakage of muddy water into the open waters was observed.

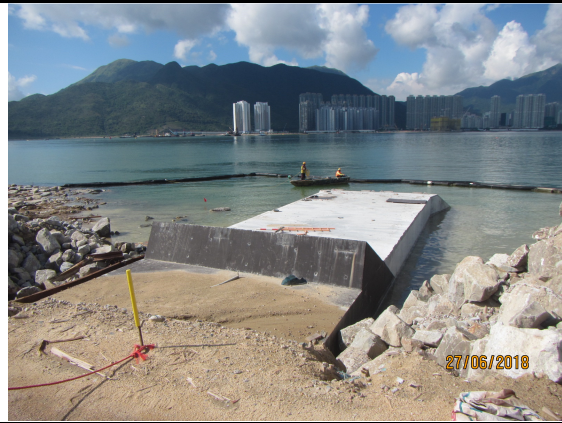
1. Silt curtain at Box Culvert C was observed as secured. No leakage of muddy water into the open waters was observed.

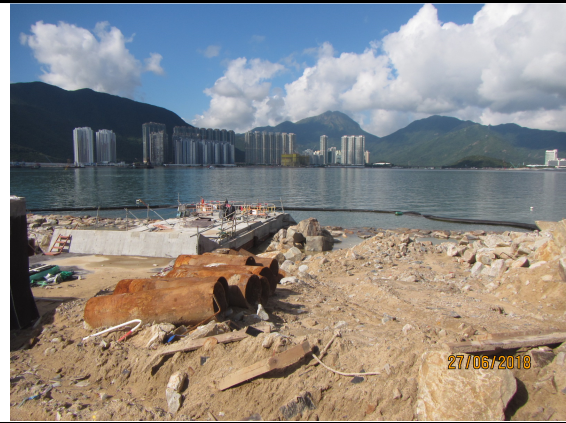
2. Silt curtain at Box Culvert D was observed as secured. No leakage of muddy water into the open waters was observed.
