### Environmental Complaint Form

<b>RECEIPT OF COMPLAINT</b>		<b>Ref: ENPO-C0139</b>
Date:	3 October 2018	
Time:	N/A	
Via:	EPD/ENPO	
<b>COMPLAINANT</b>		
Name:	Not specified in complaint	Address: N/A
Contact no.:	N/A	
<b>DETAILS OF COMPLAINT</b>		
Date:	-	
Time:	-	
Parameter:	Air quality	Other (specify): N/A
Description:	The complaint referred to a large amount of dust generated due to lack of water spraying on dirt road at HKBCF Island site. As informed by EPD, the location under complaint was near the exit/entrance of Contract No. HY/2013/04 as advised by the complainant.	
<b>INVESTIGATION RESULT &amp; RESPONSE</b>		
IEC, ER and ET notified on: 3 October 2018		
Result of investigation:		
<p>The relevant mitigation measures for access roads for the HZMB BCF Island site, as required in the EMIS and statutory requirements in the Air Pollution Control (Construction Dust) Regulations and other applicable environmental legislation, are consolidated as follows:</p> <ul style="list-style-type: none"> <li>• Immediately before leaving a construction site, every vehicle shall be washed to remove any dusty materials from its body and wheels and to ensure that no earth, mud or debris is depo

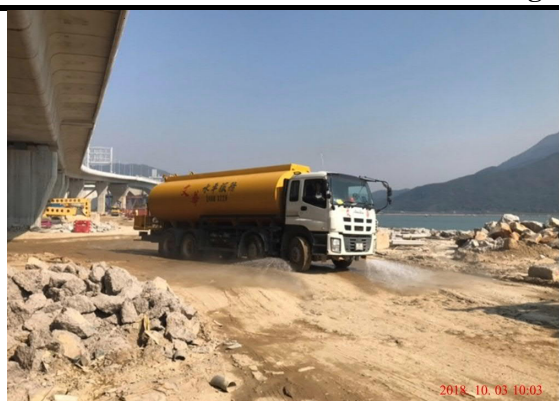
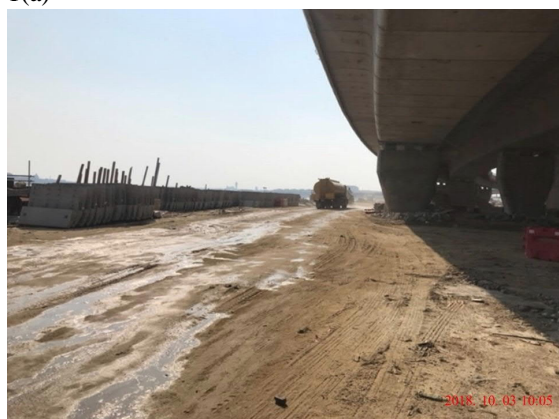
1. Water spray by water truck for HY/2013/04 site.

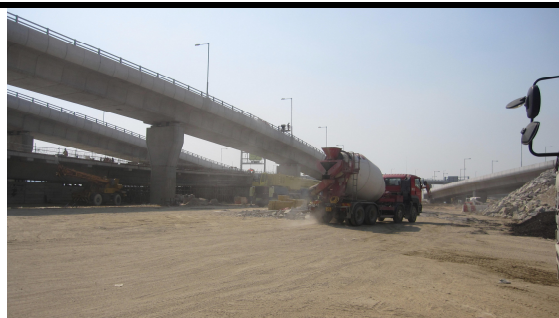
1. Site observation: Dust emission was observed along haul road near bridge D12 area. The Contractor was reminded to provide water spraying to ensure wet surface.

The Contractor was reminded to properly implement all necessary air quality mitigation measures identified in the EM&A Manual. Proper implementation of the site watering plan should be maintained to prevent potential dust dispersion due to site vehicles. Also, all site vehicles leaving HY/2013/04 site should be properly washed at the wheel washing facilities at HY/2013/04 site exit to prevent dust nuisance on the access roads and public roads thereafter.

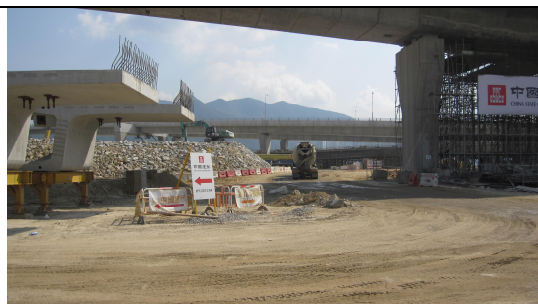
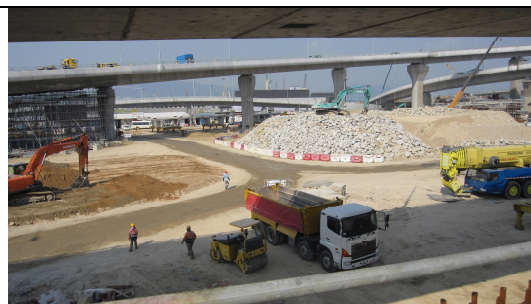
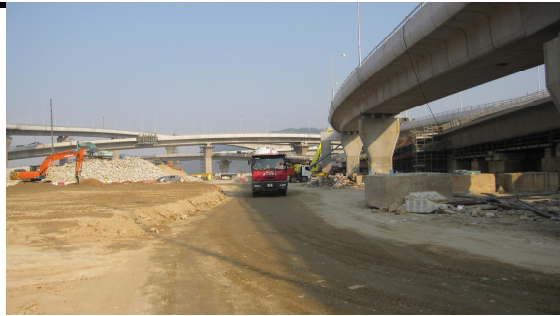
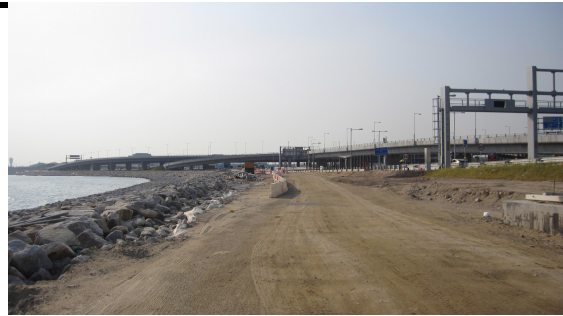
2. Other haul roads within HY/2013/04 site were provided with water spray.

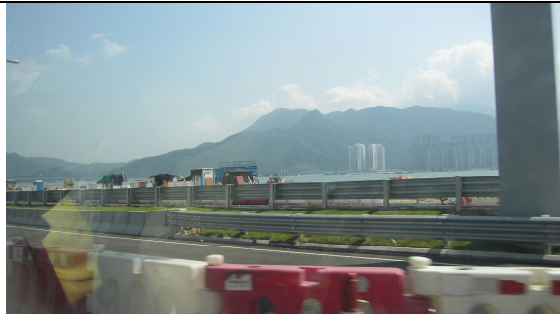
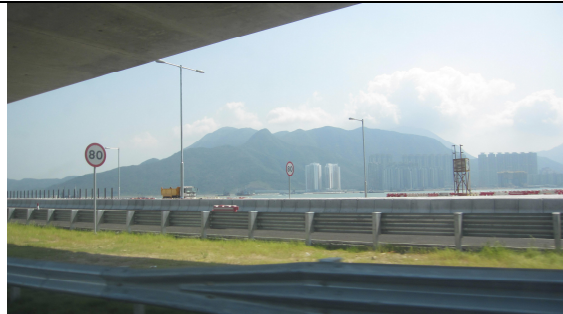
3. The vehicular entrance of HY/2013/04 site boundary was also inspected and found to be operating normally with no fugitive dust observed.

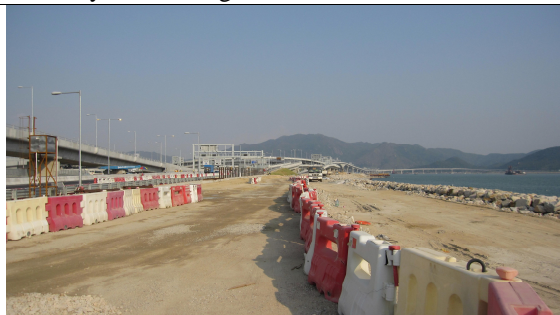
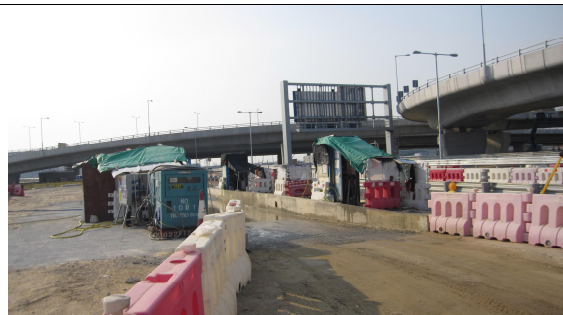
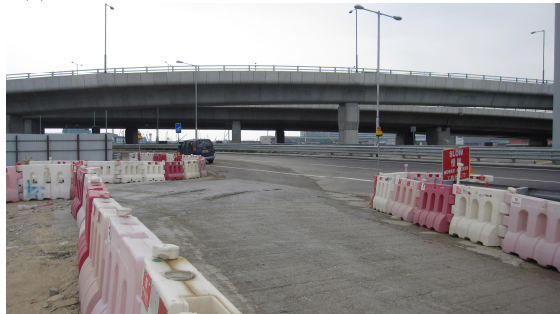
4. The wheel wash facility at the vehicular exit of HY/2013/04 site boundary was also inspected and found to be operating normally with no fugitive dust observed.
