Date of Notification: 9 August 2017

Works Inspected: Data collected from water sampling works on 12 July 2017 by Contract No. HY/2010/02 and Contract No. HY/2011/09.

Monitoring Location: Water Quality Monitoring Station

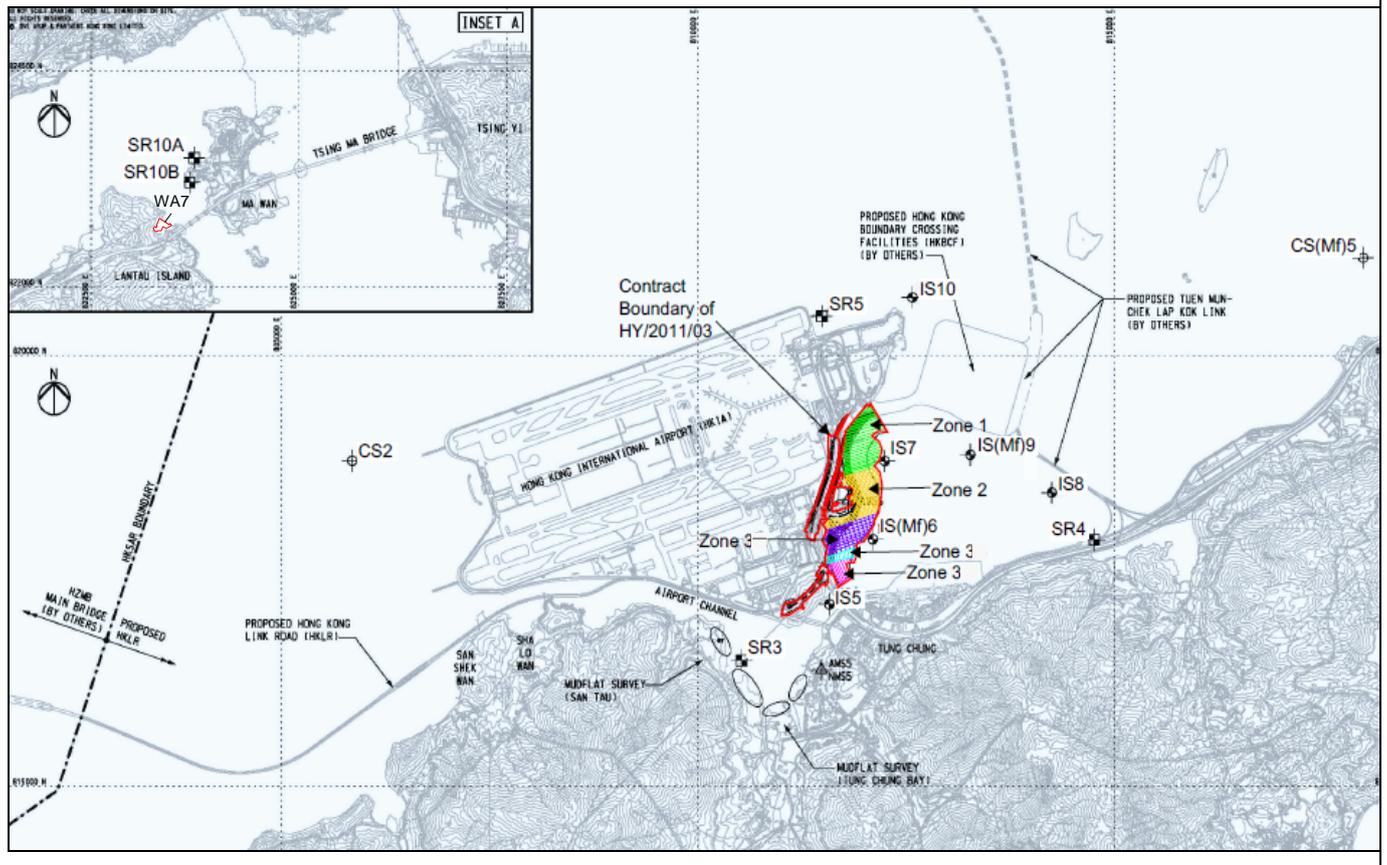
Location Plan:

On 12 July 2017, an Action Level exceedance of suspended solid was recorded at station SR3 during mid-ebb tide. The exceedance has been investigated and is considered unlikely to be related to the contract works due to the following reasons:

3. There was no marine transportation at Zones 1, 2, and 3. There were no specific activities recorded during the monitoring period that would cause any significant impacts on the monitoring results. Also, there was no muddy plume observed at station SR3 during sampling exercise.
4. No leakage of turbid water or any abnormality or malpractice for all contract works was observed during the sampling exercise.

As such, the exceedance of suspended solid level is considered to be attributed to other external factors such as sea condition, rather than the contract works.

As the suspended solid level recorded beyond the water quality criteria was not related to the contract works, no immediate

actions are considered necessary. However, the Contractor is reminded to ensure that the silt curtain is fully maintained throughout the construction works and construction works are carried out under stringent supervision to prevent any water quality impacts to the seawater.

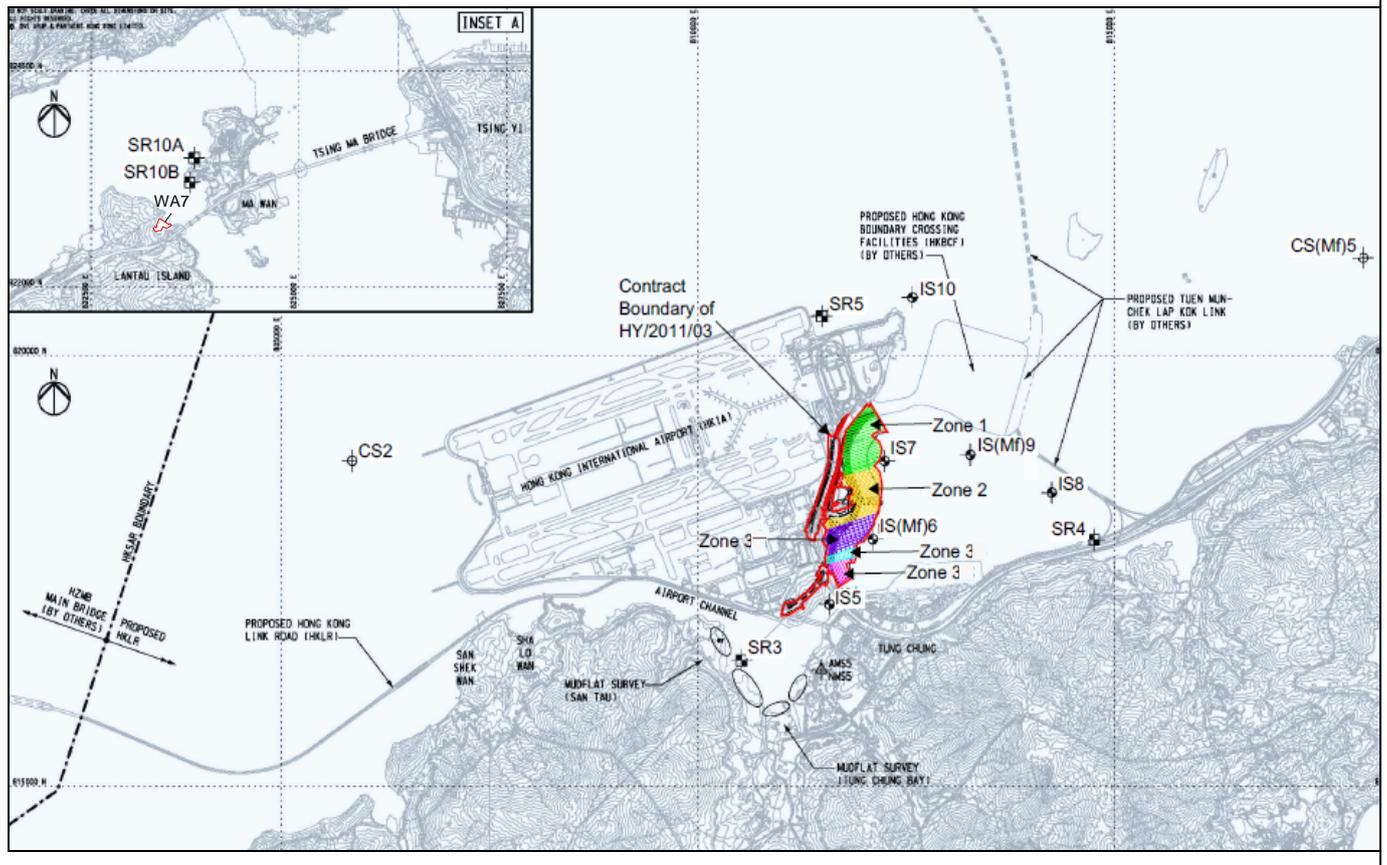
Location Plan:

On 14 July 2017, an Action Level exceedance of suspended solid was recorded at station IS7 during mid-flood tide. The exceedance has been investigated and is considered unlikely to be related to the contract works due to the following reasons:

3. There was no marine transportation at Zones 1, 2, and 3. There were no specific activities recorded during the monitoring period that would cause any significant impacts on the monitoring results. Also, there was no muddy plume observed at station IS7 during sampling exercise.
4. No leakage of turbid water or any abnormality or malpractice for all contract works was observed during the sampling exercise.

As such, the exceedance of suspended solid level is considered to be attributed to other external factors such as sea condition, rather than the contract works.

As the suspended solid level recorded beyond the water quality criteria was not related to the contract works, no immediate

actions are considered necessary. However, the Contractor is reminded to ensure that the silt curtain is fully maintained throughout the construction works and construction works are carried out under stringent supervision to prevent any water quality impacts to the seawater.
