**Contract No. HY/2011/03 -
Hong Kong- Zhuhai- Macao Bridge
Hong Kong Link Road Section between Scenic Hill and Hong Kong Boundary Crossing Facilities
Notifications of Environmental Quality Limits Exceedances** Notification No.: 278a ver 1

Date of Notification: 13 June 2018

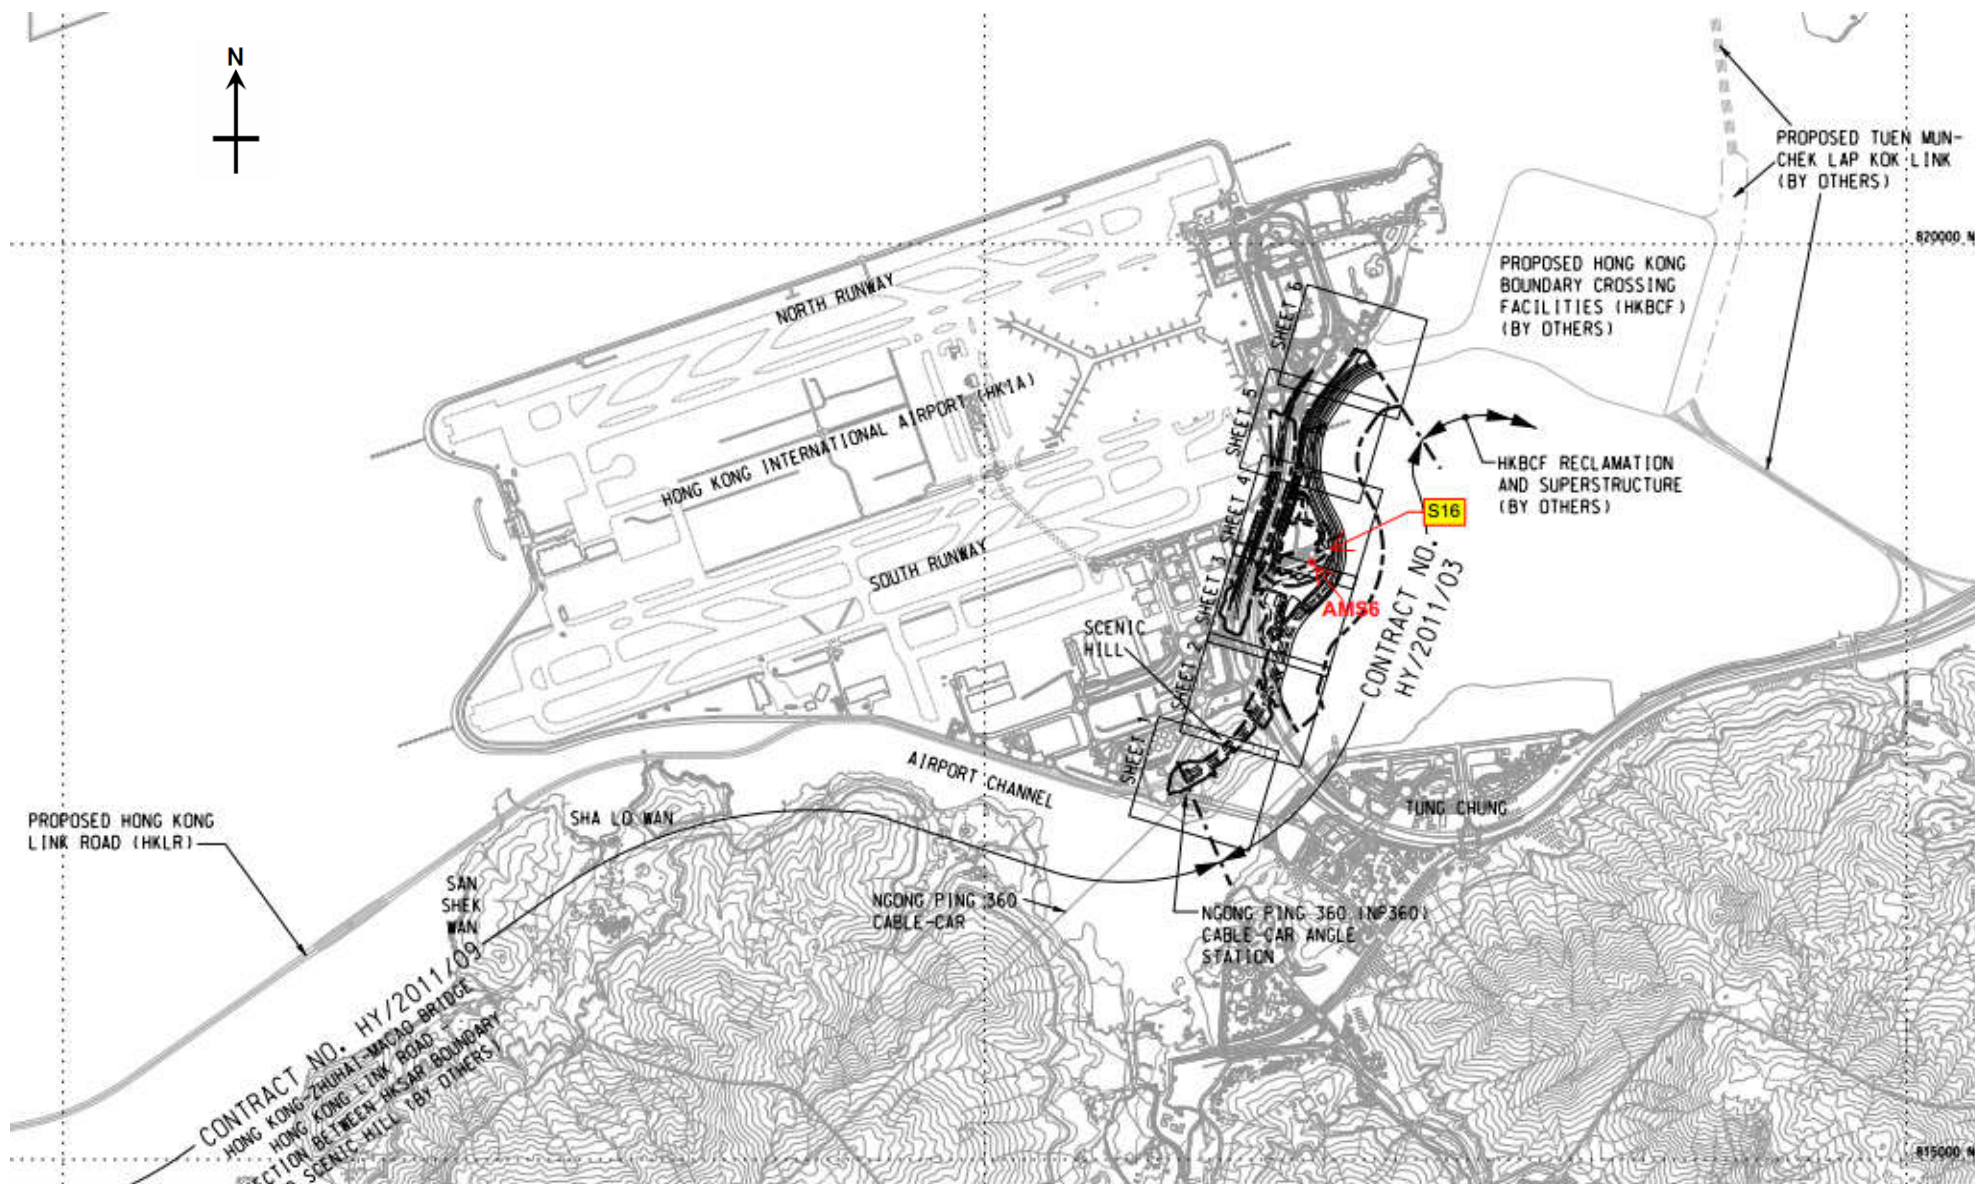
Figure 1 - Location of Construction Site S16 and Air Monitoring Station AMS6

According to the information provided by the Contractor, landscaping works were conducted at construction site S16 which is located near AMS6 during the sampling period on 1 June 2018. Figure 1 shows the location of construction site S16 and air monitoring station AMS6. According to information provided by the Contractor, water spraying was provided for dusty materials to maintain the entire surface in a damp condition and haul roads were sprayed with water by water trucks regularly.

During collection of filter paper at AMS6 on 4 June 2018, weed was observed on the filter paper which was used for monitoring on 1 June 2018. Also, the weed in the vicinity of station AMS6 was found to be cleared by other parties. It is noted that the weed removal work in the vicinity of station AMS6 was not carried out under the Contract No. HY/2011/03. The weed clearing activities in the vicinity of AMS6 may be one of dust sources to cause the 24-hr TSP LL exceedance on 1 June 2018. An additional monitoring was carried out on 6 June 2018 and a routine monitoring was carried out on 7 June 2018. The 24-hr TSP result on 6 and 7 June 2018 were $32 \mu\text{g}/\text{m}^3$ which were below Action and Limit Level. It was also noted that no Action and Limit Level exceedances of 1-hr TSP were recorded at air monitoring station AMS6 - Dragonair Building during the period from 1 June 2018 to 20 June 2018.

It was noted that the Contractor has implemented dust control measure throughout the construction phase. There is no direct evidence that the exceedance is related to the Contract. No immediate actions are considered necessary. However, the Contractor is reminded to continuously implement the dust mitigation measures as specified in Environmental Mitigation Implementation Schedule (EMIS), Environmental Management Plan, Method Statements, General and Particular Specifications of this Contract throughout the construction phase.
