#### Contract HY/2011/09

# Hong Kong-Zhuhai-Macao Bridge Hong Kong Link Road-Section between HKSAR Boundary and Scenic Hill

Landscape Monitoring Report (Long Term Management)

(23 May 2022 – 22 May 2023)

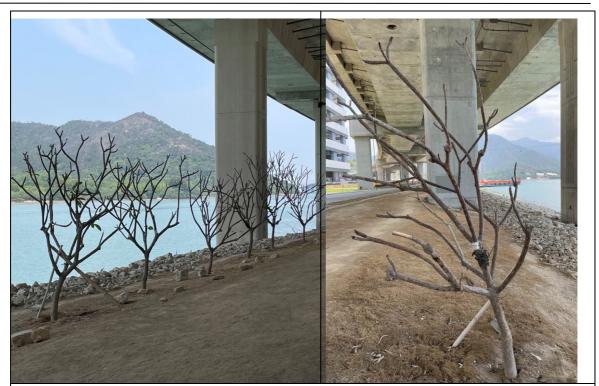
Photo 1 – Dry soil surface and withered grass ground cover

3.9 In addition, the soil surface at the planter under the bridge deck was very dry during site inspection. Withered grass ground cover and no sprinkler irrigation system was observed (Photo 1). Moreover, most of the plants were observed dead or going to die soon at the planting location (Photo 2).

No.	Description	Recommendations
1	Soil condition	For the soil at the planting zone under the bridge deck is very dry. Water must be added the area.
2	Dead plants and any other plants found to be in poor conditions	Replacing or remove all dead plants and any other plants found to be in poor conditions.
3	Vigorous growth of epicormics shoots	Properly pruning on epicormic shoots.
4	Dieback twigs on tree crown	Properly remove die back tree branches.
5	Unbalanced crown	Crown cleaning consists of selective removal of dead, dying, diseased and weak branches from a tree's crown.
6	Leaning tree	Providing stakes for leaning trees; re-staking all trees with broken/leaning tree stakes
7	Pest infestation	Implement pest control measures. Apply fungicides where appropriate. Liaise with a professional tree specialist to evaluate the extent of the damage to the tree and recommend a course of action.
8	Decay of bark tissue / dead branches	Use a sharp knife or wood chisel to give a clean cut to the wound area so the dead bark is not impeding the growth of the callous or "wound wood" that will grow to attempt to compartmentalize the decay of the wound. Remove the dead branches.
