Ref/Project number Contract No. HY/2012/08 Tuen Mun-Chek Lap

Subject Notification of Exceedance for Air Quality

# CONTRACT NO. HY/2012/08 TUEN MUN - CHEK LAP KOK LINK NORTHERN CONNECTION SUB-SEA TUNNEL SECTION

## Air Quality Impact Monitoring Notification of Exceedance

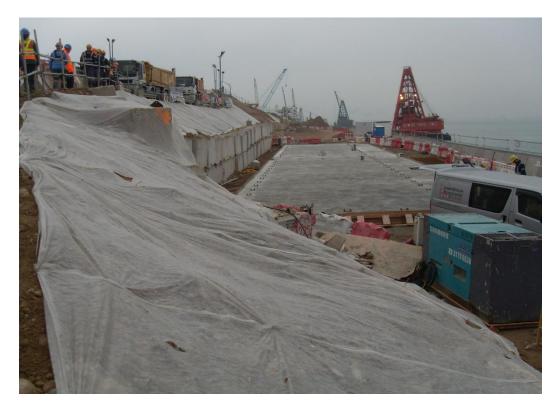
Hydro-seeding of area where works have been completed. (Reclamation Works Area)

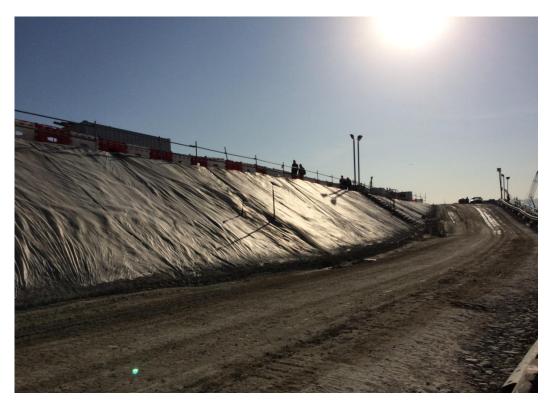
Hydro-seeding of area where works have been completed. (Reclamation Works Area)

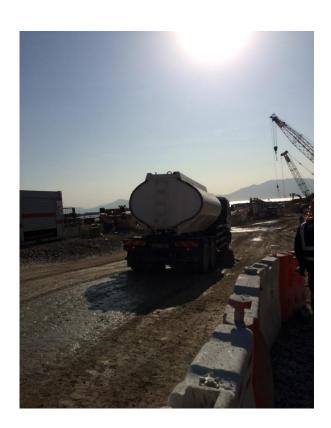
Use of water truck on exposed soil within the Project site and associated work areas. (Reclamation Works Area)
