ENVIRONMENTAL COMPLAINT INVESTIGATION REPORT

Our Reference: 0212330_Complaint LOG_20160519_04

Project	Contract No. HY/2012/08 Tuen Mun - Chek Lap Kok Link - Northern Connection Sub-Sea Tunnel Section	Scale
Drawings	SOUTH VENTILATION SHAFT T R DBW MARINE SET-UP JET GROUTING BARGE - Dust Collector Piping System	No scale
W G	air with small amount of cement particles

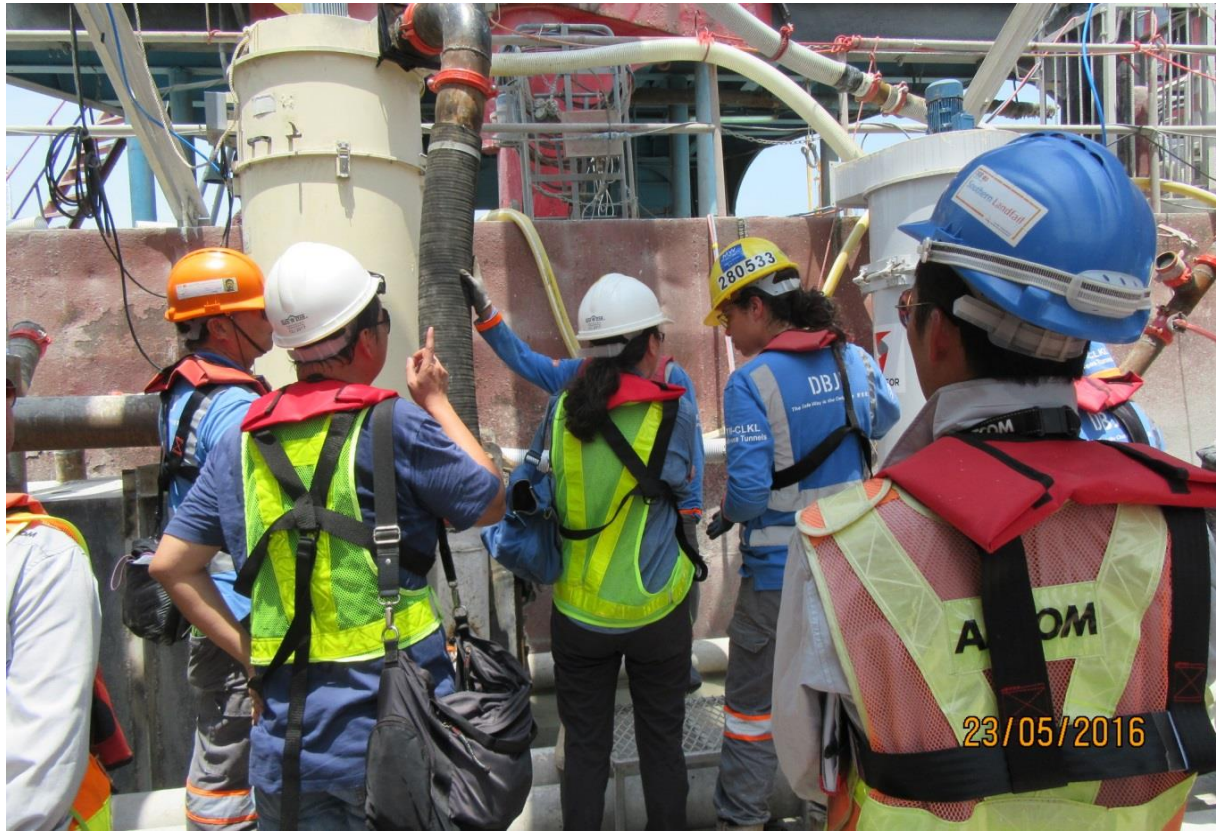
Also, a joint site inspection was carried out with the Contractor, SOR and EPD on 23 May 2016 to verify the remedial measures (see photo records on Annex A). No further defects were observed and no adverse comments were received.

A joint site inspection was carried out by the ET, the Contractor, SOR and EPD on 23 May 2016.
(Barge area - Southern Landfall)
