Ref/Project number Contract No. HY/2012/08 Tuen Mun-Chek Lap
Kok Link-Northern Connection Sub-sea Tunnel
Section

Subject Notification of Exceedance for Air Quality
Impact Monitoring

Air Quality Impact Monitoring
Notification of Exceedance

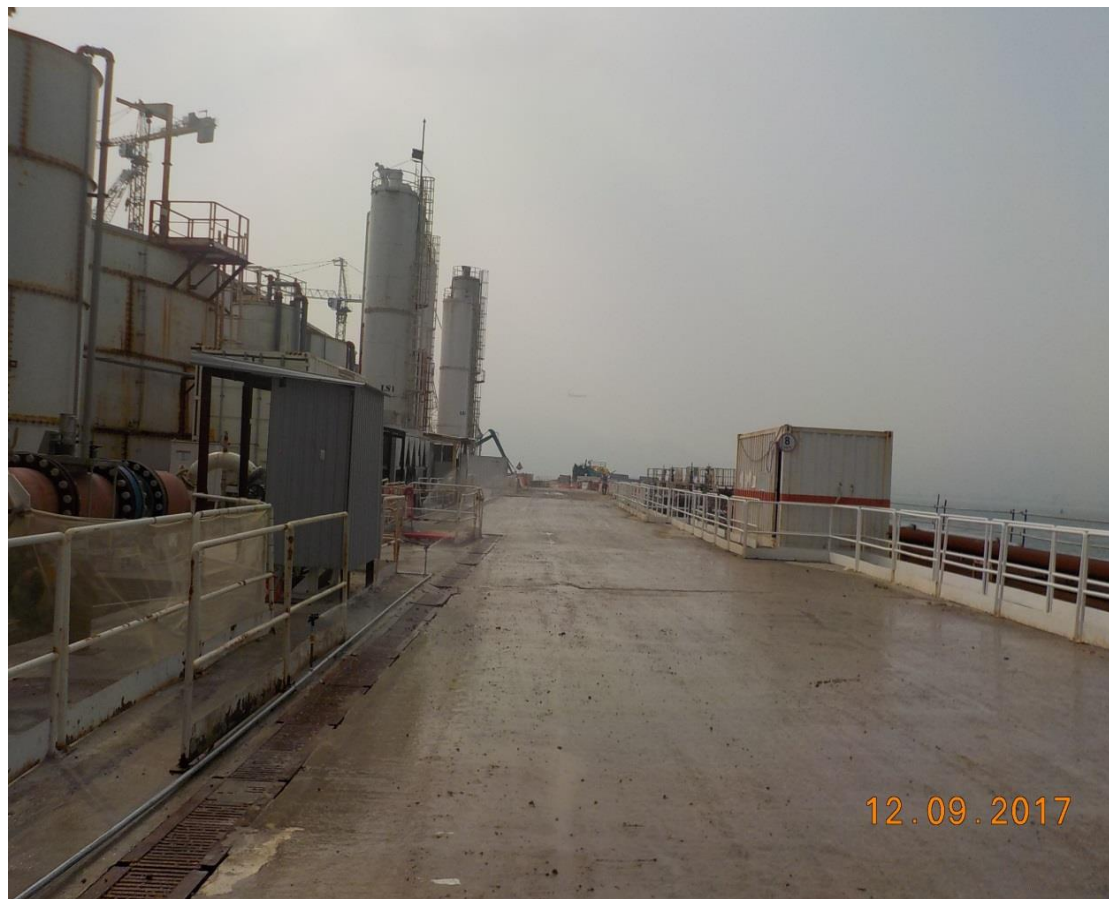
Water spraying was applied frequently during dry conditions.(Works Area Portion N-B)

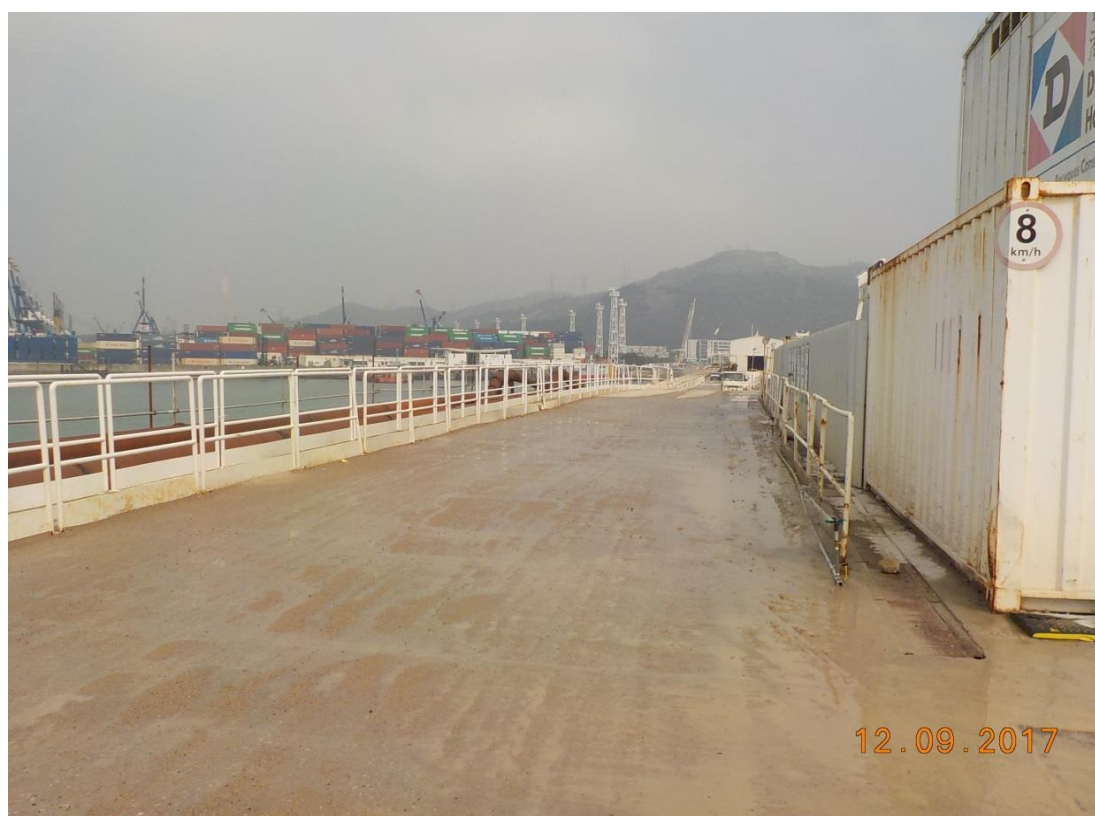
No dust nuisance was observed. (Works Area Portion N-B)

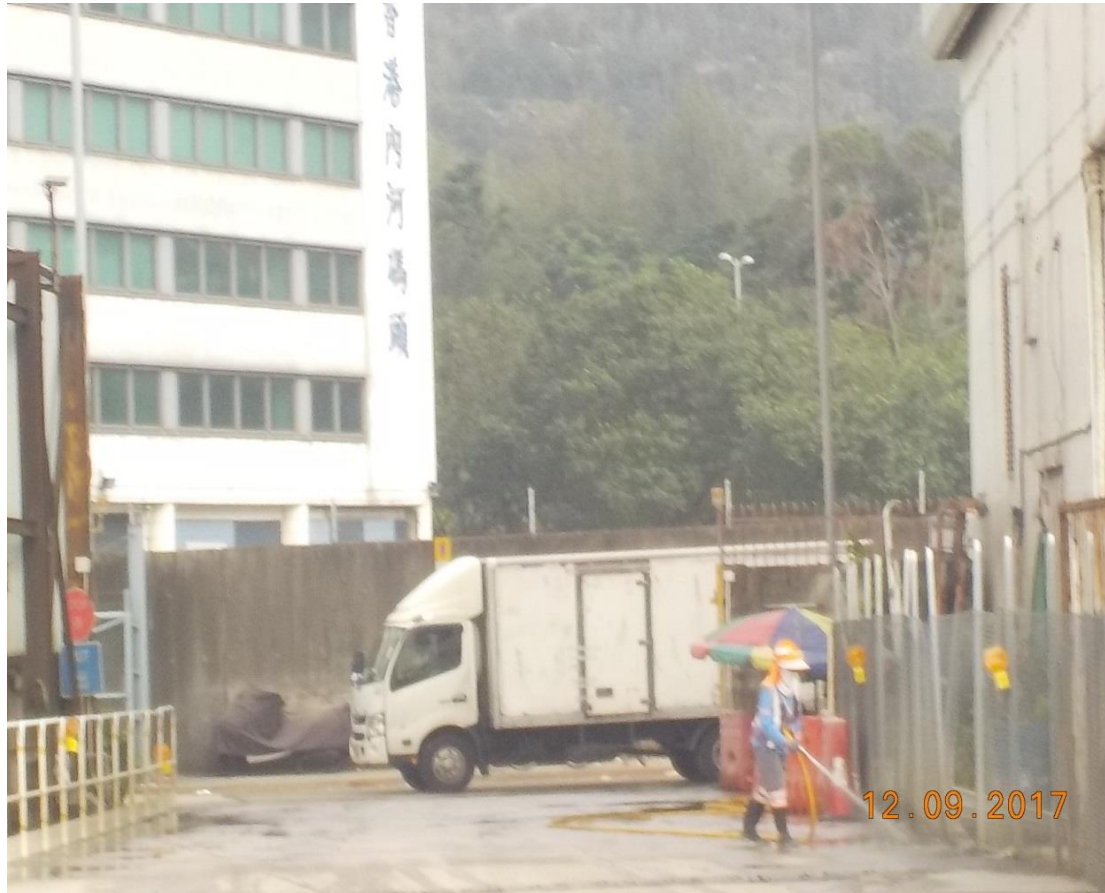
Water spraying was applied frequently during dry conditions. (Works Area Portion N-A)

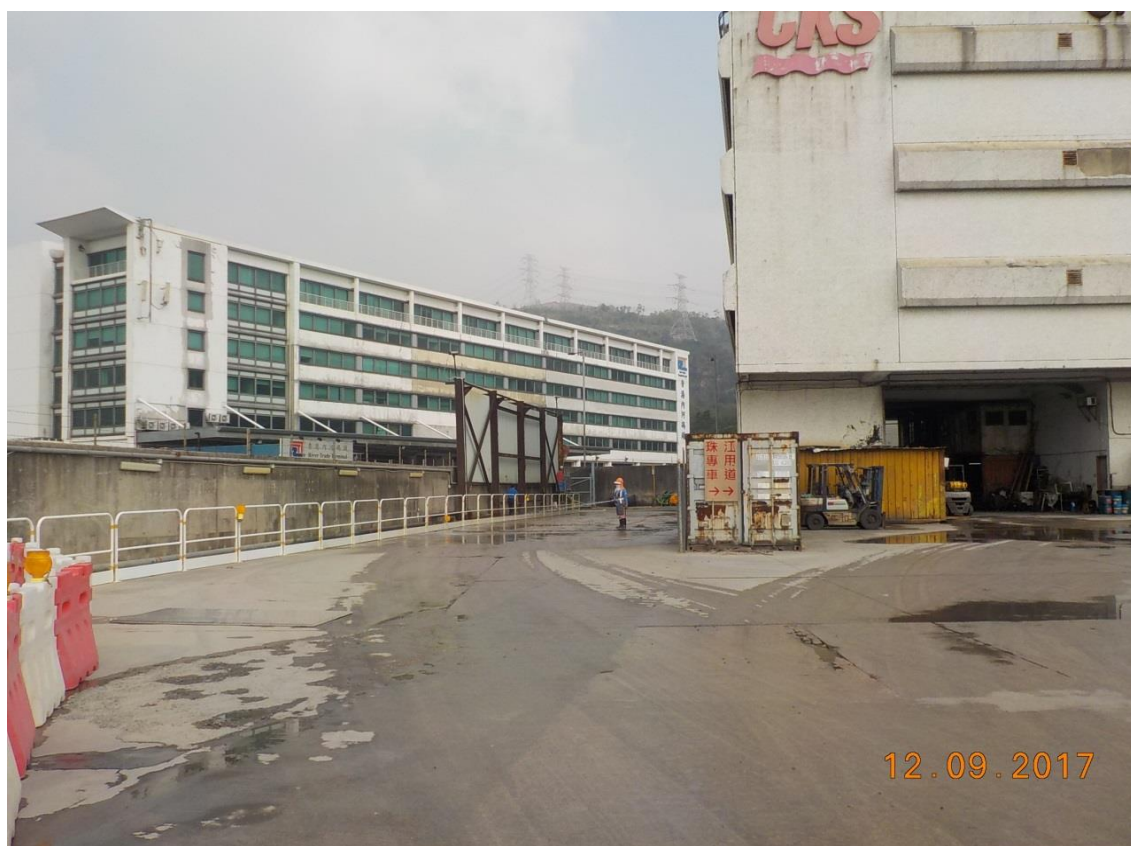
Water spraying was applied frequently during dry conditions. (Works Area Portion N-A)

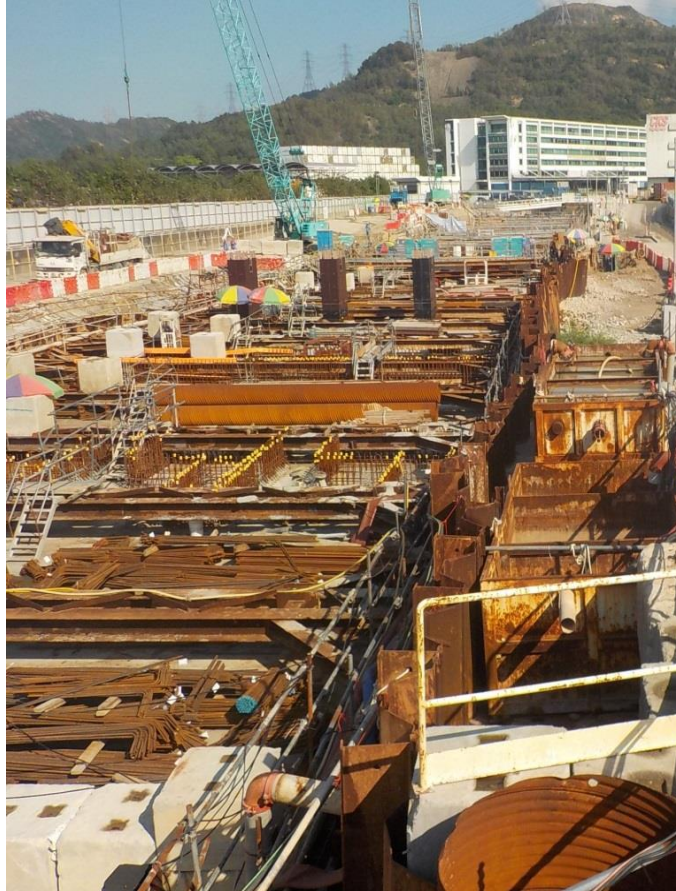
Box Culvert Extension. (Works Area Portion N-A)

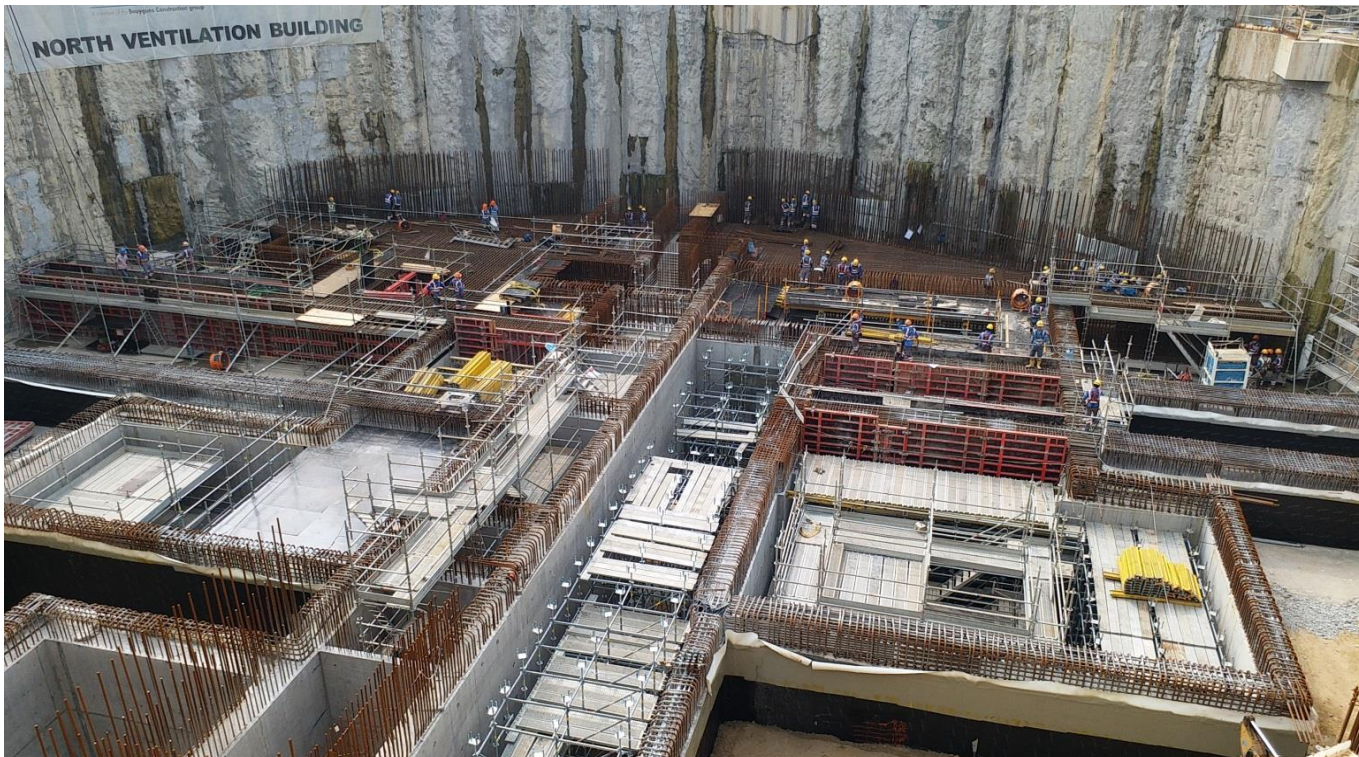
Construction of Ventilation Building (Works Area Portion N-C)

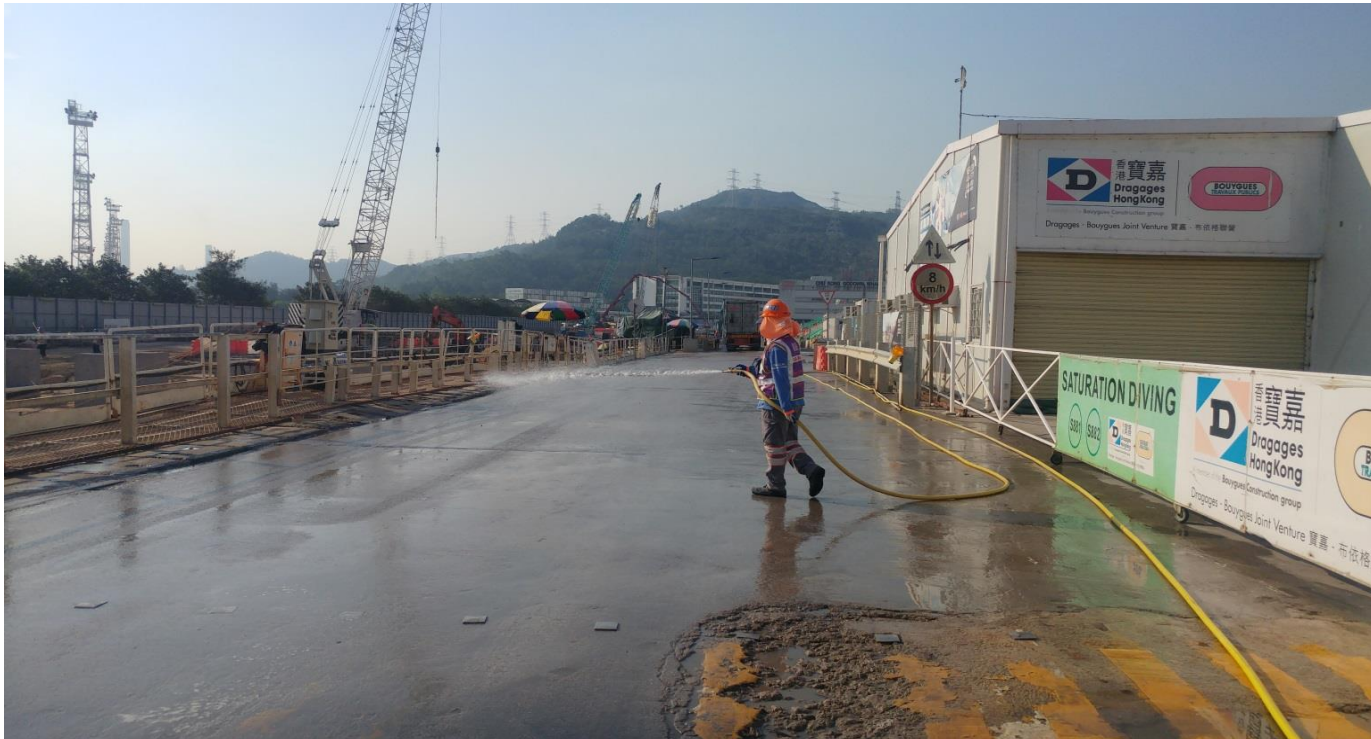
Water spraying was applied frequently during dry conditions. (Works Area Portion N-A)

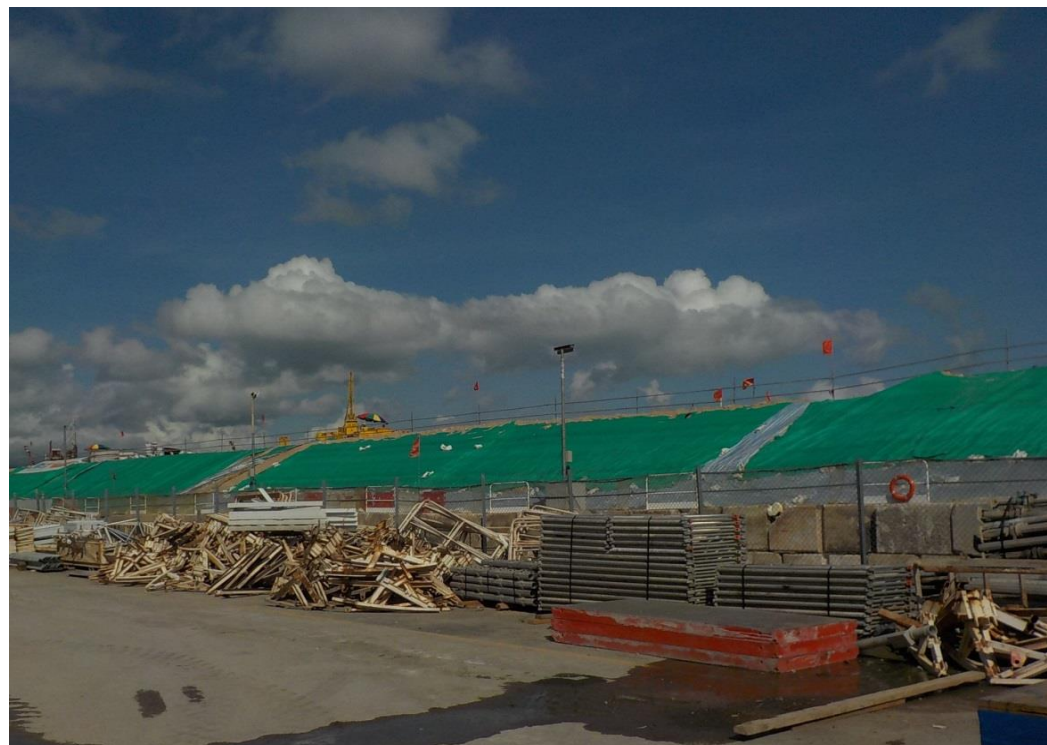
Exposed soil surface are covered by tarpaulin sheets to prevent dust nuisance. (Works Area Portion N-A)

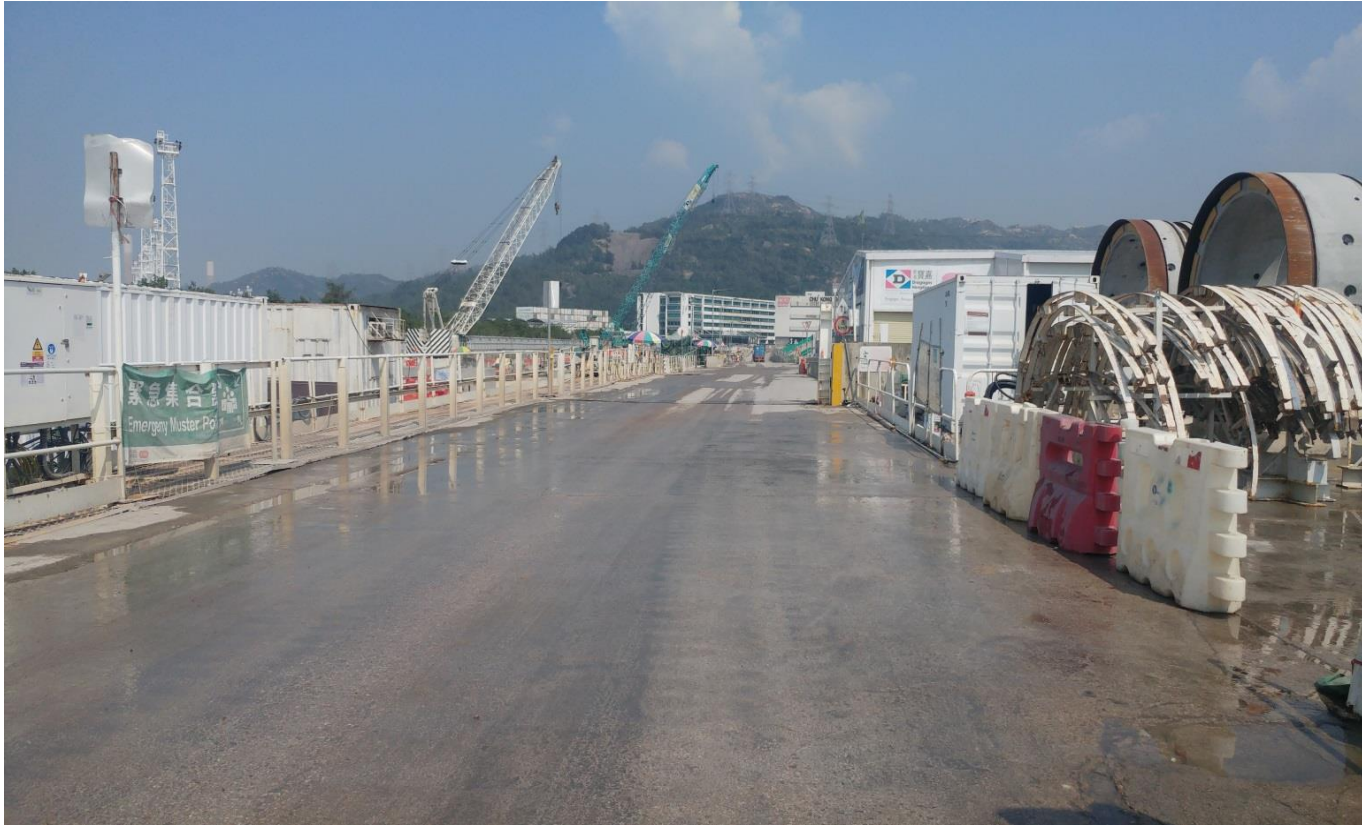
Water spraying was applied frequently during dry conditions.(Works Area Portion N-B)

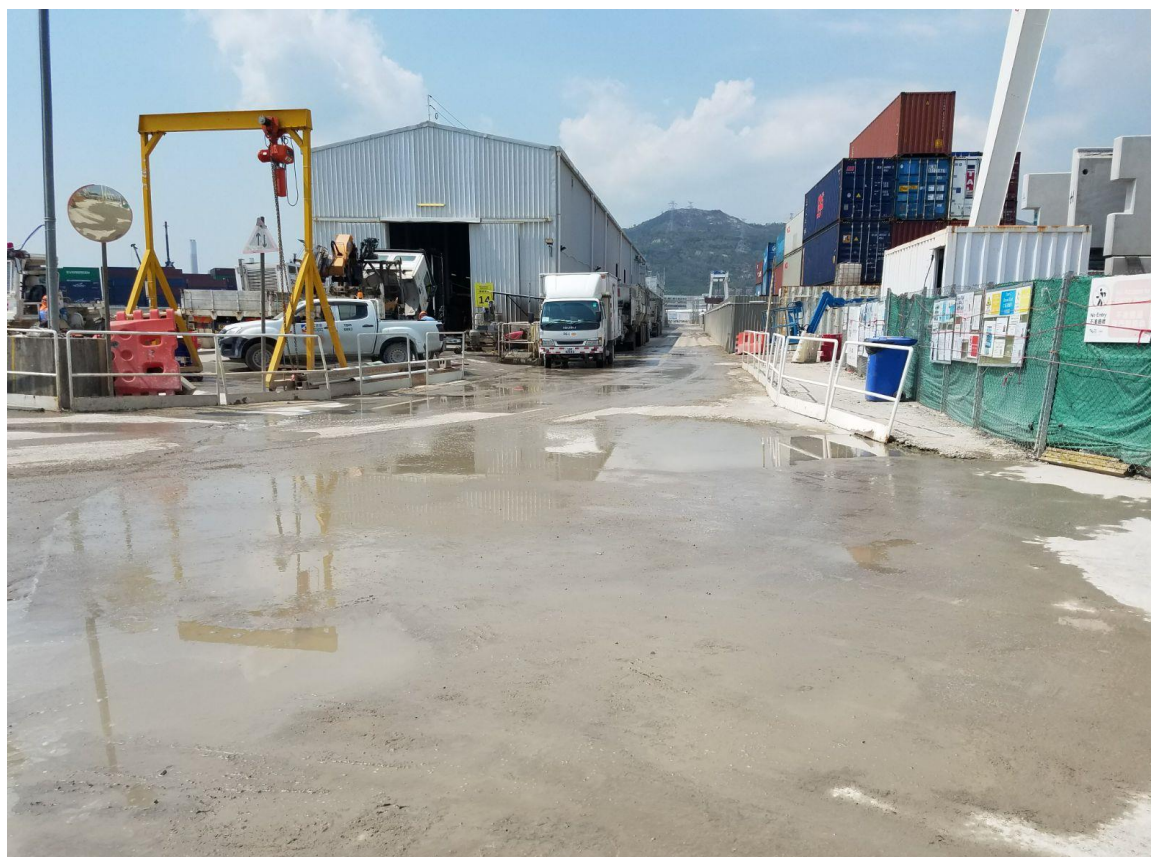
No dust nuisance was observed. (Works Area Portion N-B)

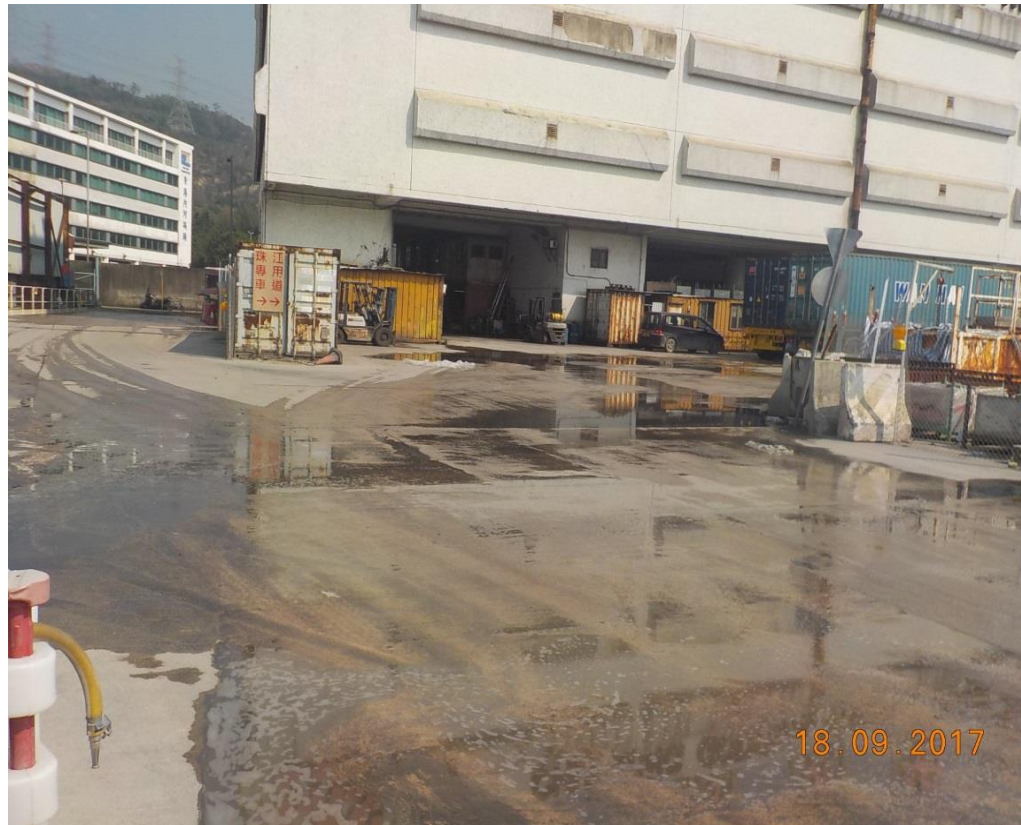
Water spraying was applied frequently during dry conditions. (Works Area Portion N-A)

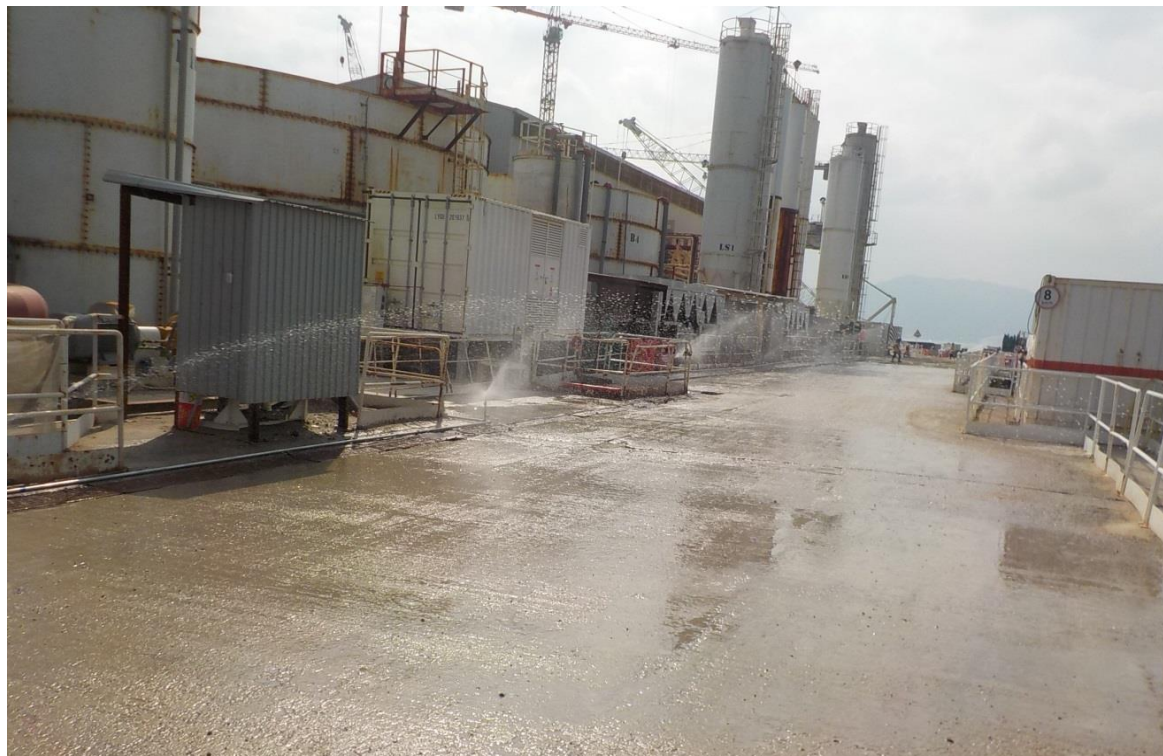
Use of sprinklers for water spraying,. (Works Area Portion N-C)

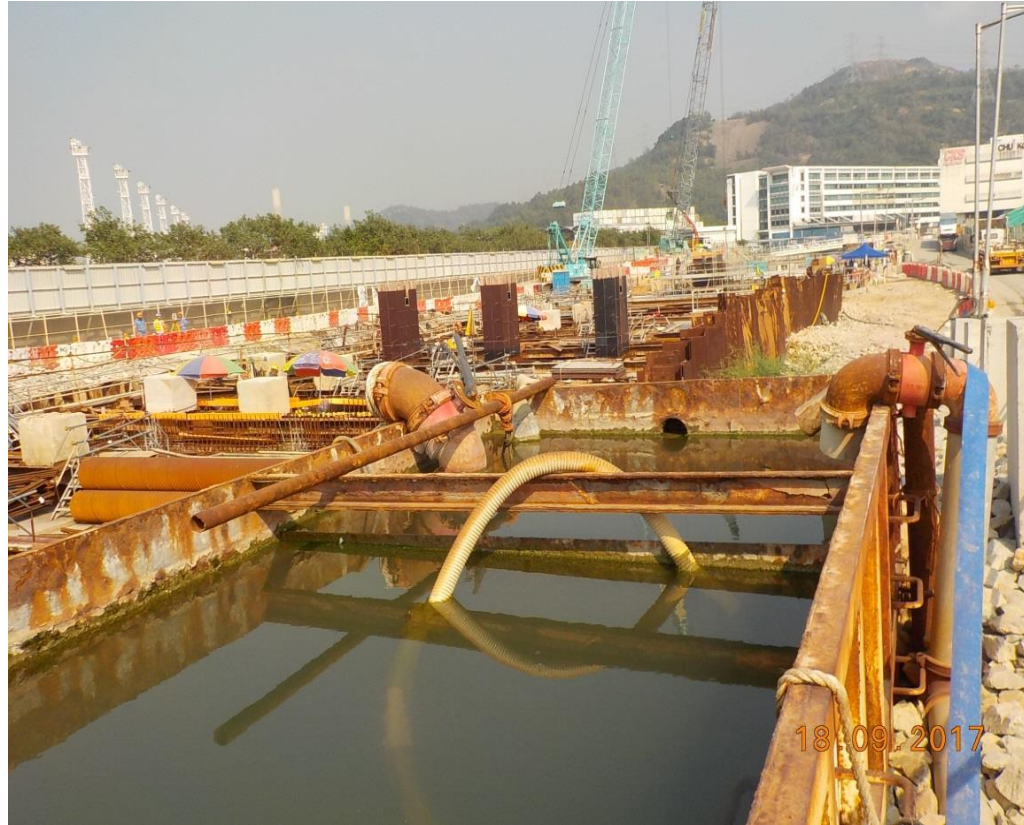
Box Culvert Extension. (Works Area Portion N-A)

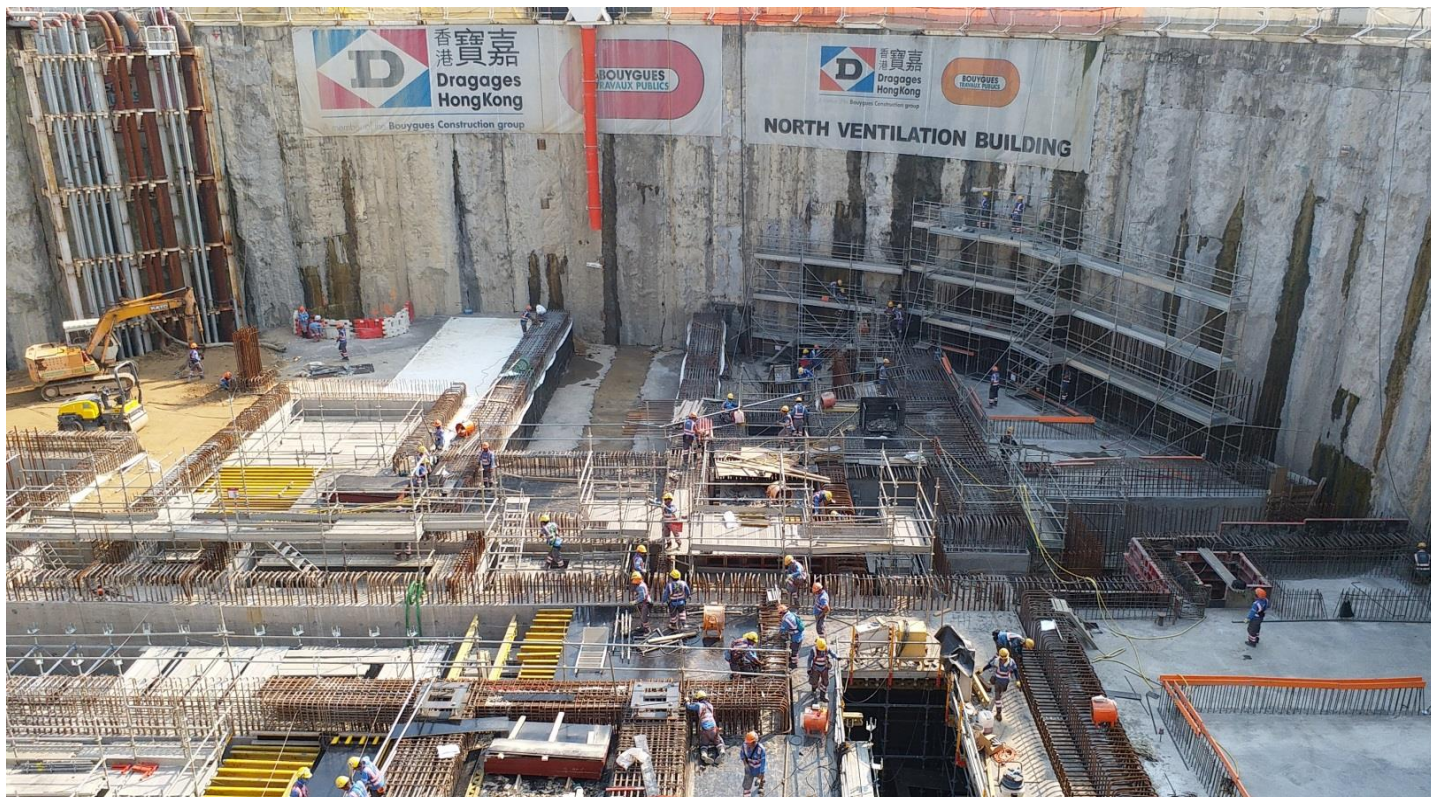
Construction of Ventilation Building. (Works Area Portion N-C)

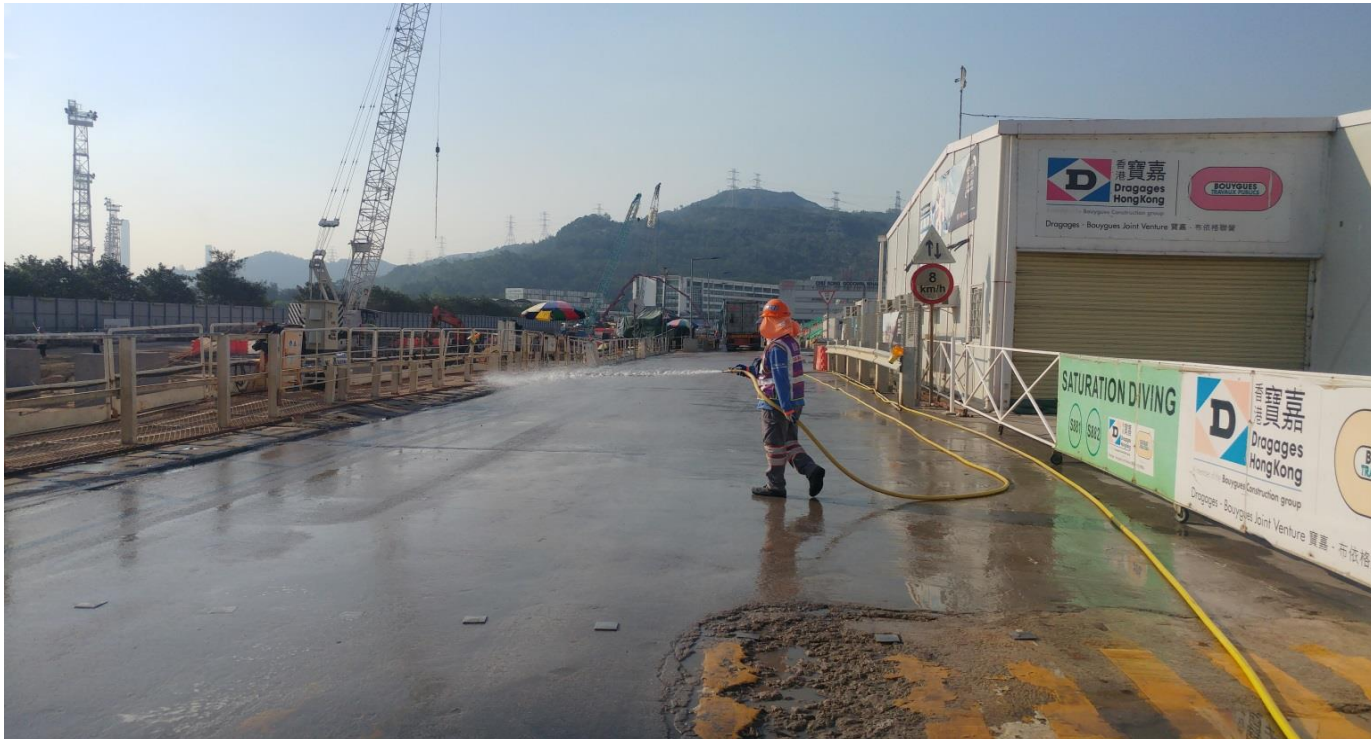
Water spraying was applied frequently during dry conditions. (Works Area Portion N-A)

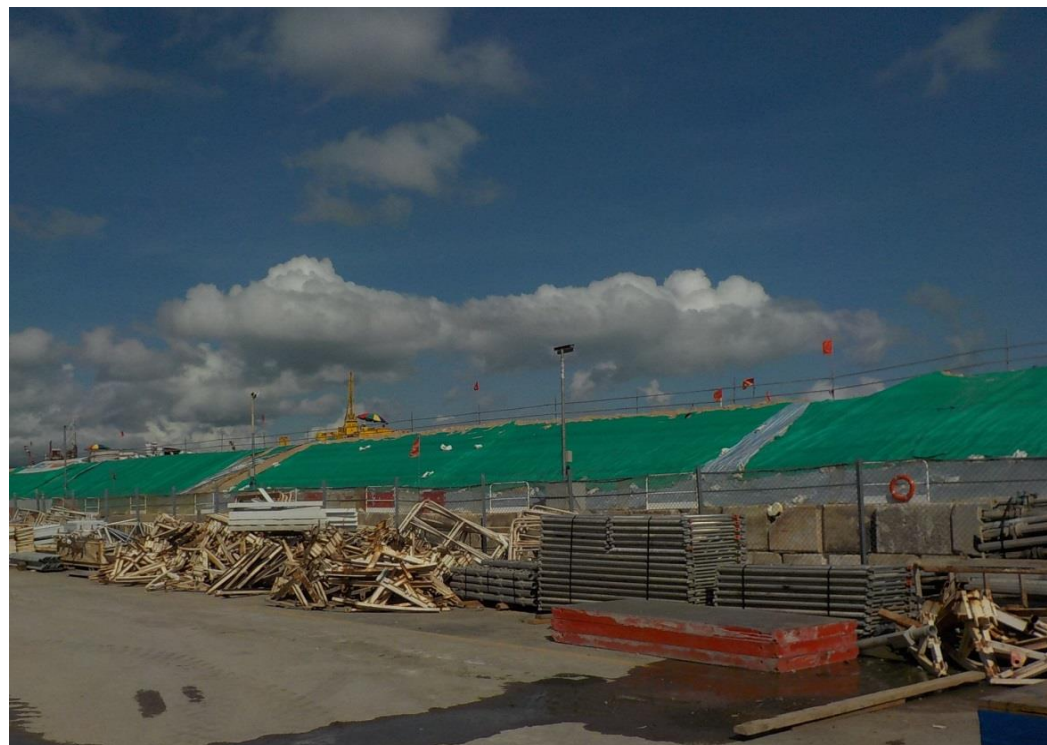
Exposed soil surface are covered by tarpaulin sheets to prevent dust nuisance. (Works Area Portion N-A)

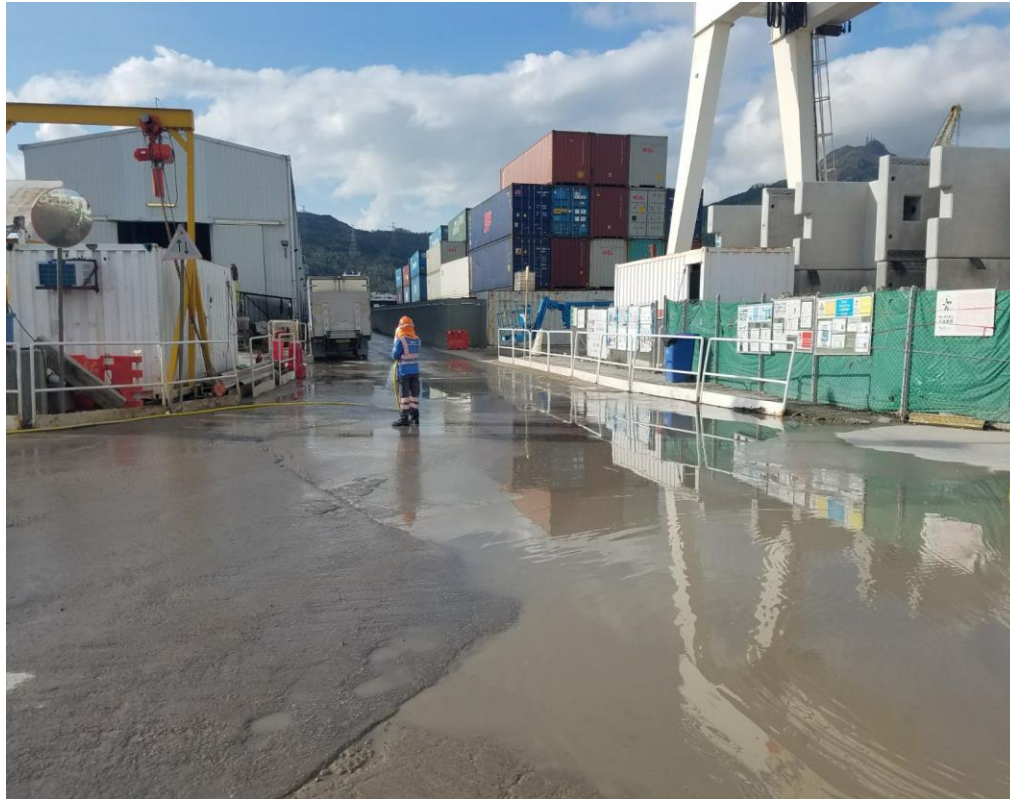
Water spraying was applied frequently during dry conditions.(Works Area Portion N-B)

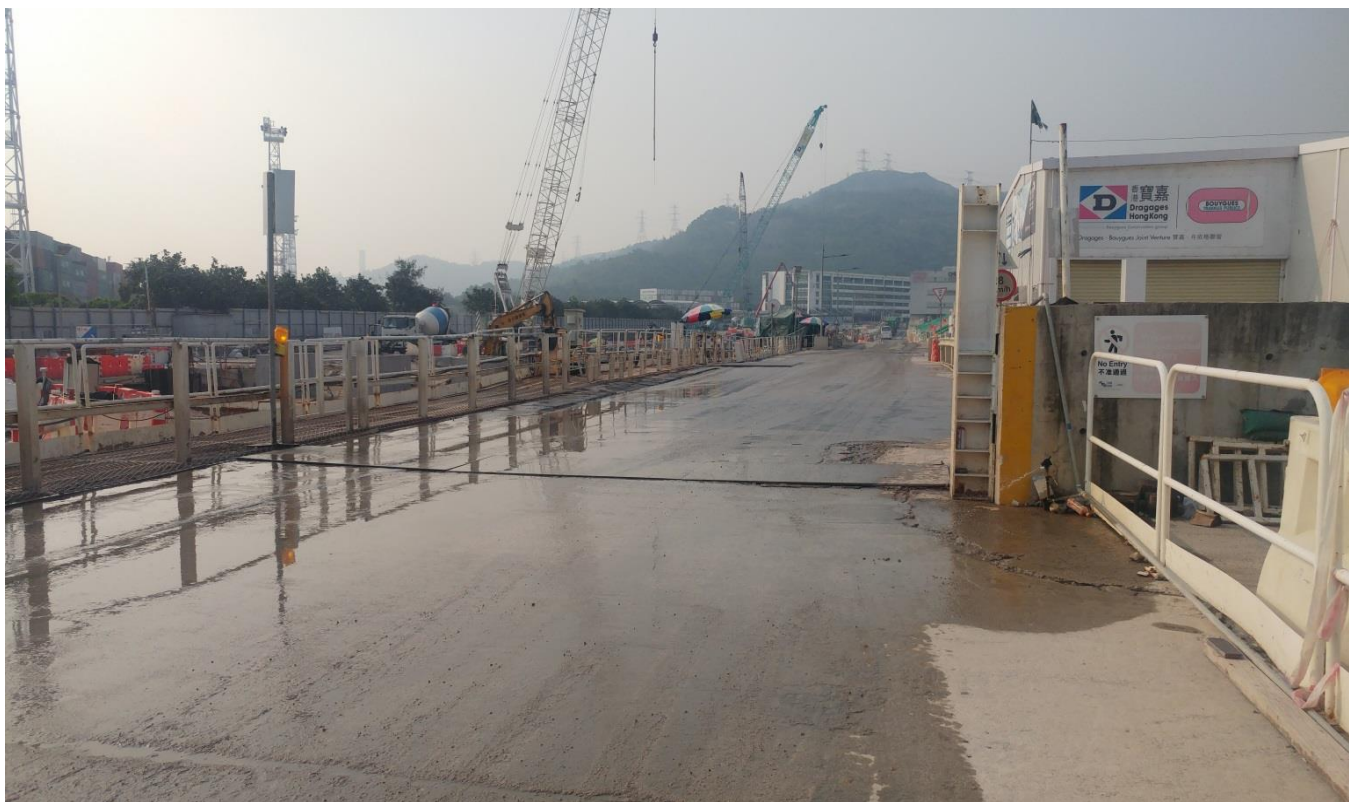
No dust nuisance was observed. (Works Area Portion N-A)

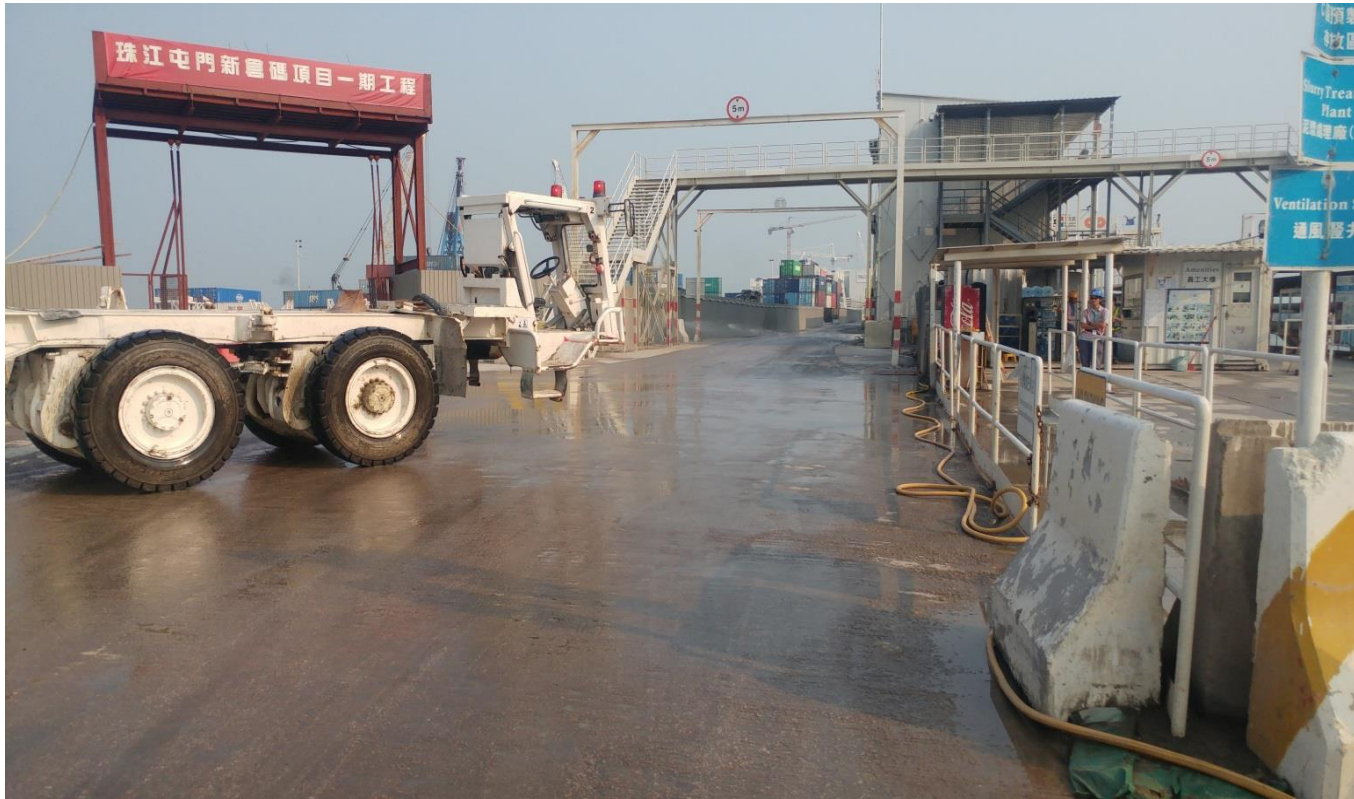
Water spraying was applied frequently during dry conditions. (Works Area Portion N-A)

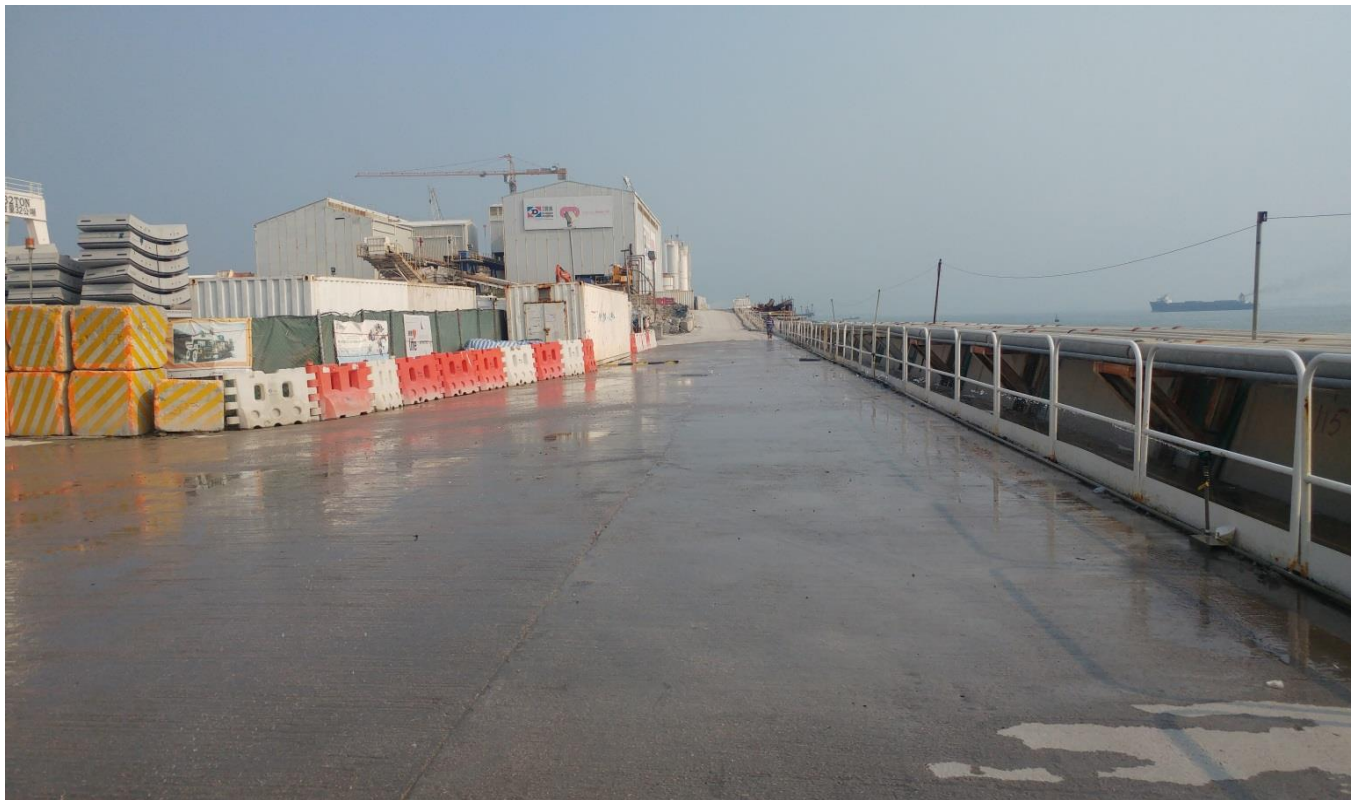
Water spraying was applied frequently during dry conditions. (Works Area Portion N-B)

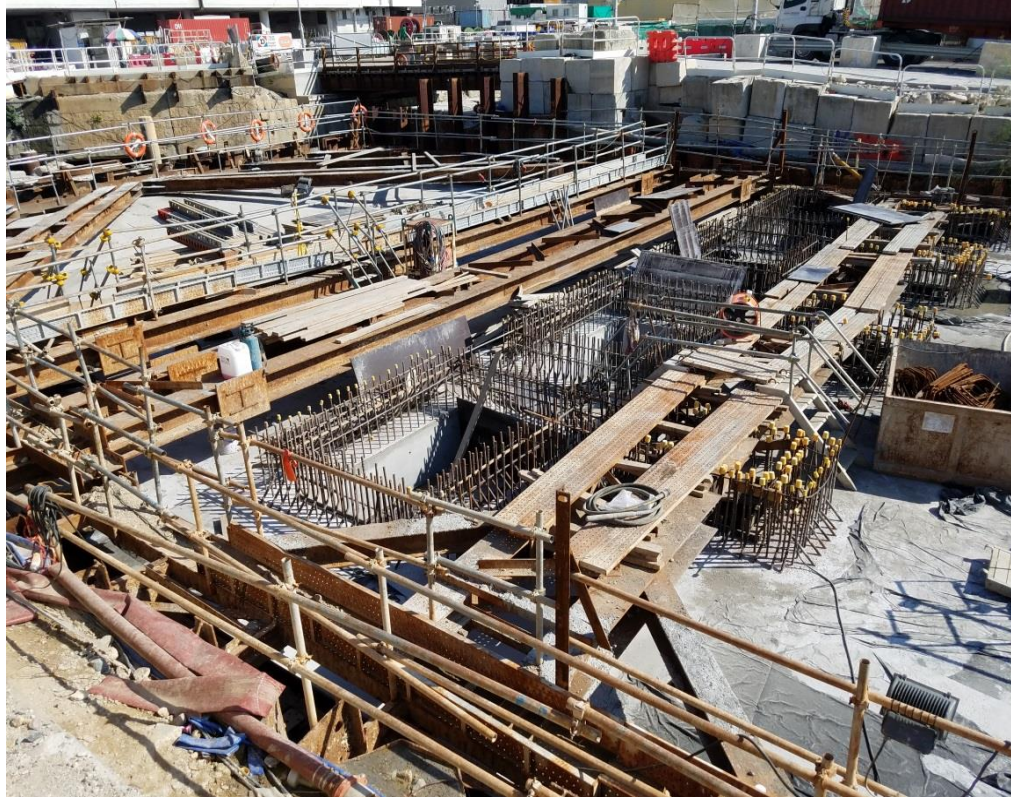
Box Culvert Extension. (Works Area Portion N-A)

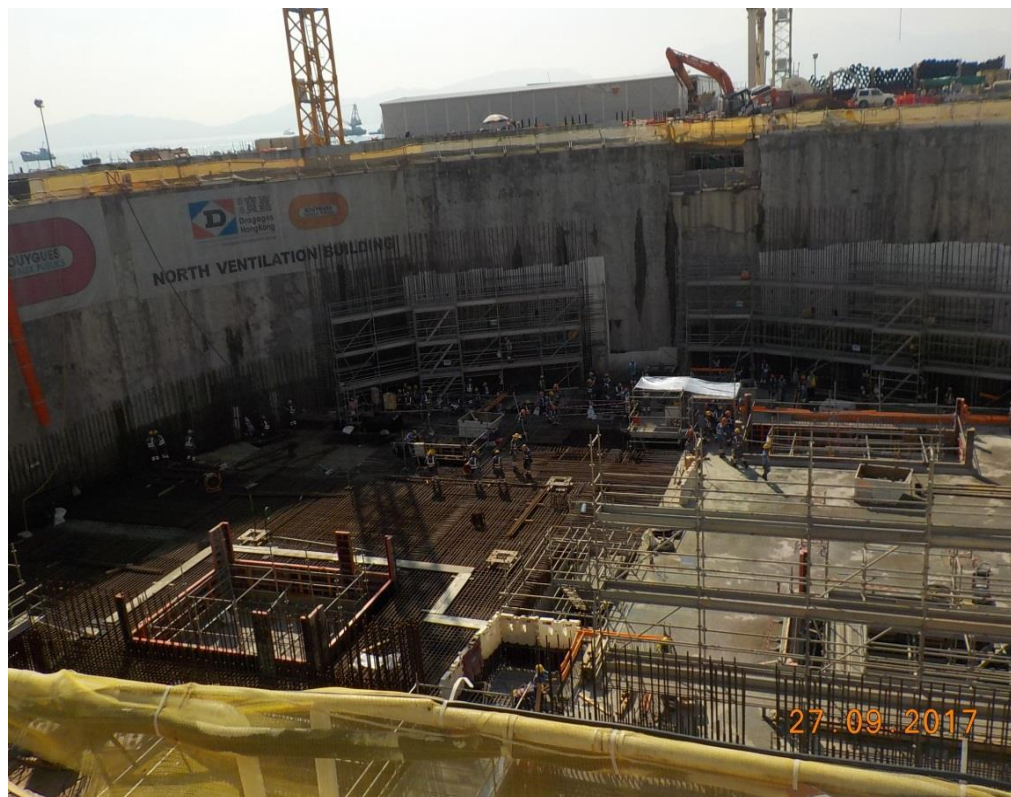
Construction of Ventilation Building. (Works Area Portion N-C)

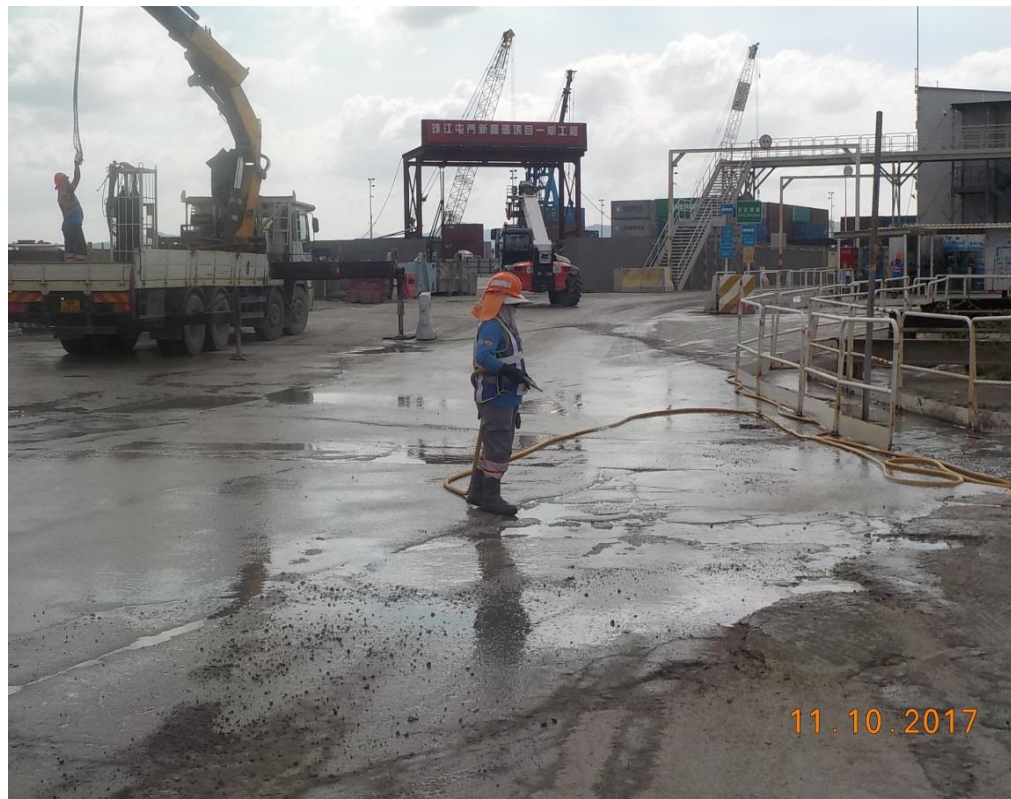
Water spraying was applied frequently during dry conditions.(Works Area Portion N-A)

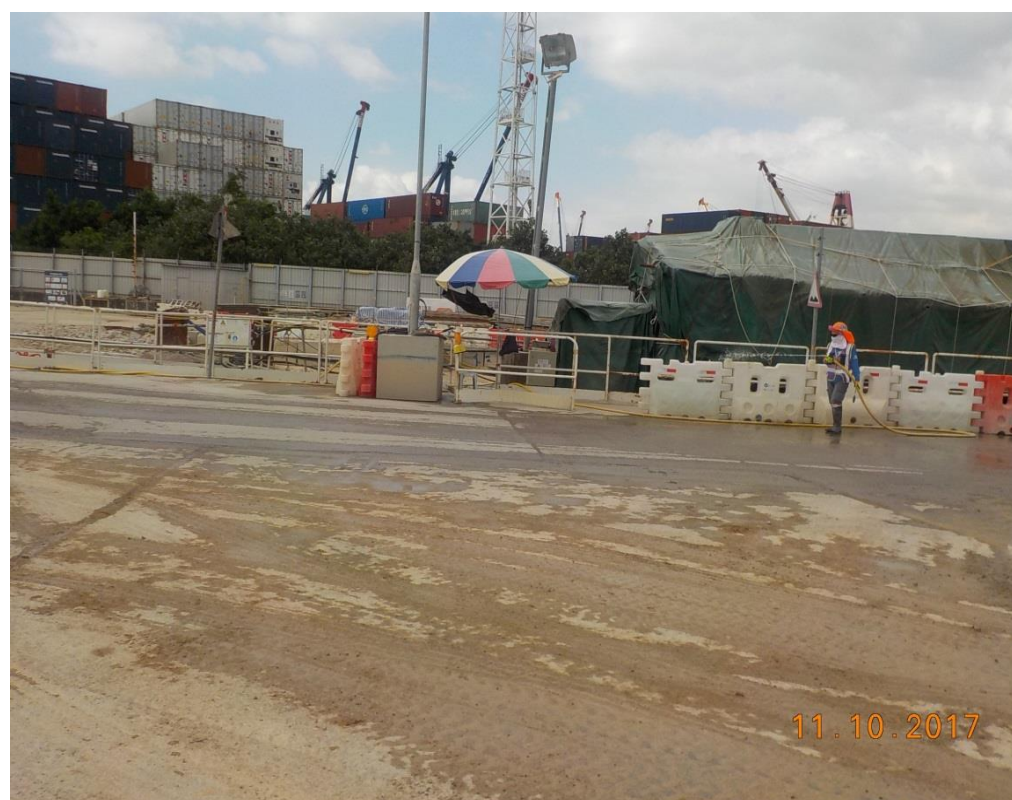
Water spraying was applied frequently during dry conditions.(Works Area Portion N-A)
