CONTRACT NO. HY/2012/08 TUEN MUN – CHEK LAP KOK LINK – NORTHERN CONNECTION SUB-SEA TUNNEL SECTION

Air Quality Impact Monitoring Notification of Exceedance

ENVIRONMENTAL COMPLAINT/ENQUIRY INVESTIGATION REPORT

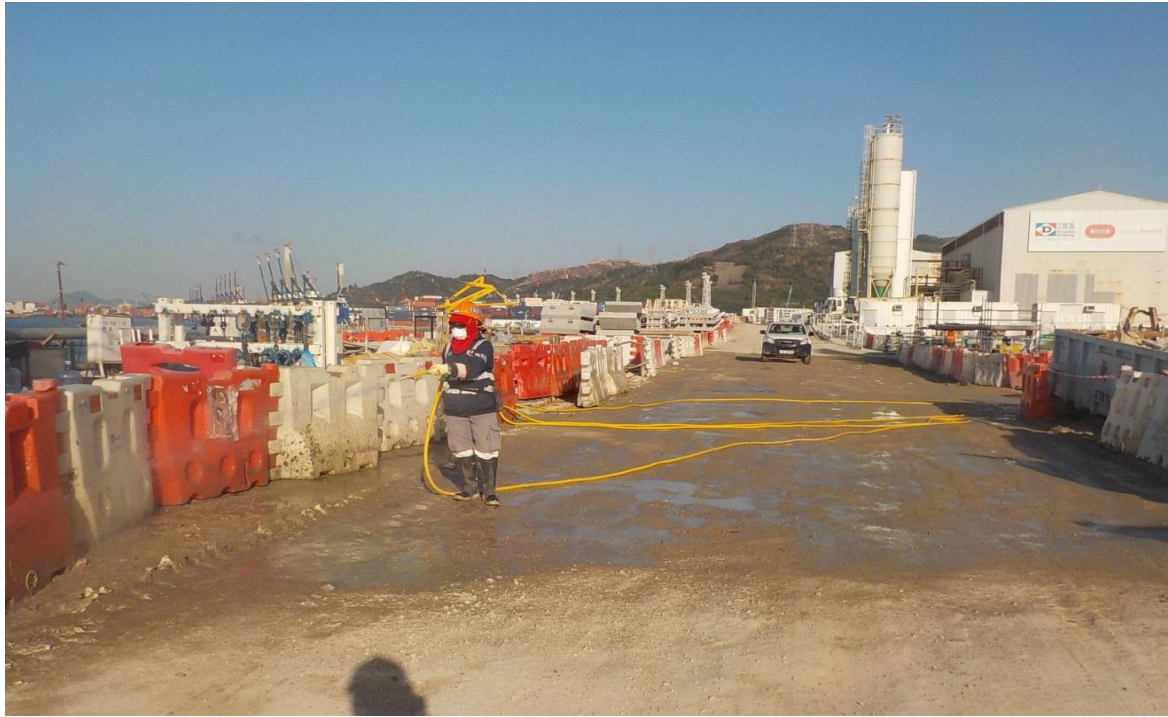
Water spraying was applied frequently during dry conditions.(Works Area Portion N-C)

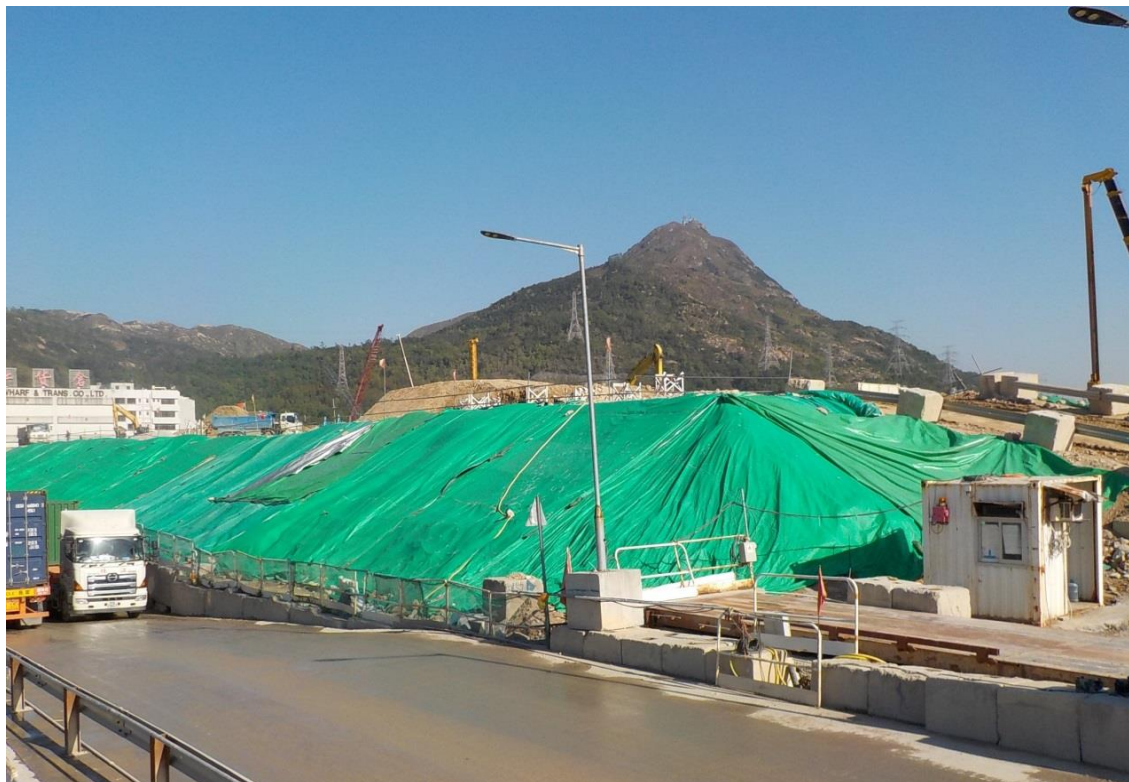
Exposed soil at Portion N-A was covered by tarpaulin sheets. (Works Area Portion N-A)

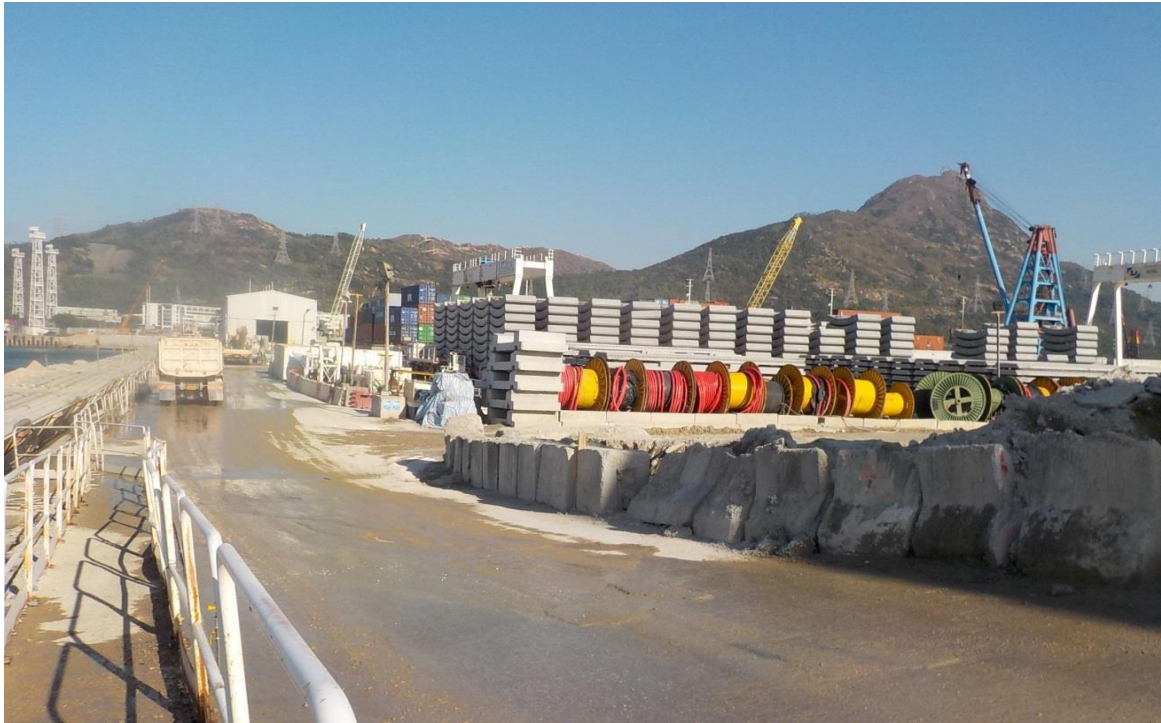
Water spraying was applied frequently during dry conditions.(Works Area Portion N-C)

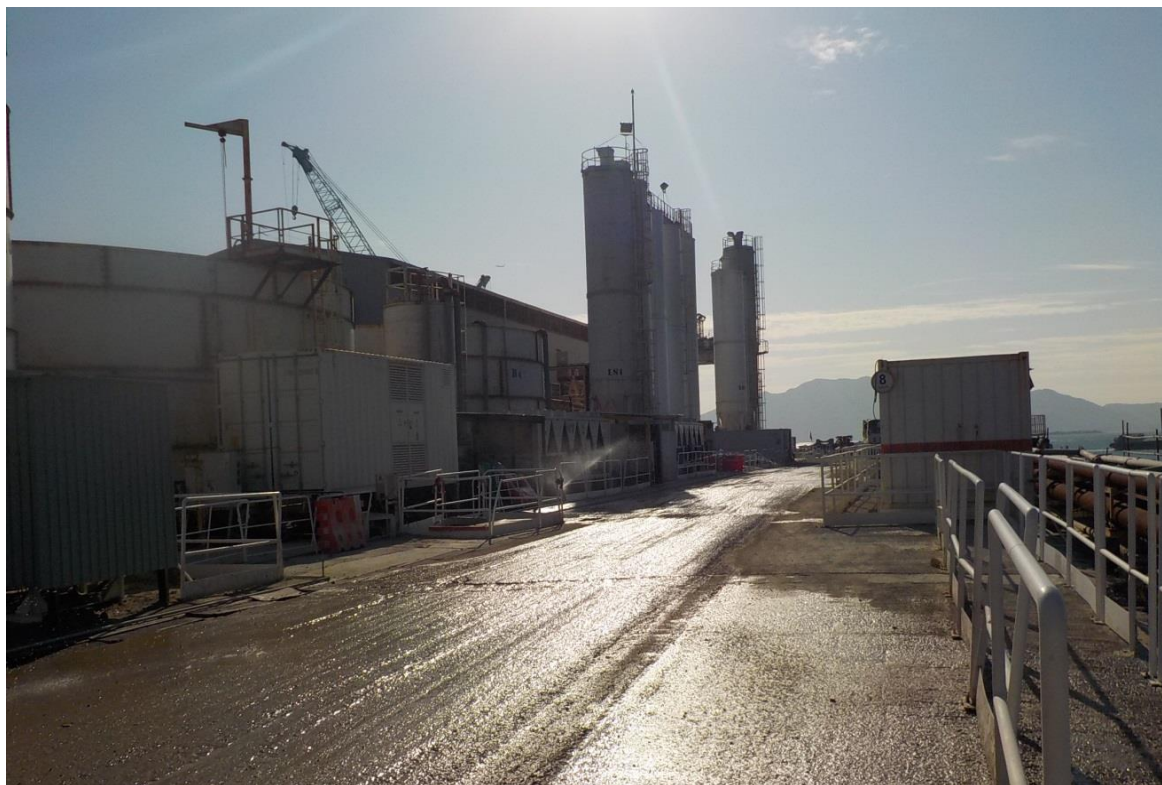
Water spraying was applied frequently during dry conditions.(Works Area Portion N-B)

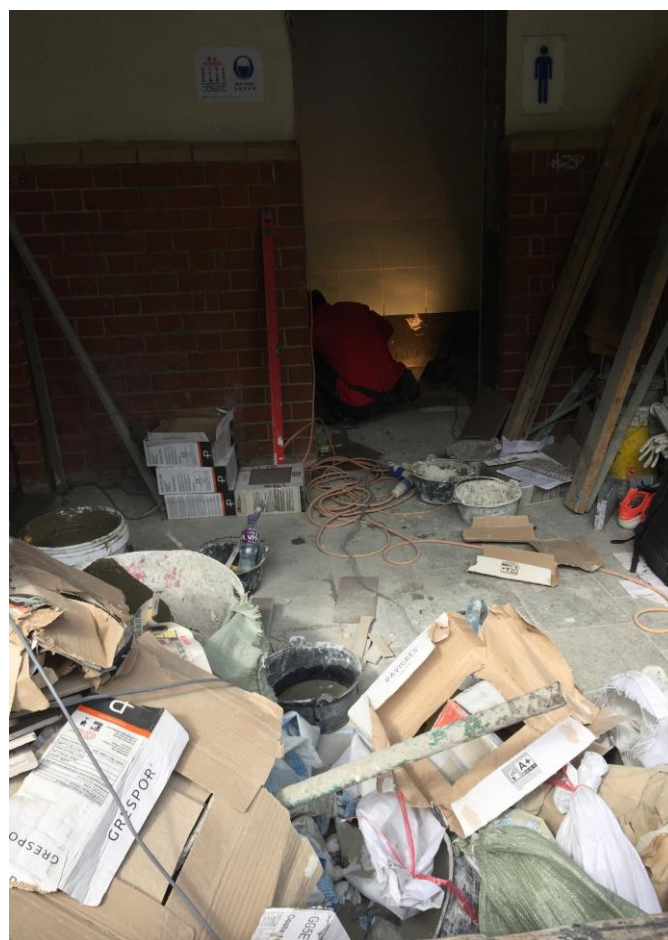
Dusty environment was observed at ASR10. (Photos on 25/1/2018)

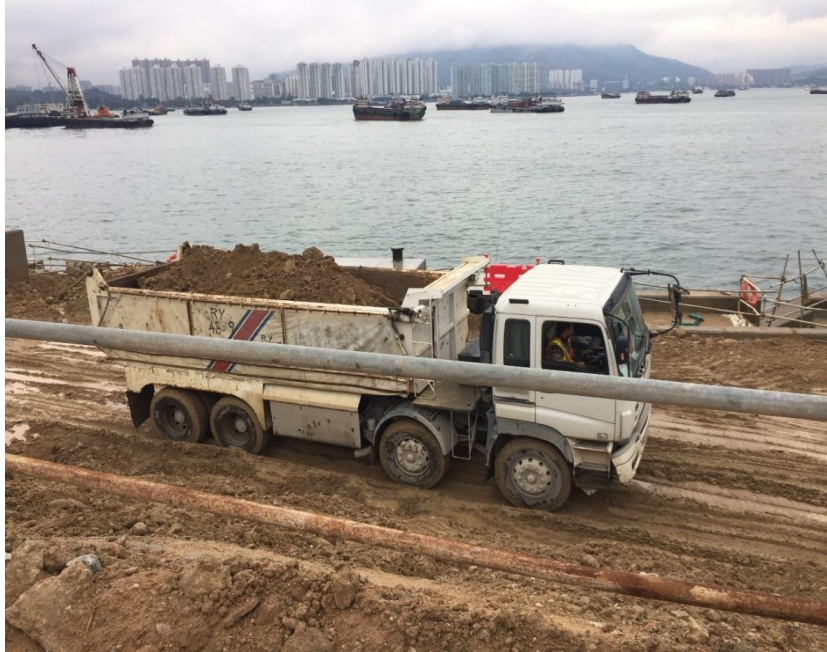
Water spraying was applied on inert C&D waste to avoid dust impact during transportation.
(Works Area Portion N-A)

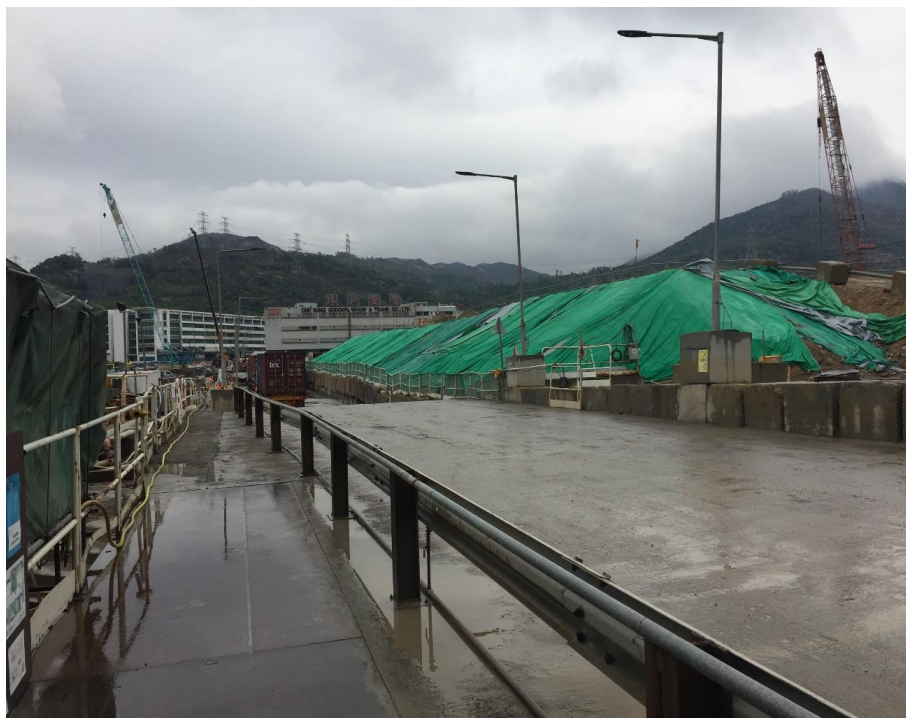
Exposed soil at Portion N-A was covered by tarpaulin sheets. (Works Area Portion N-A)

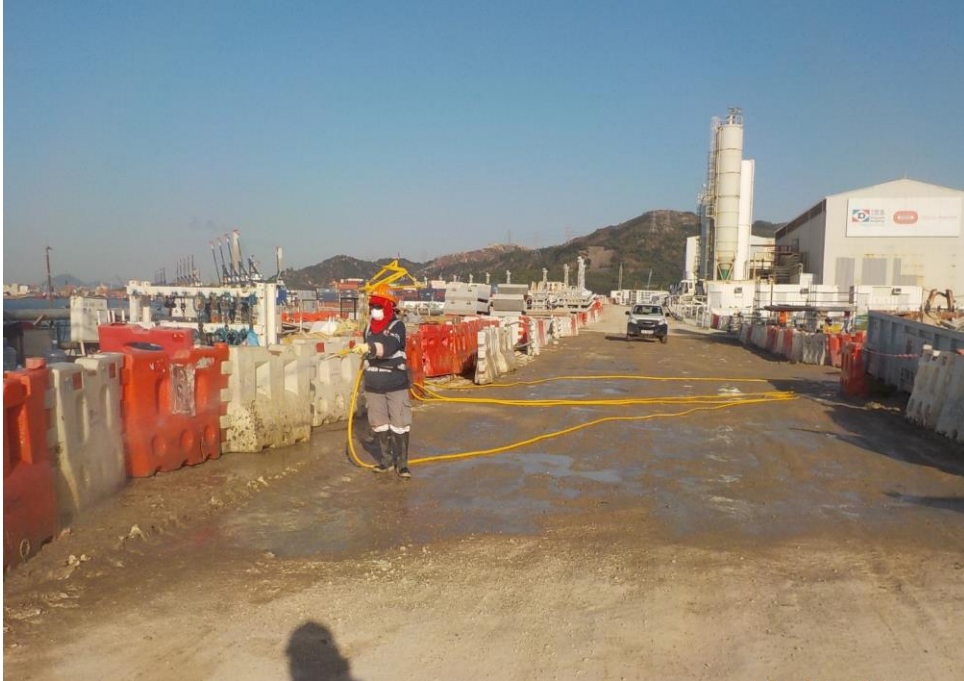
Water spraying was applied frequently during dry condition. (Works Area Portion N-B)

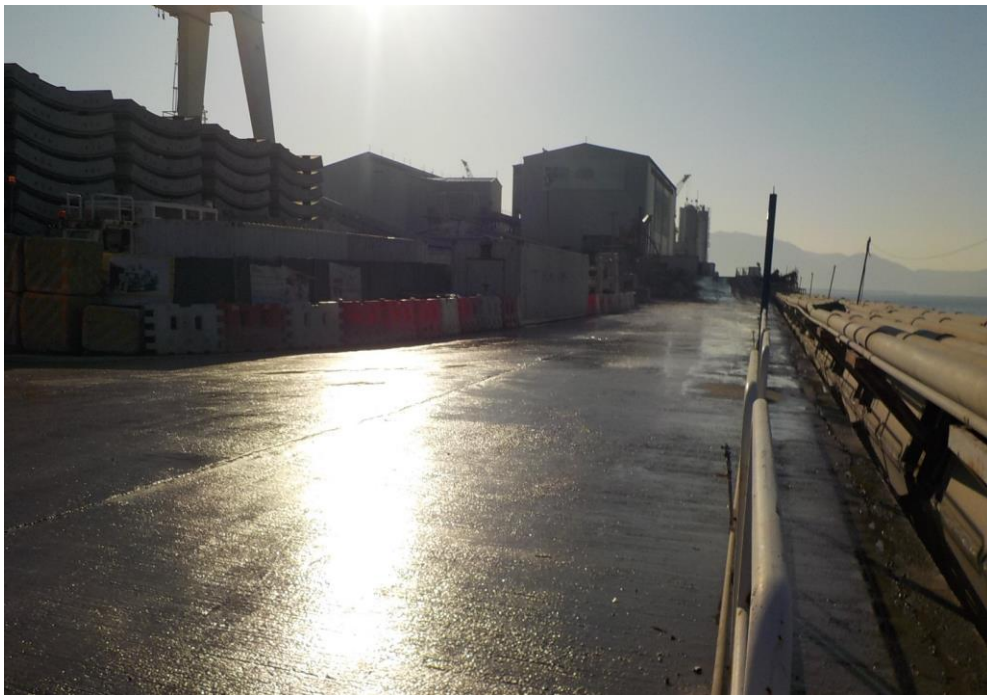
Water spraying was applied frequently during dry condition. (Works Area Portion N-B)

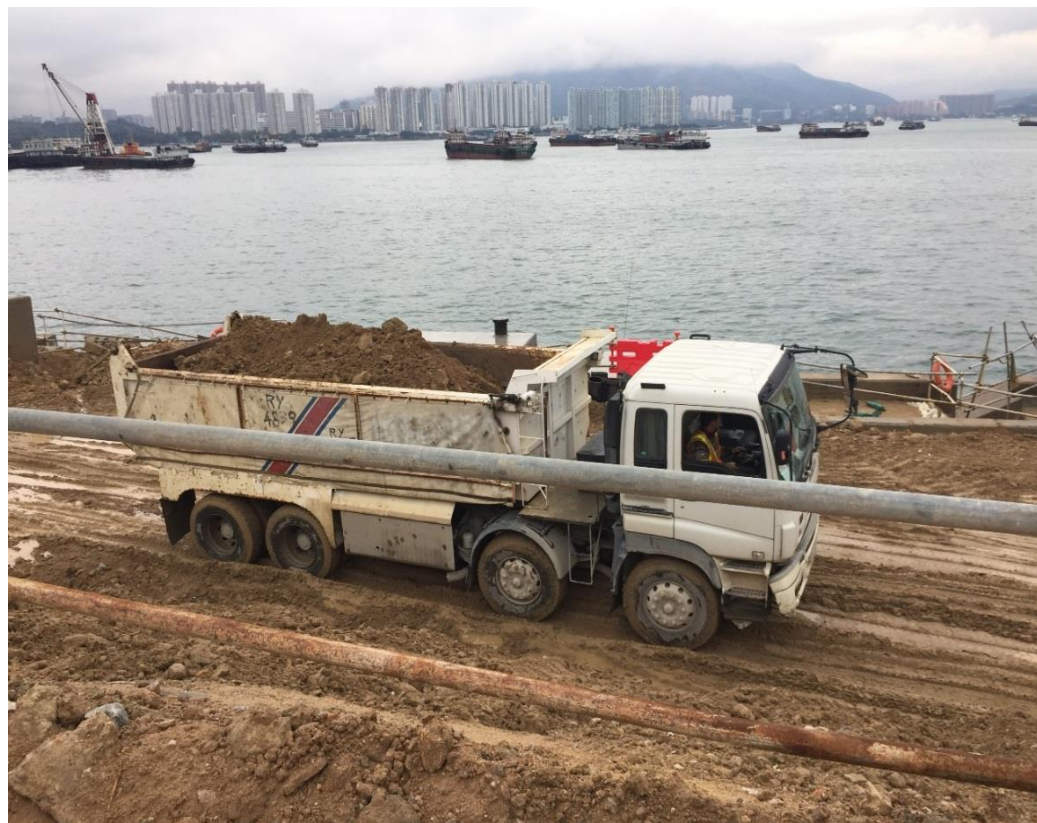
Water spraying was applied on inert C&D waste to avoid dust impact during transportation.
(Works Area Portion N-A)

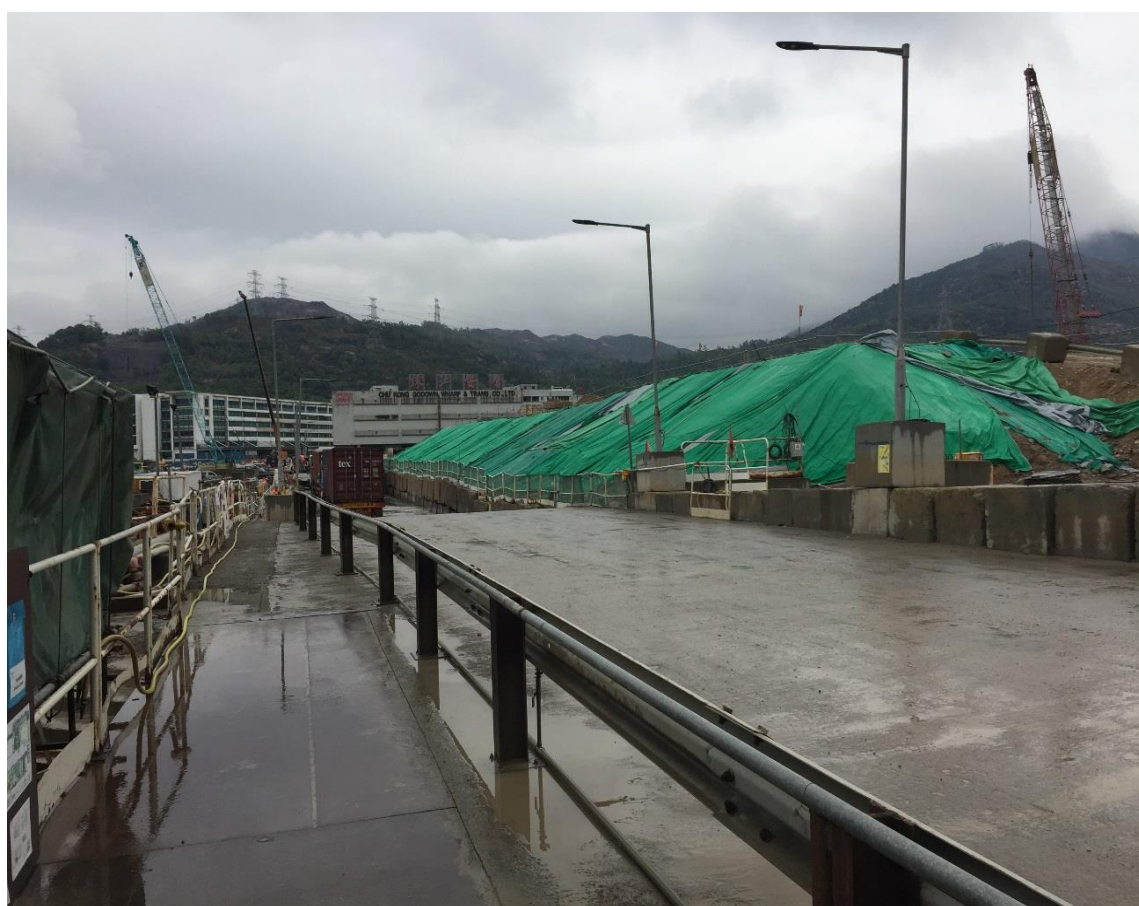
Exposed soil at Portion N-A was covered by tarpaulin sheets. (Works Area Portion N-A)

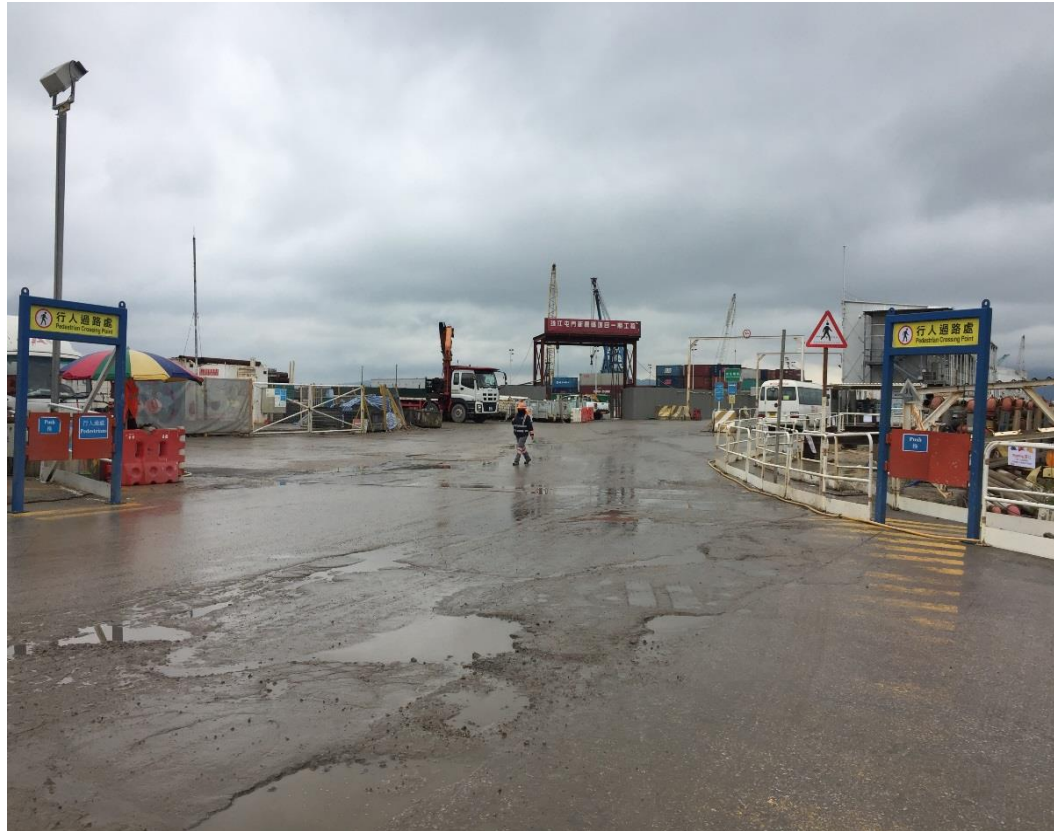
Water spraying was applied to prevent dust impact. (Works Area Portion N-A)

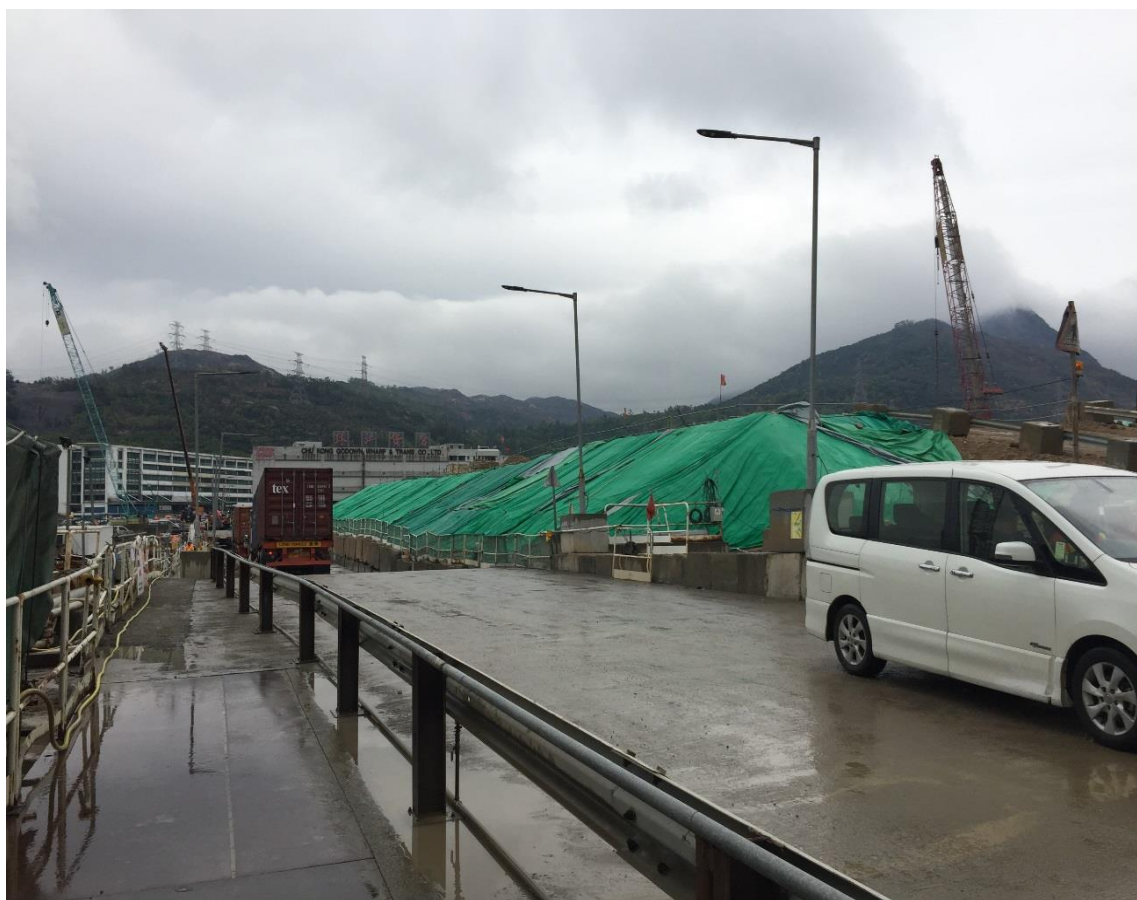
Water spraying was applied to prevent dust impact. (Works Area Portion N-A)

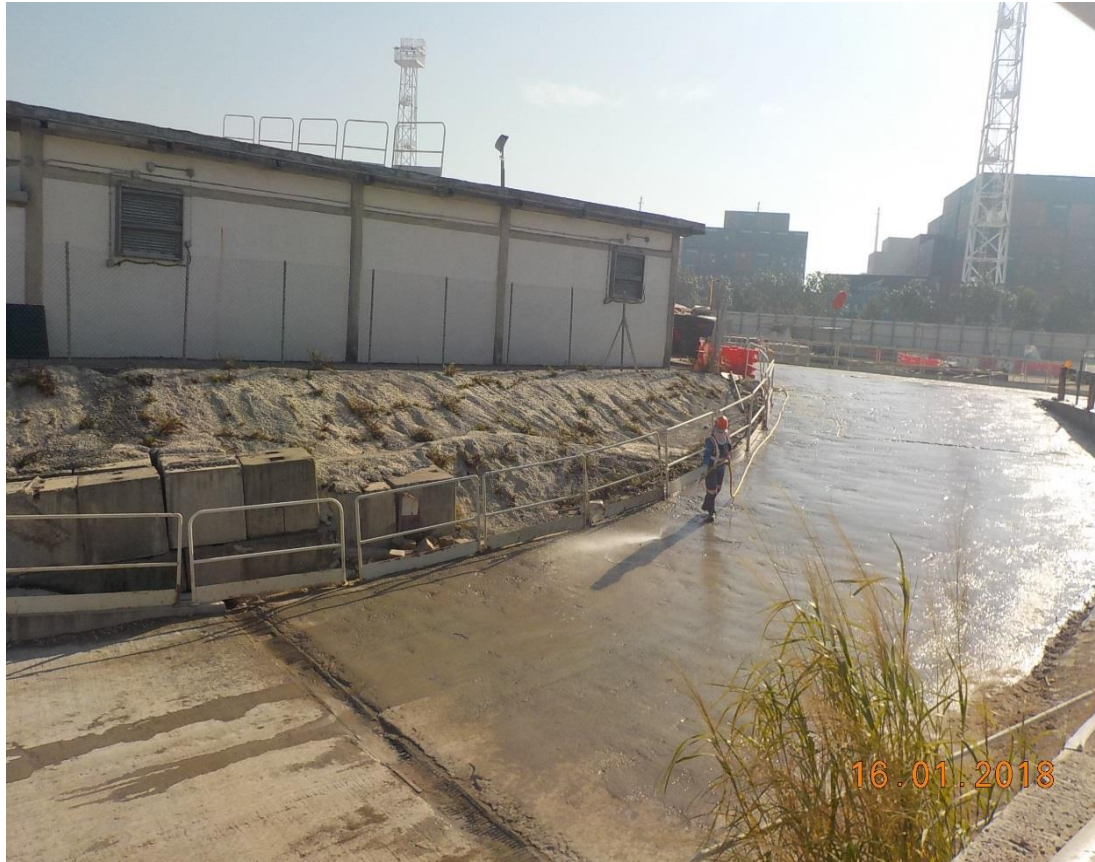
Water spraying was applied to prevent dust impact. (Works Area Portion N-A)

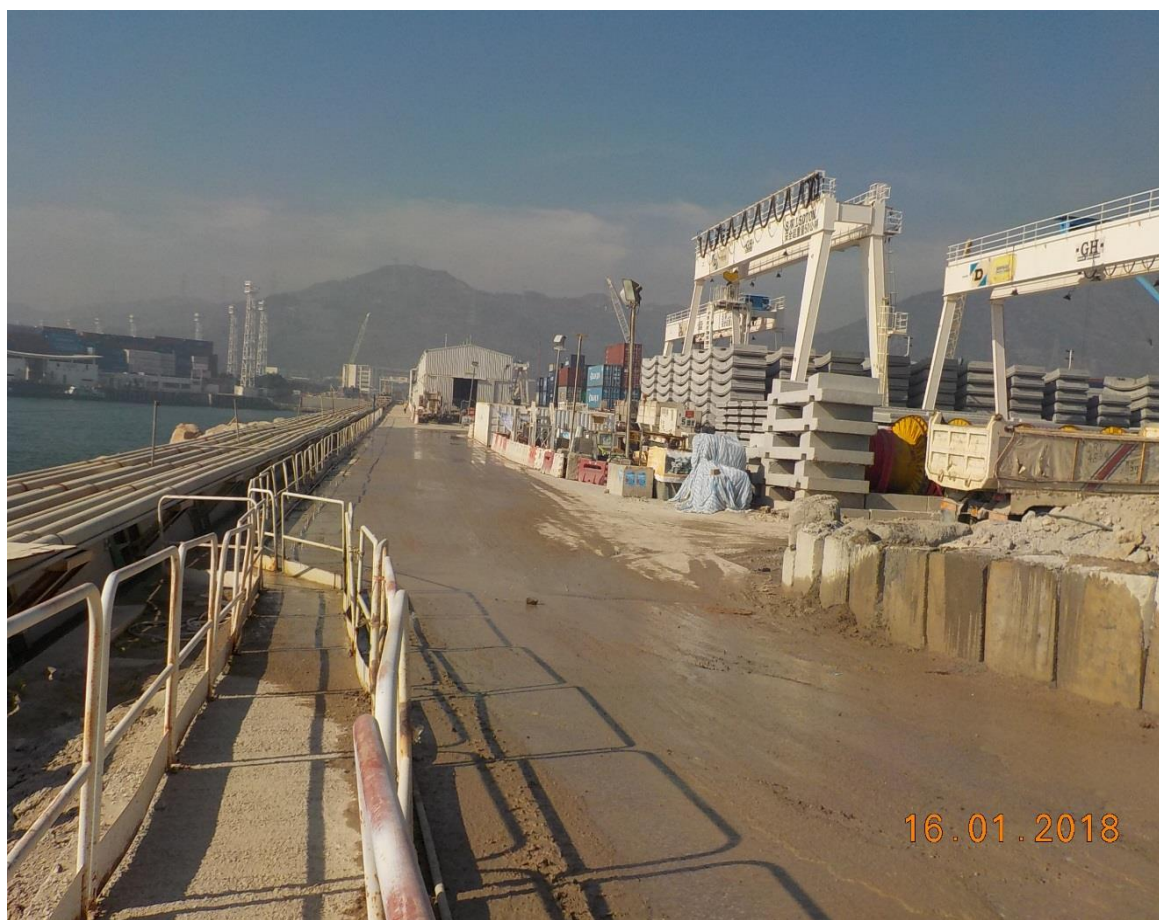
Water spraying was applied to prevent dust impact. (Works Area Portion N-B)

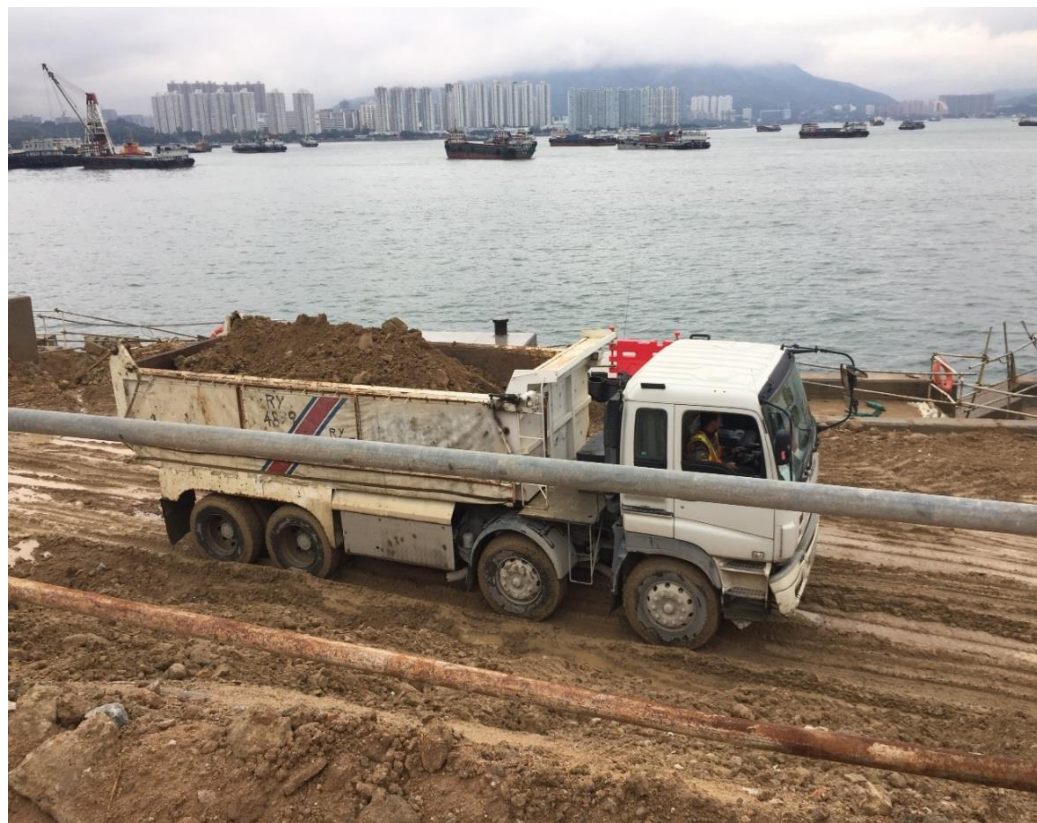
Water spraying was applied on inert C&D waste to avoid dust impact during transportation.
(Works Area Portion N-A)

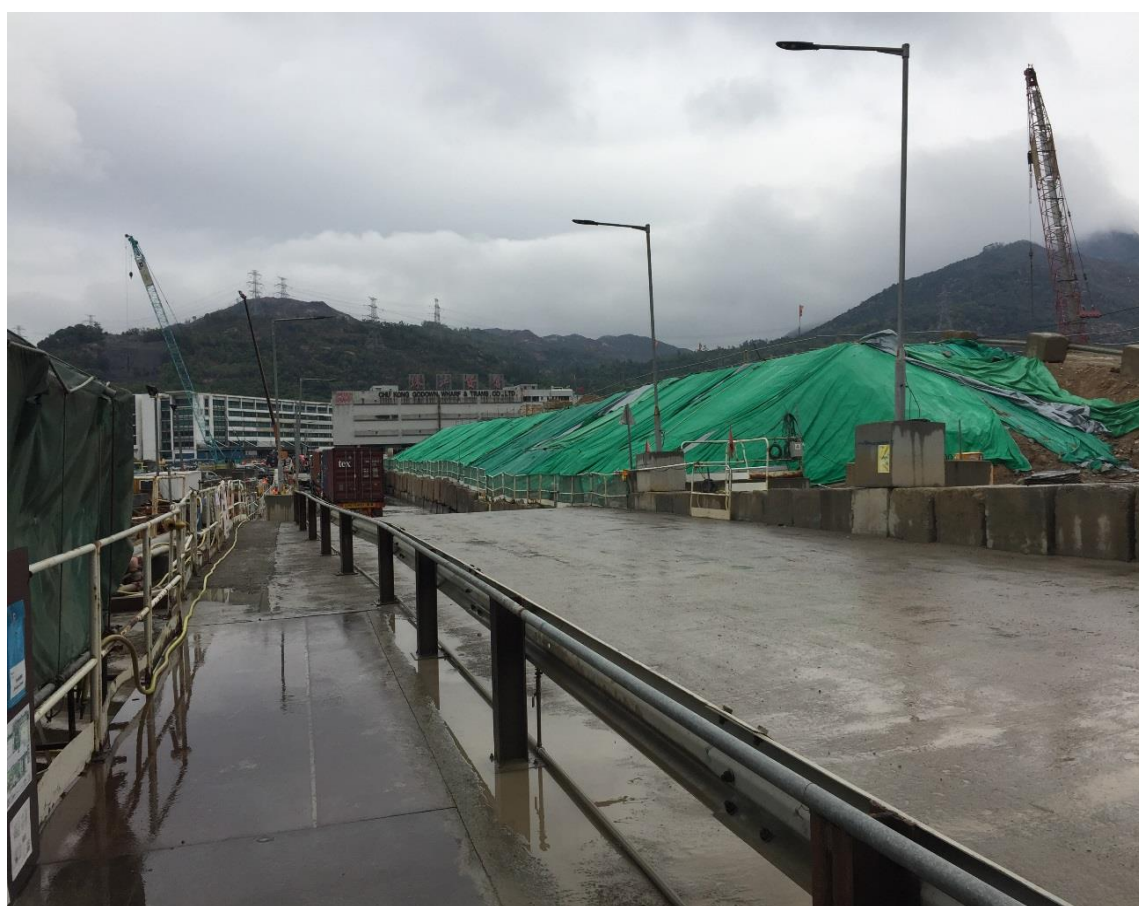
Exposed soil at Portion N-A was covered by tarpaulin sheets. (Works Area Portion N-A)

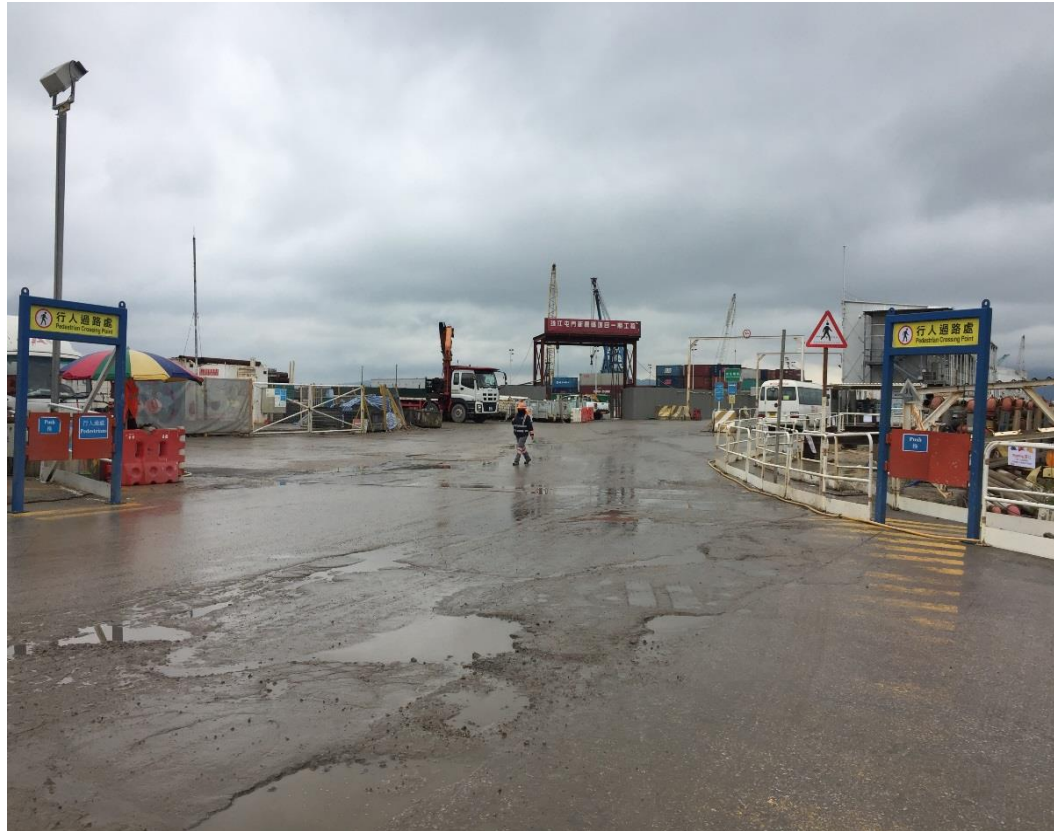
Water spraying was applied to prevent dust impact. (Works Area Portion N-A)

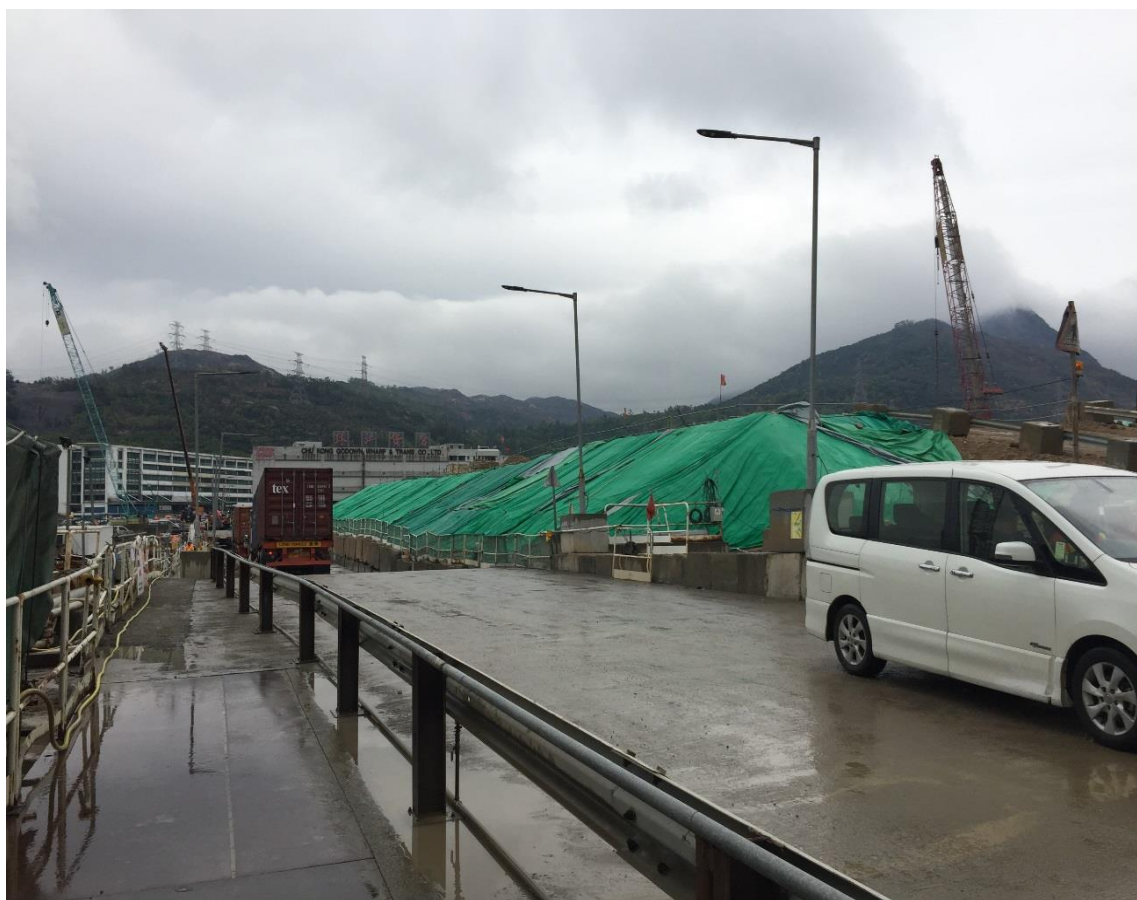
Water spraying was applied to prevent dust impact. (Works Area Portion N-A)

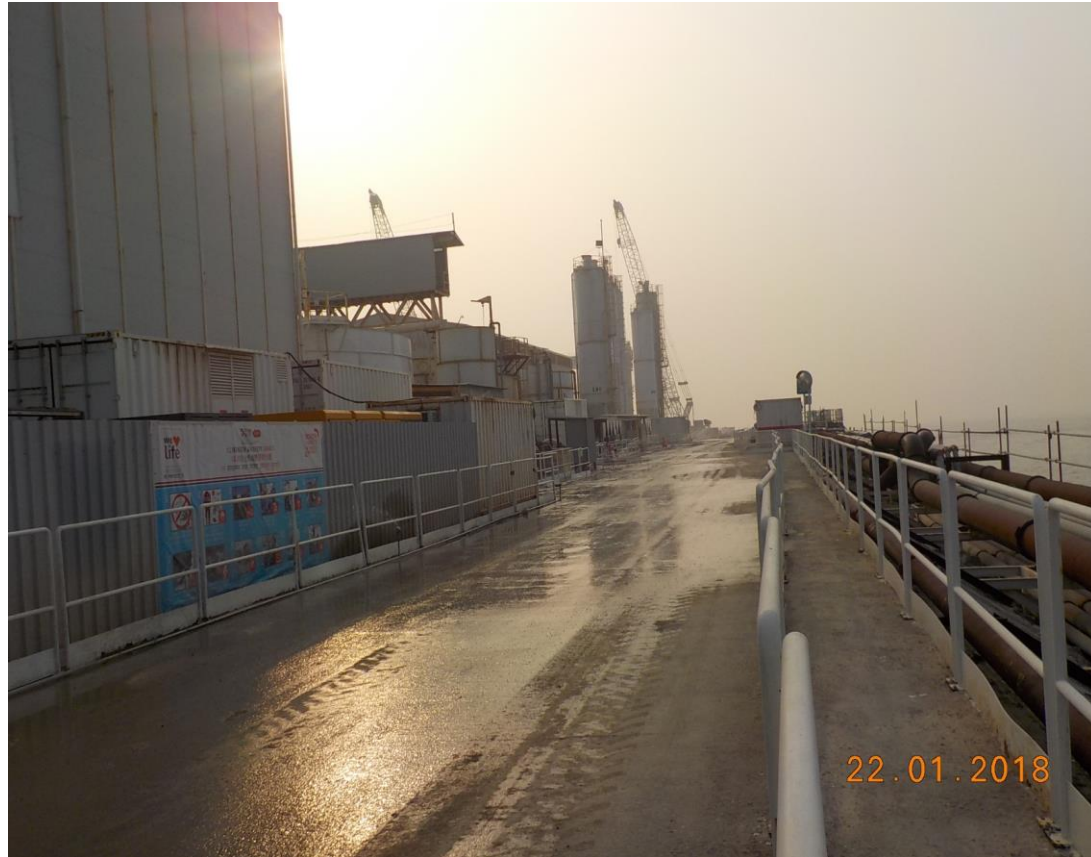
Water spraying was applied to prevent dust impact. (Works Area Portion N-B)

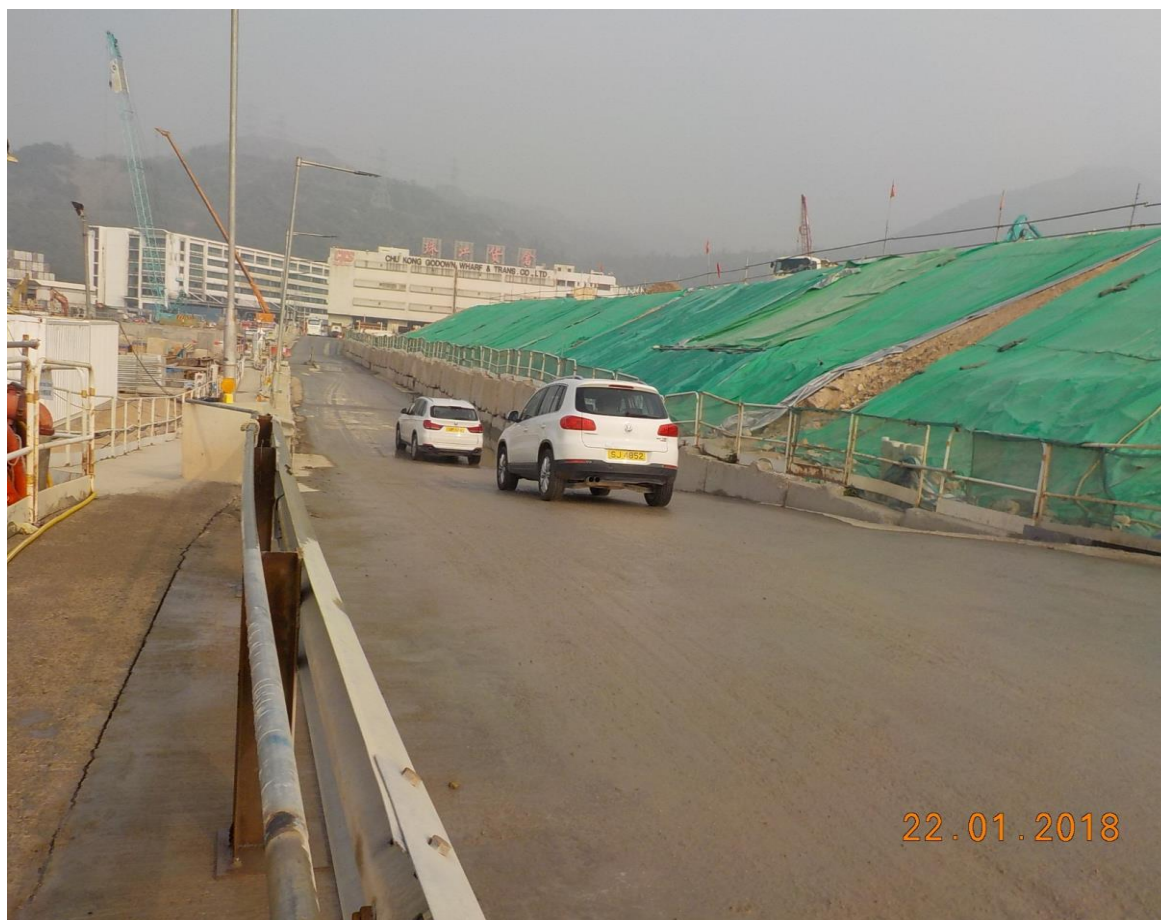
Exposed soil at Portion N-A was covered by tarpaulin sheets. (Works Area Portion N-A)

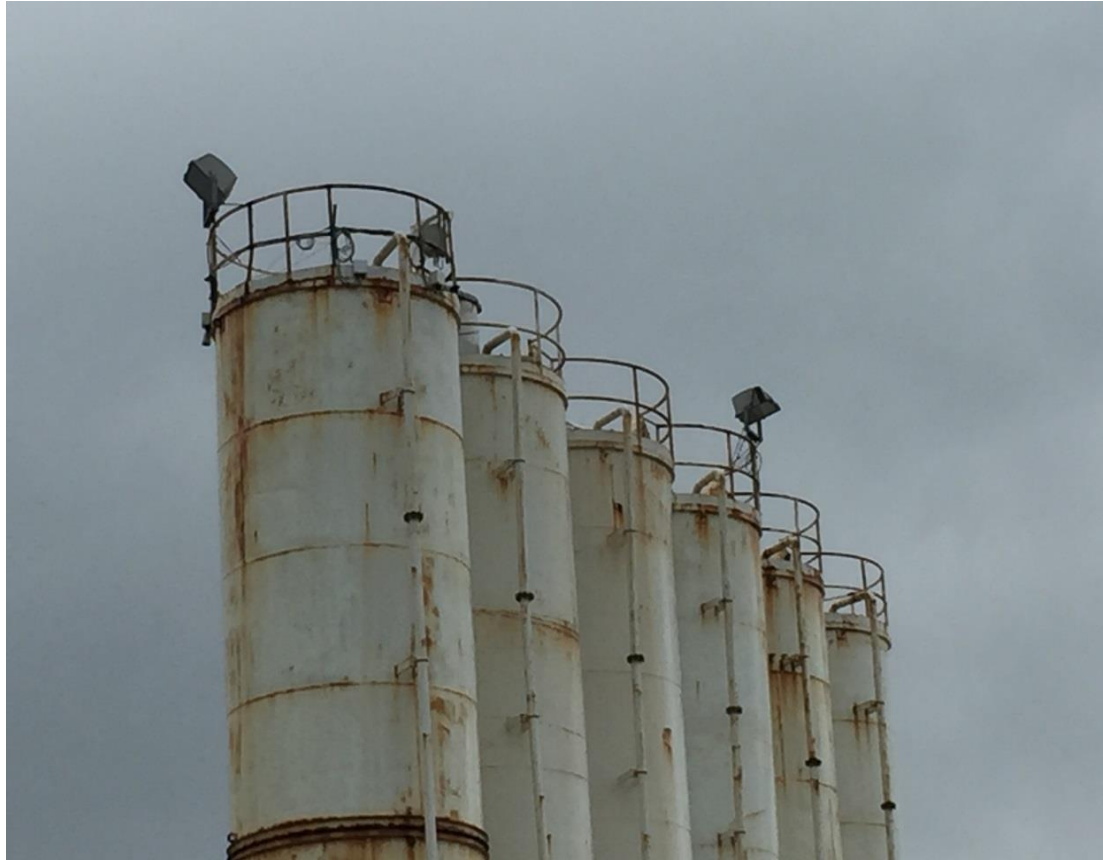
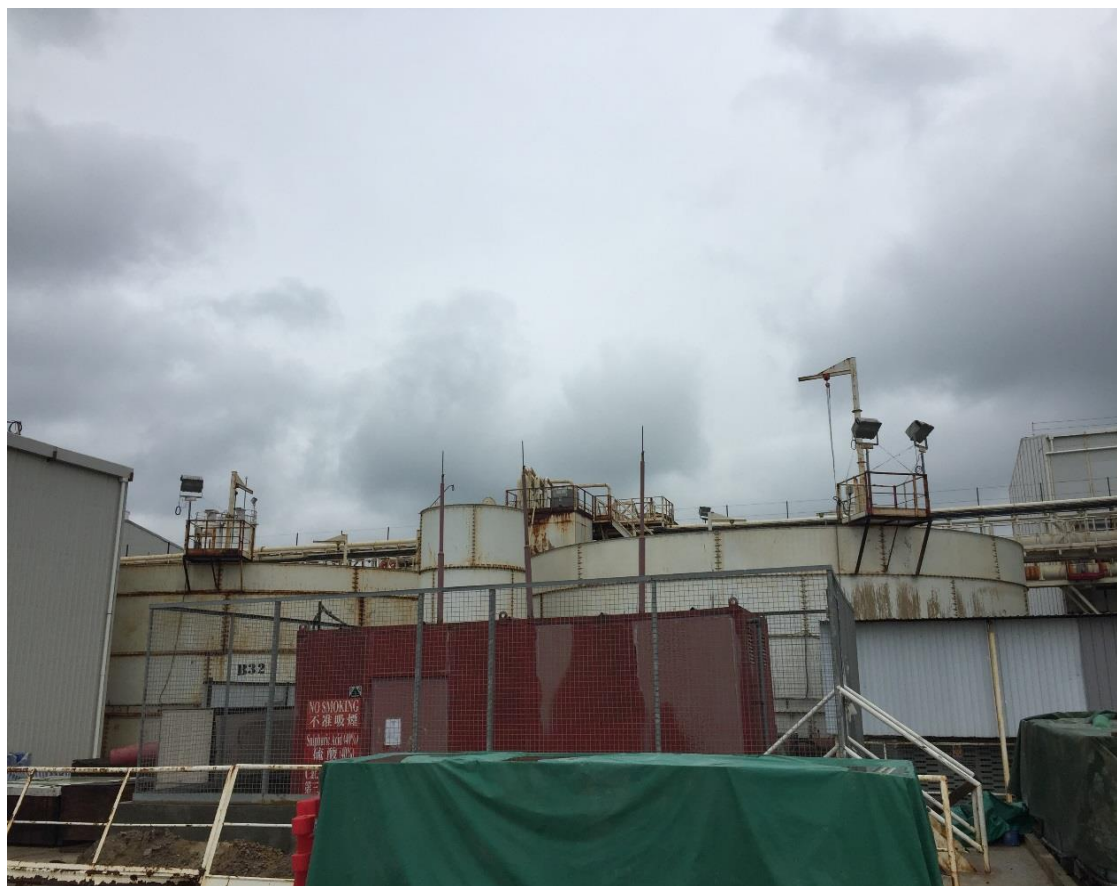
According to the Contractor, night-time lighting is essential to illuminate the main access road in order to provide a safe and efficient working environment for the site staff. Traffic routes within the site were also illuminated for the transportation of construction materials. As there was no ground construction works at night-time, noise impact was not expected and was not observed during the inspection. The Contractor also reported that they have only one barge working at daylight hours near the site which is responsible for the transportation of C&D wastes. Most barges near the site are not working under this Contract. Photo record is provided in Annex A.

Direction of the lighting at STP is adjusted towards the ground.

The Contractor are also recommended to fit caps at the lightings at STP to restrict the direction of beam and area of illumination and adopt soft roadside light.

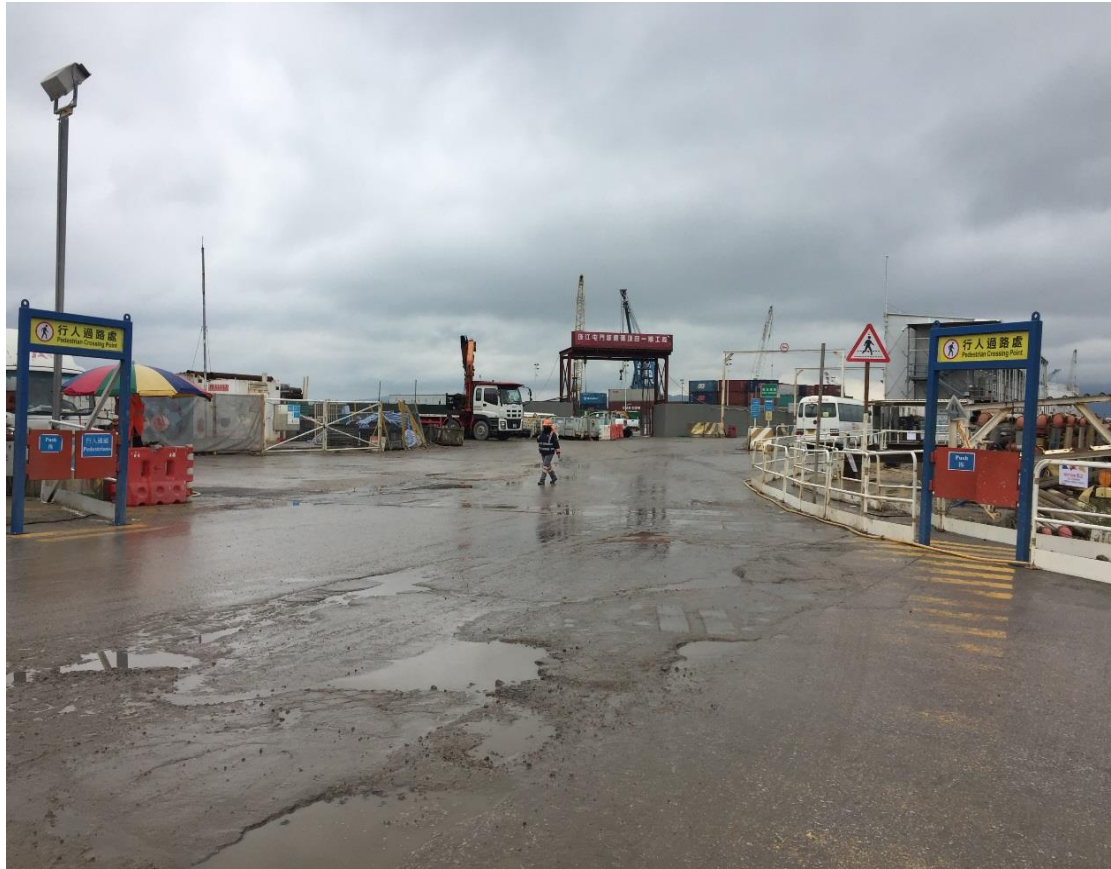
Water spraying is applied.

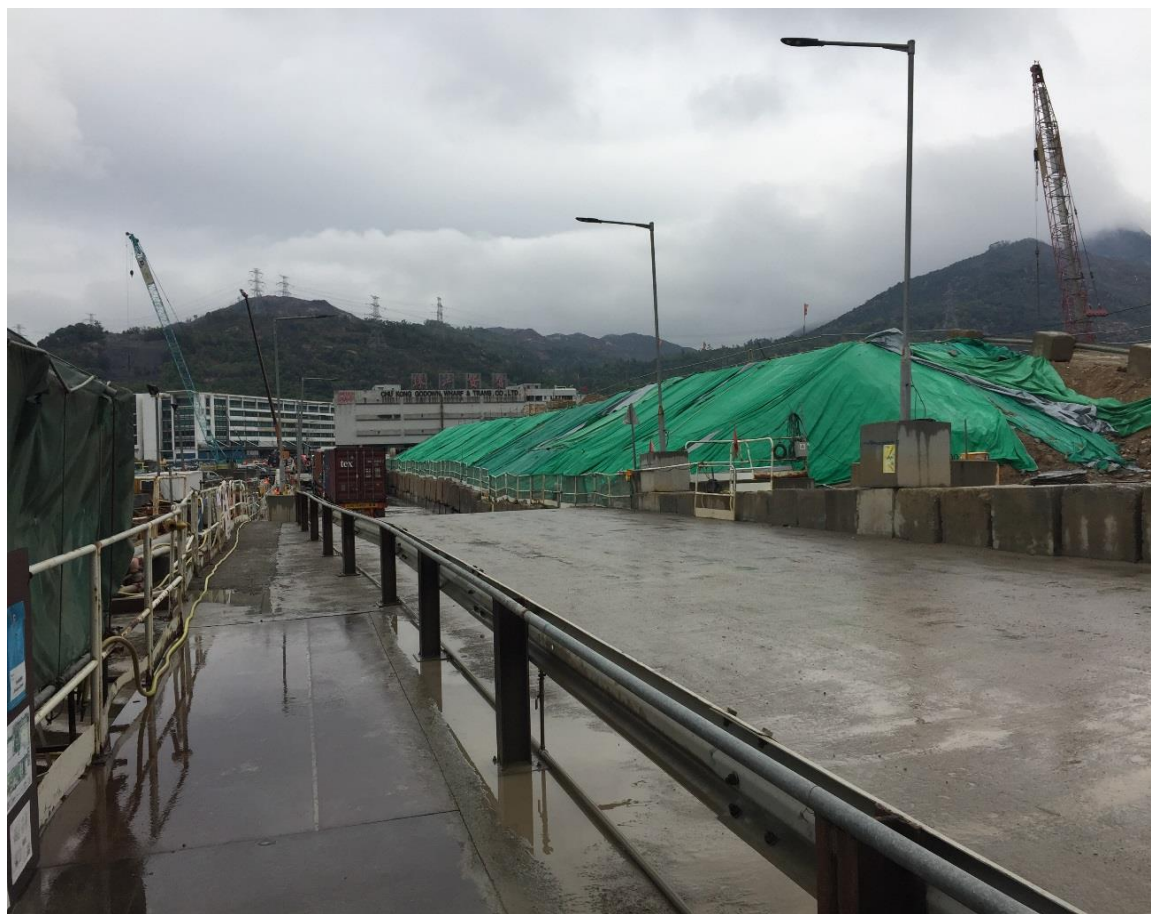
Exposed soil is covered by tarpaulin sheets
