CONTRACT NO. HY/2012/08 TUEN MUN – CHEK LAP KOK LINK – NORTHERN CONNECTION SUB-SEA TUNNEL SECTION

Air Quality Impact Monitoring Notification of Exceedance

ENVIRONMENTAL COMPLAINT/ENQUIRY INVESTIGATION REPORT

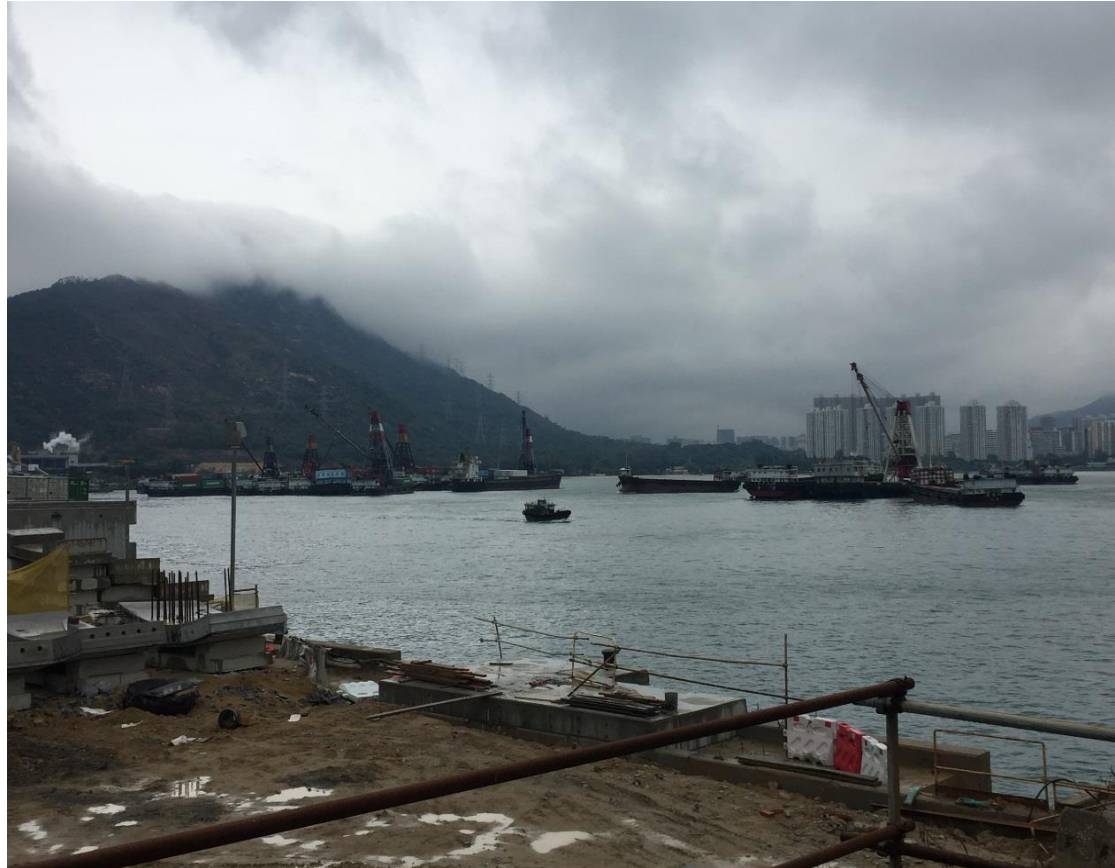
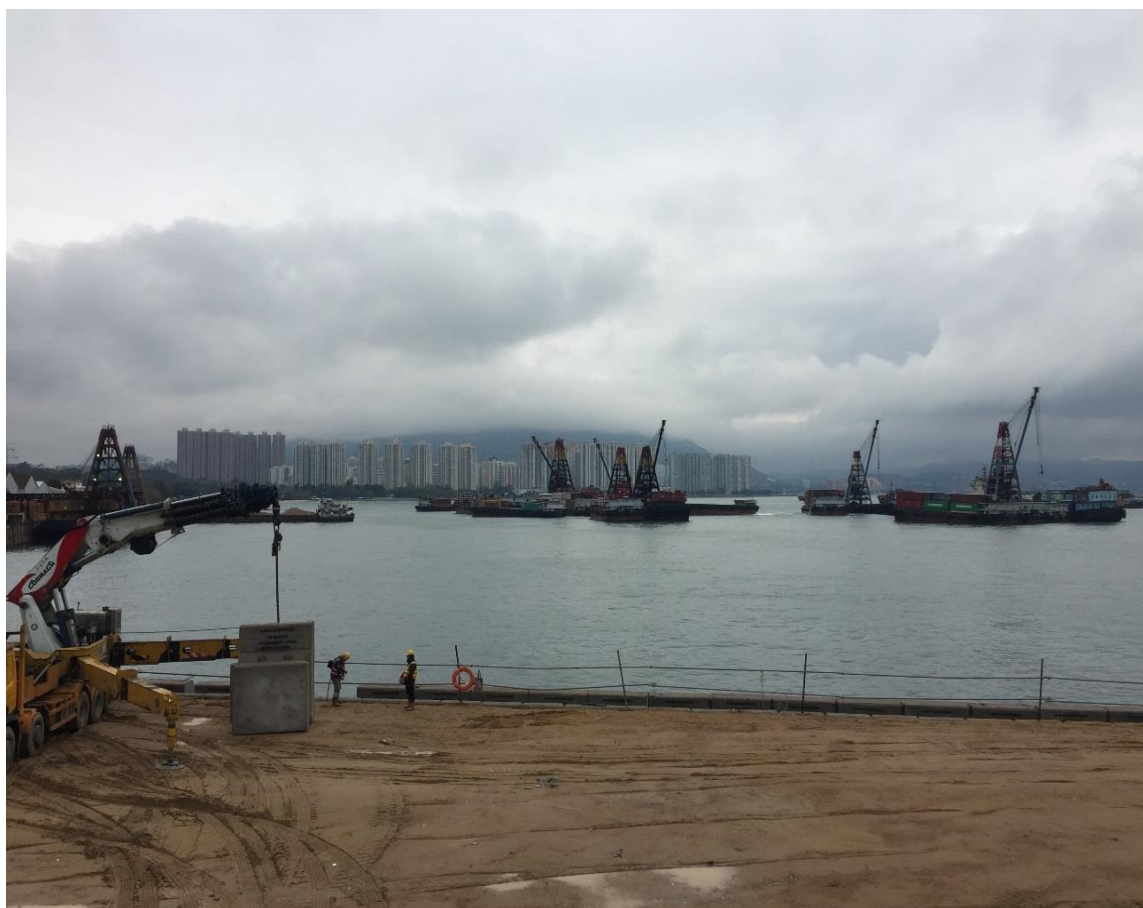
Barges not under this Contract are observed near the site

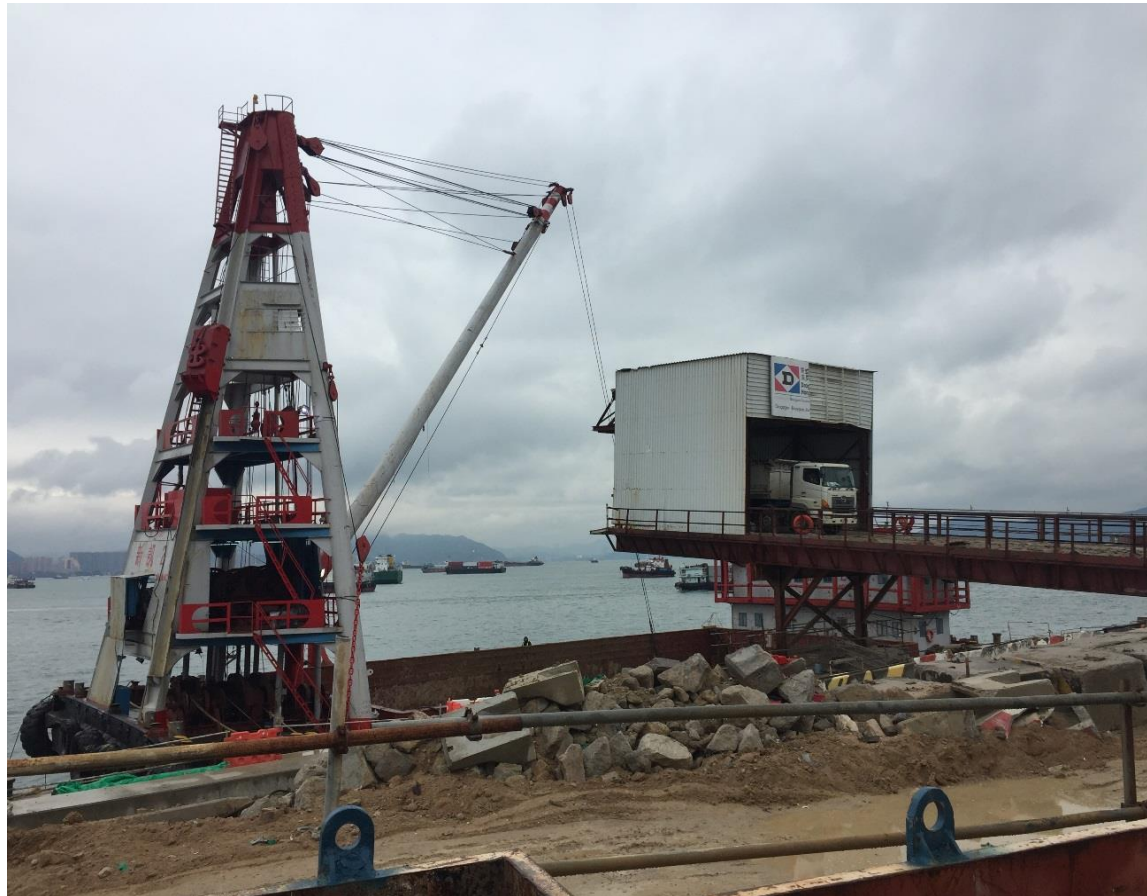
Barge for transportation of C&D material

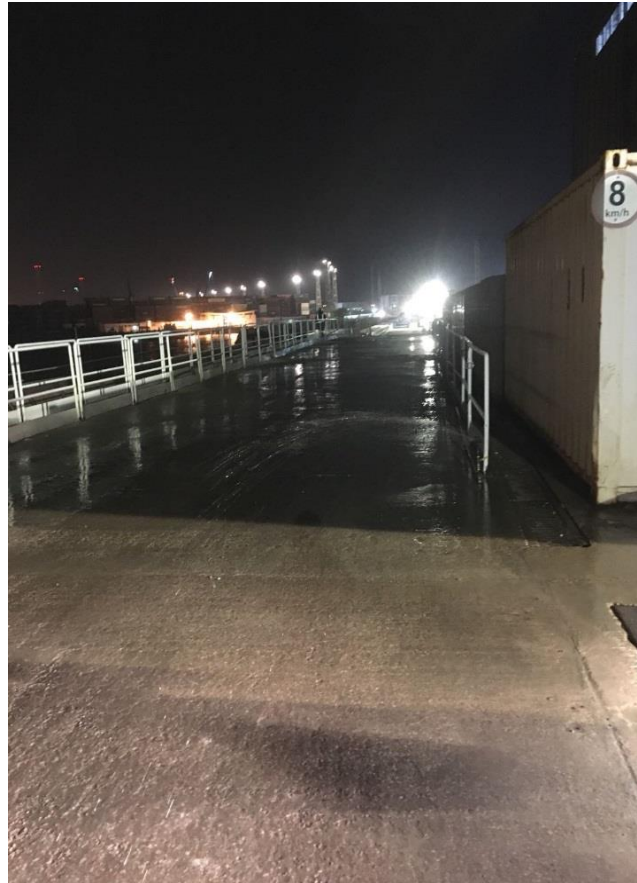
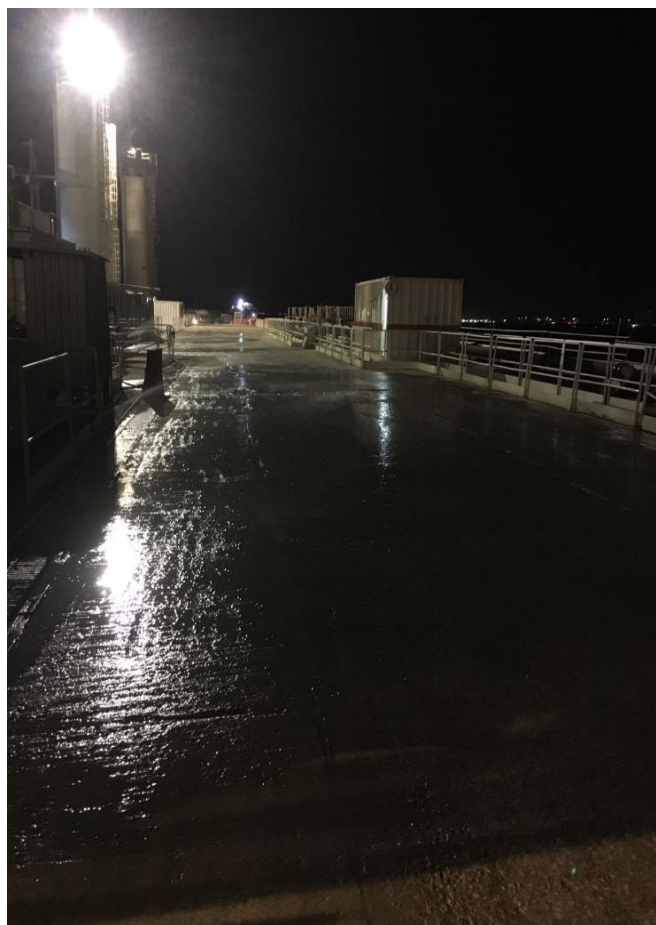
Site conditions at night-time

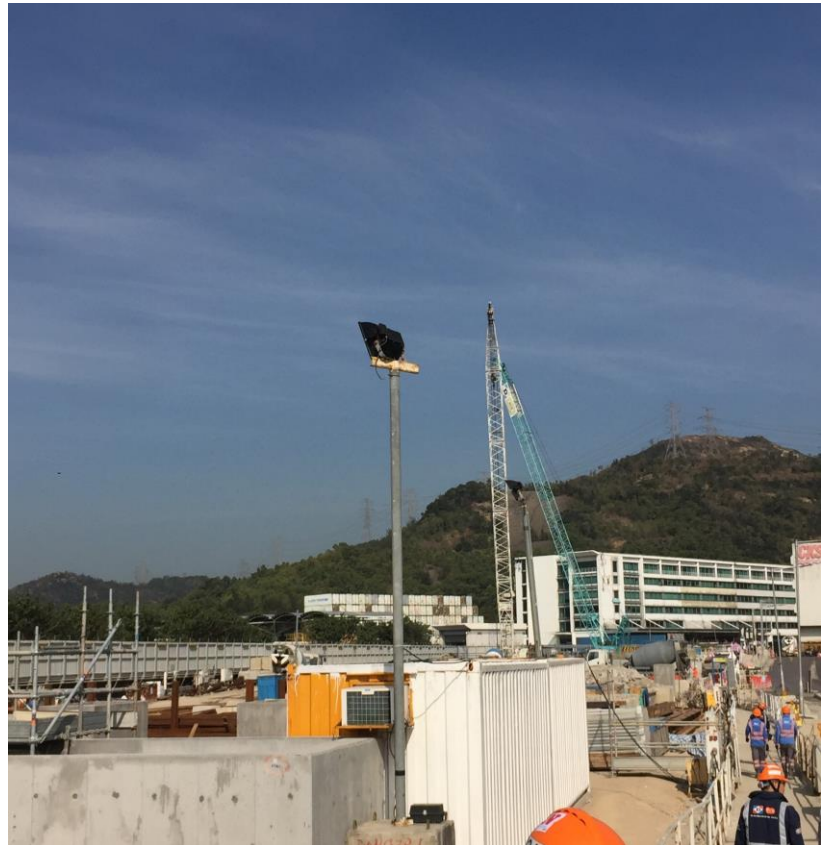
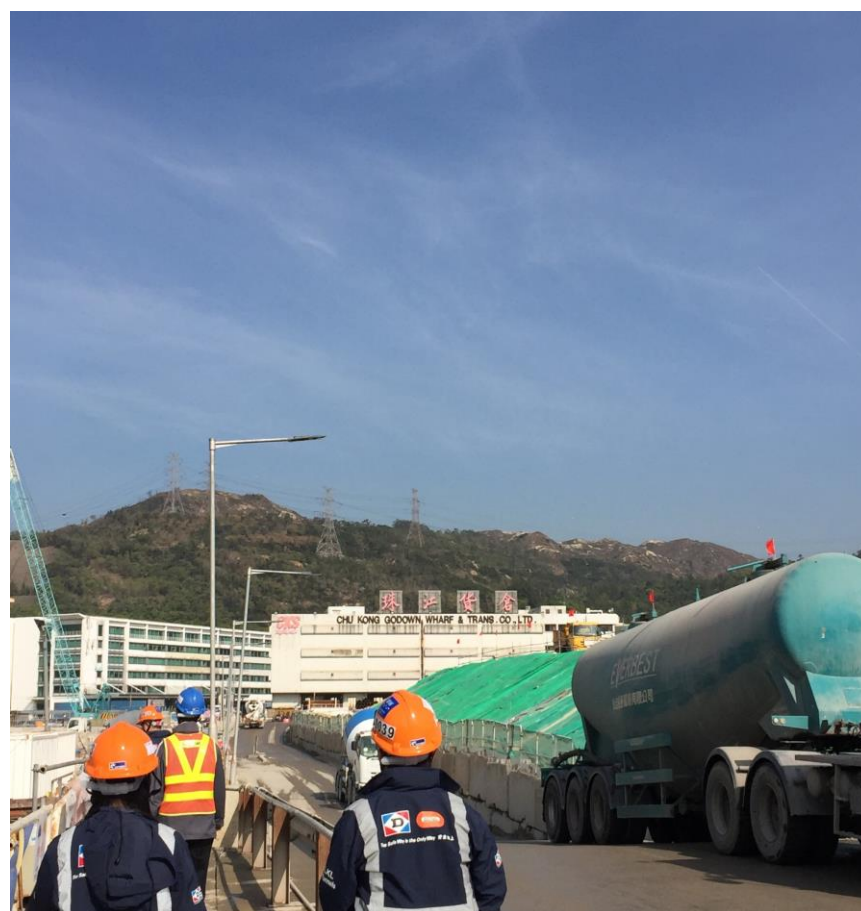
Lighting at the main site access
