**Ref/Project number** Contract No. HY/2012/08 Tuen Mun–Chek Lap  
Kok Link–Northern Connection Sub-sea Tunnel  
Section

**Subject** Notification of Exceedance for Air Quality  
Impact Monitoring

## CONTRACT NO. HY/2012/08 TUEN MUN – CHEK LAP KOK LINK – NORTHERN CONNECTION SUB-SEA TUNNEL SECTION

### Air Quality Impact Monitoring Notification of Exceedance

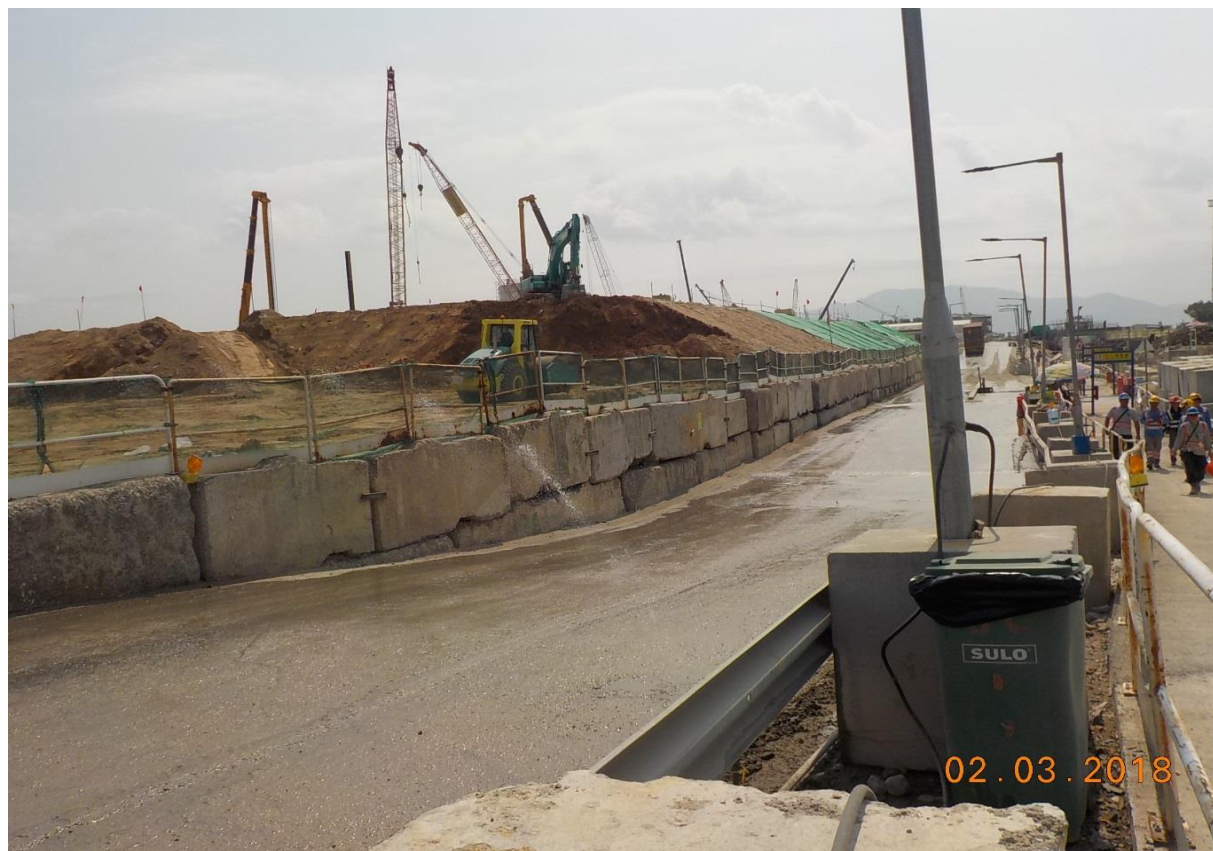
Water spraying was applied frequently on site.  
(Works Area Portion N-A)

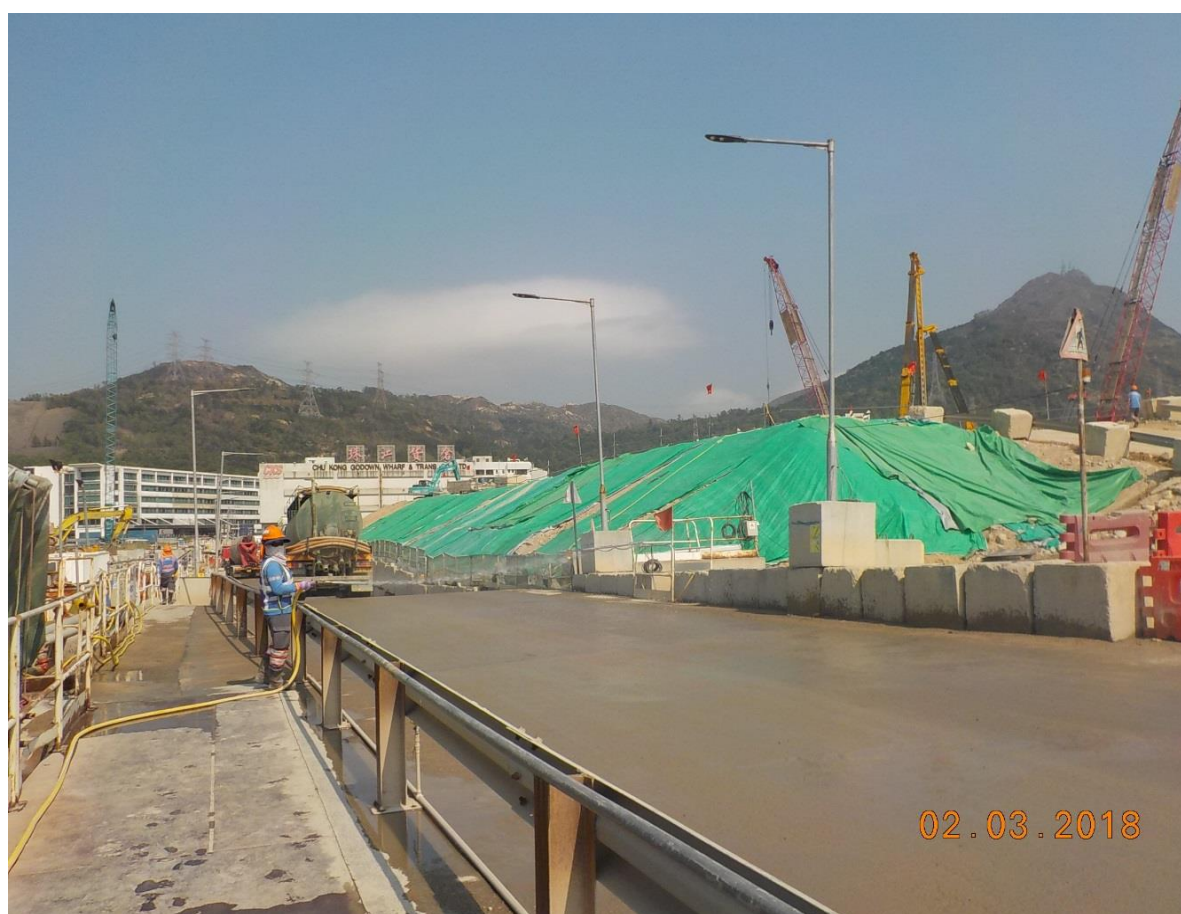
Exposed soil at Portion N-A was covered by tarpaulin sheets. (Works Area Portion N-A)

<b>Actions Taken/ To Be Taken</b>	<p>According to the photo record on 2 March 2018, the Contractor has properly implemented dust suppression measures on site. Follow up site inspection was carried out on 19 March 2018. Box culvert extension was carried out at Works Area Portion N-A and Construction of Ventilation Building was carried out at Portion N-C. Water spraying was applied to prevent dust. Photo record is provided in Annex A. Photos taken during AQM were also provided. No significant dust impact was observed at ASR1. Dust suppression measures were properly implemented during the site inspections.</p> <p>The Contractor has been reminded to implement the required mitigation measures as per the EP, approved EIA and Updated EM&amp;A Manual including watering to maintain all exposed road surfaces and dust sources wet, use of sprinklers for water spraying, covering the materials having the potential to create dust by clean tarpaulin, use of water truck and watering on all exposed soil within the Project site) throughout the construction period. The Contractor was also reminded to ensure all dust mitigation measures are provided at Portion N-A and Portion N-C, where the construction works are carried out.</p> <p>As occasional exceedances were observed at ASR1, the Contractor has been reminded to enhance their dust mitigation measures at the works area, especially Portion N-A, which is closest to ASR1. Water spraying should be applied more frequently to prevent dust. The Contractor should also ensure that the exposed soil at Portion N-A was covered by tarpaulin sheets.</p>

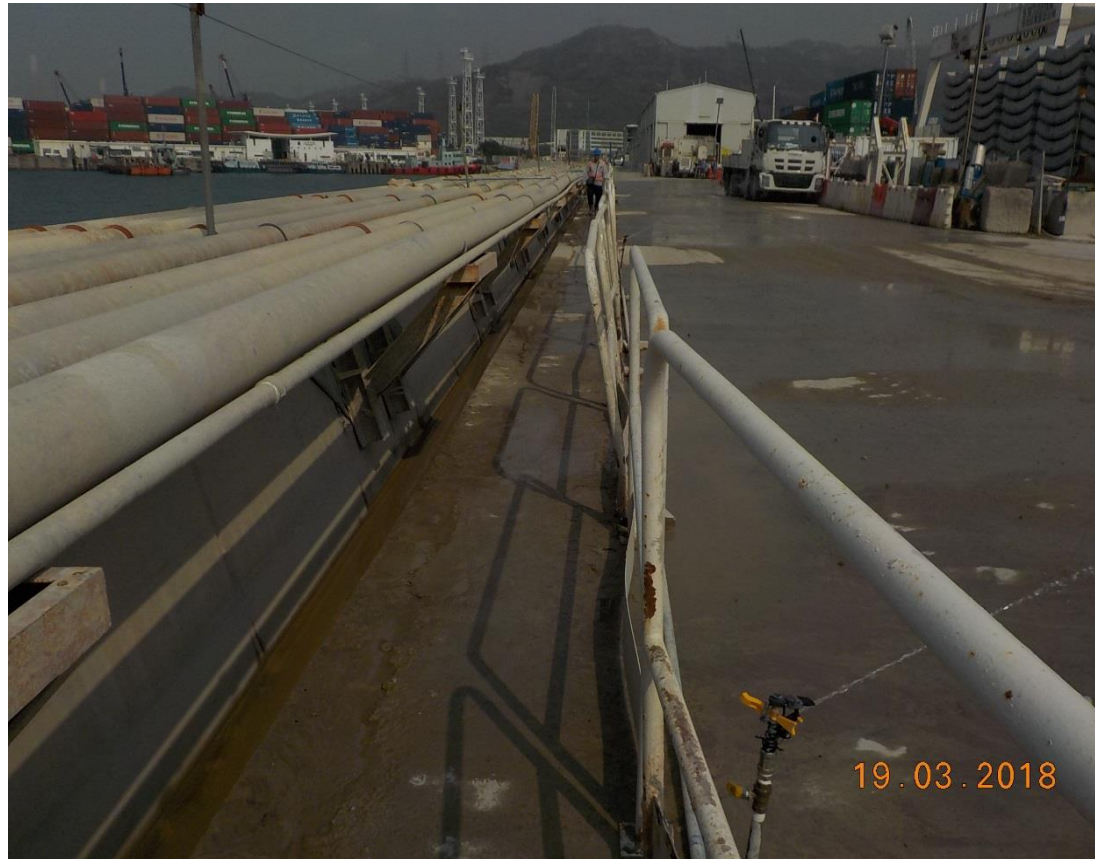
Water spraying was applied frequently on site.  
(Works Area Portion N-C)

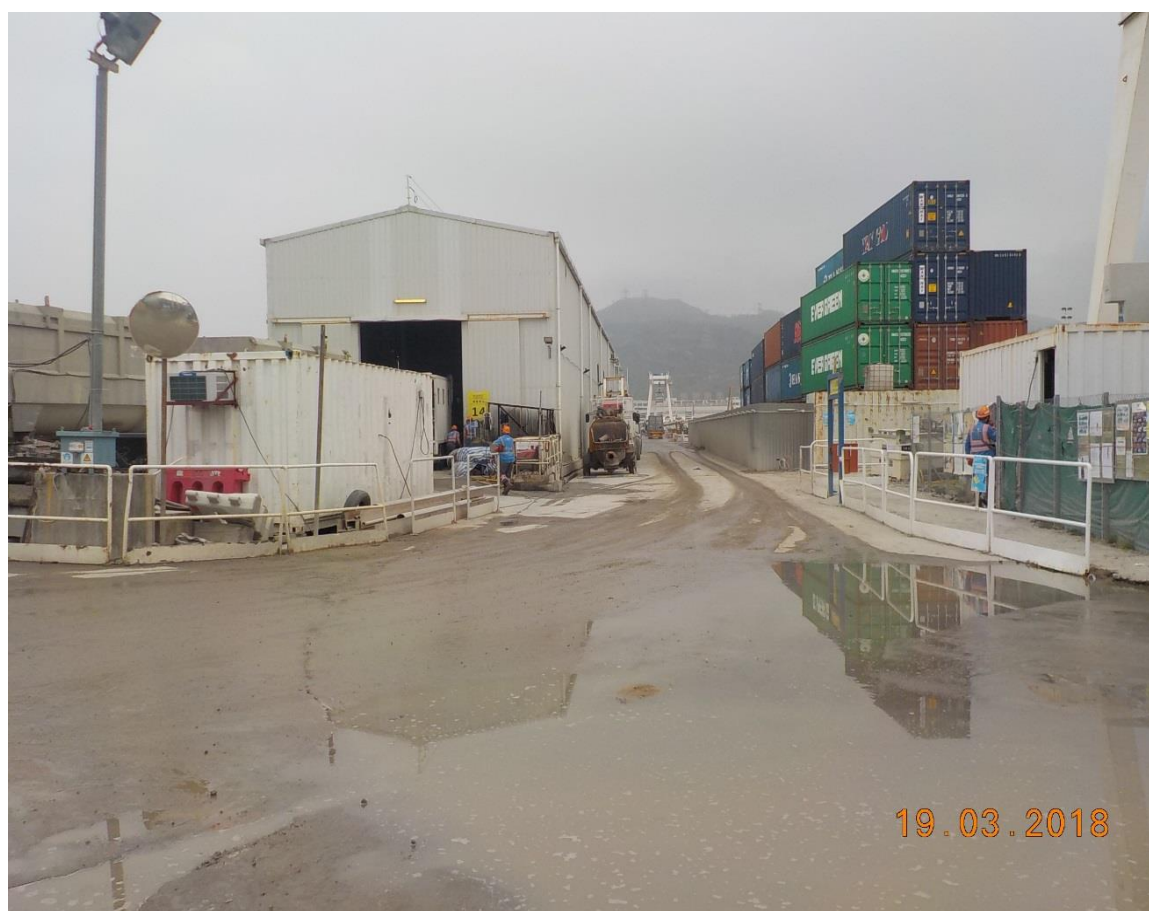
Water spraying was applied frequently on site.  
(Works Area Portion N-B)

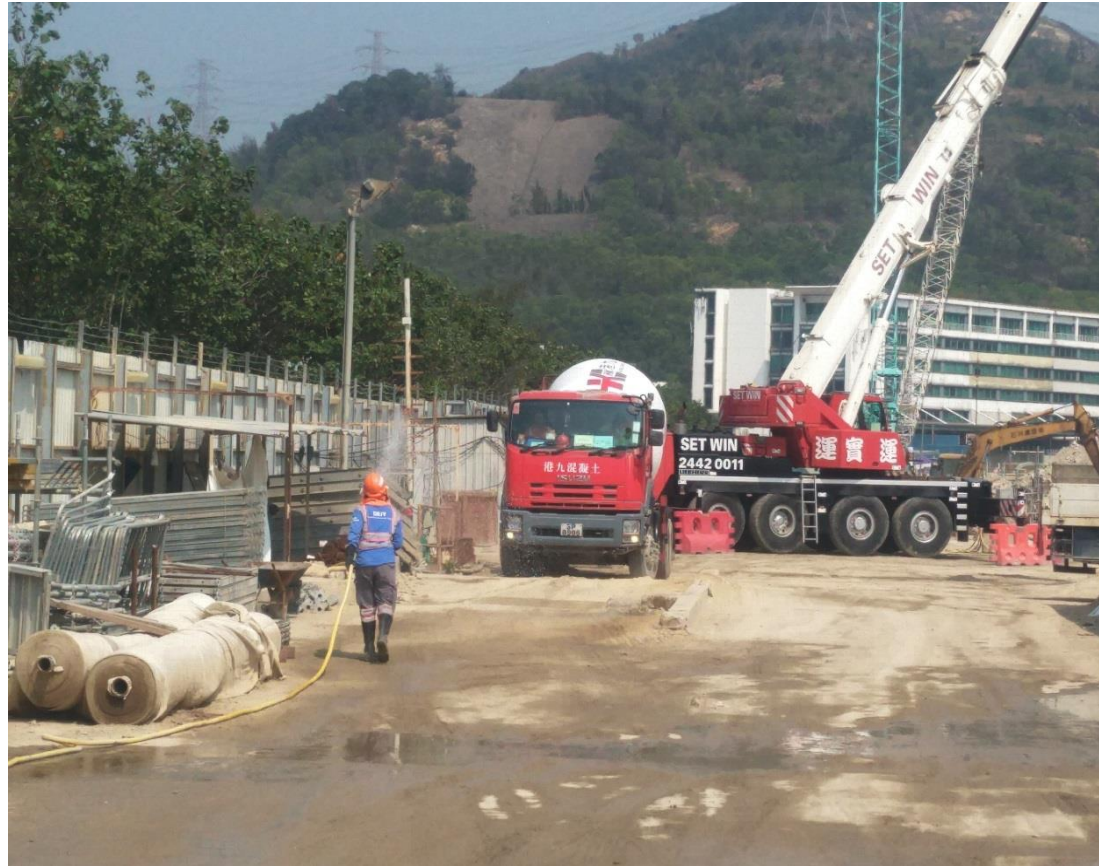
Water spraying was applied frequently on site.  
(Works Area Portion N-A)

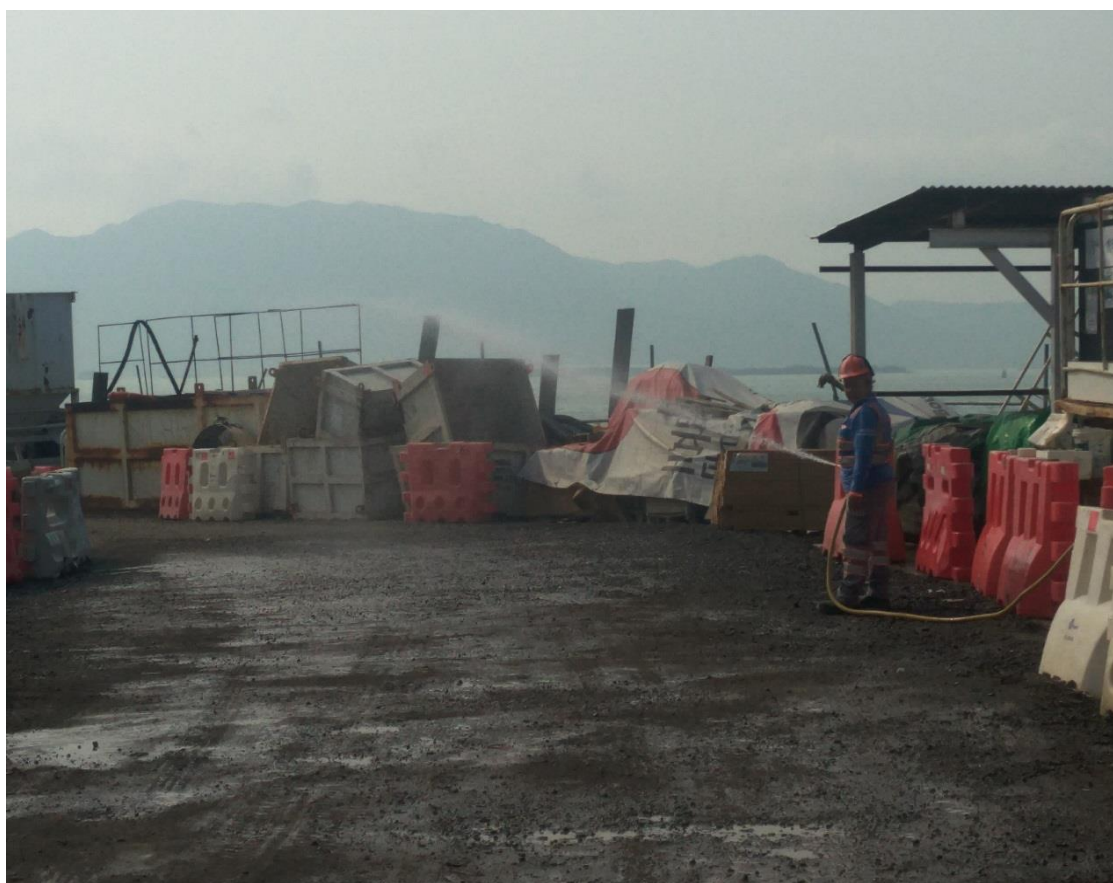
Water spraying was applied frequently on site.  
(Works Area Portion N-C)

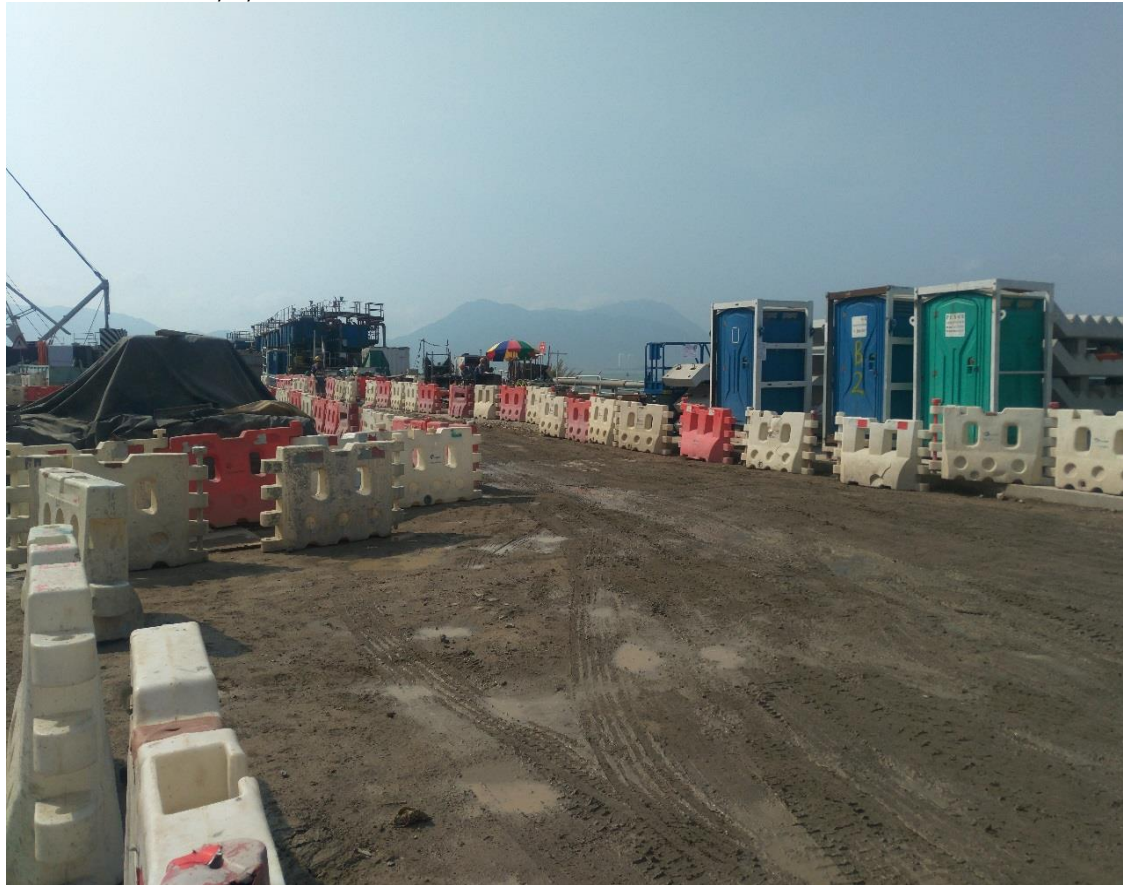
Water spraying was applied frequently on site.  
(Works Area Portion N-C)

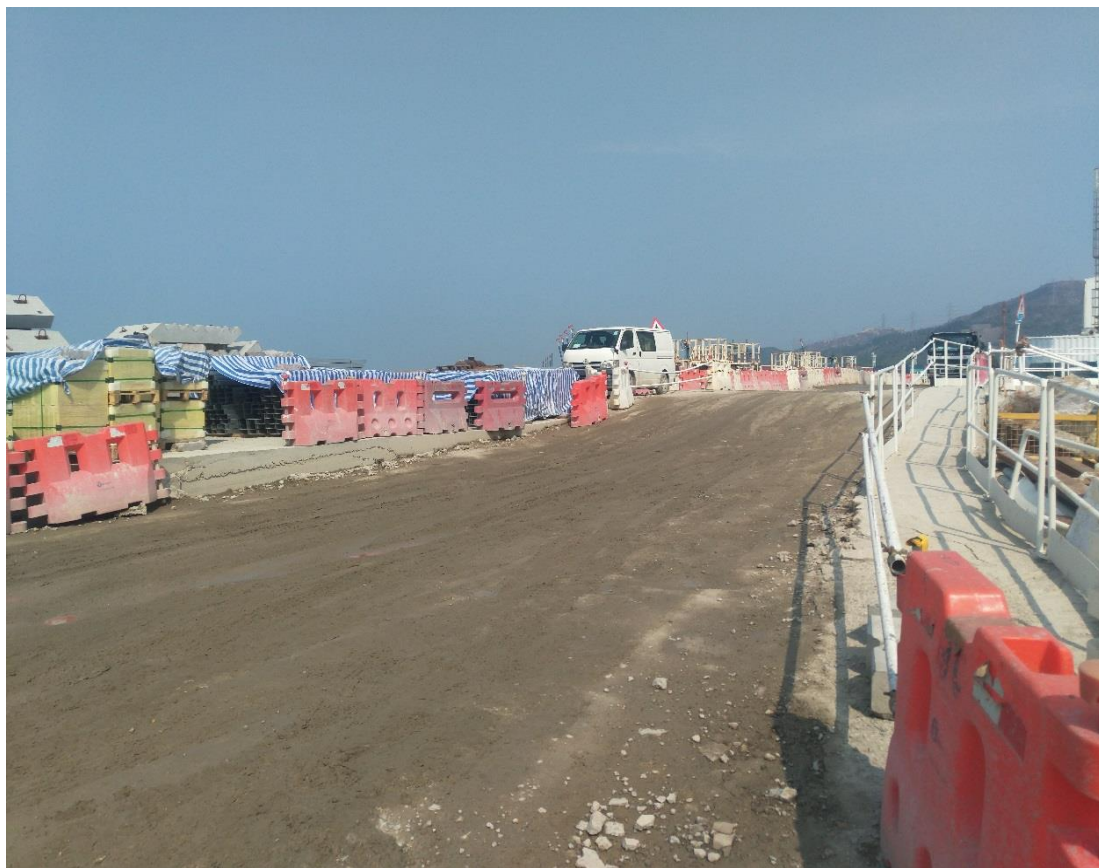
Water spraying was applied frequently on site.  
(Works Area Portion N-C)
