CONTRACT NO. HY/2012/08

TUEN MUN – CHEK LAP KOK LINK – NORTHERN CONNECTION SUB-SEA TUNNEL SECTION

ENVIRONMENTAL COMPLAINT INVESTIGATION REPORT

Our Reference: 0212330_Complaint LOG_20160519_04

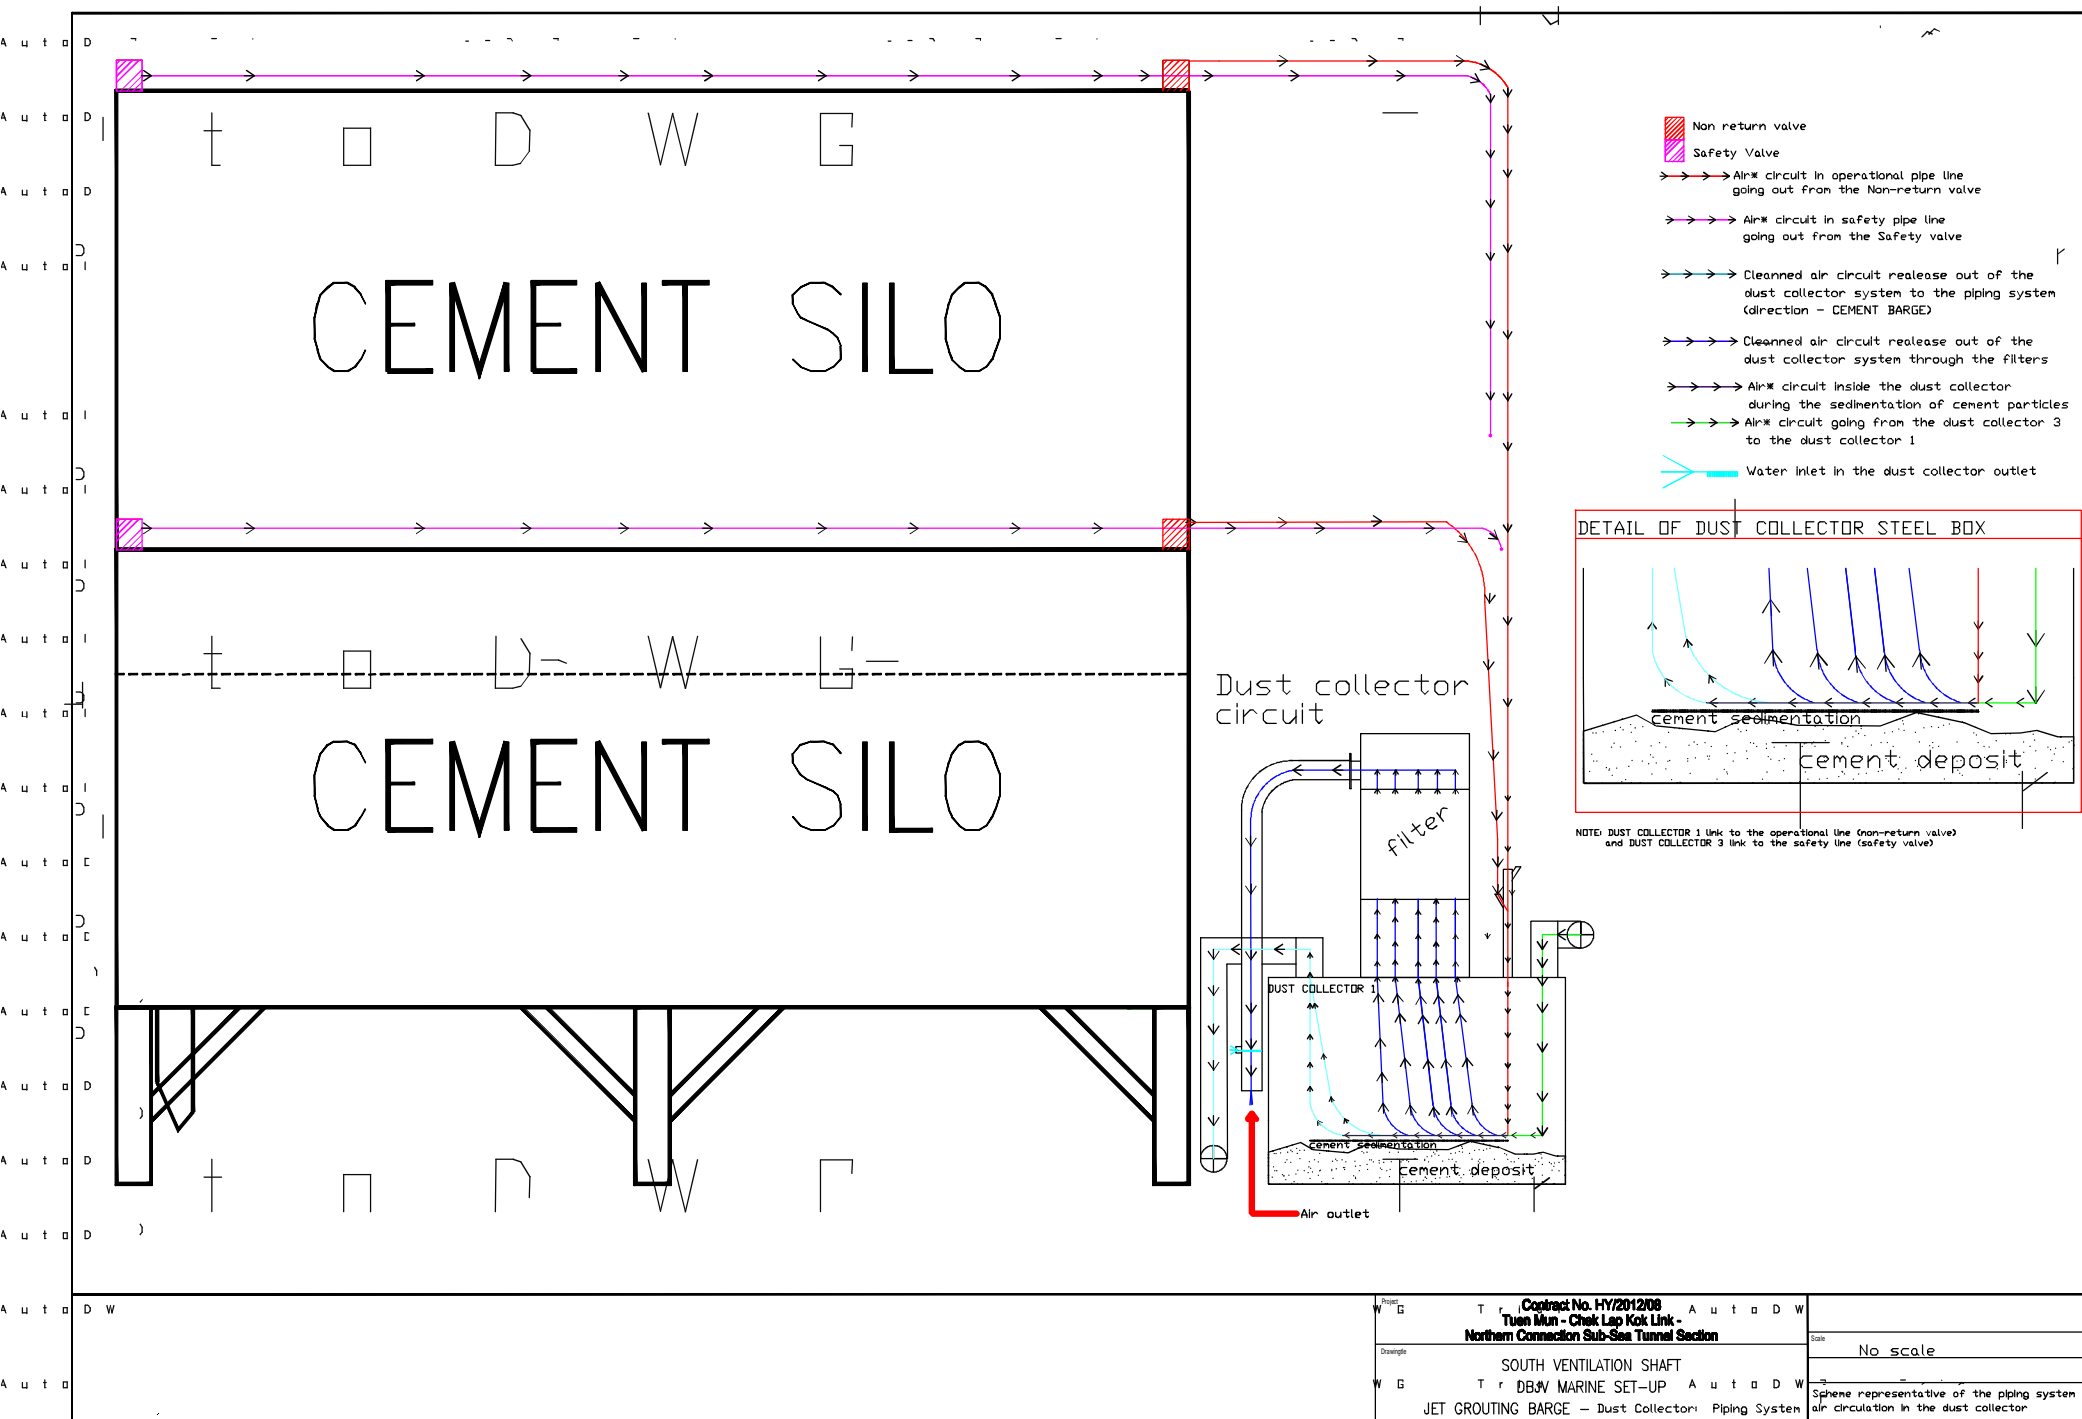
Project	Contract No. HY/2012/08 Tuen Mun - Chek Lap Kok Link - Northern Connection Sub-Sea Tunnel Section	Scale
Drawings	SOUTH VENTILATION SHAFT T R DBW MARINE SET-UP JET GROUTING BARGE - Dust Collector Piping System	No scale
W G	air with small amount of cement particles

NOTE: DUST COLLECTOR 1 link to the operational line (non-return valve)
and DUST COLLECTOR 3 link to the safety line (safety valve)

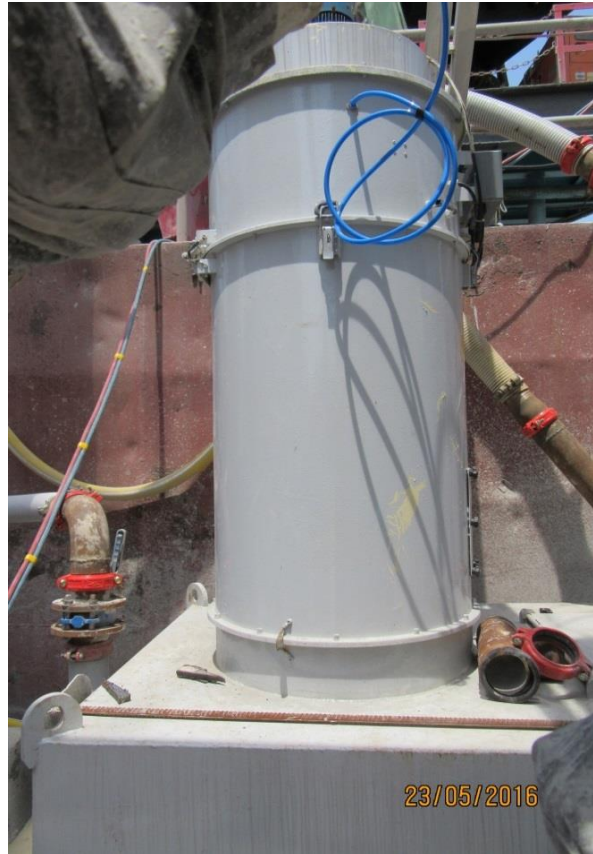
Based on the record of the Contractor's works summary, dust nuisance was recorded at the barge area of Southern Landfall on 18 May 2016 at around 4:10pm. According to the construction information provided by the Contractor, the majority of works during that period was jet grouting. After dust emission was observed from the barge, the grouting operator has stopped the works within two (2) minutes. Upon thorough investigation, it was found that the pressure of the pipe accidentally increased which caused damage on the pipe and malfunction on the filter, and thus created the dust emission. All related works had stopped. A new filter was added and the damaged pipe was replaced by a new pipe on 19 May 2016. No dust emissions were observed after the replacement.

New filter was added. (Barge area - Southern Landfall)

In the above case, 24-hour supervision of the grouting process has been recommended in order to prevent accidental dust emission. The Contractor has also been reminded to carry out weekly inspection and maintenance of the facility including pipes, filters and tanks, etc. Contingency plan should be implemented to mitigate the environmental impacts. The Contractor should stop the works immediately if similar incident occur. Verification of the facility by the ET is required before the resumption of works.

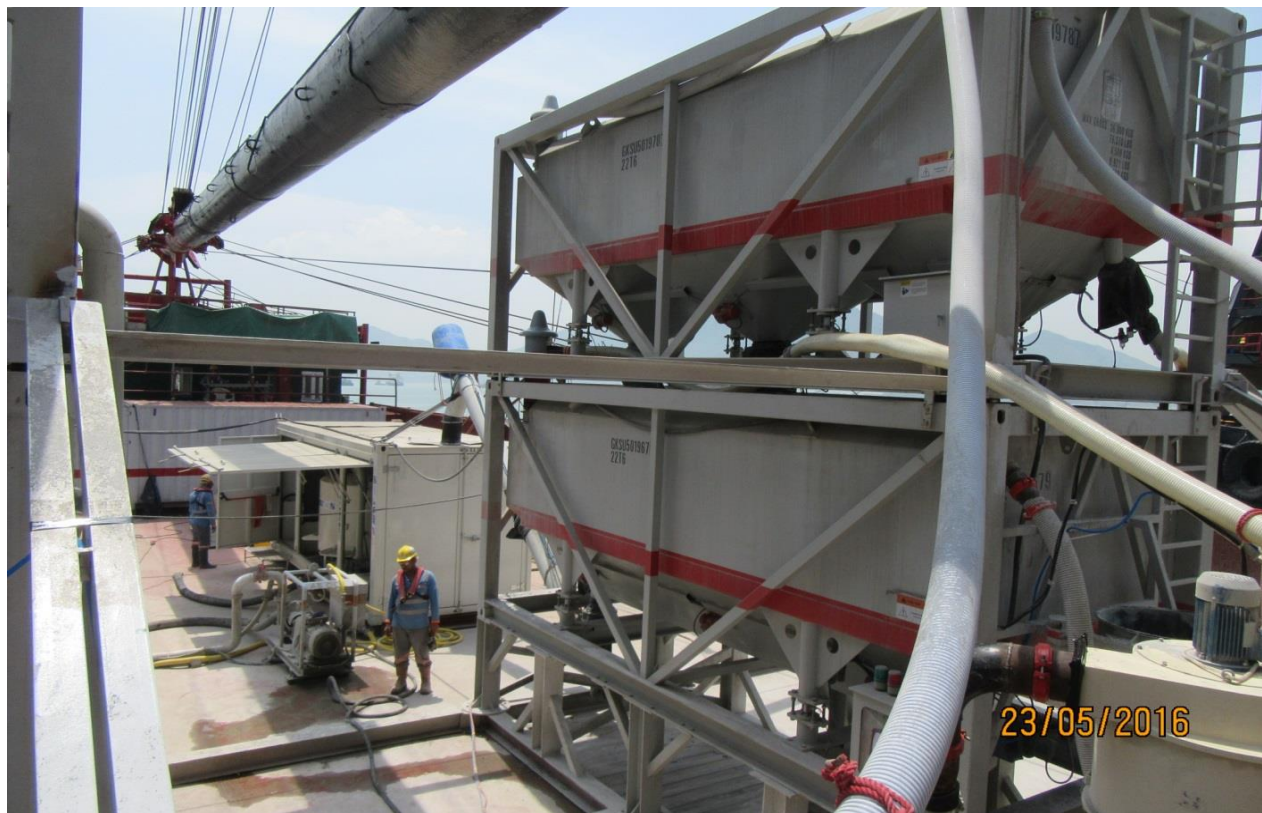
The damaged pipe was replaced by a new pipe. (Barge area - Southern Landfall)

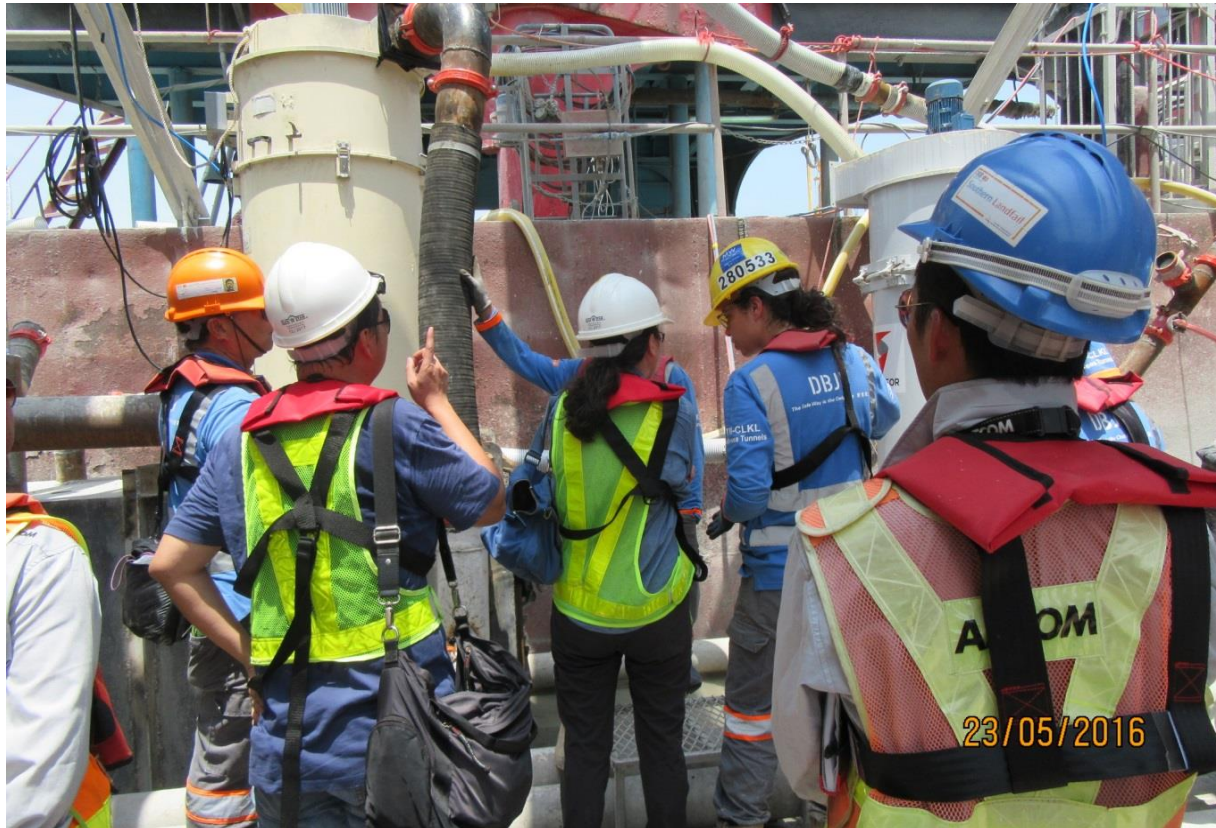
Also, a joint site inspection was carried out with the Contractor, SOR and EPD on 23 May 2016 to verify the remedial measures (see photo records on Annex A). No further defects were observed and no adverse comments were received.

A joint site inspection was carried out by the ET, the Contractor, SOR and EPD on 23 May 2016.
(Barge area - Southern Landfall)
