Notification No.: 20170901DO\_v1

**Works Inspected:** Data collected from water sampling works on 1 September 2017 and the results were issued on 4 September 2017

Monitoring Location: Water Quality Monitoring Station

Parameter: Dissolved Oxygen (DO)/ Suspended Solid (SS)/ Turbidity (TURB)

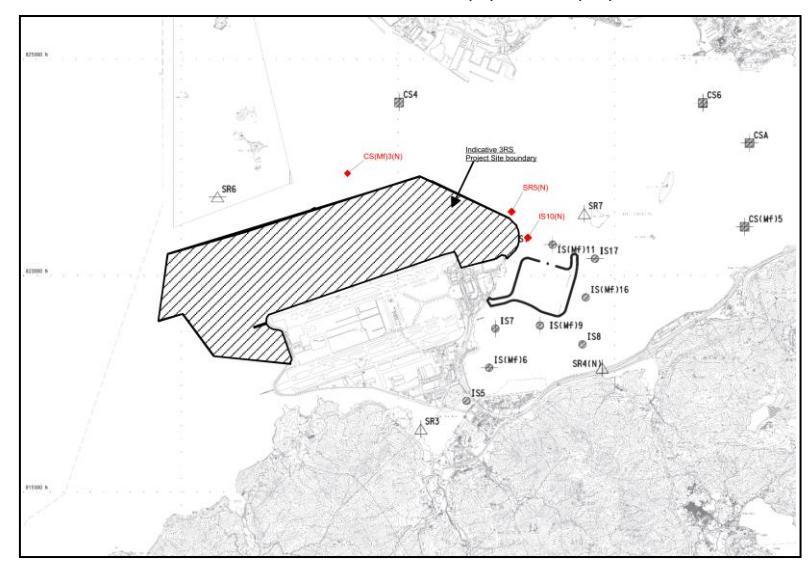
On 1 September 2017, five AL exceedances of DO recorded at IS5, IS10(N), IS(Mf)11, IS17 and SR5(N) were recorded during mid-ebb tide and three AL exceedances of DO recorded at IS5, IS10(N) and IS(Mf)11 were recorded during mid-flood tide.

As confirmed by the Contractor, there were no marine transportation and marine-based work on 1 September 2017. No site runoff within the Contract site has been observed. Therefore, it is concluded that the exceedance was not related the Contract.

As the exceedance was not related to the Contract, no immediate action are required. However, the Contractor was also reminded to implement environmental mitigation measures in accordance with Environmental Mitigation Implementation Schedule.

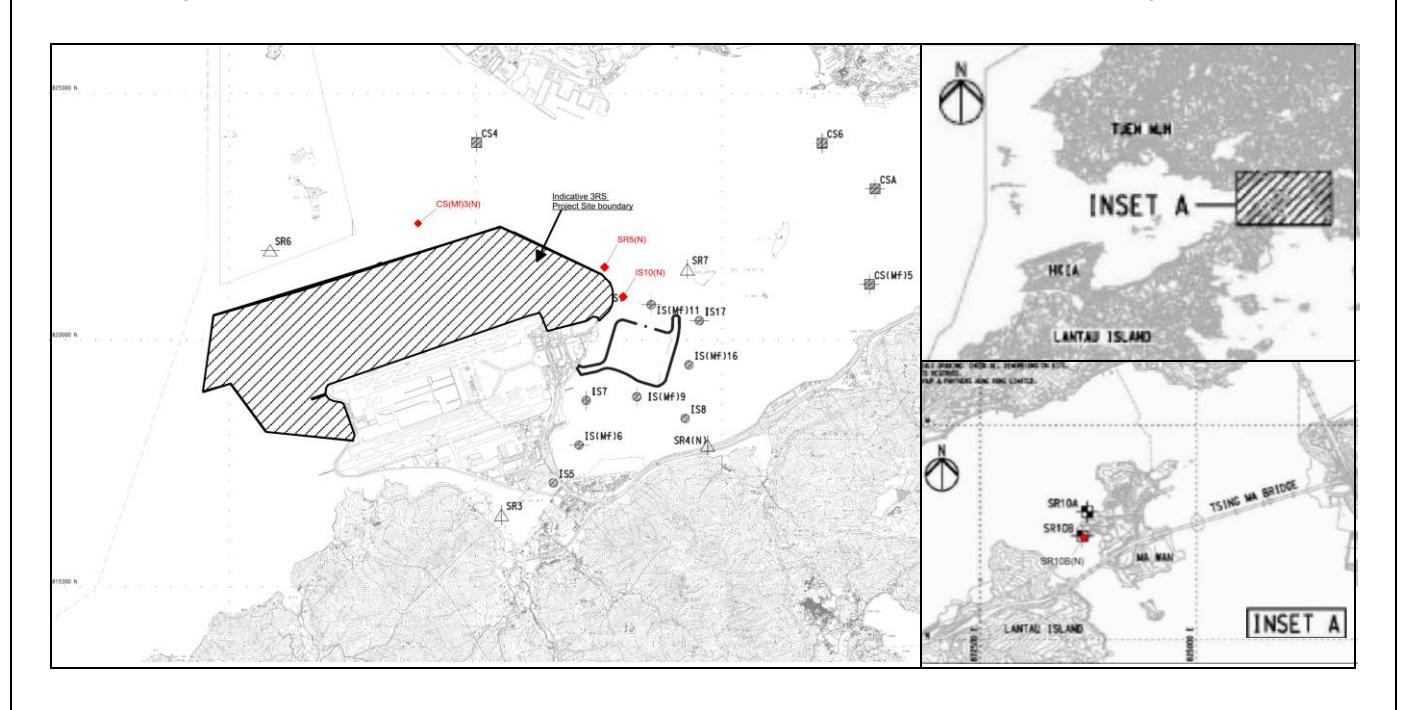
On 6 September 2017, one AL exceedance of DO recorded at IS17 was recorded during mid-ebb tide, three AL exceedances of DO recorded at SR6, SR10A, and SR10B(N) were recorded during mid-flood tide, two LL exceedances of DO recorded at SR10A and SR10B(N) were recorded during mid-ebb tide, two LL exceedances of DO recorded at SR10A and SR10B(N) were recorded during mid-ebb tide, two LL exceedances of DO recorded at SR10A and SR10B(N) were recorded during mid-flood tide and one AL exceedance of TURB recorded at IS(Mf)11 was recorded during mid-flood tide.

As confirmed by the Contractor, there were no marine transportation and marine-based work on 6 September 2017. No site runoff within the Contract site has been observed. Therefore, it is concluded that the exceedances were not related to the Contract.

As the exceedances were not related to the Contract, no immediate actions are required. However, the Contractor was also reminded to implement environmental mitigation measures in accordance with Environmental Mitigation Implementation Schedule.

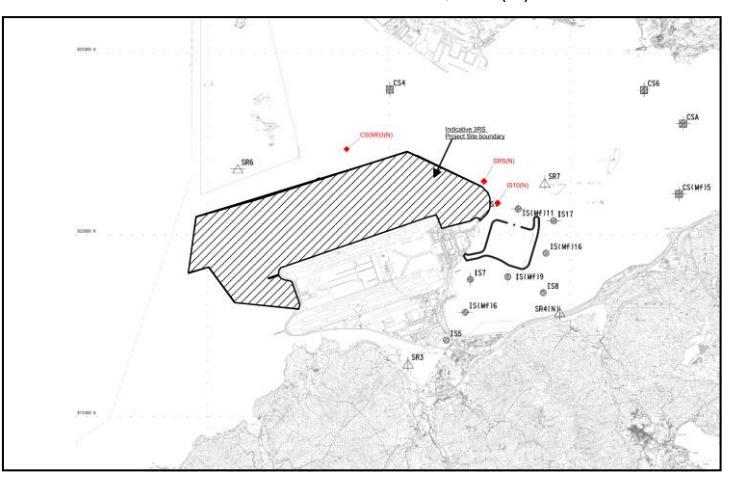
On 6 September 2017, three AL exceedances of SS recorded at IS8, SR4(N) and SR6 were recorded during mid-flood tide.

As confirmed by the Contractor, there were no marine transportation and marine-based work on 6 September 2017. No site runoff within the Contract site has been observed. Therefore, it is concluded that the exceedances were not related to the Contract.

As the exceedances were not related to the Contract, no immediate actions are required. However, the Contractor was also reminded to implement environmental mitigation measures in accordance with Environmental Mitigation Implementation Schedule.

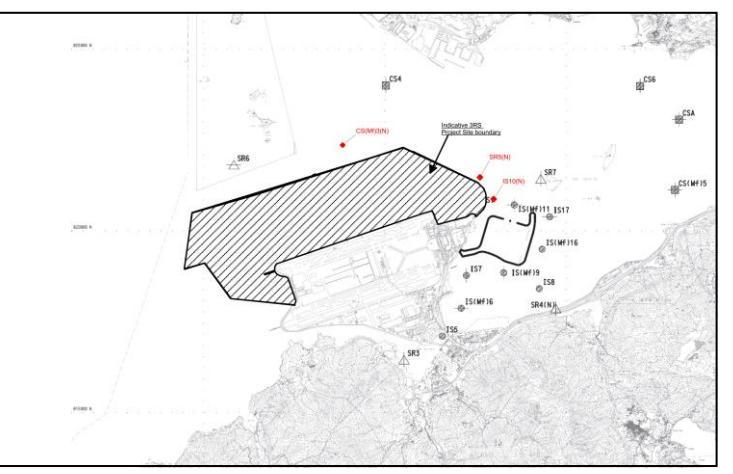
On 8 September 2017, one AL exceedance of SS recorded at IS5 was recorded during mid-ebb tide. One AL exceedance of SS recorded at IS(Mf)11 and one LL exceedance of SS at IS10(N) were recorded during mid-flood tide.

As confirmed by the Contractor, there were no marine transportation and marine-based work on 8 September 2017. No site runoff within the Contract site has been observed. Therefore, it is concluded that the exceedances were not related to the Contract.

As the exceedances were not related to the Contract, no immediate actions are required. However, the Contractor was also reminded to implement environmental mitigation measures in accordance with Environmental Mitigation Implementation Schedule.

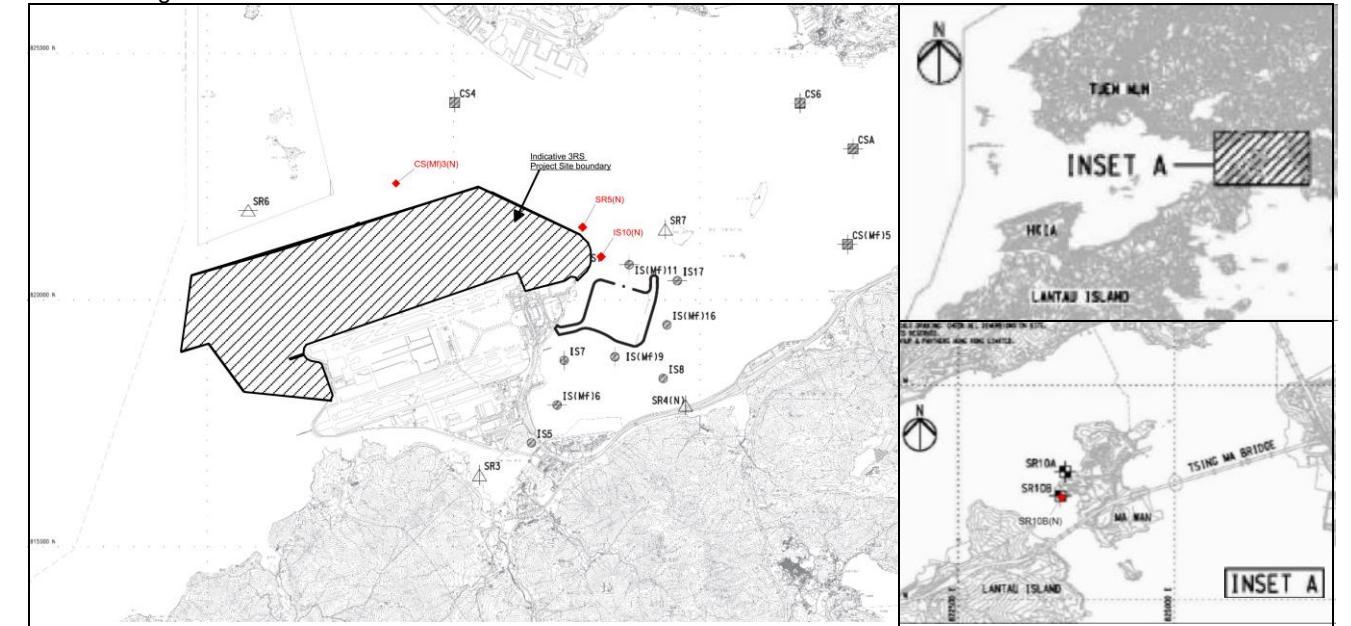
On 11 September 2017, eleven AL exceedances of DO recorded at IS10(N), IS(Mf)11, IS(Mf)16, IS17, SR5(N), SR6, SR7and SR10B(N) were recorded during mid-ebb tide, nineteen AL exceedances of DO recorded at IS8, IS(Mf)9, IS10(N), IS(Mf)11, IS(Mf)16, IS17, SR4(N), SR5(N), SR6, SR10A and SR10B(N) were recorded during mid-flood tide. One LL exceedance of DO recorded at SR10B(N) was recorded during mid-ebb tide, two LL exceedances of DO recorded at SR10A and SR10B(N) were recorded during mid-flood tide.

As confirmed by the Contractor, there were no marine transportation and marine-based work on 11 September 2017. No site runoff within the Contract site has been observed. Therefore, it is concluded that the exceedances were not related to the Contract.

As the exceedances were not related to the Contract, no immediate actions are required. However, the Contractor was also reminded to implement environmental mitigation measures in accordance with Environmental Mitigation Implementation Schedule.

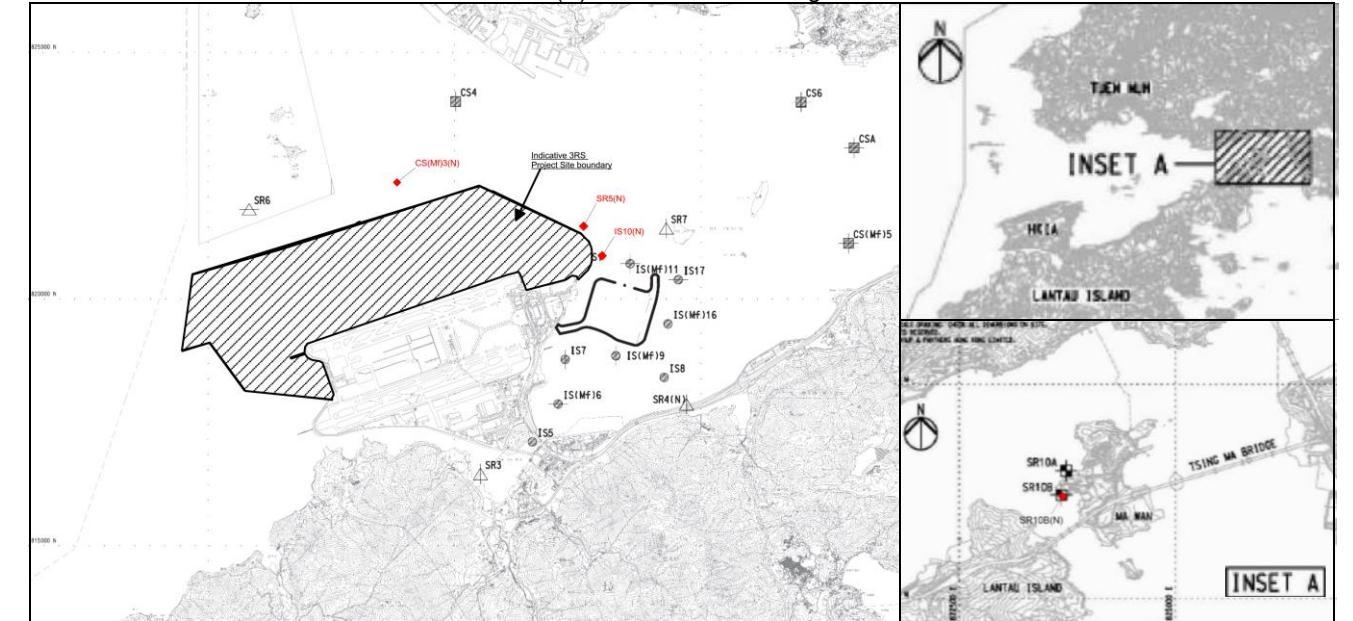
On 13 September 2017, five AL exceedances of DO recorded at IS5, IS10(N), IS(Mf)16, IS17 and SR5(N) were recorded during mid-ebb tide, eight AL exceedances of DO recorded at IS5, IS(Mf)9, IS(Mf)11, IS(Mf)16, IS17, SR10A and SR10B(N) were recorded during mid-flood tide. One LL exceedance of DO recorded at SR10A was recorded during mid-ebb tide, two LL exceedances of DO recorded at SR10A and SR10B(N) were recorded during mid-flood tide.

As confirmed by the Contractor, there were no marine transportation and marine-based work on 13 September 2017. No site runoff within the Contract site has been observed. Therefore, it is concluded that the exceedances were not related to the Contract.

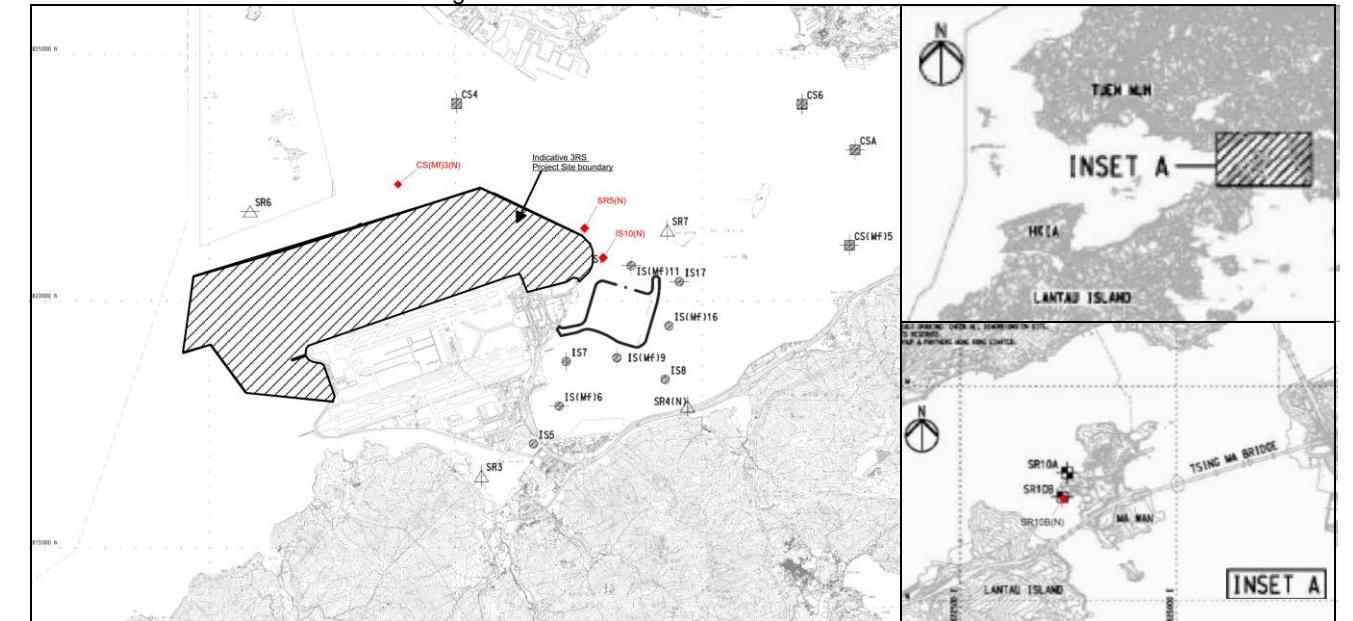
On 15 September 2017, four AL exceedances of DO recorded at IS10(N), IS(Mf)11 and IS17 were recorded during mid-ebb tide, six AL exceedances of DO recorded at IS10(N), IS(Mf)11, SR6, SR10A and SR10B(N) were recorded during mid-flood tide and two LL exceedances of DO recorded at SR10A and SR10B(N) were recorded during mid-flood tide. One AL exceedance of TURB recorded at IS8 was recorded during mid-flood tide.

As confirmed by the Contractor, there were no marine transportation and marine-based work on 15 September 2017. No site runoff within the Contract site has been observed. The muddy water was observed due to 3 fast boats were moving around near the monitoring station IS8 during measurement period. No observation photos were taken during measurement period.

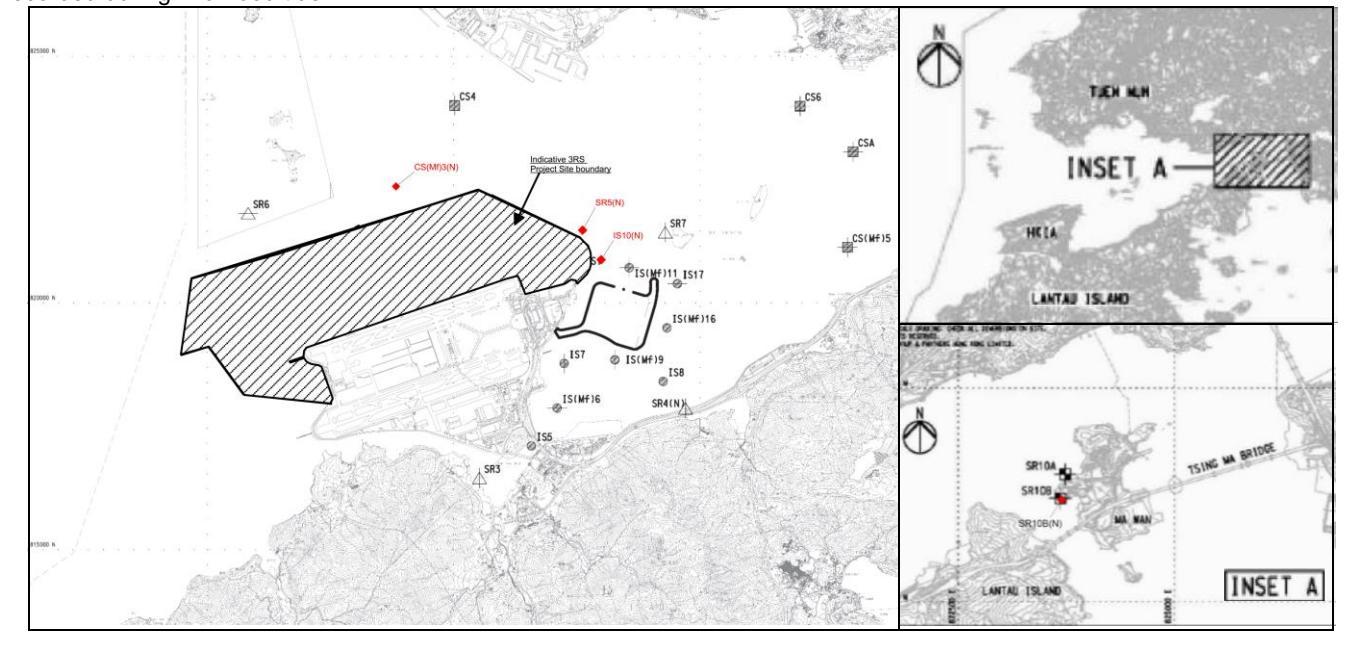
On 18 September 2017, six AL exceedances of DO recorded at IS5, IS10(N), IS(Mf)11, IS(Mf)16 and SR6 were recorded during mid-ebb tide, two AL exceedances of DO recorded at SR6 were recorded during mid-flood tide, two LL exceedances of DO recorded at SR10A and SR10B(N) were recorded during mid-flood tide and one AL exceedance of SS recorded at IS8 was recorded during mid-flood tide.

As confirmed by the Contractor, there were no marine transportation and marine-based work on 18 September 2017. No site runoff within the Contract site has been observed. Therefore, it is concluded that the exceedances were not related to the Contract.

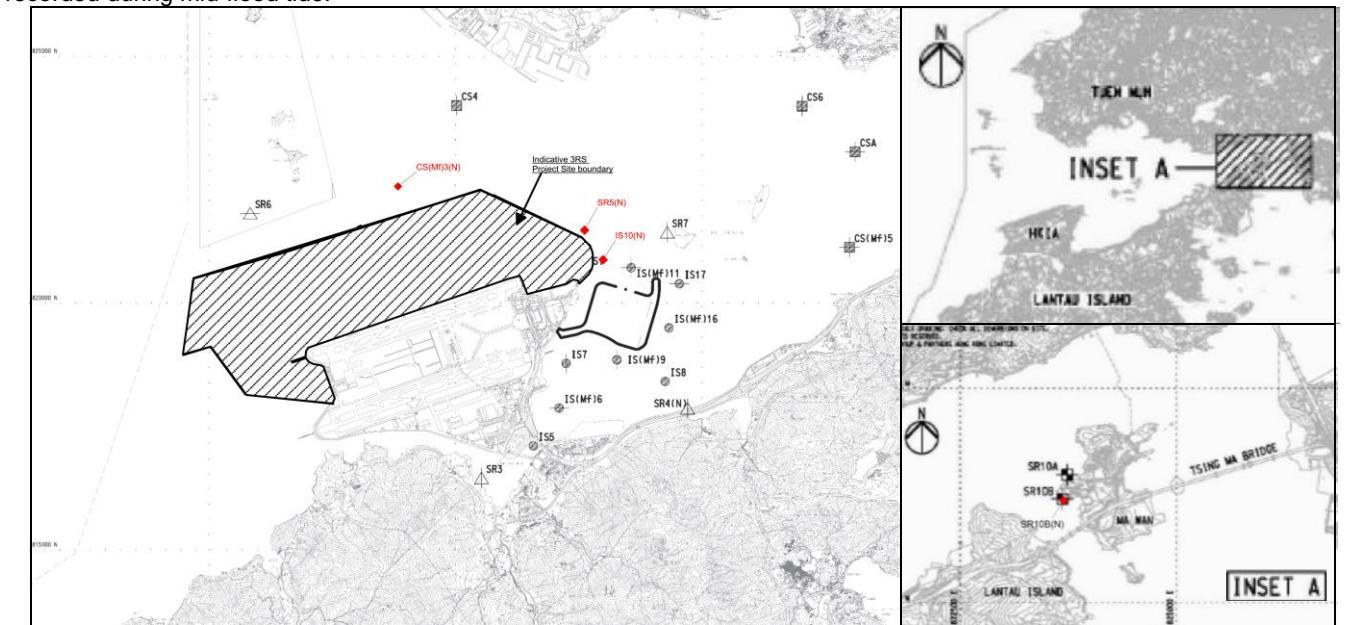
On 20 September 2017, three AL exceedances of DO at SR6 and SR10A were recorded during mid-flood tide, two LL exceedances of DO at SR10A and SR10B(N) were recorded during mid-flood tide and one AL exceedance of SS at SR6 was recorded during mid-flood tide.

As confirmed by the Contractor, there were no marine transportation and marine-based work on 20 September 2017. No site runoff within the Contract site has been observed. Therefore, it is concluded that the exceedances were not related to the Contract.

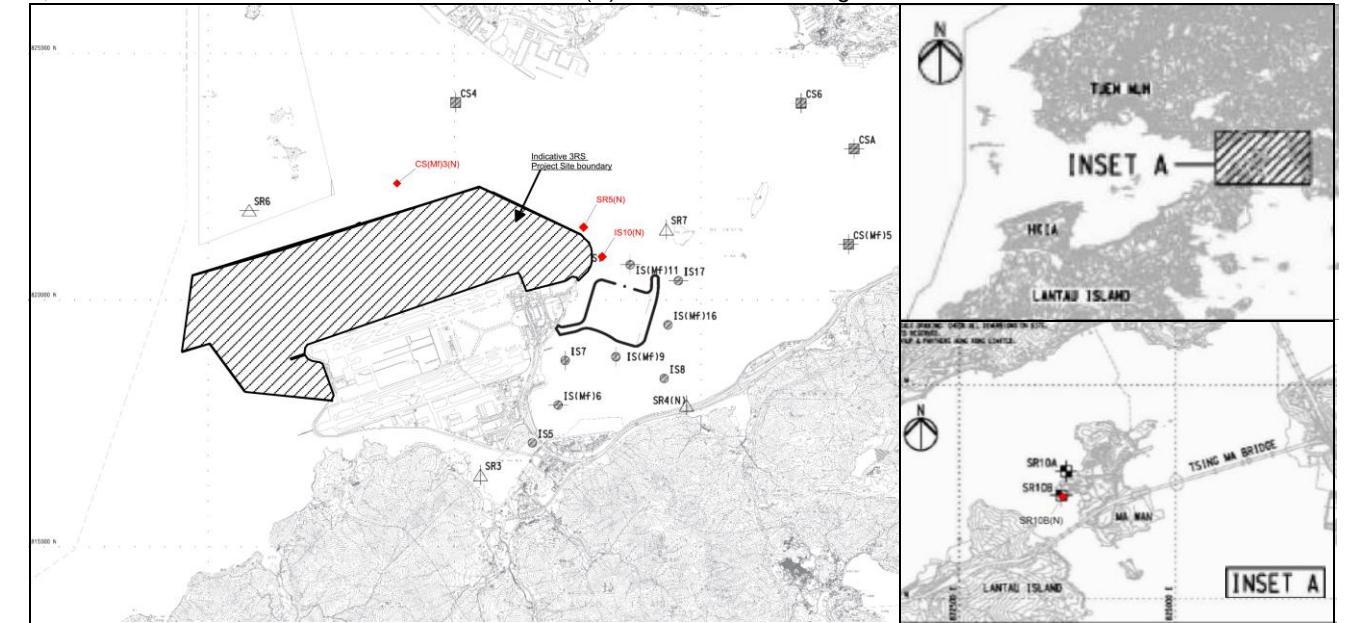
On 22 September 2017, six AL exceedances of DO at IS10(N), IS(Mf)11, SR3, SR5(N) and SR6 were recorded during mid-ebb tide, two LL exceedances of DO at SR10A and SR10B(N) were recorded during mid-ebb tide. Eleven AL exceedances of DO at IS8, IS(Mf)9, IS10(N), IS(Mf)11, IS(Mf)16, IS17, SR4(N), SR5(N), SR6, SR7 and SR10B(N) were recorded during mid-flood tide, two LL exceedances of DO at SR10A and SR10B(N) were recorded during mid-flood tide.

As confirmed by the Contractor, there were no marine transportation and marine-based work on 22 September 2017. No site runoff within the Contract site has been observed. Therefore, it is concluded that the exceedances were not related to the Contract.

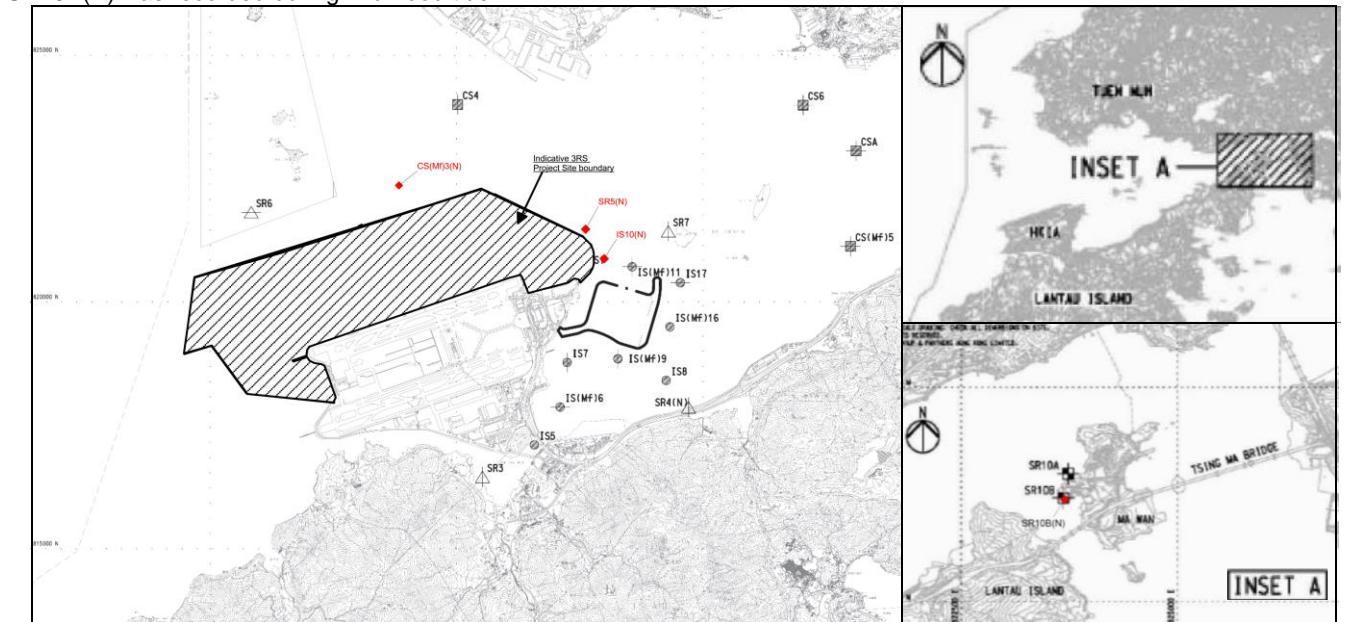
On 27 September 2017, four AL exceedances of DO at IS10(N), IS17, SR5(N) and SR10B(N) were recorded during mid-ebb tide. Two AL exceedance of DO at SR10A and SR10B(N) were recorded during mid-flood tide, one LL exceedance of DO at SR10B(N) was recorded during mid-flood tide.

As confirmed by the Contractor, there were no marine transportation and marine-based work on 27 September 2017. No site runoff within the Contract site has been observed. Therefore, it is concluded that the exceedances were not related to the Contract.

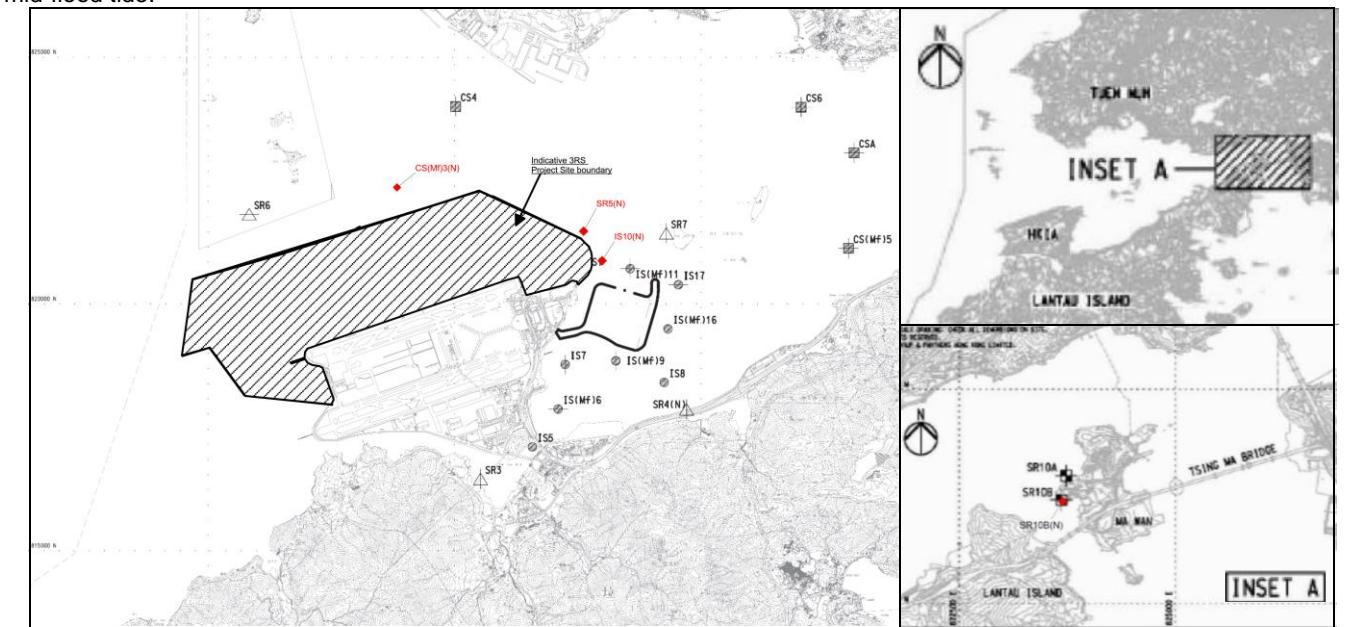
On 29 September 2017, eight AL exceedances of DO at IS7, IS8, IS10(N), IS(Mf)11, IS(Mf)16, SR5(N) and SR10B(N) were recorded during mid-ebb tide. Five AL exceedance of DO at IS5, IS10(N), IS(Mf)11, IS17 and SR5(N) were recorded during mid-flood tide.

As confirmed by the Contractor, there were no marine transportation and marine-based work on 29 September 2017. No site runoff within the Contract site has been observed. Therefore, it is concluded that the exceedances were not related to the Contract.

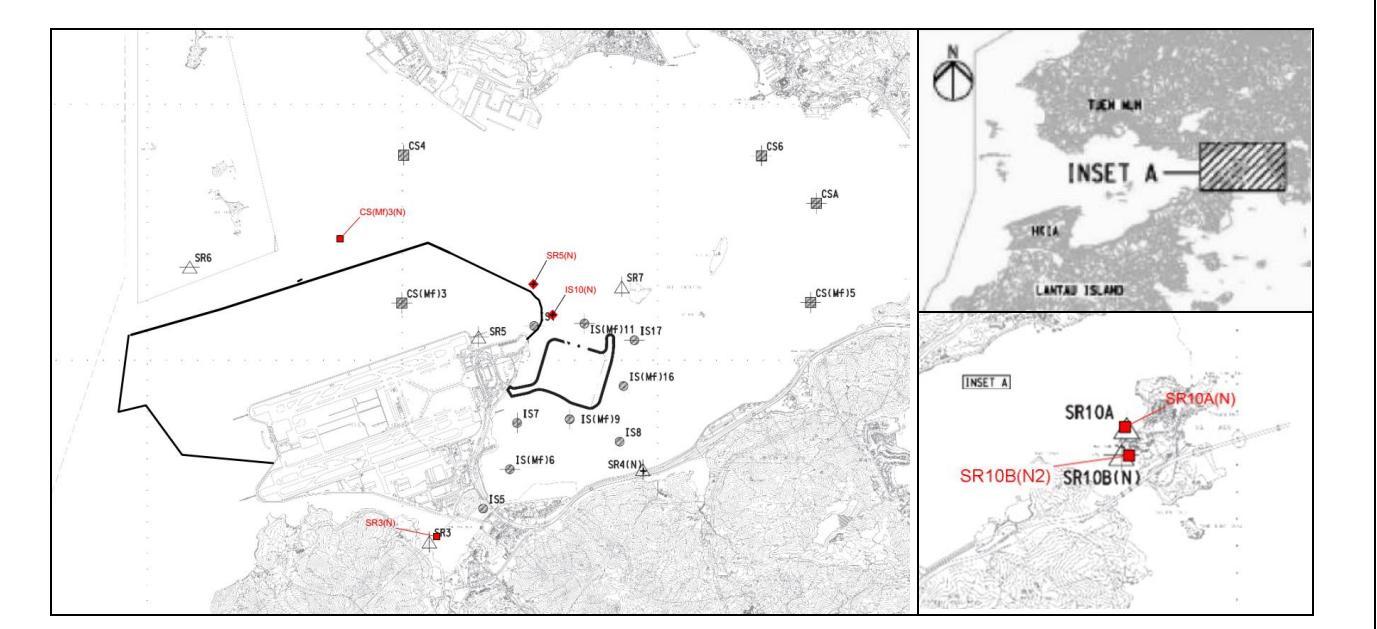
On 2 October 2017, one AL exceedance of DO at SR10A was recorded during mid-ebb tide, two AL exceedances of DO at SR10A and SR10B(N) were recorded during mid-flood tide and one LL exceedance of DO at SR10B(N) was recorded during mid-flood tide.

As confirmed by the Contractor, there were no marine transportation and marine-based work on 2 October 2017. No site runoff within the Contract site has been observed. Therefore, it is concluded that the exceedances were not related to the Contract.

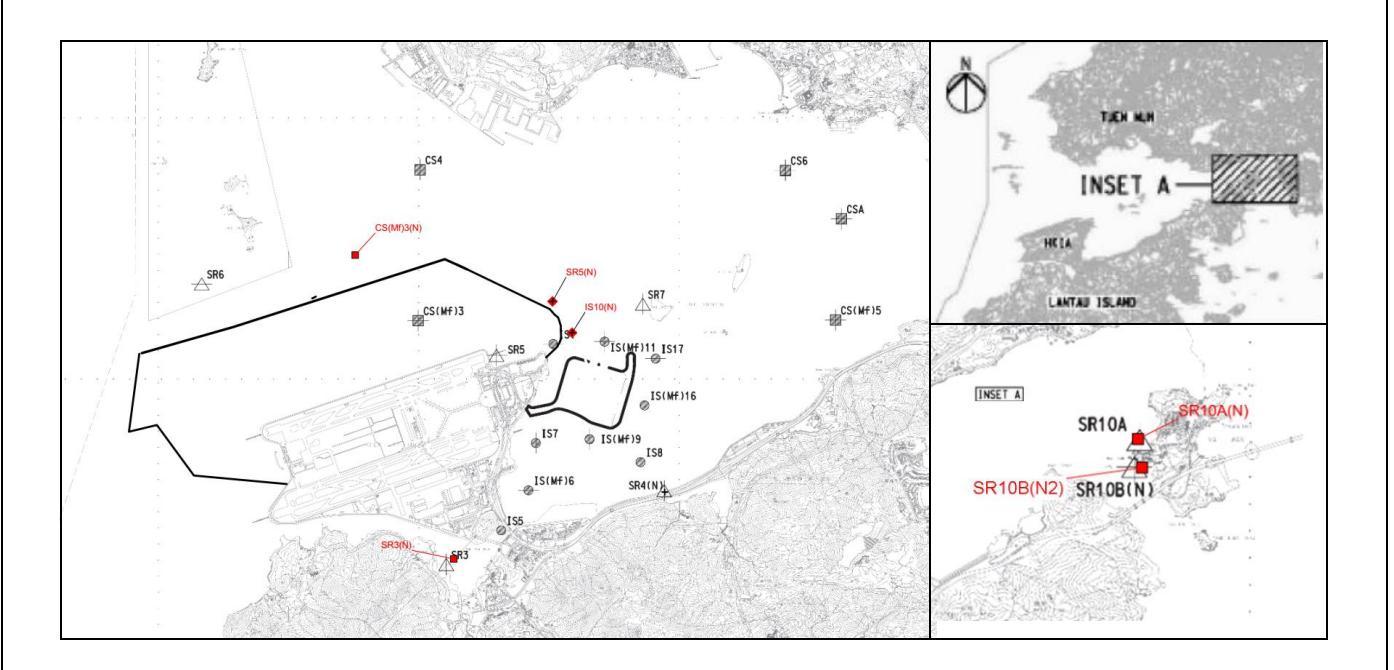
On 4 October 2017, one AL exceedance of DO at SR10A was recorded during mid-ebb tide, two AL exceedances of DO at SR10A and SR10B(N) were recorded during mid-flood tide, two LL exceedances of DO at SR10A and SR10B(N) were recorded during mid-ebb tide and two LL exceedances of DO at SR10A and SR10B(N) were recorded during mid-flood tide.

As confirmed by the Contractor, there were no marine transportation and marine-based work on 4 October 2017. No site runoff within the Contract site has been observed. Therefore, it is concluded that the exceedances were not related to the Contract.

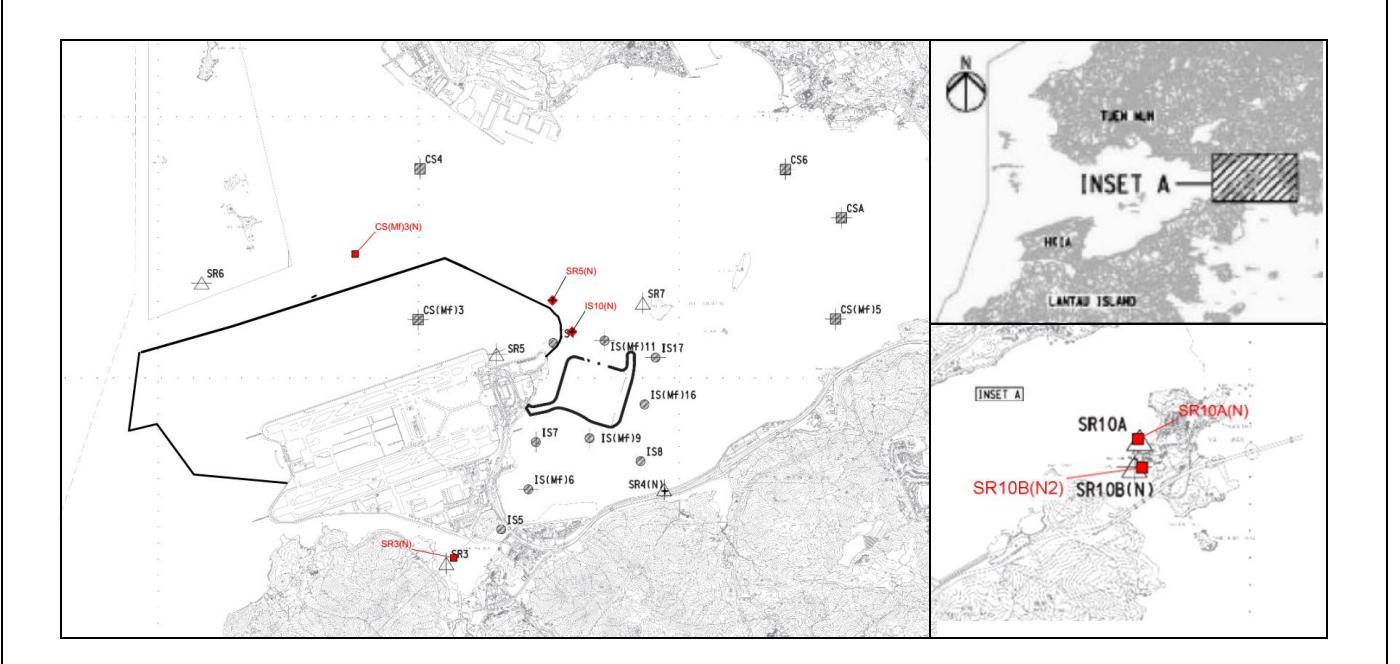
On 6 October 2017, one AL exceedance of DO at SR10B(N) was recorded during mid-flood tide, one LL exceedance of DO at SR10B(N) was recorded during mid-ebb tide and one LL exceedance of DO at SR10B(N) was recorded during mid-flood tide.

As confirmed by the Contractor, there were no marine transportation and marine-based work on 6 October 2017. No site runoff within the Contract site has been observed. Therefore, it is concluded that the exceedances were not related to the Contract.

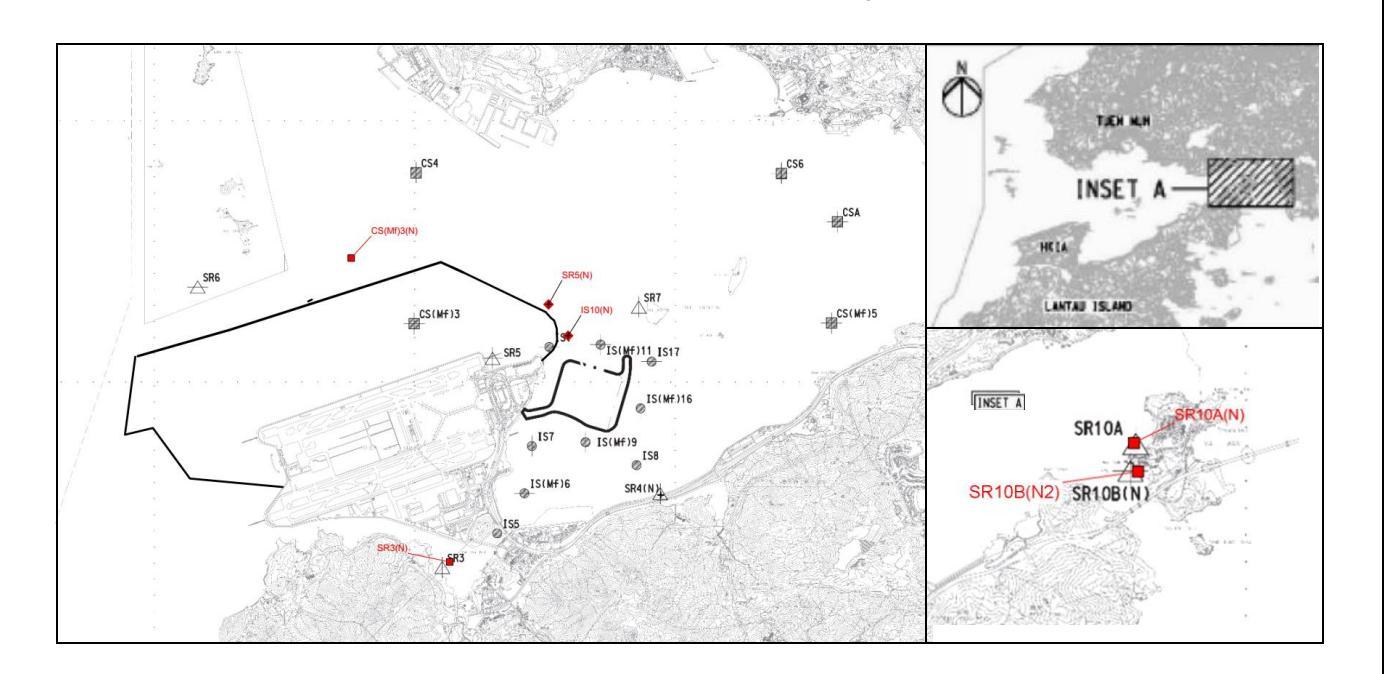
On 9 October 2017, one LL exceedance of DO at SR10B(N) was recorded during mid-flood tide.

As confirmed by the Contractor, there were no marine transportation and marine-based work on 9 October 2017. No site runoff within the Contract site has been observed. Therefore, it is concluded that the exceedance was not related to the Contract.

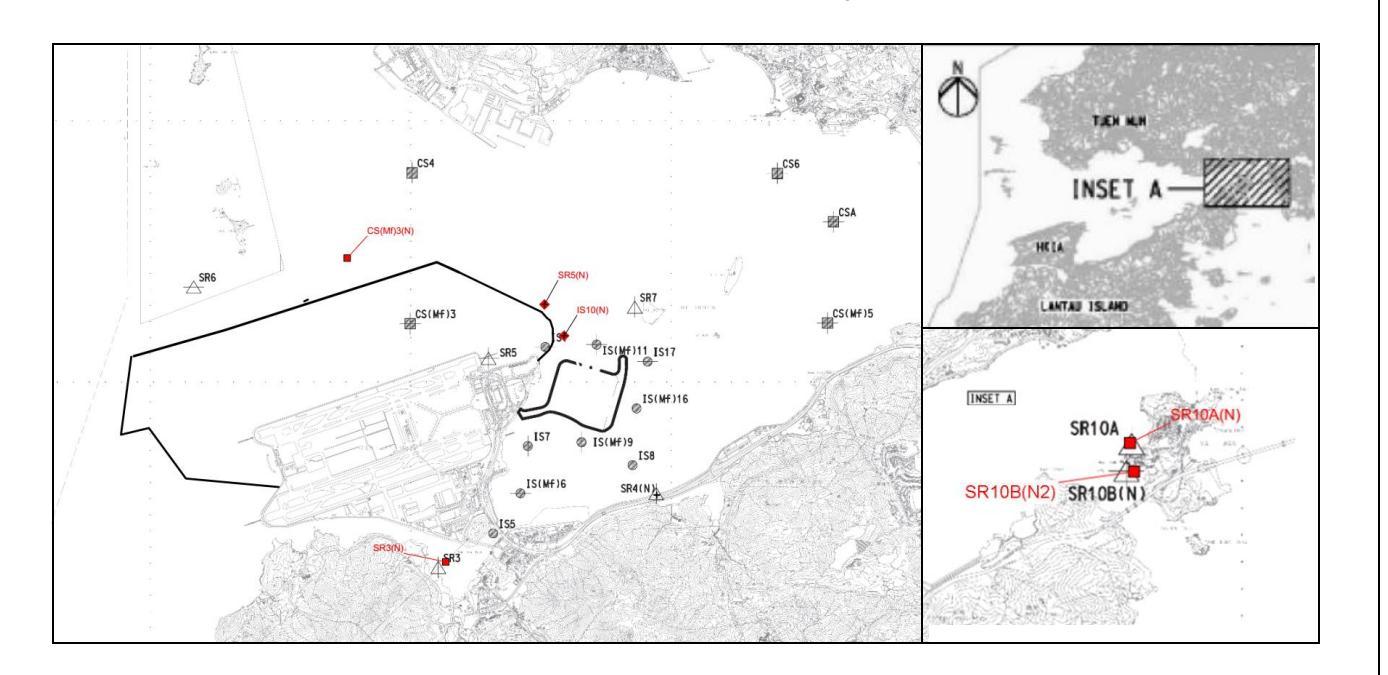
On 18 October 2017, one AL exceedance of SS at SR5(N) was recorded during mid-flood tide.

As confirmed by the Contractor, there was no marine transportation and marine-based work on 18 October 2017. No site runoff within the Contract site has been observed. Therefore, it is concluded that the exceedances were not related to the Contract.

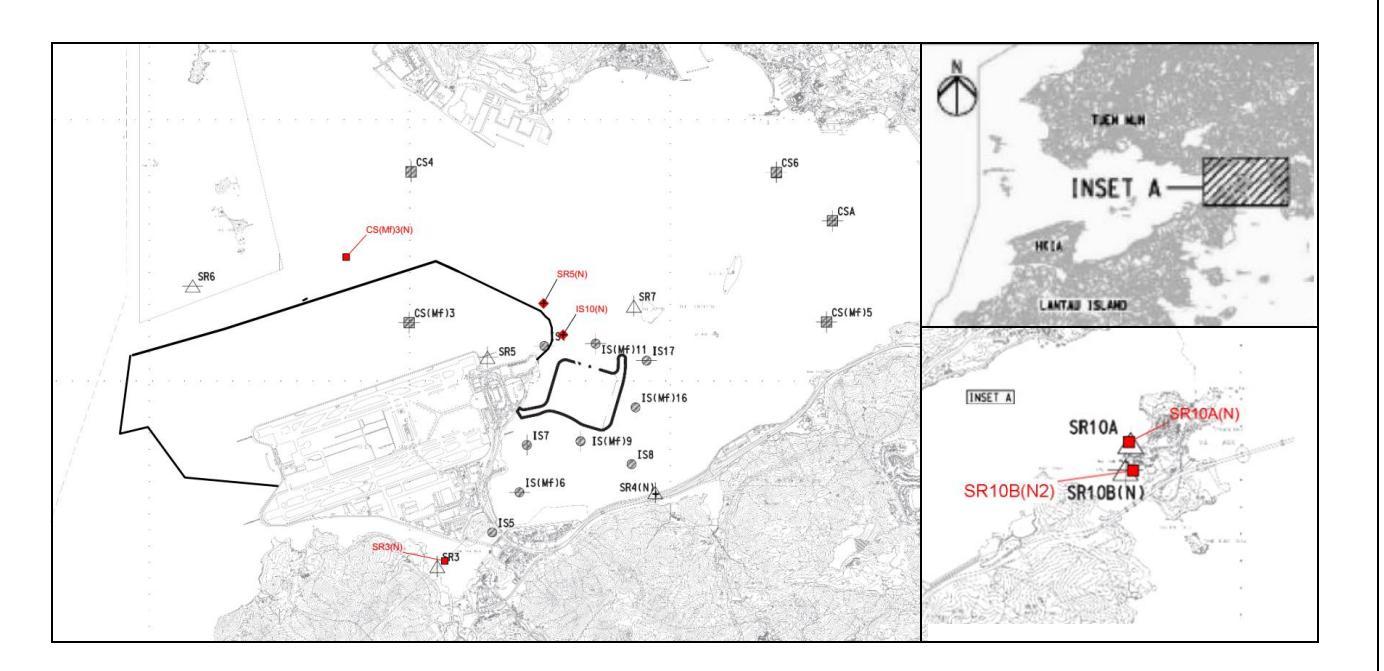
ontrol stations of mid-flood tide: CS(Mf)5, CS6 and CSA
On 20 October 2017, three AL exceedances of SS at IS(Mf)11, SR5(N) and SR7 were recorded during mid-flood tide.

As confirmed by the Contractor, there was no marine transportation and marine-based work on 20 October 2017. No site runoff within the Contract site has been observed. Therefore, it is concluded that the exceedances were not related to the Contract.

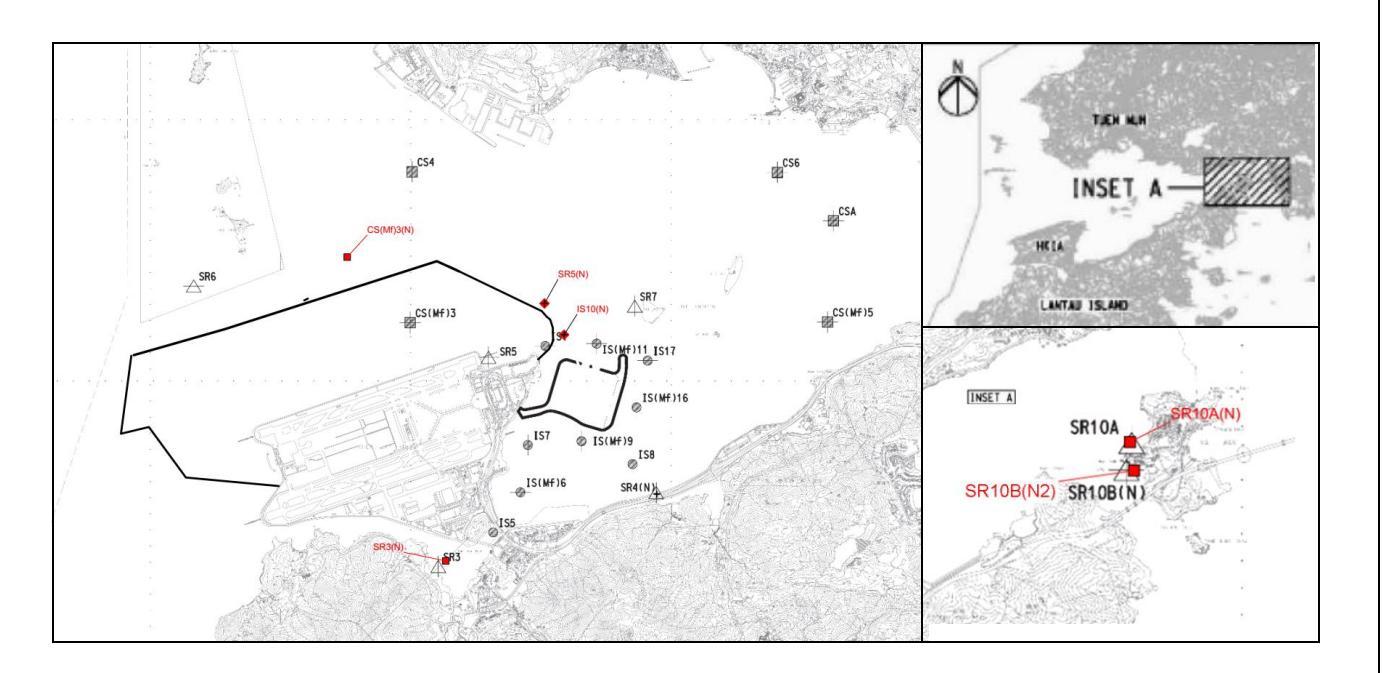
On 23 October 2017, one AL exceedance of SS at SR5(N) was recorded during mid-flood tide.

As confirmed by the Contractor, there was no marine transportation and marine-based work on 23 October 2017. No site runoff within the Contract site has been observed. Therefore, it is concluded that the exceedances were not related to the Contract.

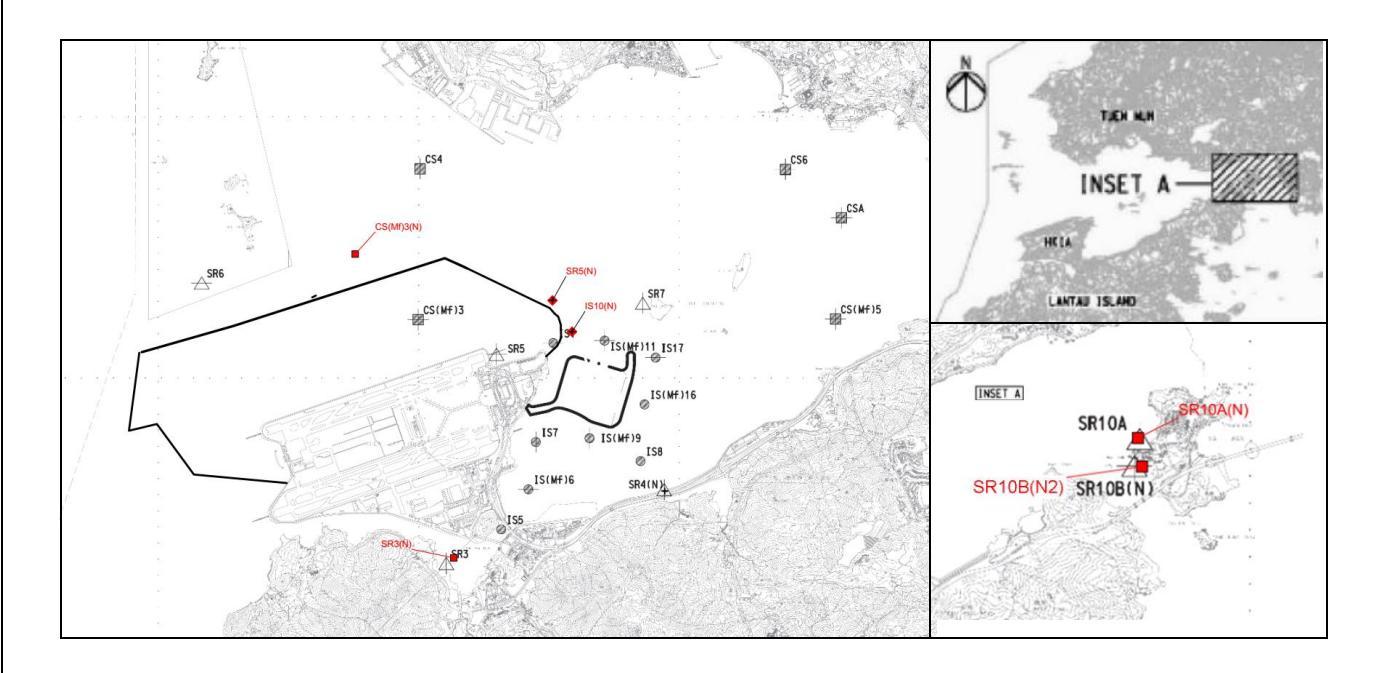
On 3 November 2017, one AL exceedance of SS at SR6 was recorded during mid-ebb tide. Two AL exceedances of SS at IS(Mf)11 and SR7 were recorded during mid-flood tide. One LL exceedance of SS at SR5(N) was recorded during mid-flood tide.

As confirmed by the Contractor, there was no marine transportation and marine-based work on 3 November 2017. No site runoff within the Contract site has been observed. Therefore, it is concluded that the exceedances were not related to the Contract.

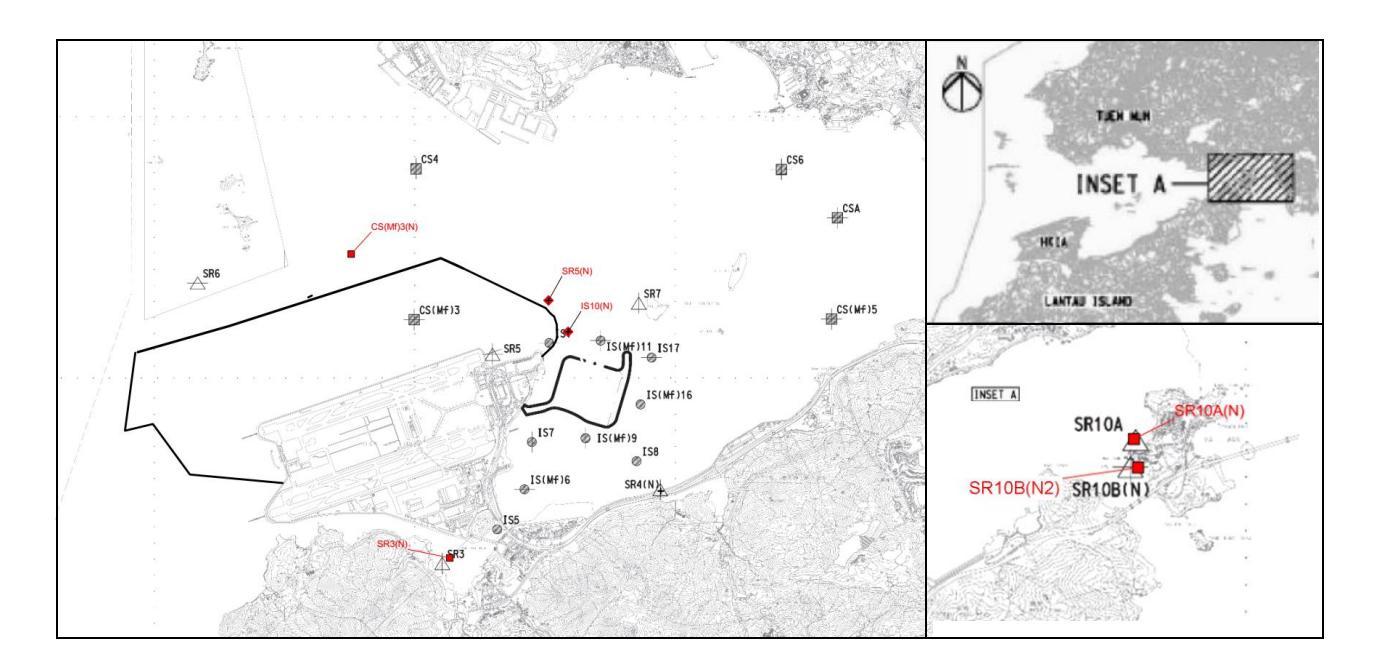
On 6 November 2017, five AL exceedances of SS at IS(Mf)6, IS(Mf)16, SR7, SR10A and SR10B(N) were recorded during mid-flood tide.

As confirmed by the Contractor, there was no marine transportation and marine-based work on 6 November 2017. No site runoff within the Contract site has been observed. Therefore, it is concluded that the exceedances were not related to the Contract.

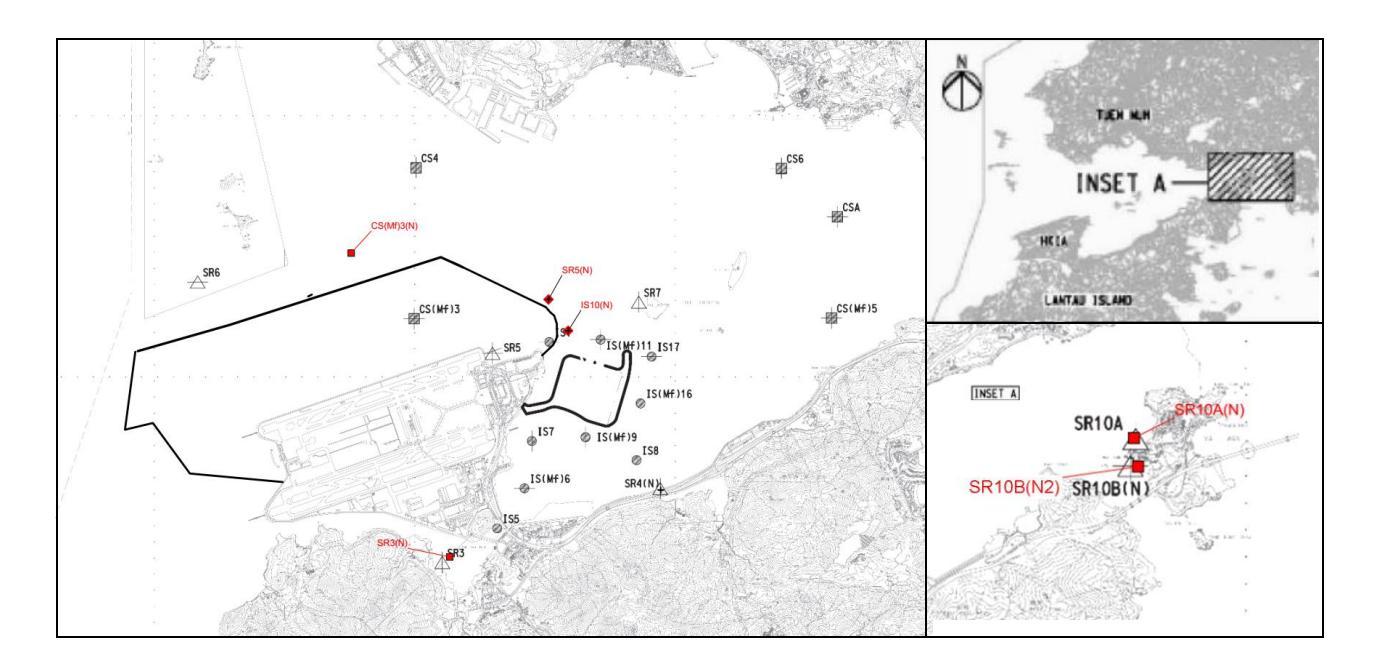
On 8 November 2017, one AL exceedance of SS at IS(Mf)11 was recorded during mid-flood tide. One AL exceedance of SS at SR6 was recorded during mid-ebb tide. Two LL exceedances of SS at SR4(N) and SR5(N) were recorded during mid-flood tide.

As confirmed by the Contractor, there was no marine transportation and marine-based work on 8 November 2017. No site runoff within the Contract site has been observed. Therefore, it is concluded that the exceedances were not related to the Contract.

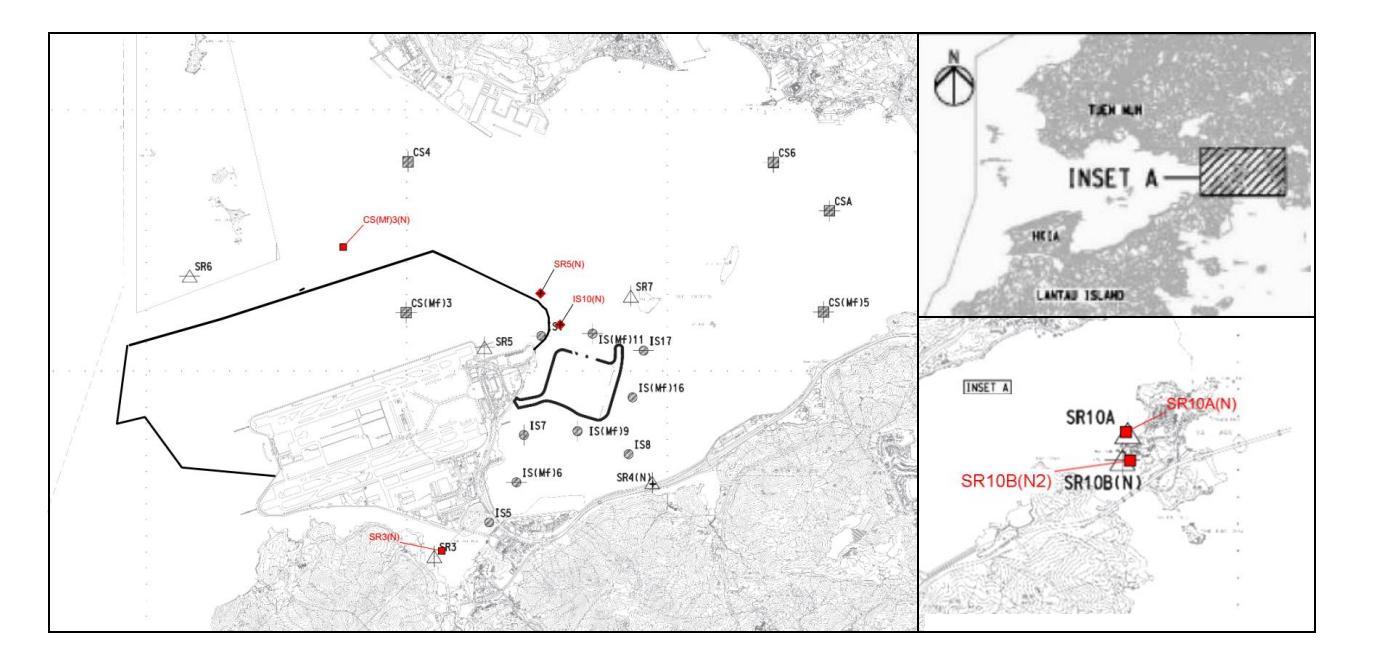
On 13 November 2017, one AL exceedance of SS at IS8 was recorded during mid-flood tide.

As confirmed by the Contractor, there was no marine transportation and marine-based work on 13 November 2017. No site runoff within the Contract site has been observed. Therefore, it is concluded that the exceedances were not related to the Contract.
