Notification No.: 20170901DO\_v1

**Works Inspected:** Data collected from water sampling works on 1 September 2017 and the results were issued on 4 September 2017

Monitoring Location: Water Quality Monitoring Station

Parameter: Dissolved Oxygen (DO)/ Suspended Solid (SS)/ Turbidity (TURB)

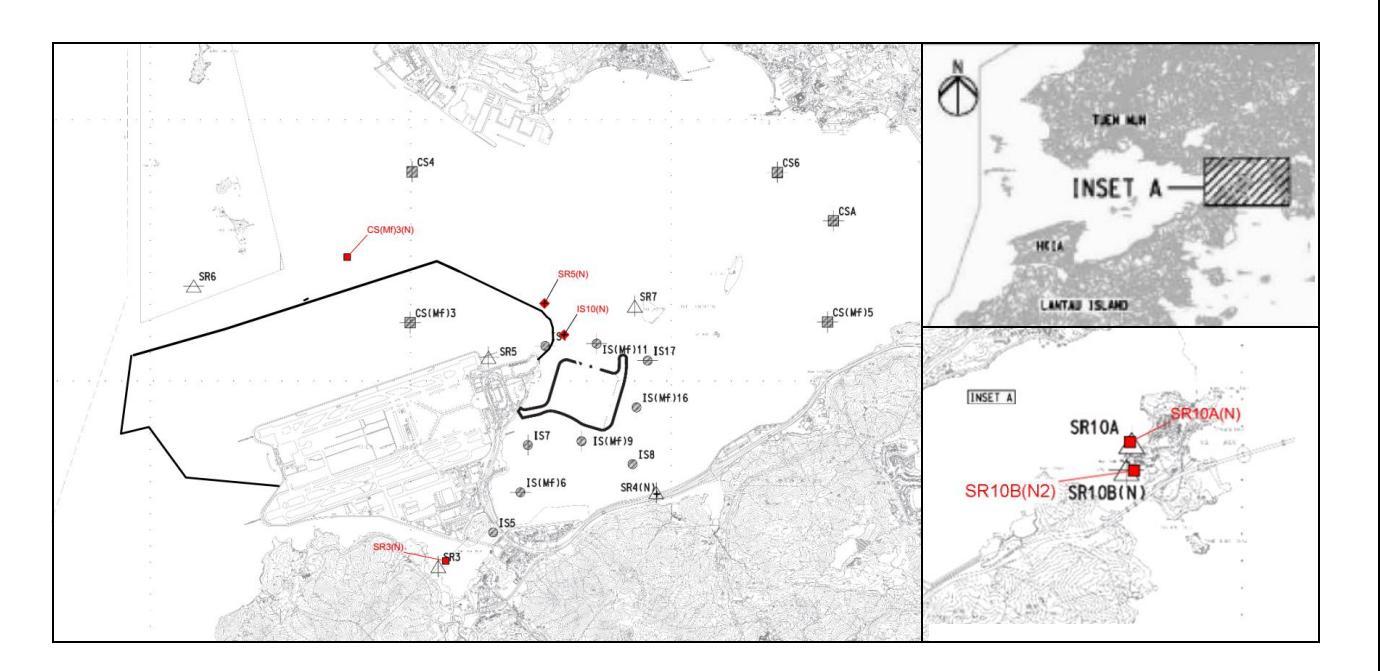
On 15 November 2017, one AL exceedance of SS at IS(Mf)6 was recorded during mid-flood tide.

As confirmed by the Contractor, there was no marine transportation and marine-based work on 15 November 2017. No site runoff within the Contract site has been observed. Therefore, it is concluded that the exceedances were not related to the Contract.

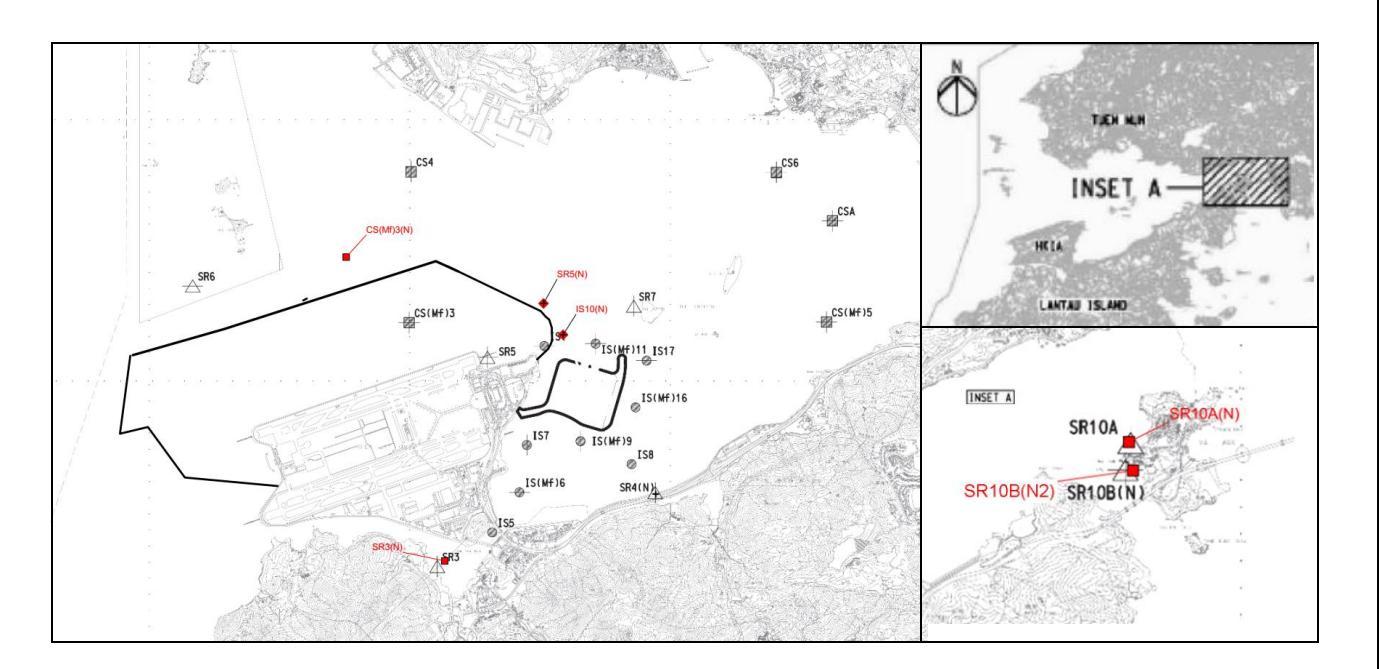
On 20 November 2017, one AL exceedance of SS at SR7 was recorded during mid-flood tide.

As confirmed by the Contractor, there was no marine transportation and marine-based work on 20 November 2017. No site runoff within the Contract site has been observed. Therefore, it is concluded that the exceedances were not related to the Contract.

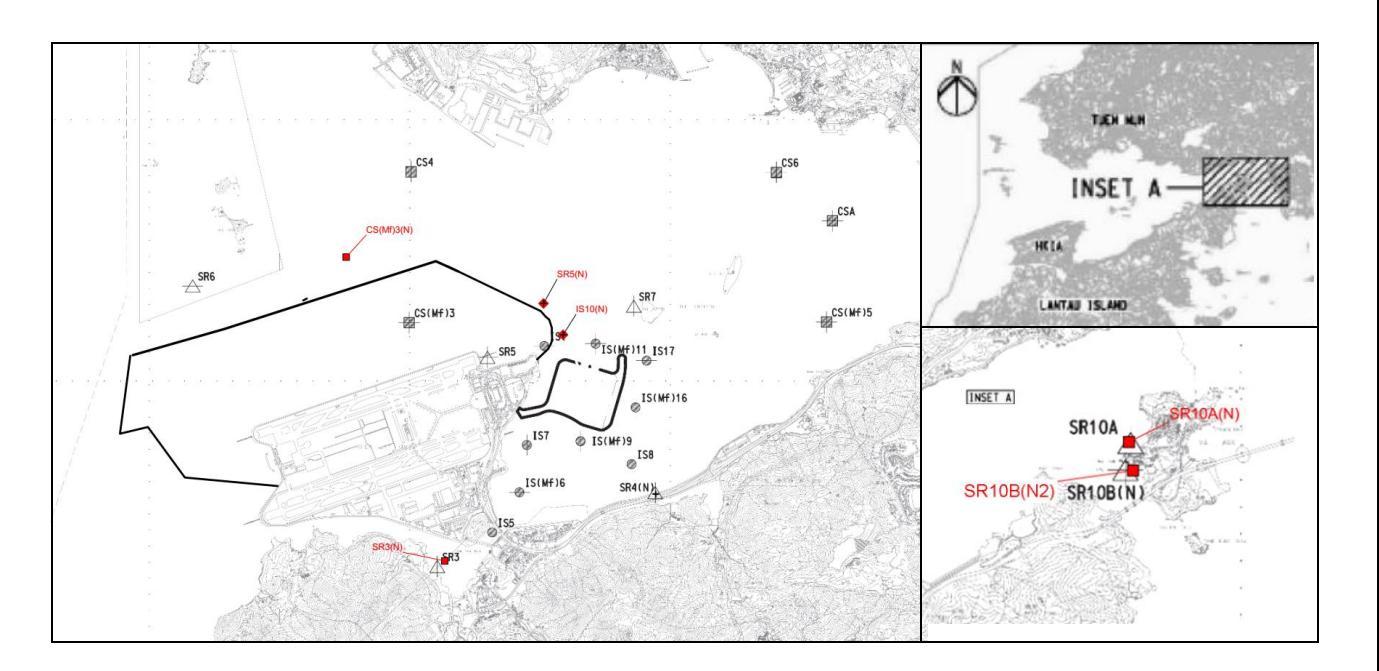
On 24 November 2017, one AL exceedance of SS at IS8 was recorded during mid-flood tide.

As confirmed by the Contractor, there was no marine transportation and marine-based work on 24 November 2017. No site runoff within the Contract site has been observed. Therefore, it is concluded that the exceedances were not related to the Contract.
