Contract No. HY/2011/03 -Hong Kong- Zhuhai- Macao Bridge Hong Kong Link Road Section between Scenic Hill and Hong Kong Boundary Crossing Facilities Notifications of Environmental Quality Limits Exceedances Notification No.: 307 ver 0

Contract No. HY/2011/03 -Hong Kong- Zhuhai- Macao Bridge Hong Kong Link Road Section between Scenic Hill and Hong Kong Boundary Crossing Facilities Notifications of Environmental Quality Limits Exceedances Notification No.: 307e

Parameter: Dissolved Oxygen (DO)/ Suspended Solids (SS)/ Turbidity (TURB)

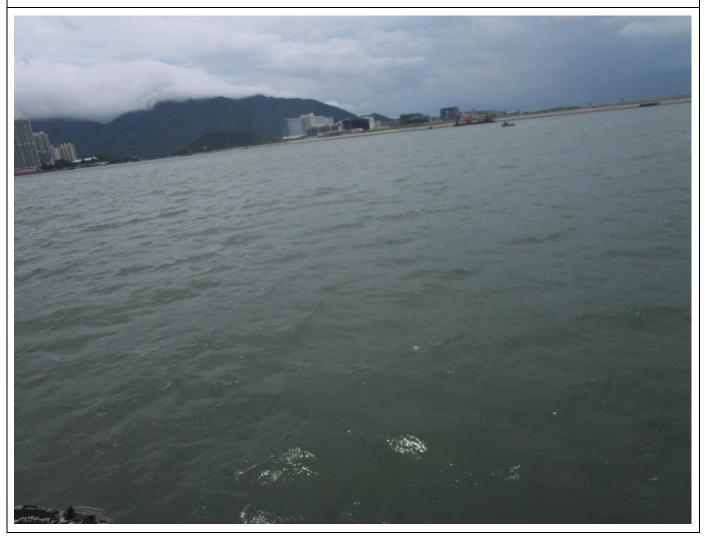
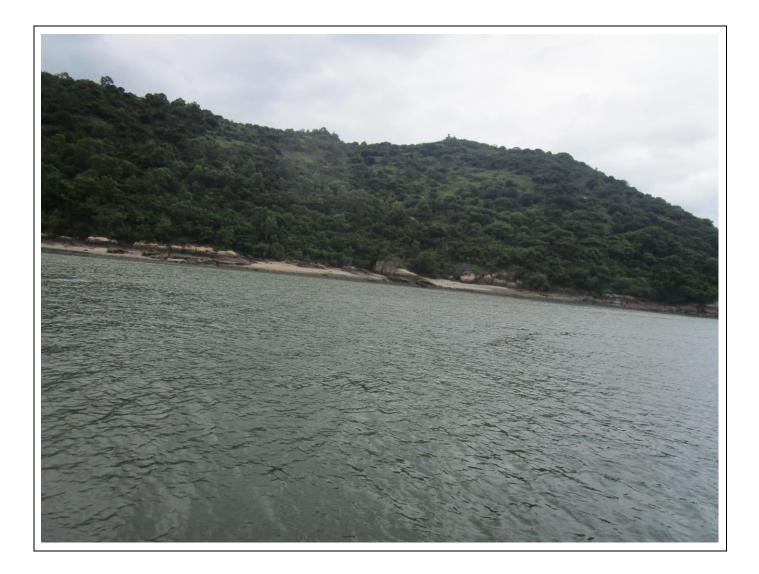
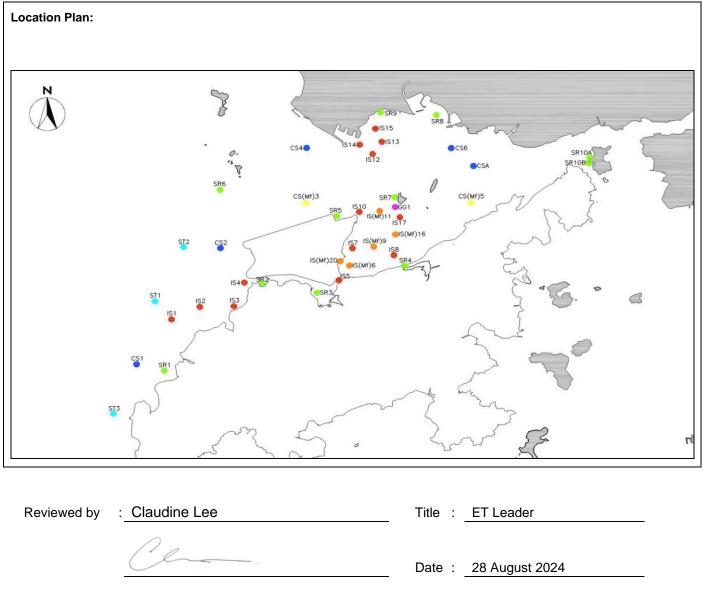
Monitoring Photo Record

On 21 August 2024, exceedance of the AL at station IS5, IS8(N), IS10(N), SR4(N3), SR5(N), SR10A(N), SR10B(N2) and IS(Mf)6 were recorded during mid-ebb tide. The exceedances have been investigated and are considered unlikely to be related to contract works due to the following reason:

- 1. No major marine works were carried out near the monitoring stations. Removal of temporary toe loading platform was being carried out within silt curtains within the limited shoreline area during the sampling period.
- 2. The ranges of dissolved oxygen at stations IS5, IS8(N), IS10(N), SR4(N3), SR5(N), SR10A(N), SR10B(N2) and IS(Mf)6 during the baseline monitoring are shown as below.

The measured DO levels during mid-ebb tide at stations IS5 (Middle), IS8(N), IS10(N) (Middle), SR4(N3), SR10A(N), and IS(Mf)6 were within the ranges of dissolved oxygen during baseline monitoring.

3. There were no specific activities recorded during the monitoring period that would cause any significant impacts on the monitoring results.

As such, natural fluctuation is considered to be attributed to low dissolved oxygen levels, rather than the contract works.

As the dissolved oxygen levels recorded beyond the water quality criteria were not related to contract works, no immediate actions are considered necessary.
