Contract No. HY/2010/02

**Hong Kong – Zhuhai – Macao Bridge  
Hong Kong Boundary Crossing  
Facilities –  
Reclamation Works****Monthly EM&A Report for November 2015**

Version: Rev. 0 Date: 11 December 2015

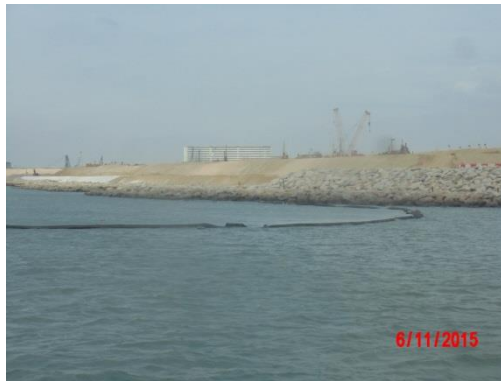
4.6.4.4 With reference to the silt curtain checking record, defects such as disconnection of the silt curtain was not observed at south part of the perimeter silt curtain which are close to the IS(Mf)9.

4.6.4.5 Furthermore, no filling activities was observed in progress at the sea area south to HKBCF reclamation works and no silt plume was observed to flow from the inside of the perimeter silt curtain to the outside of the perimeter silt curtain when monitoring was conducted at IS(Mf)9. Also refer to the attached photo record taken at sea area located south of HKBCF reclamation works on 6 November 2015 for reference of sea condition on 6 November 2015, which shows that no silt plume was observed.

4.6.4.6 Photo record which shows the sea condition at southern part of the HKBCF reclamation works on 06 November 2015. No silt plume was observed.

4.6.4.8 As such, the exceedance was likely due to local effects in the vicinity of IS(Mf)9.
