Contract No. HY/2010/02

## Hong Kong – Zhuhai – Macao Bridge Hong Kong Boundary Crossing Facilities – Reclamation Works

Monthly EM&A Report for October 2017

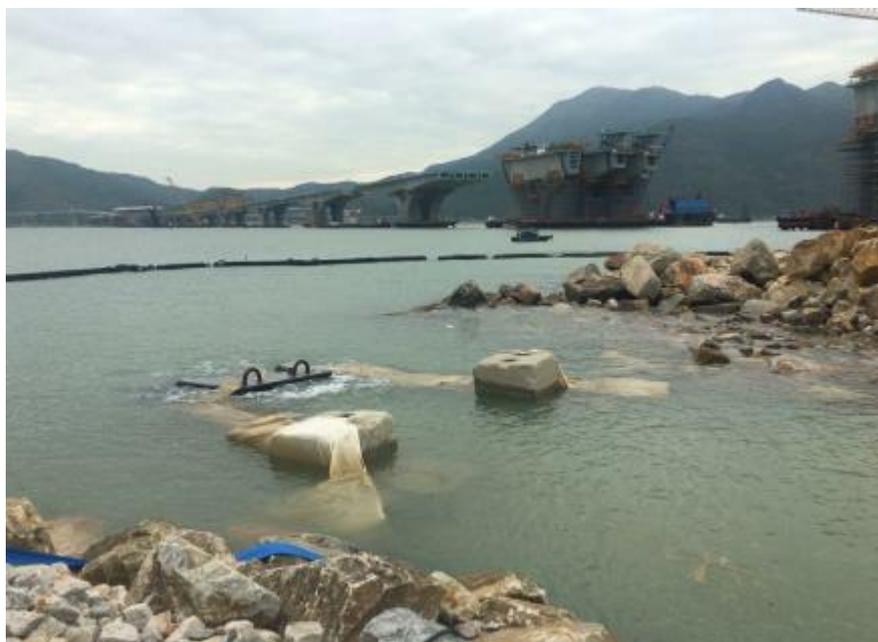
- Weekly site inspections were also conducted on 19 and 26 October 2017 and 2 November 2017 to check the site mitigation measures associated with the active works, with referred to photo record taken on 19 and 26 Oct 2017 and November 2017, they shows active works areas were confined within silt curtain which was adequately maintained during the period and no silt plume was observed at active works areas.
- Photo record taken by ET on 19 October 2017 during weekly site inspection shows that no yellowish muddy water was observed at active works area of outfall pipeline installation.

- Photo record taken by ET on 19 October 2017 during weekly site inspection shows that no yellowish muddy water was observed at active works area of seawall construction.

6.6.1.4 Nevertheless, the Contractor was reminded to continue to fully and properly implement all water quality mitigation measures i.e. wastewater from temporary site facilities should be controlled to prevent direct discharge to surface or marine waters.

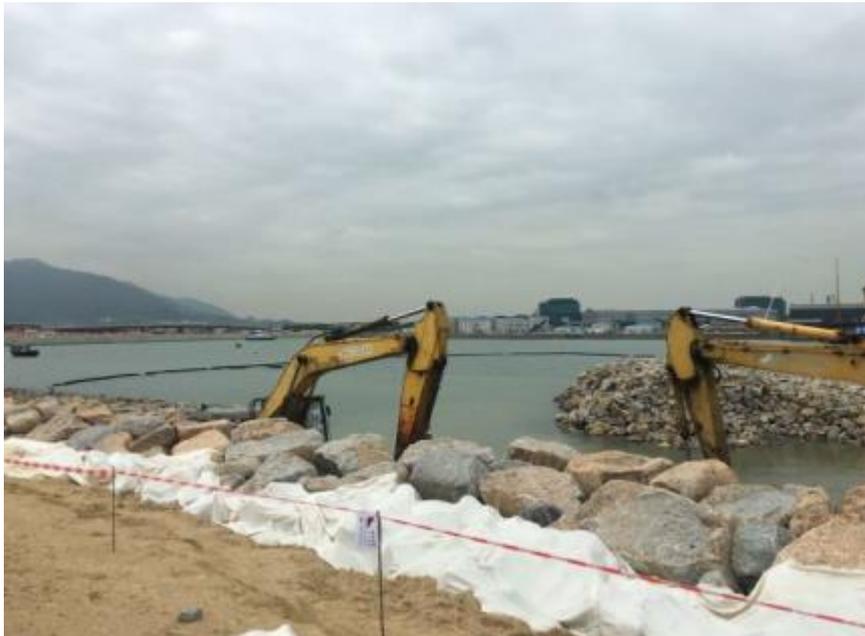
- Photo record taken by ET on 26 October 2017 during weekly site inspection shows that no yellowish muddy water was observed at active works area of outfall pipeline installation.

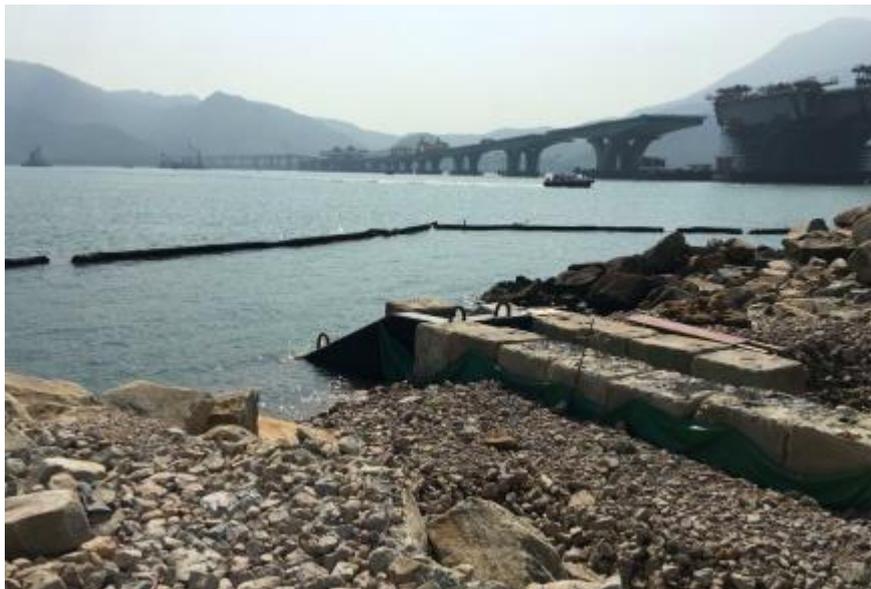
- Photo record taken by ET on 26 October 2017 during weekly site inspection shows that no yellowish muddy water was observed at active works area of seawall construction.

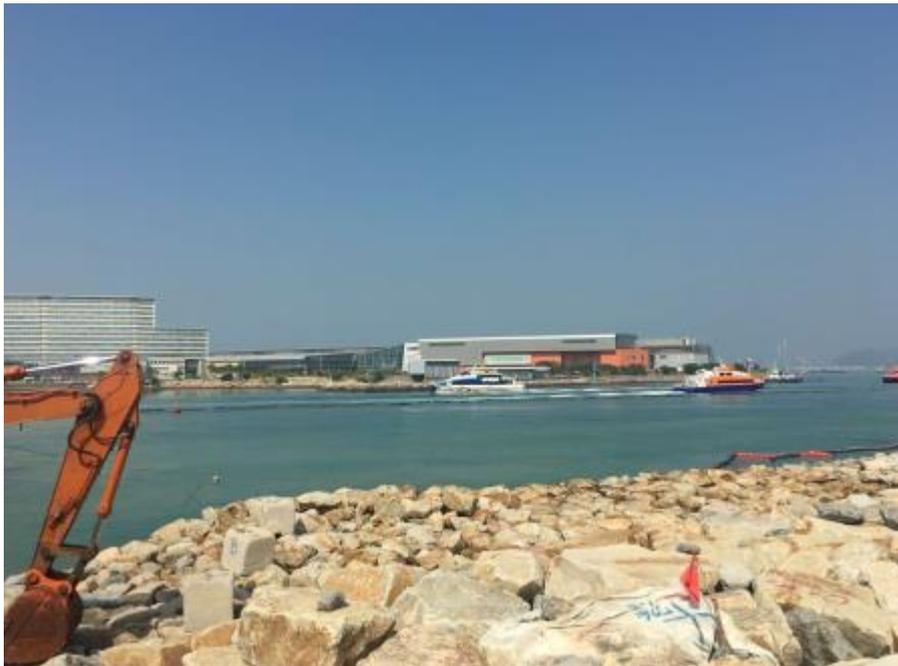
- Photo record taken by ET on 2 November 2017 during weekly site inspection shows that no yellowish muddy water was observed at active works area of outfall pipeline installation.

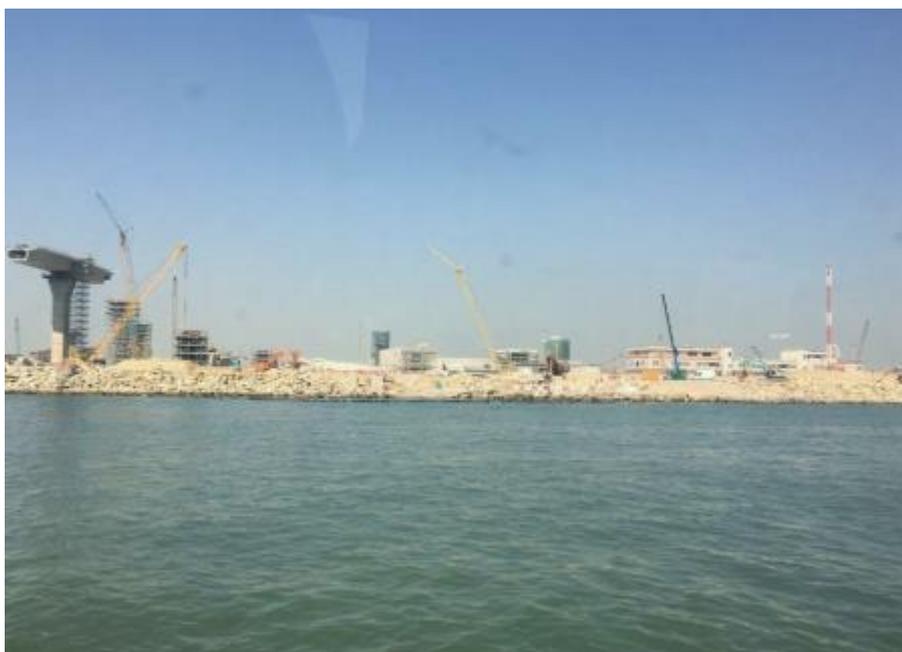
- Photo record taken by ET on 2 November 2017 during weekly site inspection shows that no yellowish muddy water was observed at active works area of seawall construction.

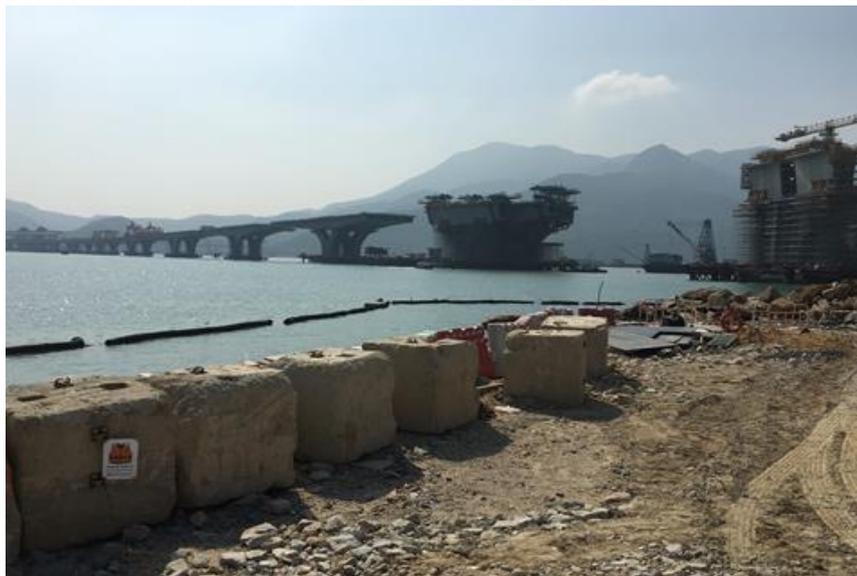
- out on 20 October 2017 which are unlikely to cause SS exceedances at the monitoring stations IS(Mf)11 and SR7 mentioned in Table 1.
- With referred to photo record taken on 21 and 26 Oct 2017 active works area was confined within silt curtain which was properly maintained during the period and no silt plume was observed at active works areas.
- In addition, there was no exceedances recorded at monitoring stations IS(Mf)16 and IS10(N) which are located closer to active works than it is of monitoring station mentioned in Table 1.
- Therefore, the recorded SS exceedances on 20 October 2017 during flood tide were unlikely to be related to construction works under Contract HY/2010/02.

Photo record shows condition of silt curtain and active works area at outfall area on 26 Oct 2017.

The Contractor to properly implement all relevant water quality mitigation measures.

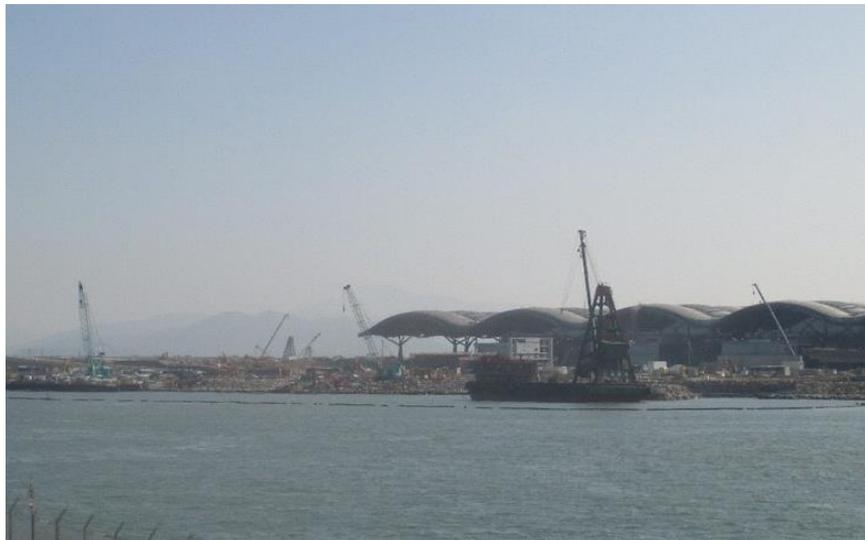
Photo record shows silt curtain condition and active seawall construction area on 21 Oct 2017.
