Contract No. HY/2010/02

**Hong Kong – Zhuhai – Macao Bridge  
Hong Kong Boundary Crossing  
Facilities –  
Reclamation Works****Monthly EM&A Report for November 2017**

**Contract No. HY/2010/02 – HZMB HKBCF – Reclamation Works  
Monthly Environmental Monitoring & Audit Report for November 2017**

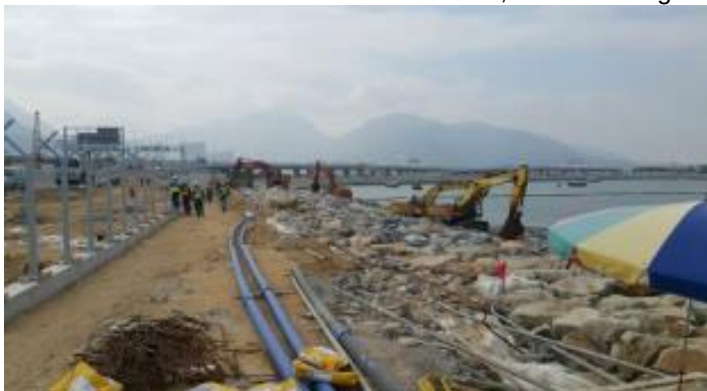
Photo record taken on 23 November 2017, shows no fugitive dust was generated at seawall construction area.

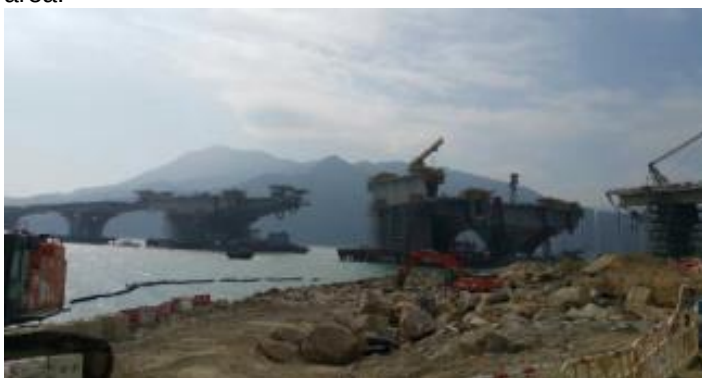
Photo record taken on 23 November 2017, shows no fugitive dust was generated at outfall pipeline installation area.

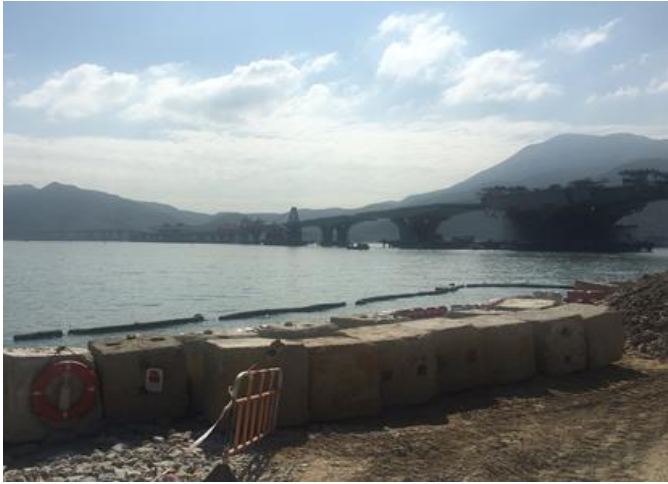
- out on 3 November 2017 which are unlikely to cause SS exceedances at the monitoring stations IS(Mf)11 and SR7 mentioned in Table 1.
- With referred to photo record taken on 9 November 2017 active works area was confined within silt curtain which was properly maintained during the period and no silt plume was observed at active works areas.
- In addition, there was no exceedances recorded at monitoring stations IS(Mf)16 and IS10(N) which are located closer to active works than it is of monitoring station mentioned in Table 1.
- Therefore, the recorded SS exceedances on 3 November 2017 during flood tide were unlikely to be related to construction works under Contract HY/2010/02.

Photo record show silt curtain condition and active seawall construction area on 9 Nov 2017.

The Contractor to properly implement all relevant water quality mitigation measures.

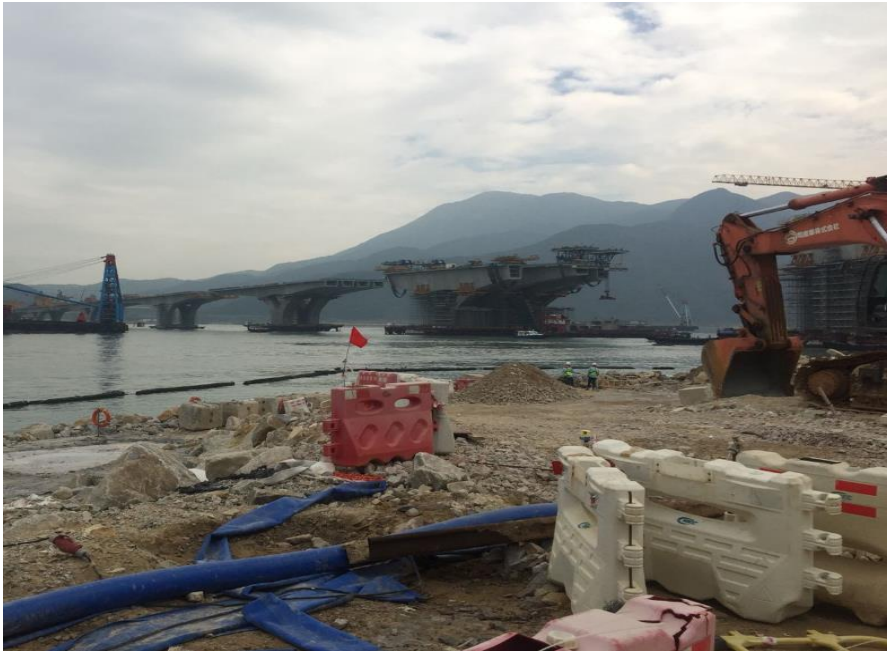
- carried out on 6 November 2017 which are unlikely to cause SS exceedances at the monitoring stations IS(Mf)16 and SR7 mentioned in Table 1.
- With referred to photo record taken on 6 November 2017 active works area were confined within silt curtain which were properly maintained during the period and no silt plume was observed at active works areas.

Photo record shows condition of silt curtain and active works area at outfall area on 6 Nov 2017.

The Contractor to properly implement all relevant water quality mitigation measures.

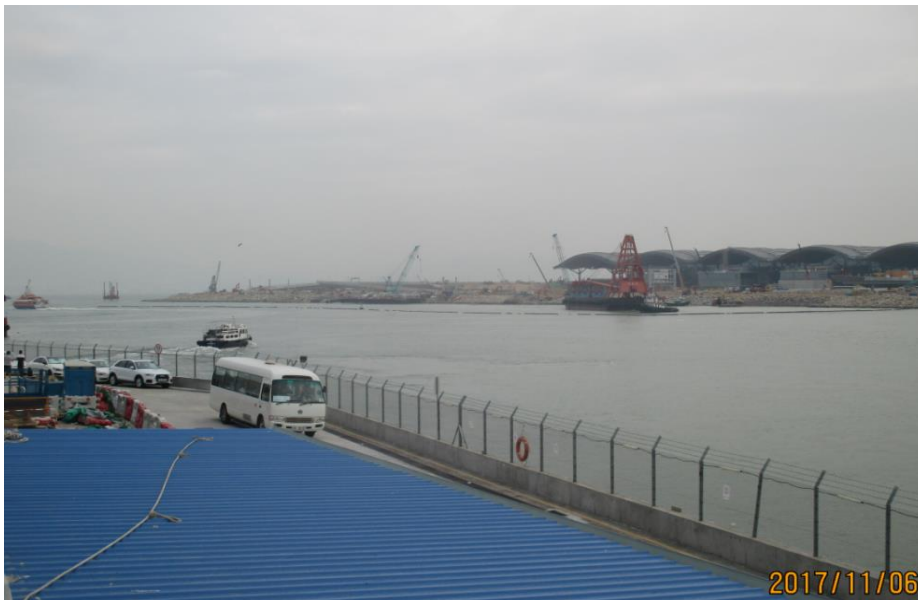
Photo record show silt curtain condition and active seawall construction area on 6 Nov 2017.

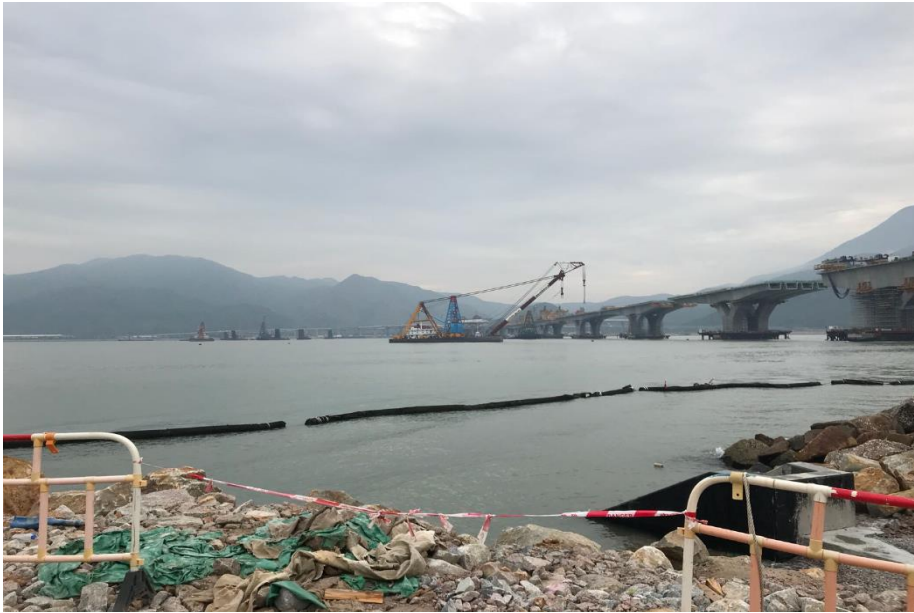
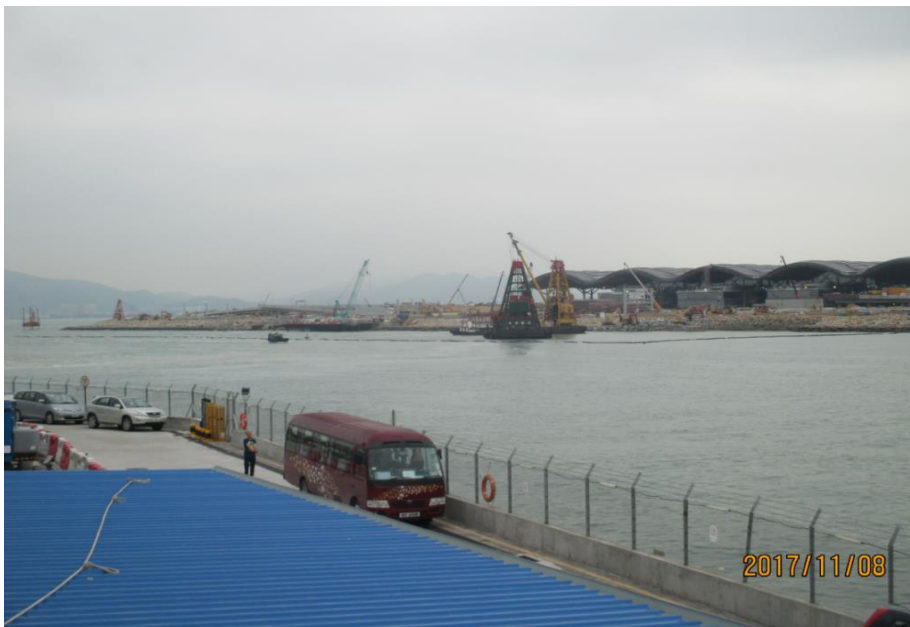
- With referred to photo record taken on 8 November 2017 active works area were confined within silt curtain which were properly maintained during the period and no silt plume was observed at active works areas.

Photo record show silt curtain condition and active seawall construction area on 8 Nov 2017.

The Contractor to properly implement all relevant water quality mitigation measures.

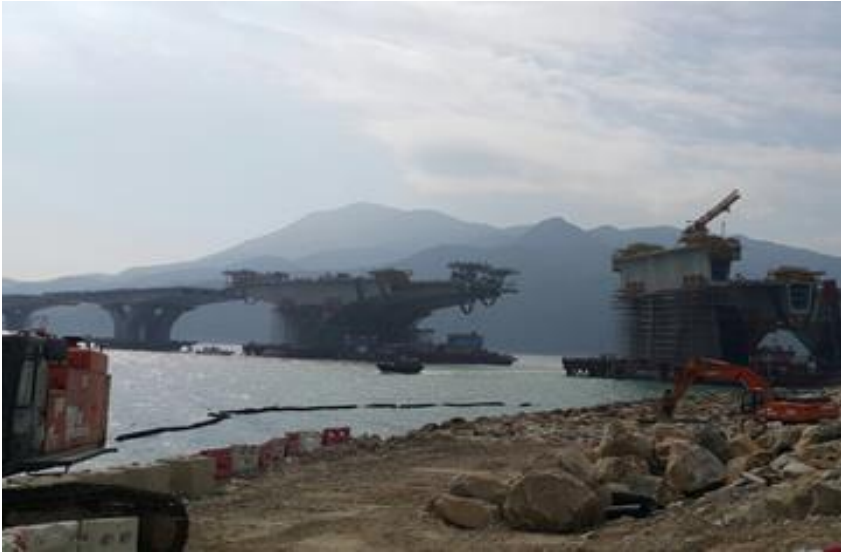
- With referred to photo record taken on 20 and 23 November 2017, active works area were confined within silt curtain which were properly maintained during the period and no silt plume was observed at active works areas.

Photo record shows condition of silt curtain and active works area at outfall area on 23 Nov 2017.

The Contractor to properly implement all relevant water quality mitigation measures.

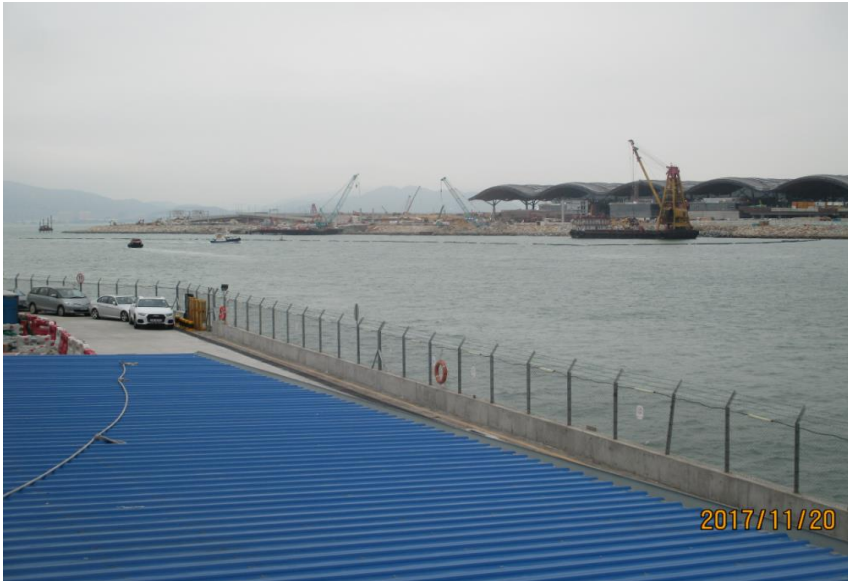
Photo record shows silt curtain condition and active seawall construction area on 20 Nov 2017.
