Contract No. HY/2010/02

**Hong Kong – Zhuhai – Macao Bridge  
Hong Kong Boundary Crossing  
Facilities –  
Reclamation Works****Monthly EM&A Report for December 2017**

**Contract No. HY/2010/02 – HZMB HKBCF – Reclamation Works  
Monthly Environmental Monitoring & Audit Report for December 2017**

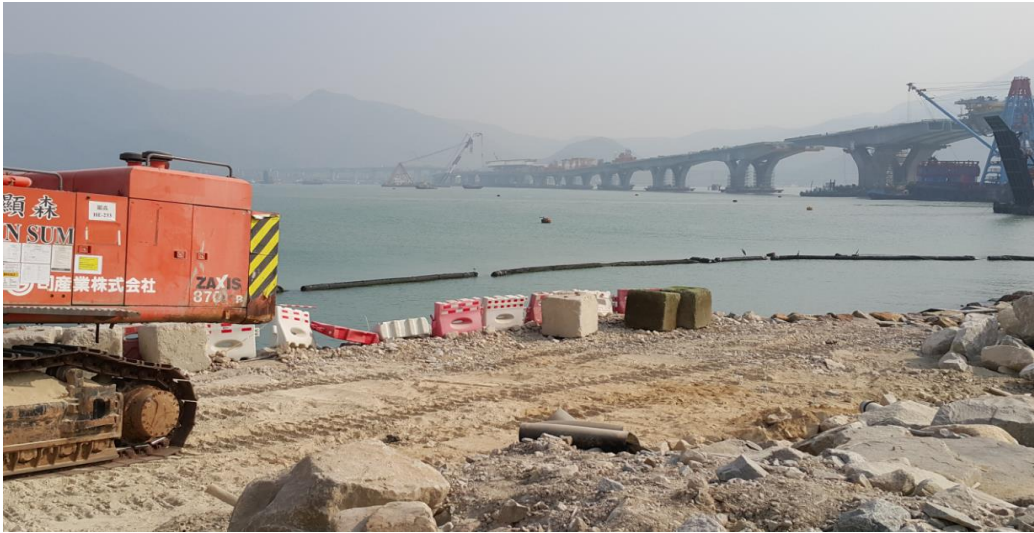
- Photo record taken on 6 and 7 December 2017 showed active works area were confined within silt curtain which were properly maintained during the period and no silt plume was observed at active works areas.

Photo record shows condition of silt curtain and active works area at outfall area on 7 Dec 2017.

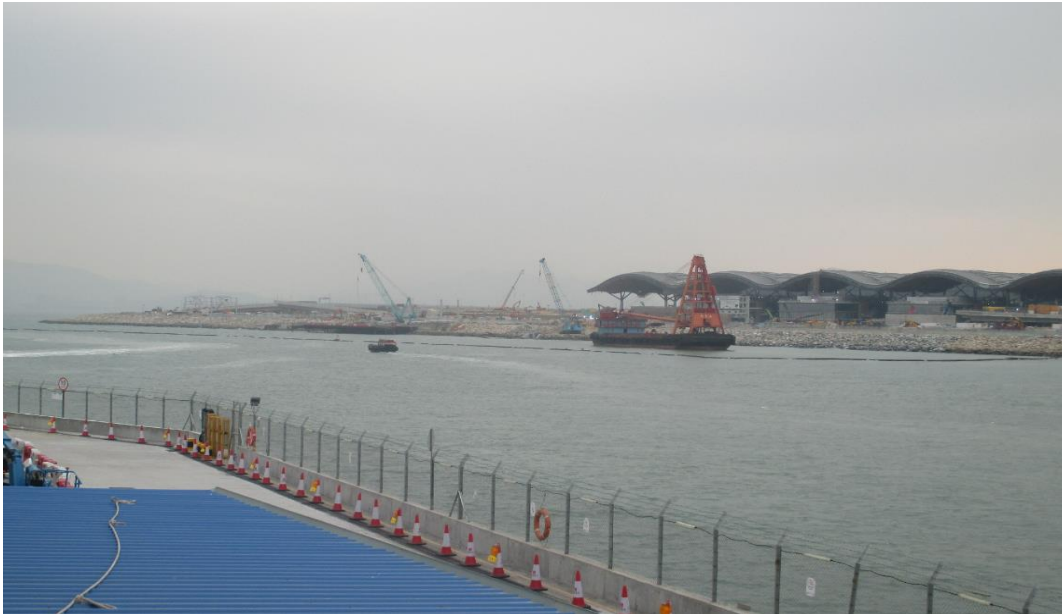
Photo record show silt curtain condition and active seawall construction area on 6 Dec 2017.

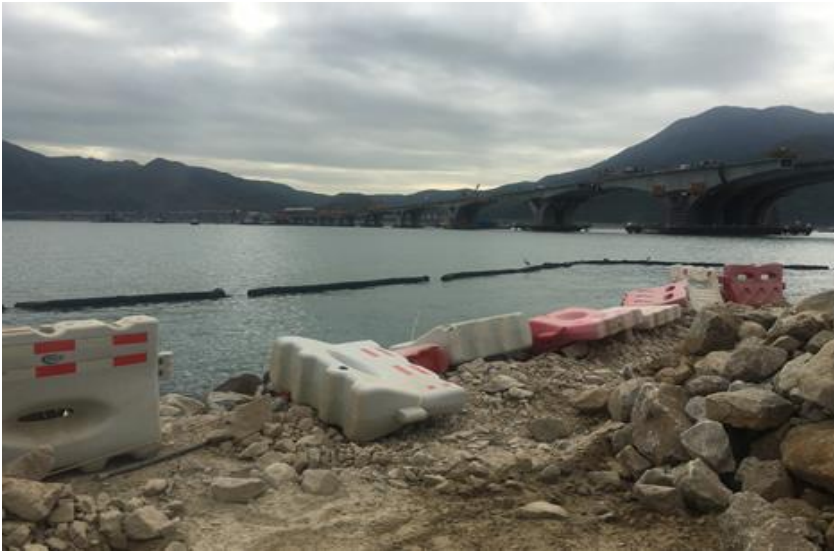
- With referred to photo record taken on 14 December 2017, active work area was confined within silt curtain which was properly maintained during the period and no silt plume was observed at active work area.
- Exceedance recorded at monitoring station IS(Mf)9 was located at the upstream of outfall works area based on dominant tidal flow during ebb tide, which was unlikely caused by construction works under this Contract.
- In addition, there was no exceedance recorded at monitoring station IS(Mf)16 which are located closer to active work area than it is of monitoring station mentioned in Table 1.
- Therefore, the recorded SS exceedances on 11 December 2017 during flood tide were unlikely to be related to construction works under Contract HY/2010/02.

Photo record shows condition of silt curtain and active works area at outfall area on 14 Dec 2017.

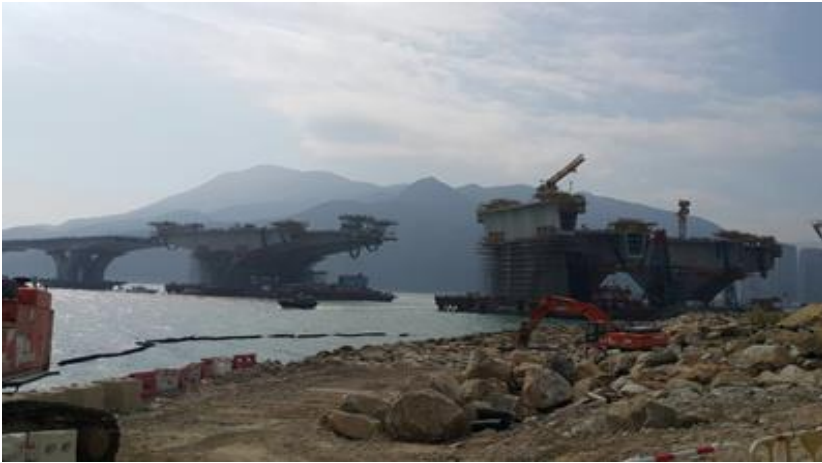
- With referred to photo record taken on 6 and 7 December 2017, active work area were confined within silt curtain which were properly maintained during the period and no silt plume was observed at active work area.

Photo record shows condition of silt curtain and active works area at outfall area on 7 Dec 2017.

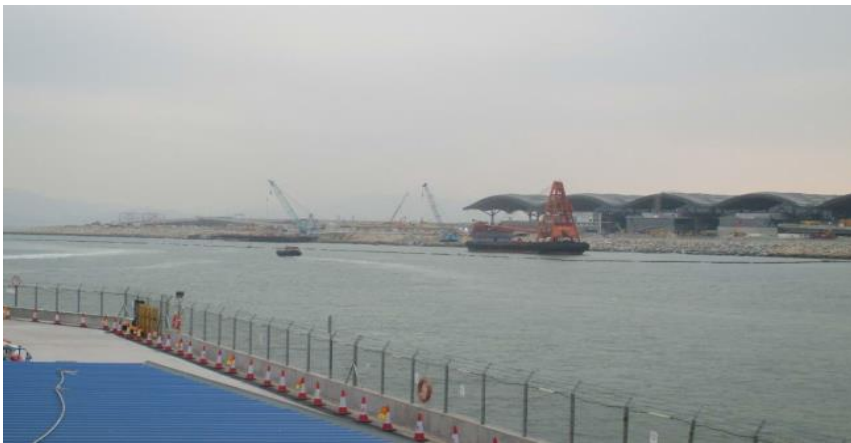
Photo record show silt curtain condition and active seawall construction area on 6 Dec 2017.

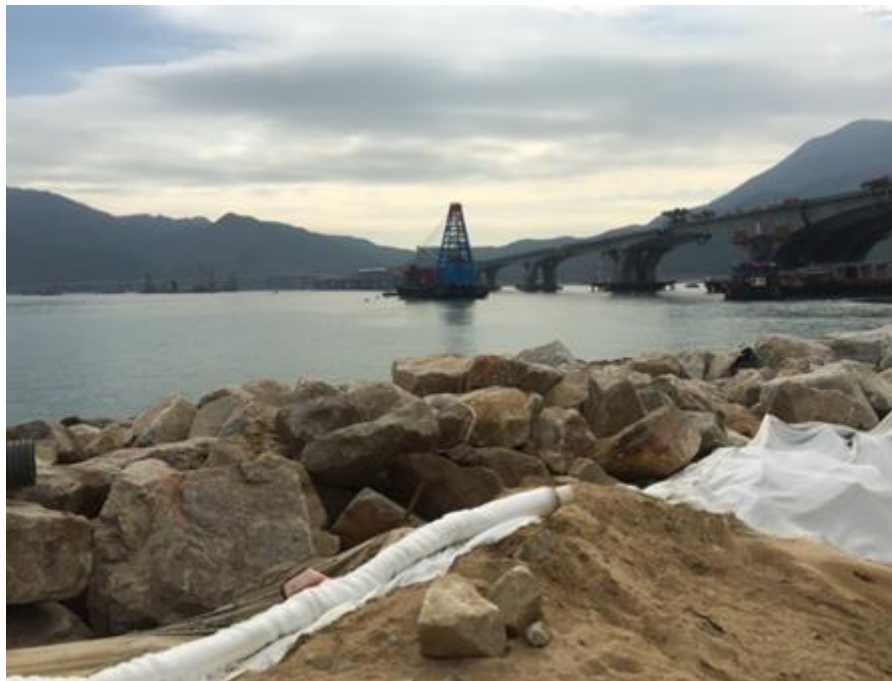
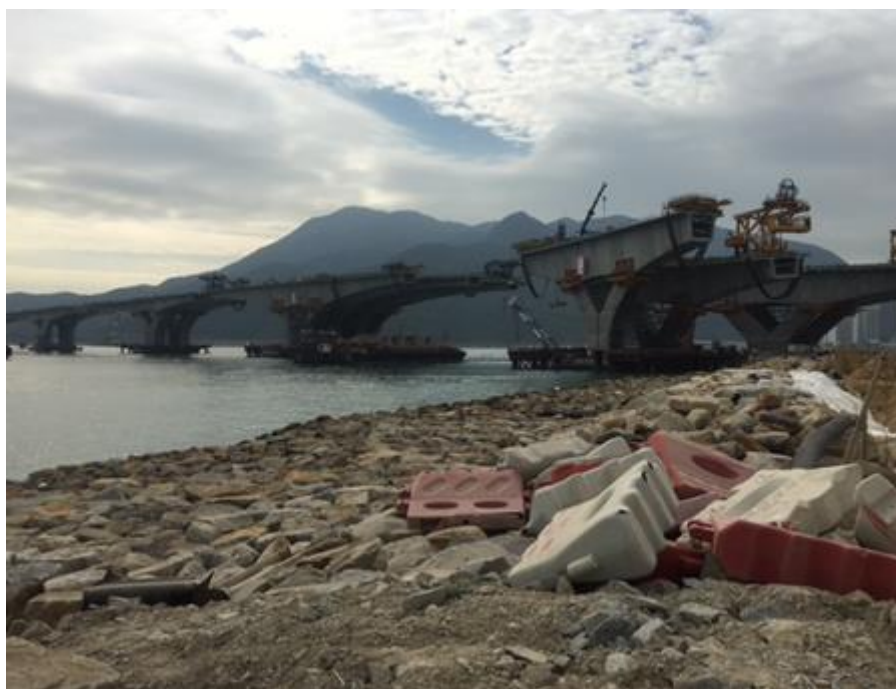
**Photo record taken on 28 December 2017 showed no fugitive dust was generated at outfall area.**

| <b>Actions taken / to be taken</b> | <p>The Contractor was recommended to continue implementing existing dust mitigation measures.</p> <p>Dust suppression should be provided to dusty materials for all works which might generate fugitive dust.</p> |
