Contract No. HY/2010/02

**Hong Kong – Zhuhai – Macao Bridge
Hong Kong Boundary Crossing
Facilities –
Reclamation Works****Quarterly EM&A Report for
March 2014- May 2014**

**Contract No. HY/2010/02 HZMB HKBCF – Reclamation Work
Quarterly Environmental Monitoring & Audit Report for Mar 2014 to May 2014**

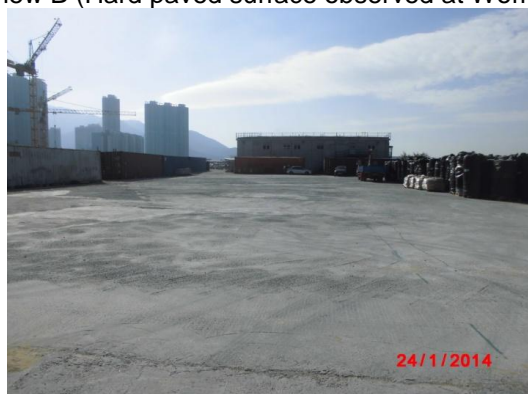
View B (Hard paved surface observed at Works Area WA2)

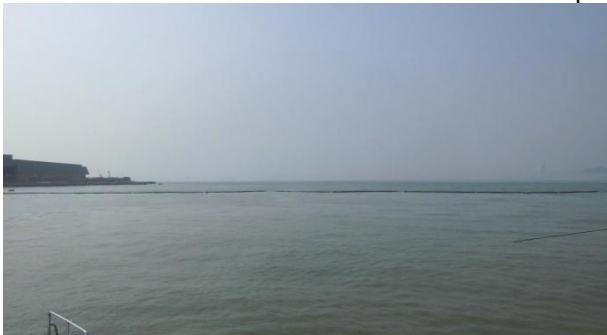
- 3.3.3.4 With reference to monitoring record and photo record taken on 19 and 20 March 2014, no silt plume was observed on sea near the northwest part of the site which is close to IS10. (Please see attached photo record)

- 3.3.3.5 Photo of sea condition taken near the northwest part of the site (Near IS10) on 19 March 14

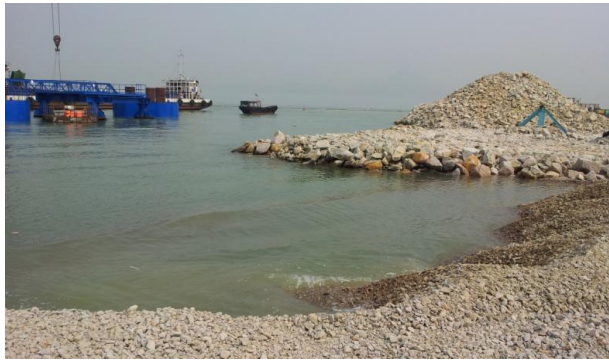
- 3.3.3.6 Photo of sea condition taken near the northwest part of the site (Near IS 10) on 20 March 14

- 3.3.3.7 In accordance with the silt curtain integrity checking record, no disconnection was observed at the northwest part of site which is near IS10.

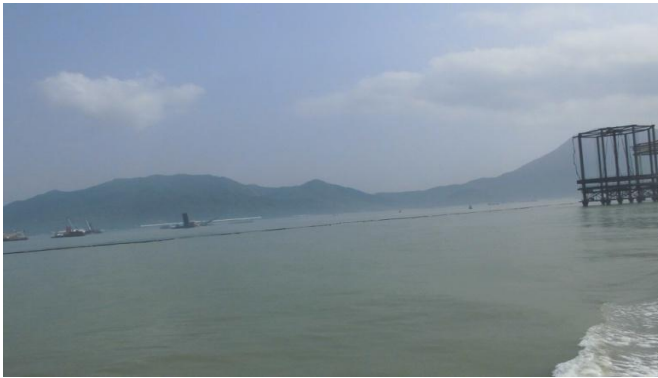
- 3.3.3.37 With reference to monitoring record and photo record taken on 19 and 20 March 2014, no silt plume was observed on sea near the northeast part of the site which is close to IS17. (Please see attached photo record)

- 3.3.3.38 Photo of sea condition taken near the northeast part of the site (Near IS17) on 19 March 14.

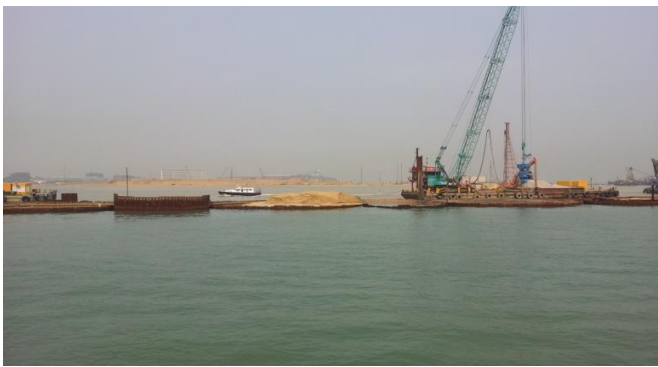
3.3.3.39 Photo of sea condition taken near the northeast part of the site (Near IS17) on 20 March 14.

- 3.3.3.40 With reference to the silt curtain checking record no defects was observed at parts of the perimeter silt curtain which are close to the locations where the exceedance was recorded during mid-ebb tide.
- 3.3.3.41 Turbidity level recorded at IS(Mf)11, IS17 and IS(Mf)16 were below the action and limit level. This indicates the turbidity level at area near IS17 was not adversely affected.
- 3.3.3.42 The exceedance is likely due to local effects in the vicinity of IS17.
- 3.3.3.43 As such, the exceedance recorded at IS17 is unlikely to be project related.
- 3.3.3.44 Nevertheless, the Contractor was reminded to ensure provision of ongoing maintenance to the silt curtains and to carry out maintenance work once defects were found.
- 3.3.3.45 Maintenance work of the silt curtain was carried out by the Contractor on a daily basis except Sunday and public holiday.

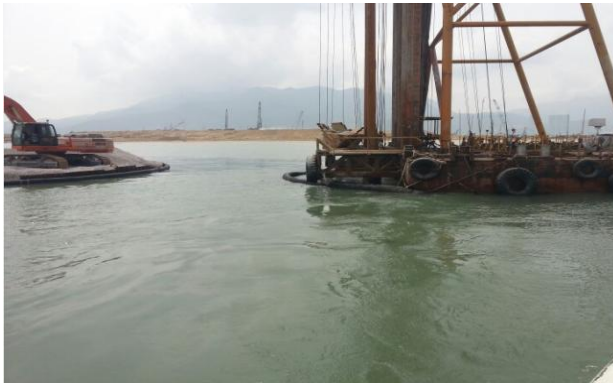
3.3.4.6 Also, in accordance with the monitoring record, no silt plume was observed to flow from the inside of the perimeter silt curtain to the outside of the perimeter silt curtain during impact water quality monitoring on 24 March 2014. (Please refer to the photo attached which shows the sea condition near IS(Mf)9 on 24 March 2014.)

3.3.4.12 Nonetheless, the Contractor was reminded to ensure provision of ongoing maintenance to the silt curtains and to carry out maintenance work once defects were found.

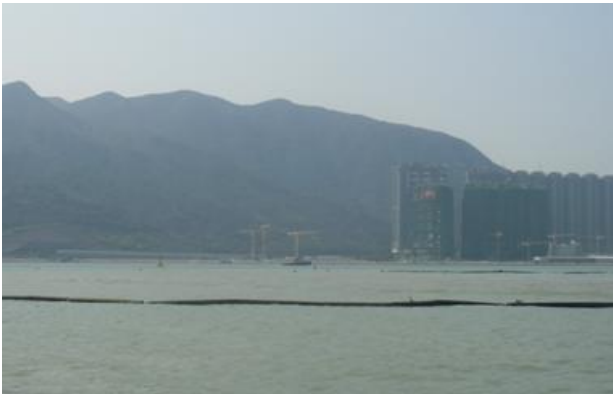
3.3.4.7 Photo of silt curtain near south part of the site IS(Mf)9 on 24 March 2014.

3.3.4.8 With referred to the monitoring data, turbidity level recorded at IS7, IS(Mf)9, IS8 and IS(Mf)16 were below the action and limit level. This indicates the turbidity level at area near IS(Mf)9 was not adversely affected.

3.3.4.9 In addition, with referred to the monitoring data, the Suspended Solids recorded at IS7, IS8 and IS(Mf)16 were below the action and limit level. This indicates the Suspended Solids at areas next to IS(Mf)9 was not adversely affected.

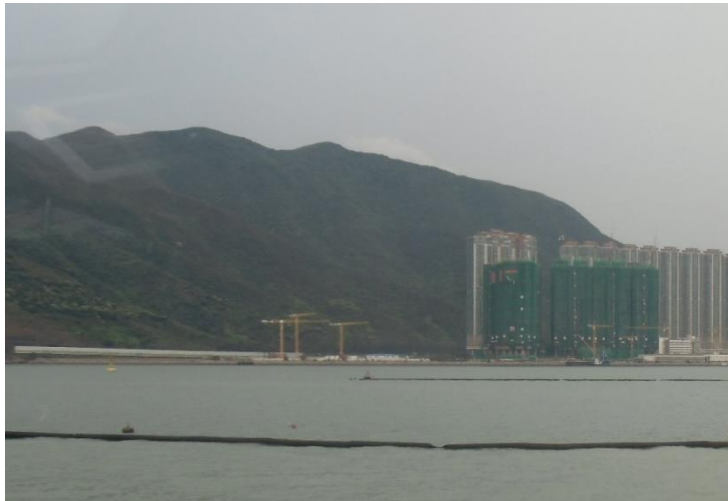
- 3.3.5.6 However, in accordance with the monitoring record, no silt plume was observed outside the perimeter silt curtain near IS(Mf)9 and IS7 on 31 March 2014. (Please refer to the photo below which shows the sea condition near IS(Mf)9 on 31 March 2014.)

- 3.3.5.7 With referred to the monitoring data, turbidity level recorded at IS(Mf)6, IS7, IS(Mf)9, IS8 and IS(Mf)16 were below the action and limit level. This indicates the turbidity level at area near IS(Mf)9 and IS7 were not adversely affected.
- 3.3.5.8 The exceedances are likely due to local effects in the vicinity of IS(Mf)9, IS7 and SR6.
- 3.3.5.9 As such, the exceedances recorded at IS(Mf)9, IS7 and SR6 were unlikely to be project related.
- 3.3.5.10 Nonetheless, the Contractor was reminded to ensure provision of ongoing maintenance to the silt curtains and to carry out maintenance work once defects were found.
- 3.3.5.11 Maintenance work of the silt curtain was carried out by the Contractor on a daily basis except Sunday and public holiday.
- 3.3.5.12 The event action plan is annexed in Appendix L.

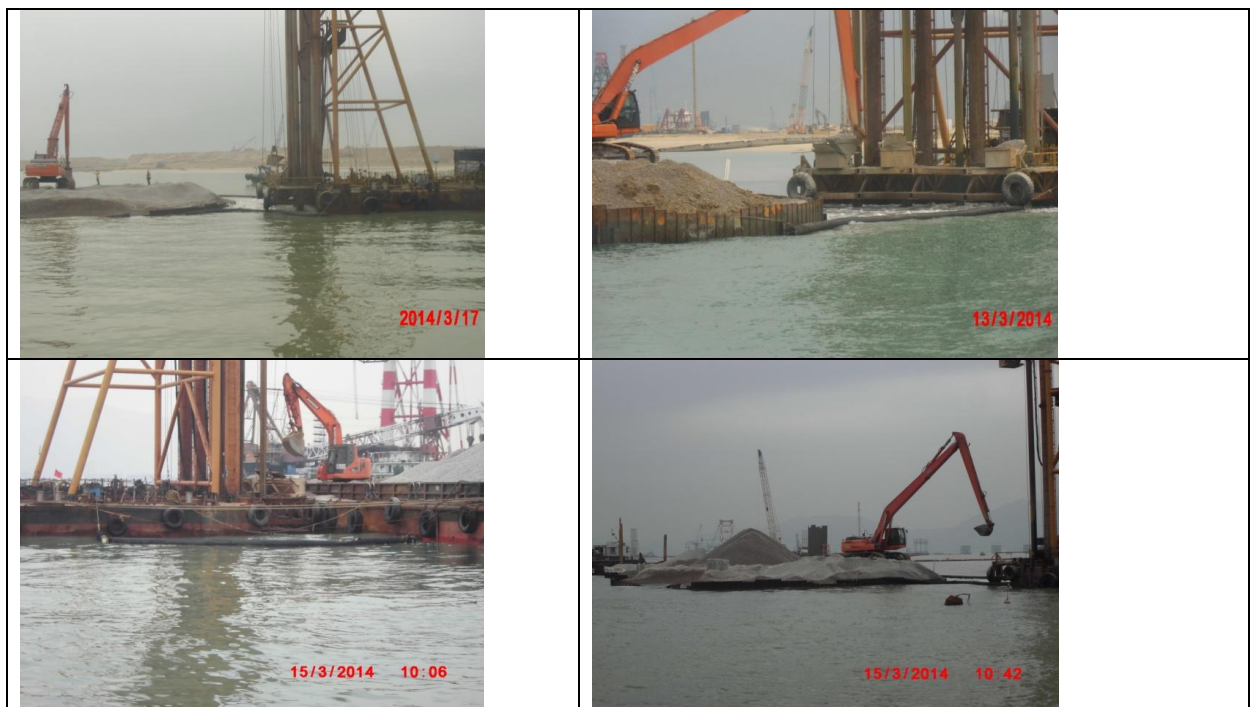
7.1.2.4 Therefore, with reference to the available information, it is indicated that the abovementioned sea water colored in blue observed in vicinity of HKBCF is unlikely to be project related.

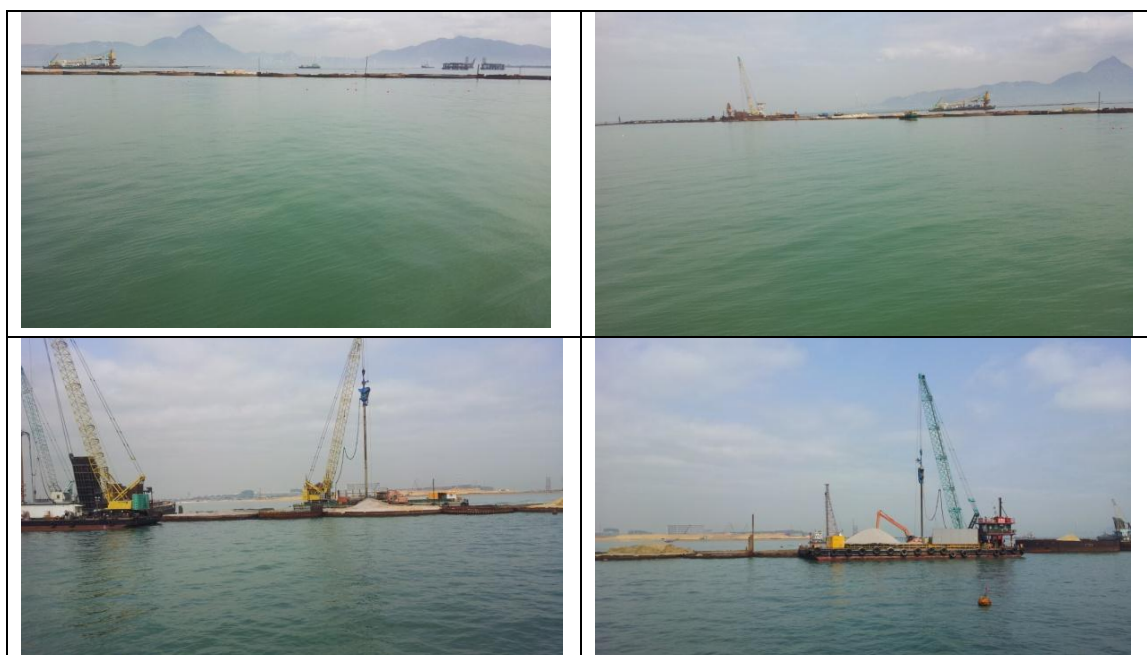
7.1.3.2 The locations of stone column installation (please refer to the attached layout map for the locations of stone column installation) and impact water quality monitoring data recorded on 21 March 2014 were reviewed. In accordance with the monitoring records, no discoloration of sea water or silty plume appearance outside the perimeter silt curtain was observed during the water quality monitoring conducted on 21 March 2014. Also, no Action/ Limit level exceedance of water quality was recorded in the vicinities where stone column installations were carried out.

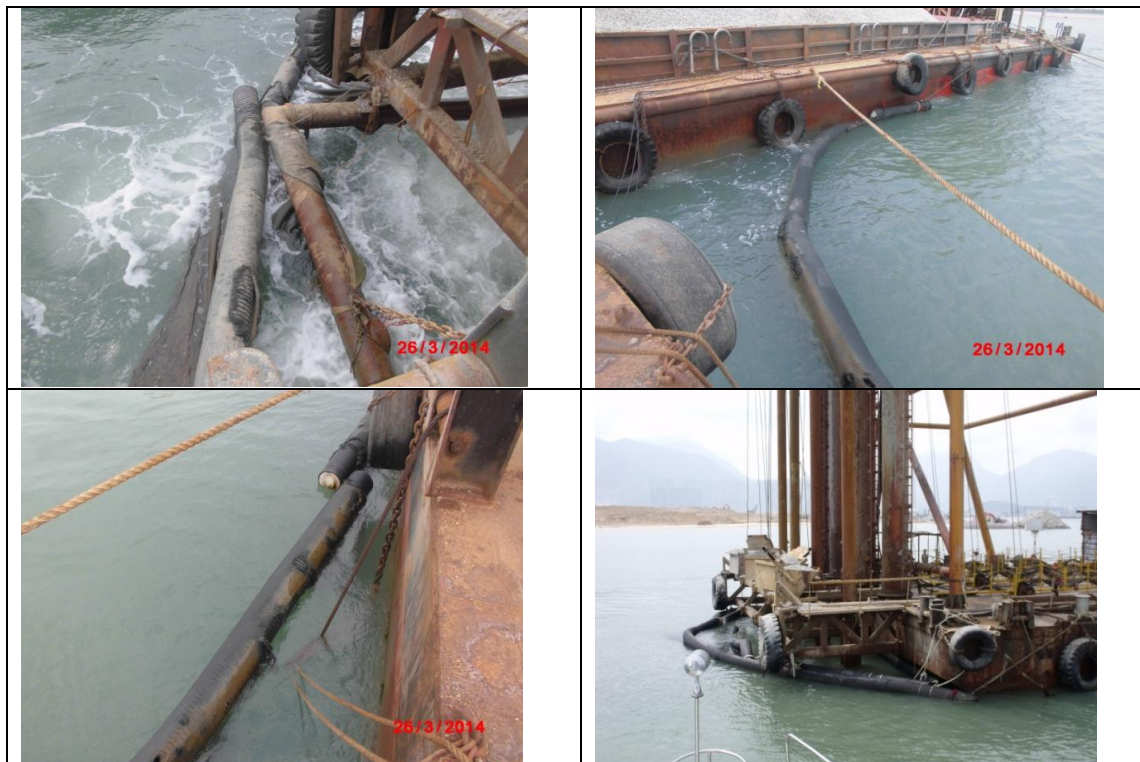
7.1.3.4 Therefore, with reference to the available information, it is indicated that the abovementioned complaint of muddy water which was found being discharged from the construction site of Hong Kong-Zhuhai-Macao Bridge HKBCF – Reclamation Works on 22 March 2014 is unlikely to be project related.

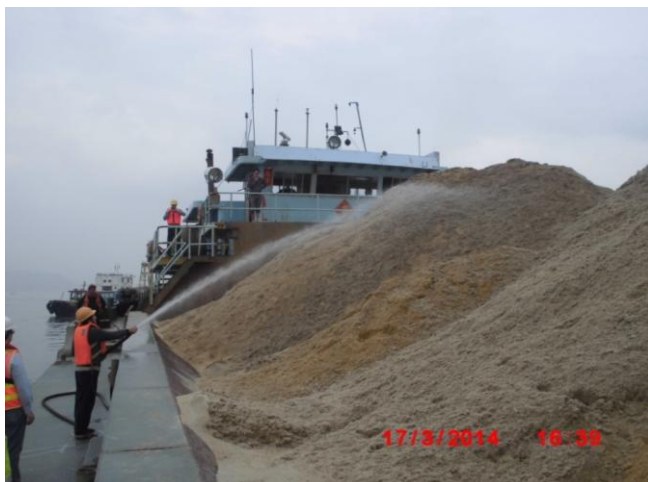
3. Photo record below shows that watering equipment was used to keep the sand filling material wet.

7.1.4.3 Photo record shows that watering equipment was provided on pelican barge loaded with sand for watering of sand filling material to keep the sand material wet:

7.1.4.4 Nevertheless, the Contractor was reminded to continue to properly implement all dust mitigation measures.

7.1.4.5 The Contractor was advised to ensure to continue the provision of fugitive dust mitigation measures to barges loaded with filling material such as watering to sand filling material on sand barges to keep the surface of stockpile of filling material wet.

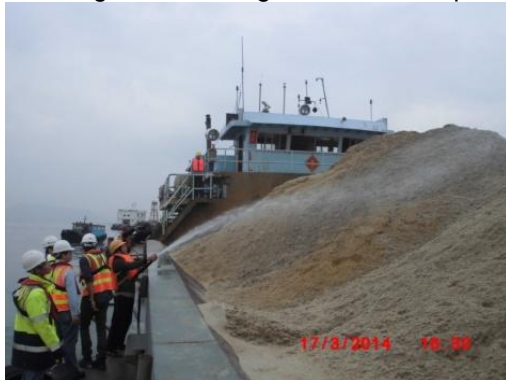
1. There is no sufficient information provided by the complainant to make sure that the concerned barges are related to this project.
2. The sand barges at the construction site of the reclamation works were regularly checked and so far, all sand barges were observed equipped with watering equipments.
3. Photo record below shows that watering equipment was used to keep the sand filling material wet.

7.1.6.3 Photo record shows that watering equipment was provided on pelican barge loaded with sand for watering of sand filling material to keep the sand material wet:

7.1.6.4 Nevertheless, the Contractor was reminded to continue to properly implement all dust mitigation measures.

7.1.6.5 The Contractor was advised to ensure to continue the provision of fugitive dust mitigation measures to barges loaded with filling material such as watering to sand filling material on sand barges to keep the surface of stockpile of filling material wet.
