Contract No. HY/2010/02

**Hong Kong – Zhuhai – Macao Bridge
Hong Kong Boundary Crossing
Facilities –
Reclamation Works**

**Quarterly EM&A Summary Report for
June 2017 – August 2017**

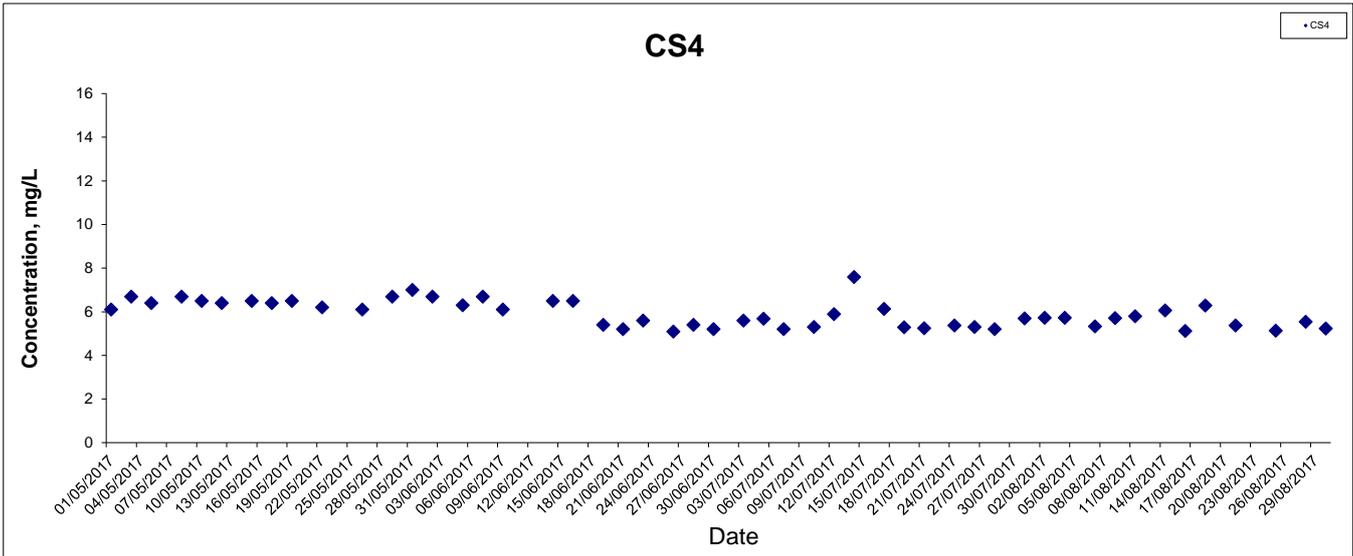
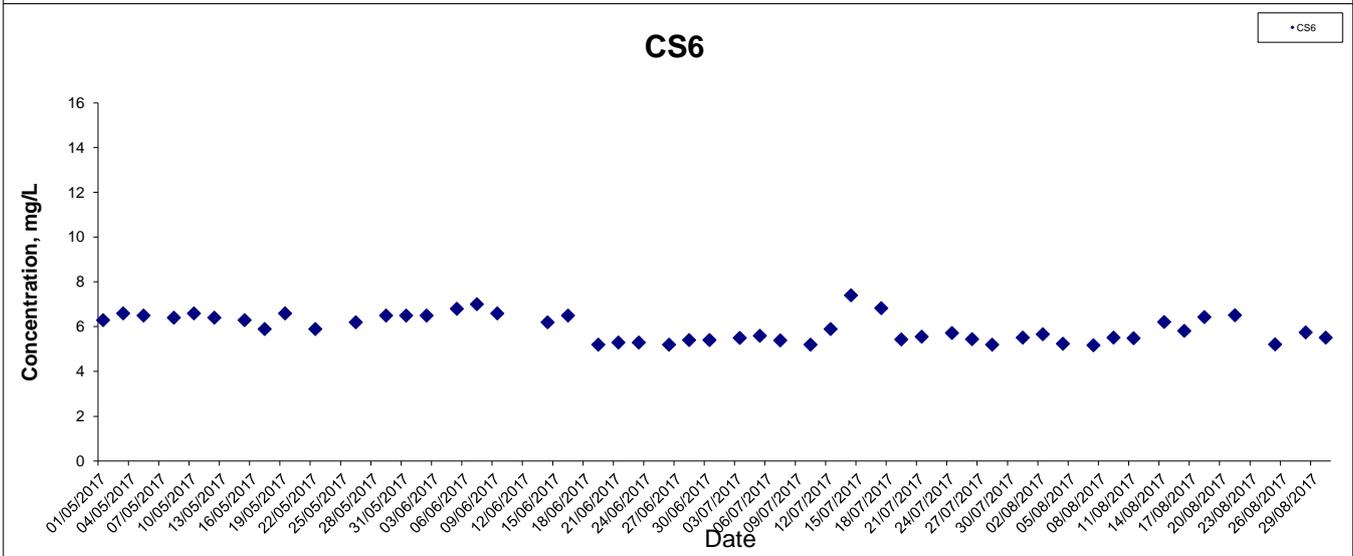
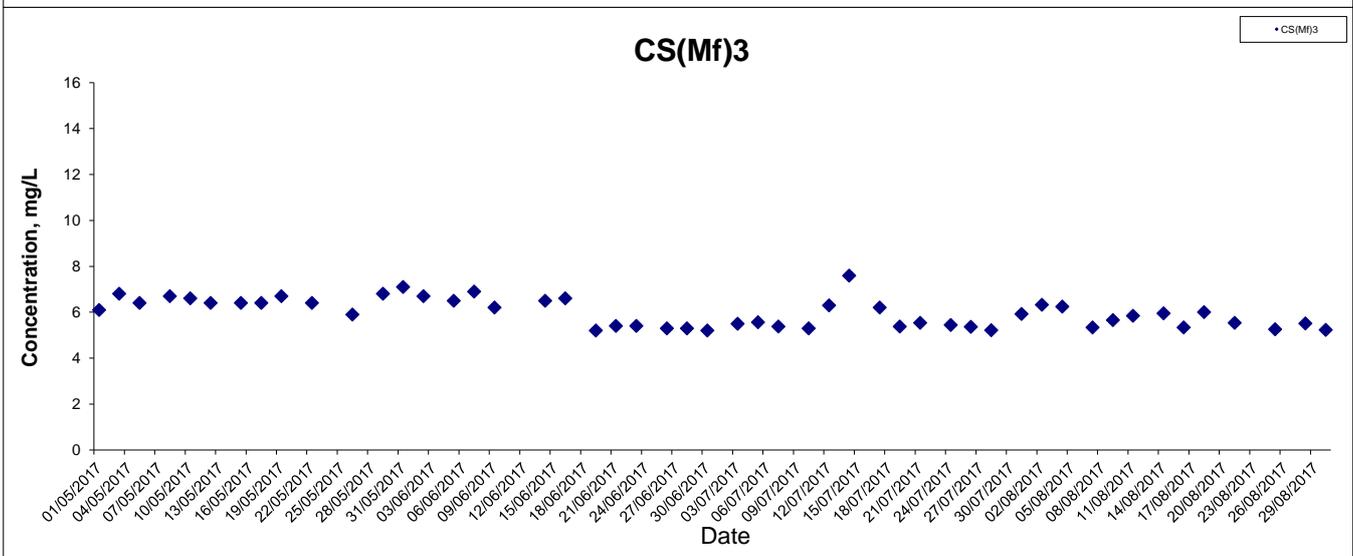
Dissolved Oxygen (Surface & Middle) at Mid-Ebb Tide

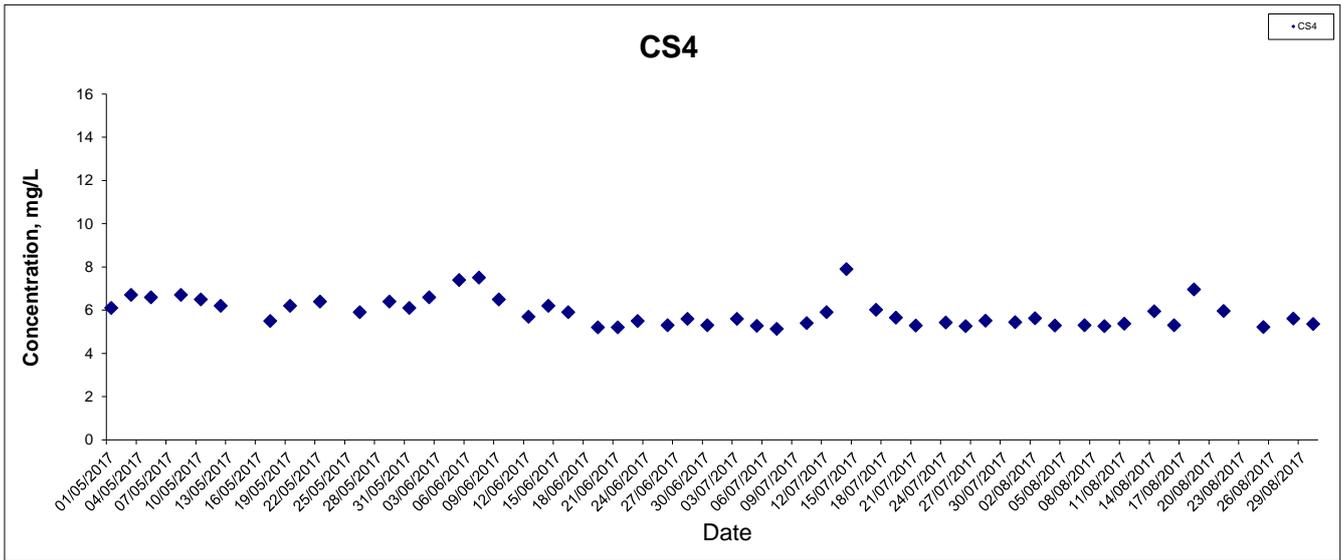
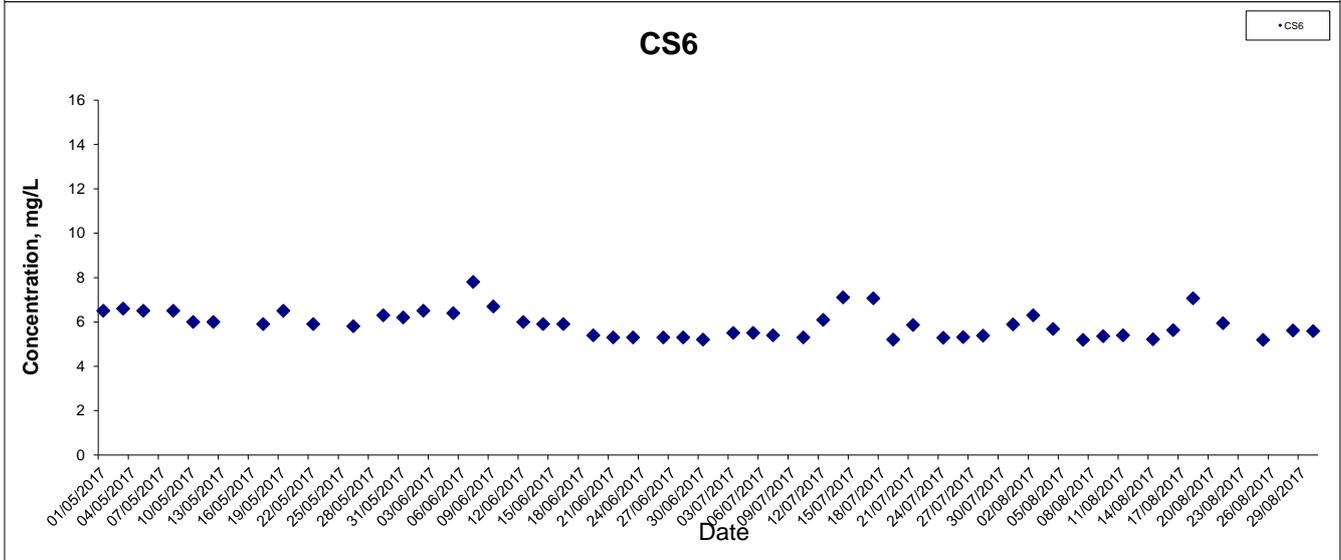
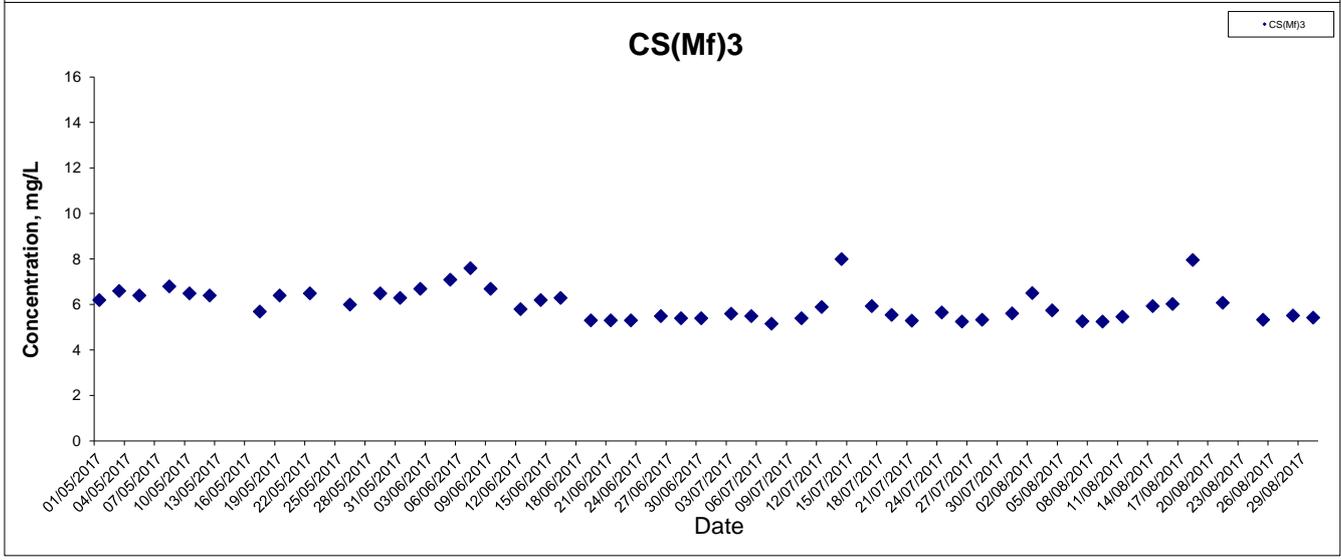
Dissolved Oxygen (Surface & Middle) at Mid-Flood Tide

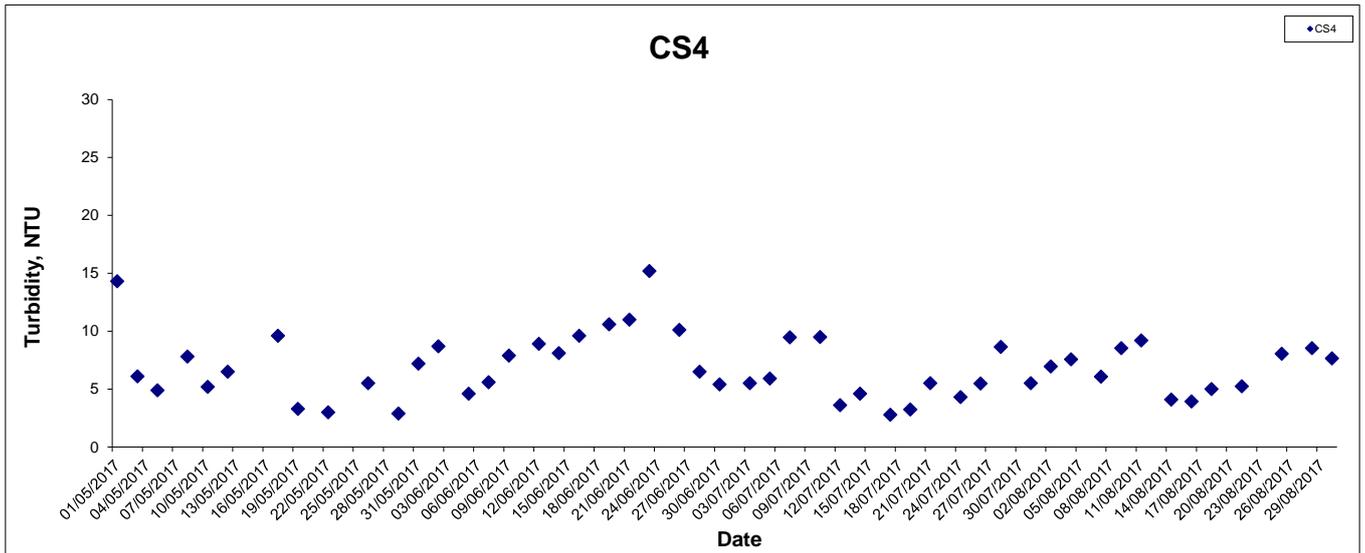
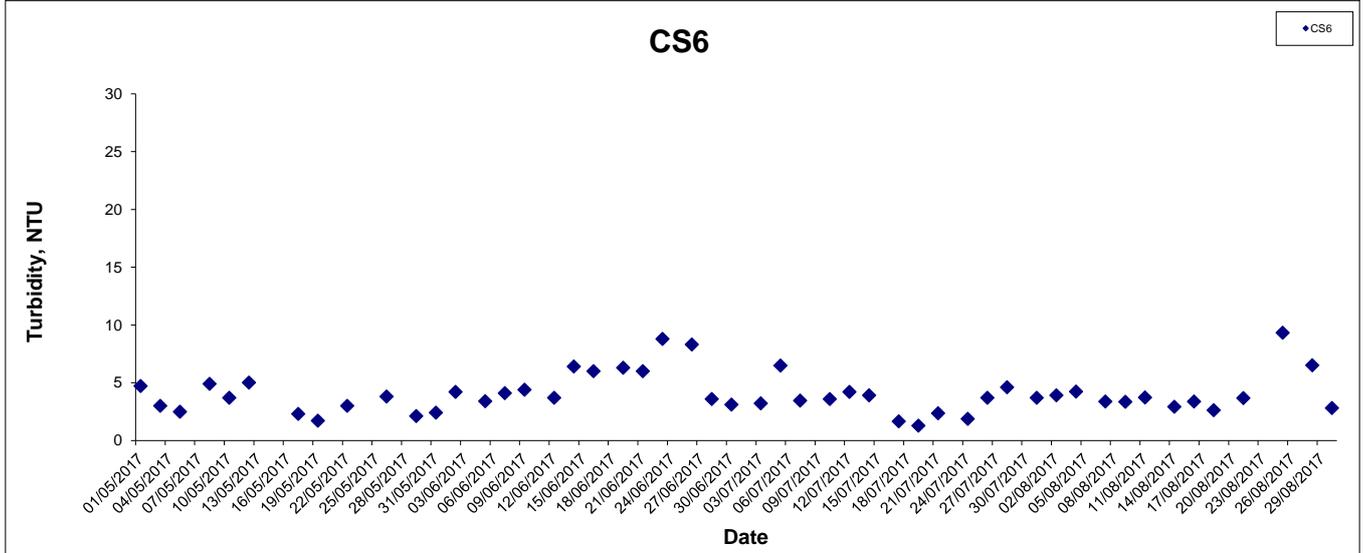
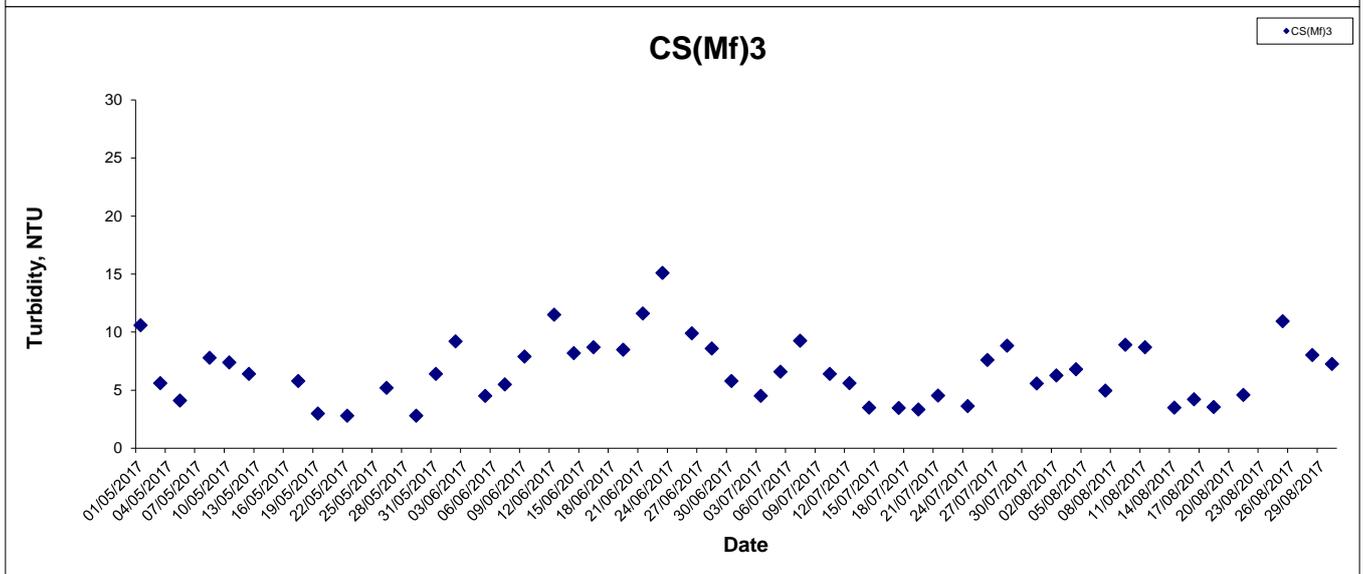
Turbidity at Mid-Flood Tide

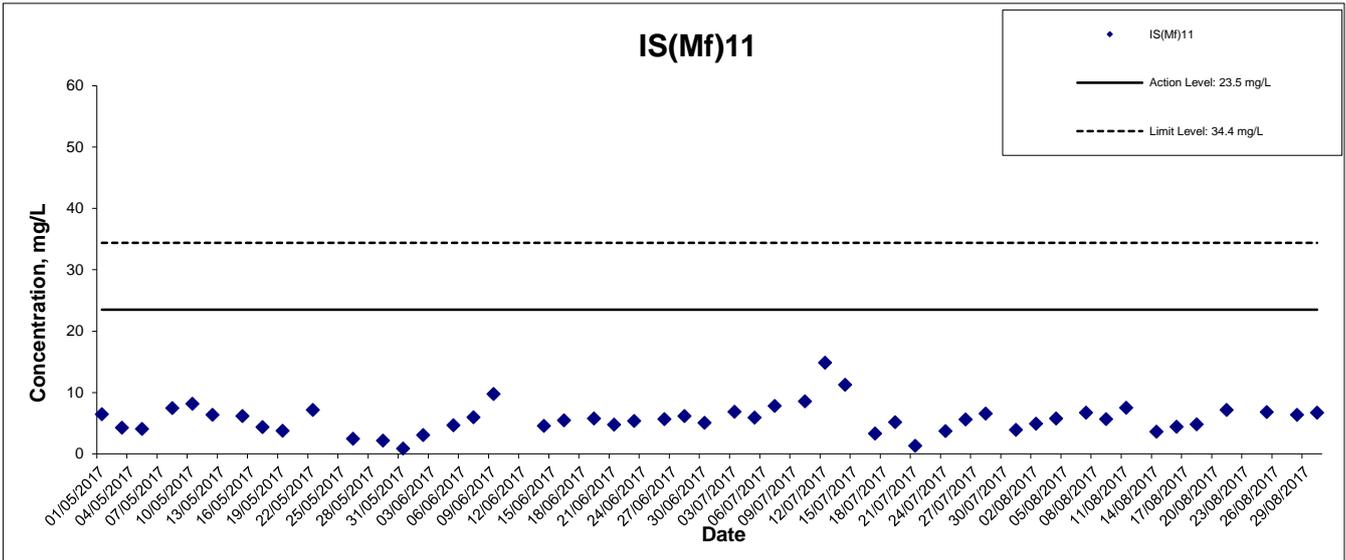
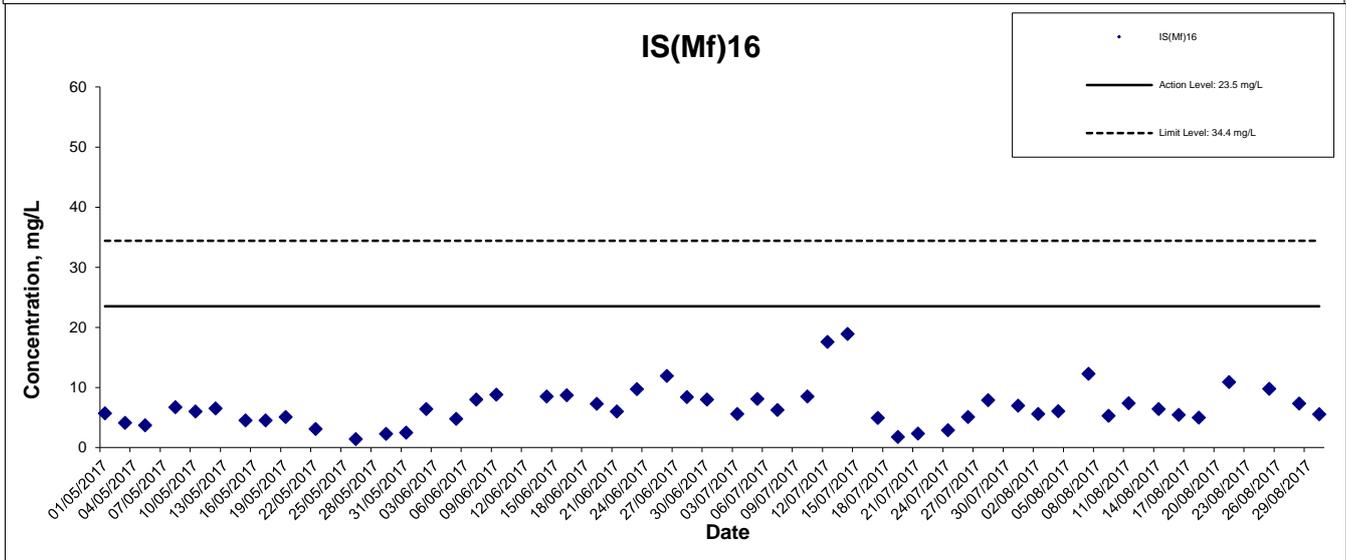
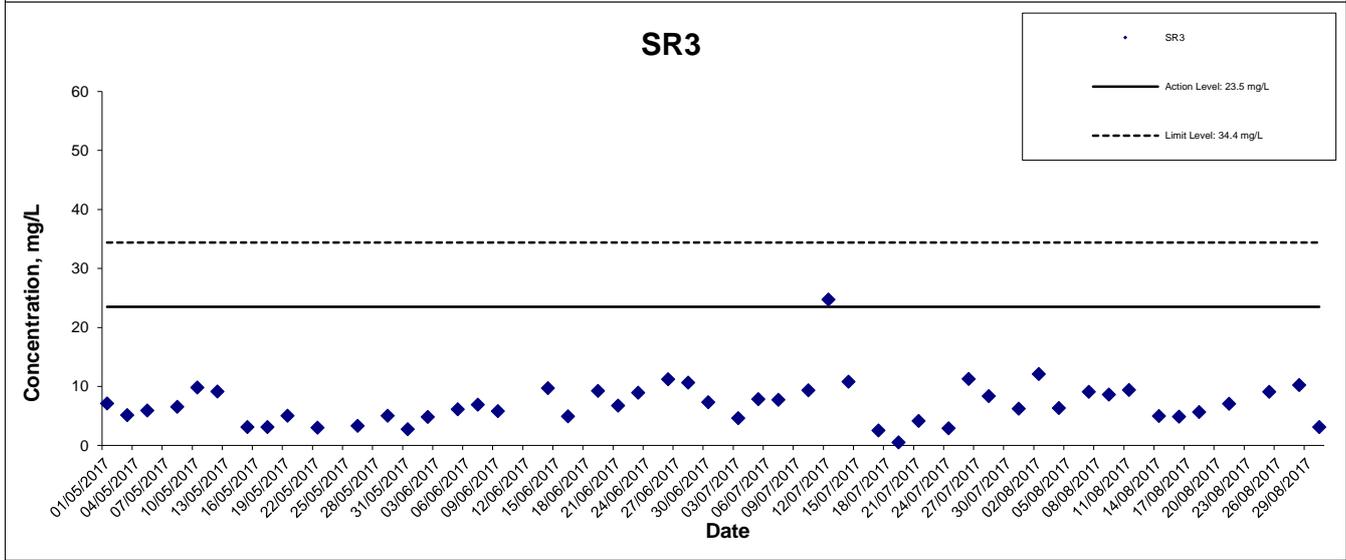
Suspended Solids at Mid-Ebb Tide

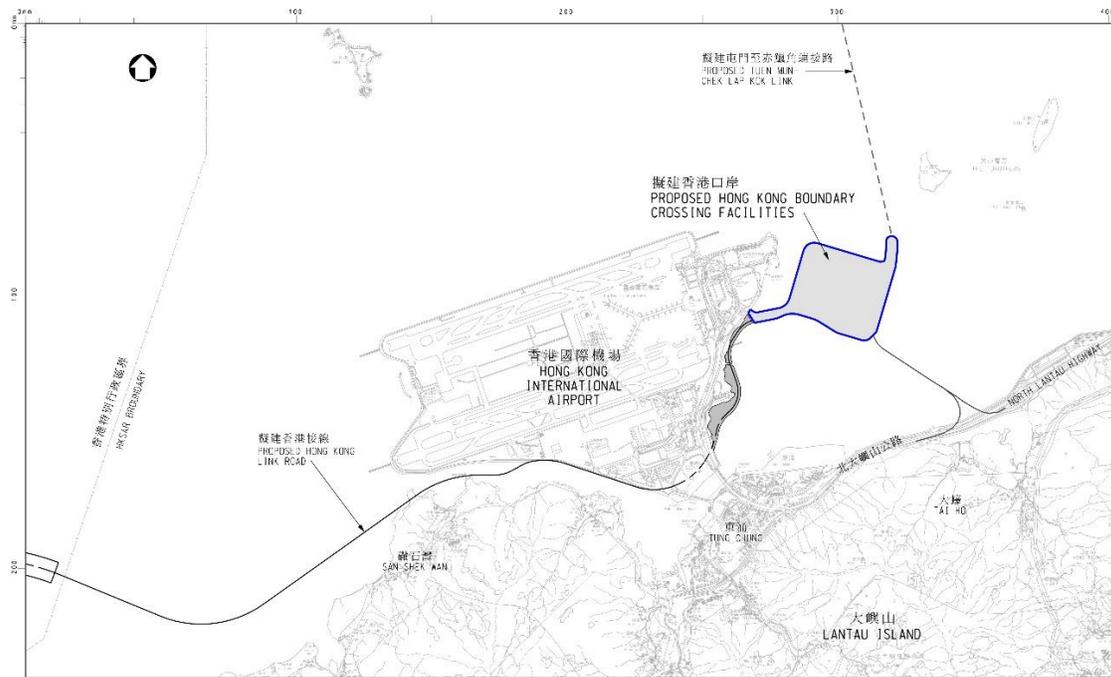
Figure 1. The Hong Kong Boundary Crossing (HKBCF) Reclamation Sites, North Lantau, Hong Kong (http://www.hzmb.hk/eng/img/overview/about_overview03_p01l.jpg)

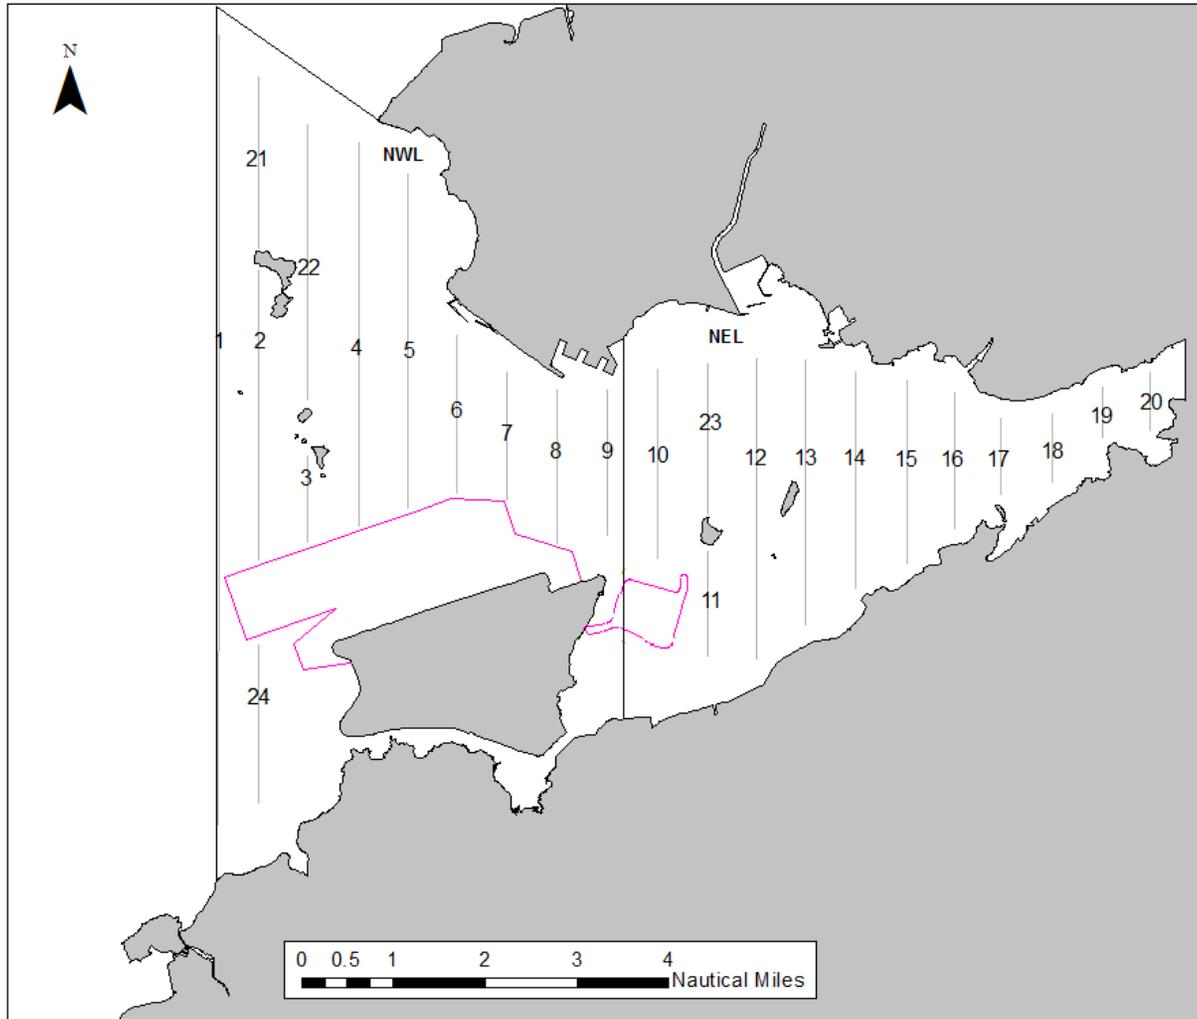
The total transect length for NEL and NWL combined is 99 km (approved 12-05-2017)

Figure 2 Location of Transect Lines for Impact Monitoring during HKBCF (modification to accommodate 3RS))

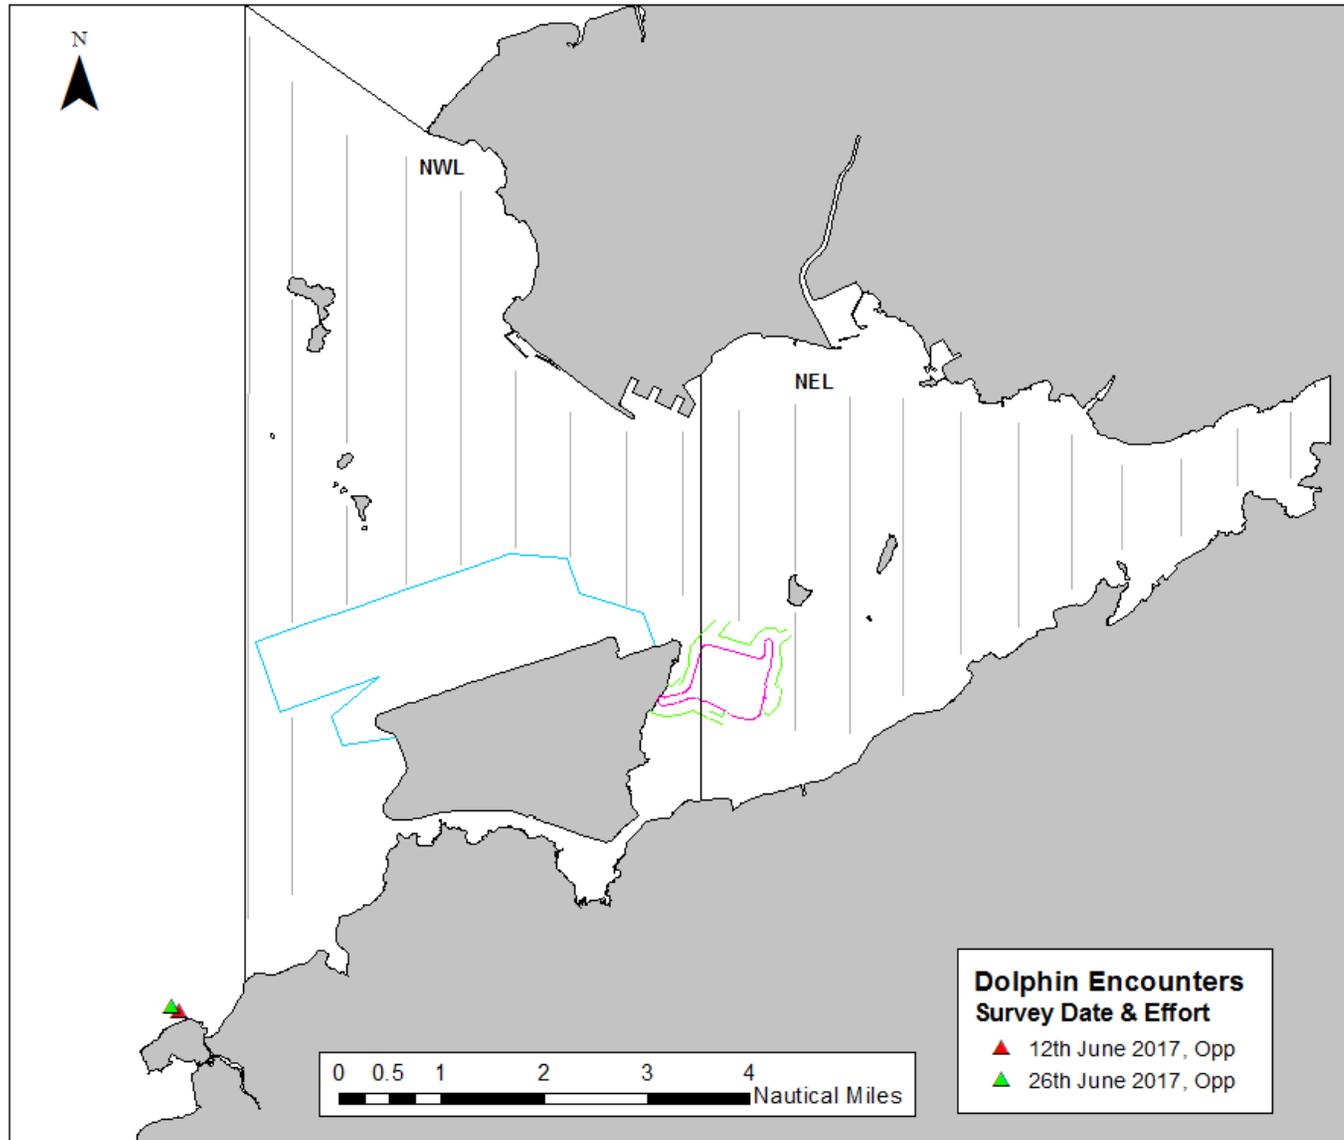
Figure 3 Distribution of Sightings Recorded During Impact Monitoring Surveys for HKBCF (June 2017)⁹

⁹ The silt curtain at HKBCF (green) was removed in phases throughout this quarter and the lines depicted here shows the maximum extent of the silt curtain coverage during the reporting period

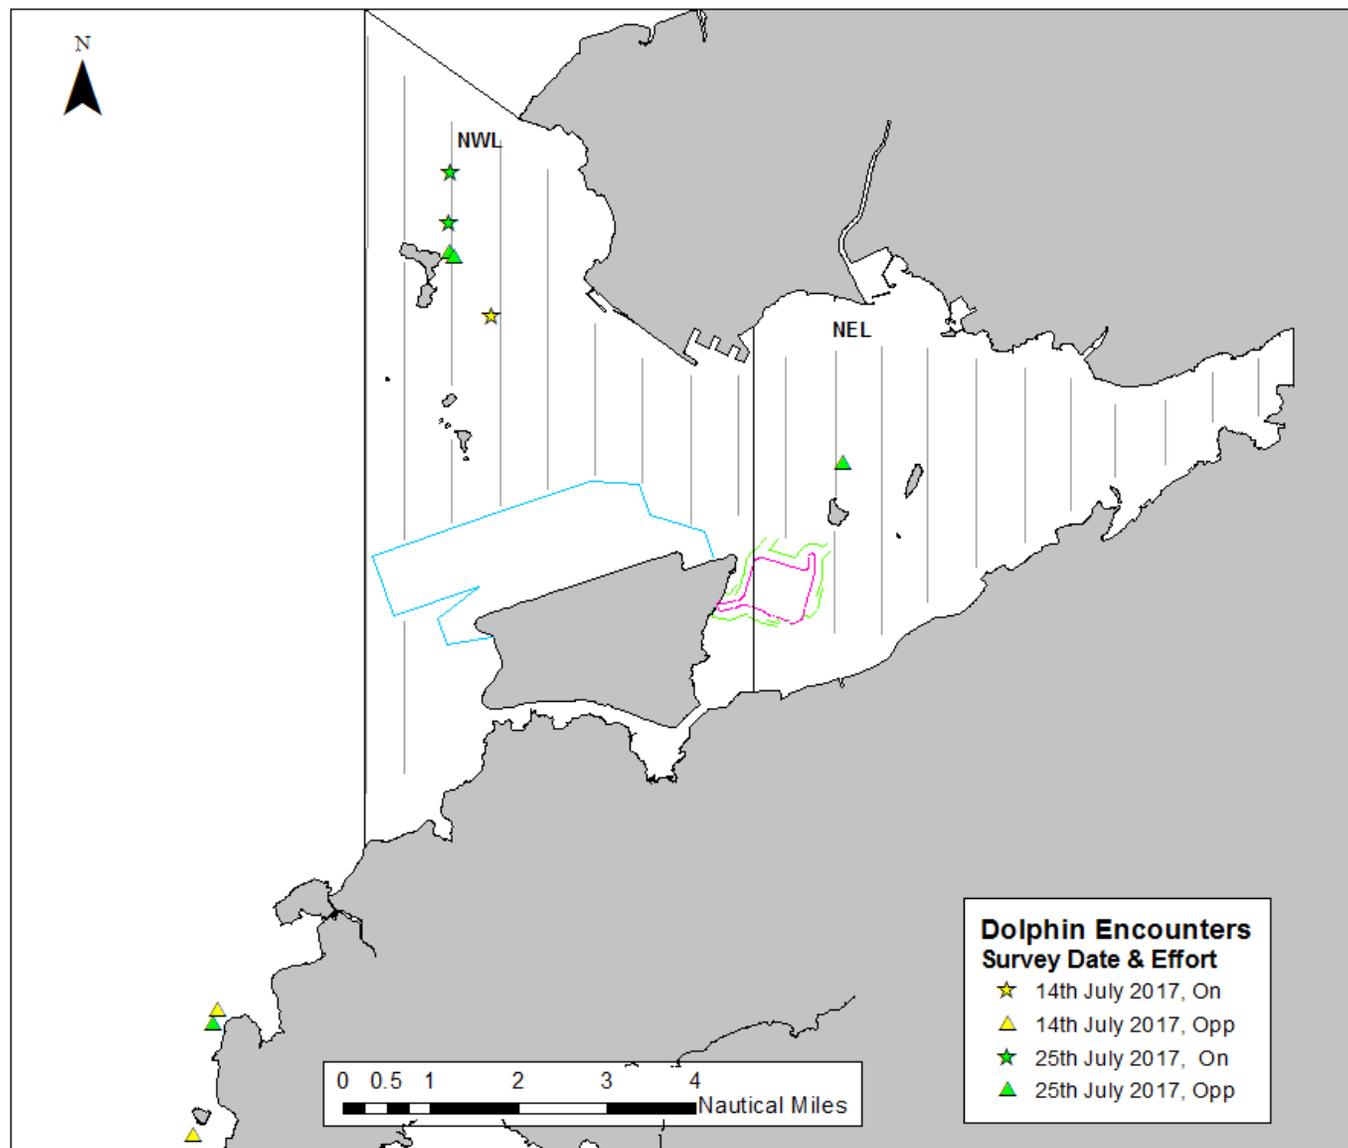
Figure 4 Distribution of Sightings Recorded During Impact Monitoring Surveys for HKBCF (July 2017)¹⁰

¹⁰ The silt curtain at HKBCF (green) was removed in phases throughout this quarter and the lines depicted here shows the maximum extent of the silt curtain coverage during the reporting period

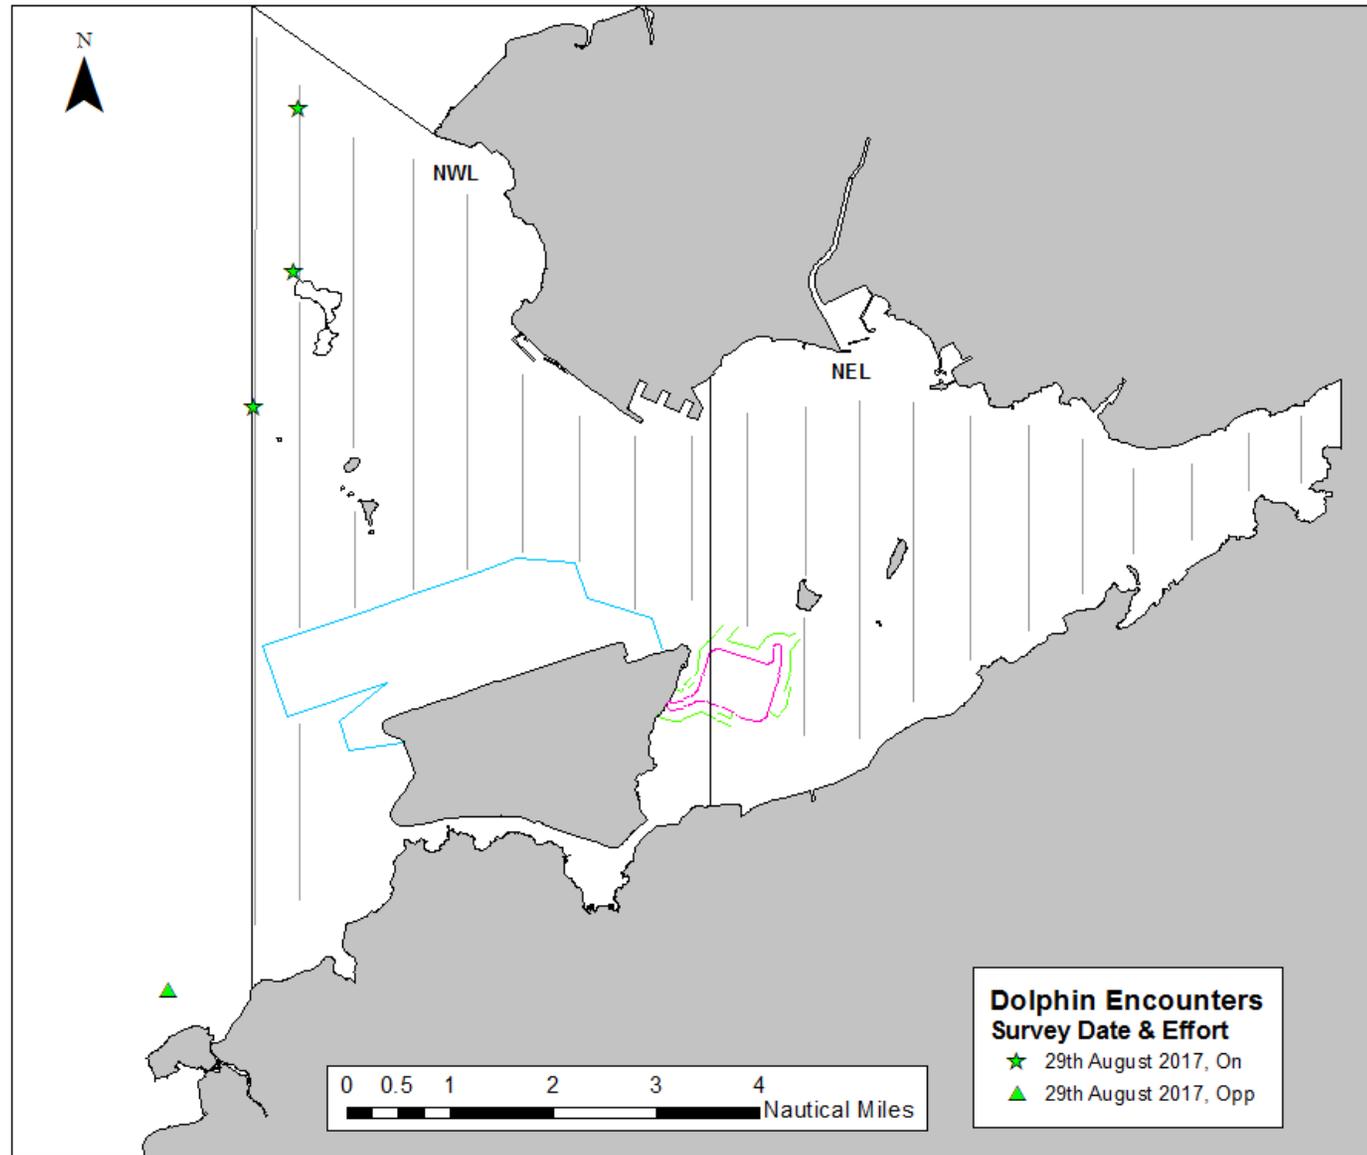
Figure 5 Distribution of Sightings Recorded During Impact Monitoring Surveys for HKBCF (August 2017)¹¹

¹¹ The silt curtain at HKBCF (green) was removed in phases throughout this quarter and the lines depicted here shows the maximum extent of the silt curtain coverage during the reporting period

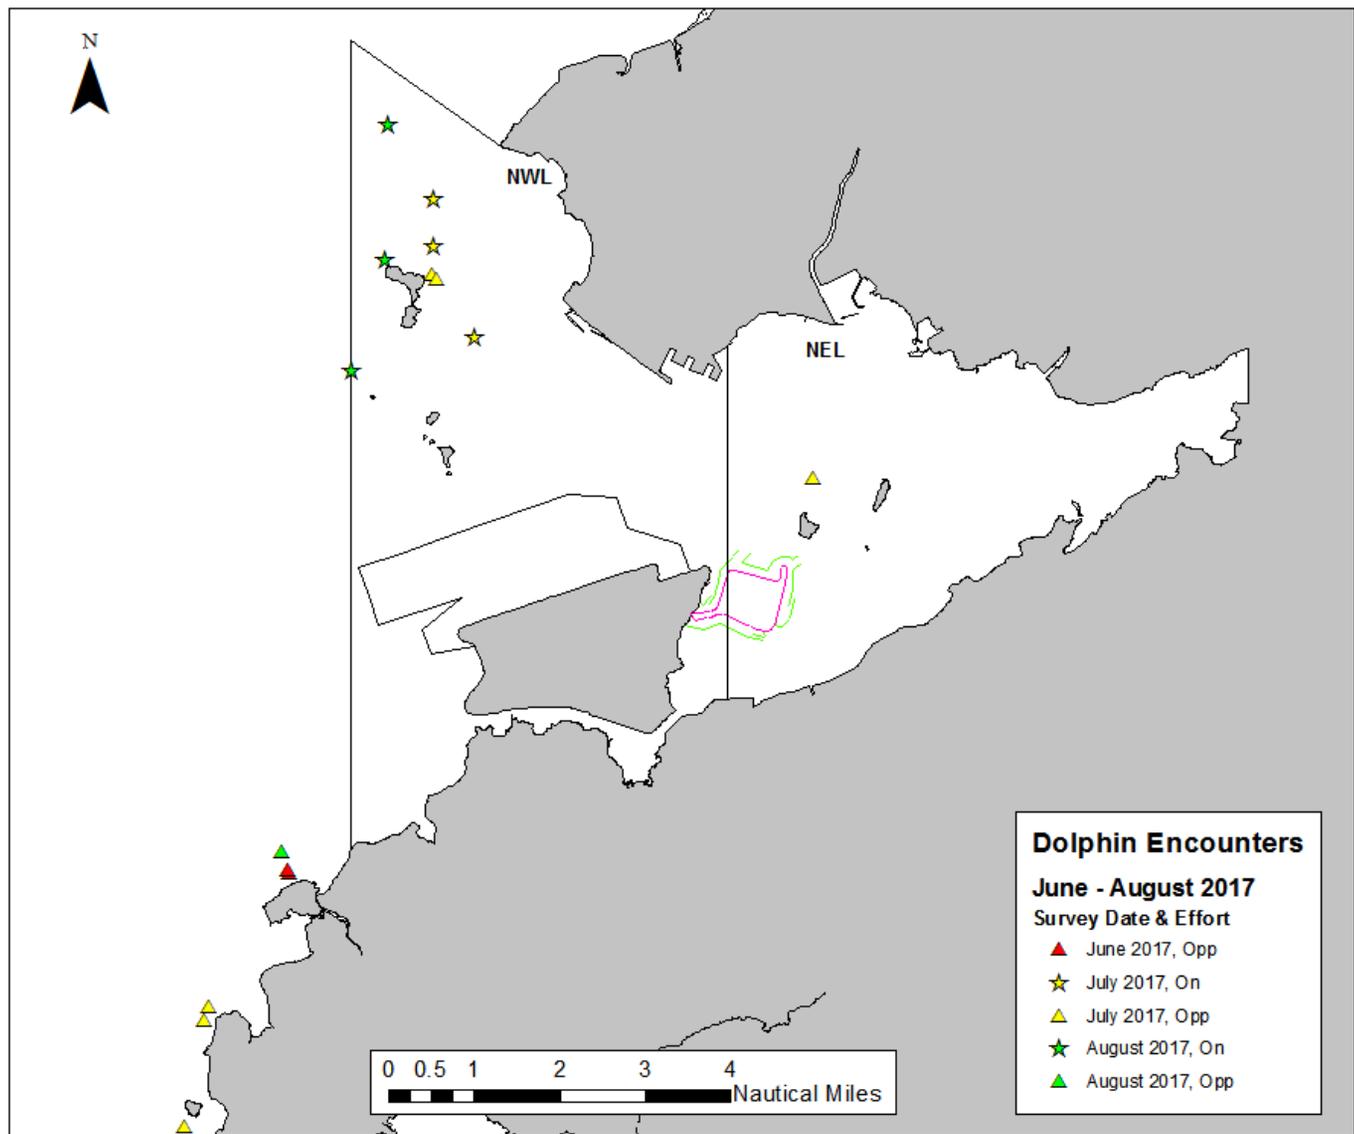
Figure 6. Distribution of Sightings Recorded During Impact Monitoring Surveys for HKBCF (June-August 2017)¹²

¹² The silt curtain at HKBCF (green) was removed in phases throughout this quarter and the lines depicted here shows the maximum extent of the silt curtain coverage during the reporting period

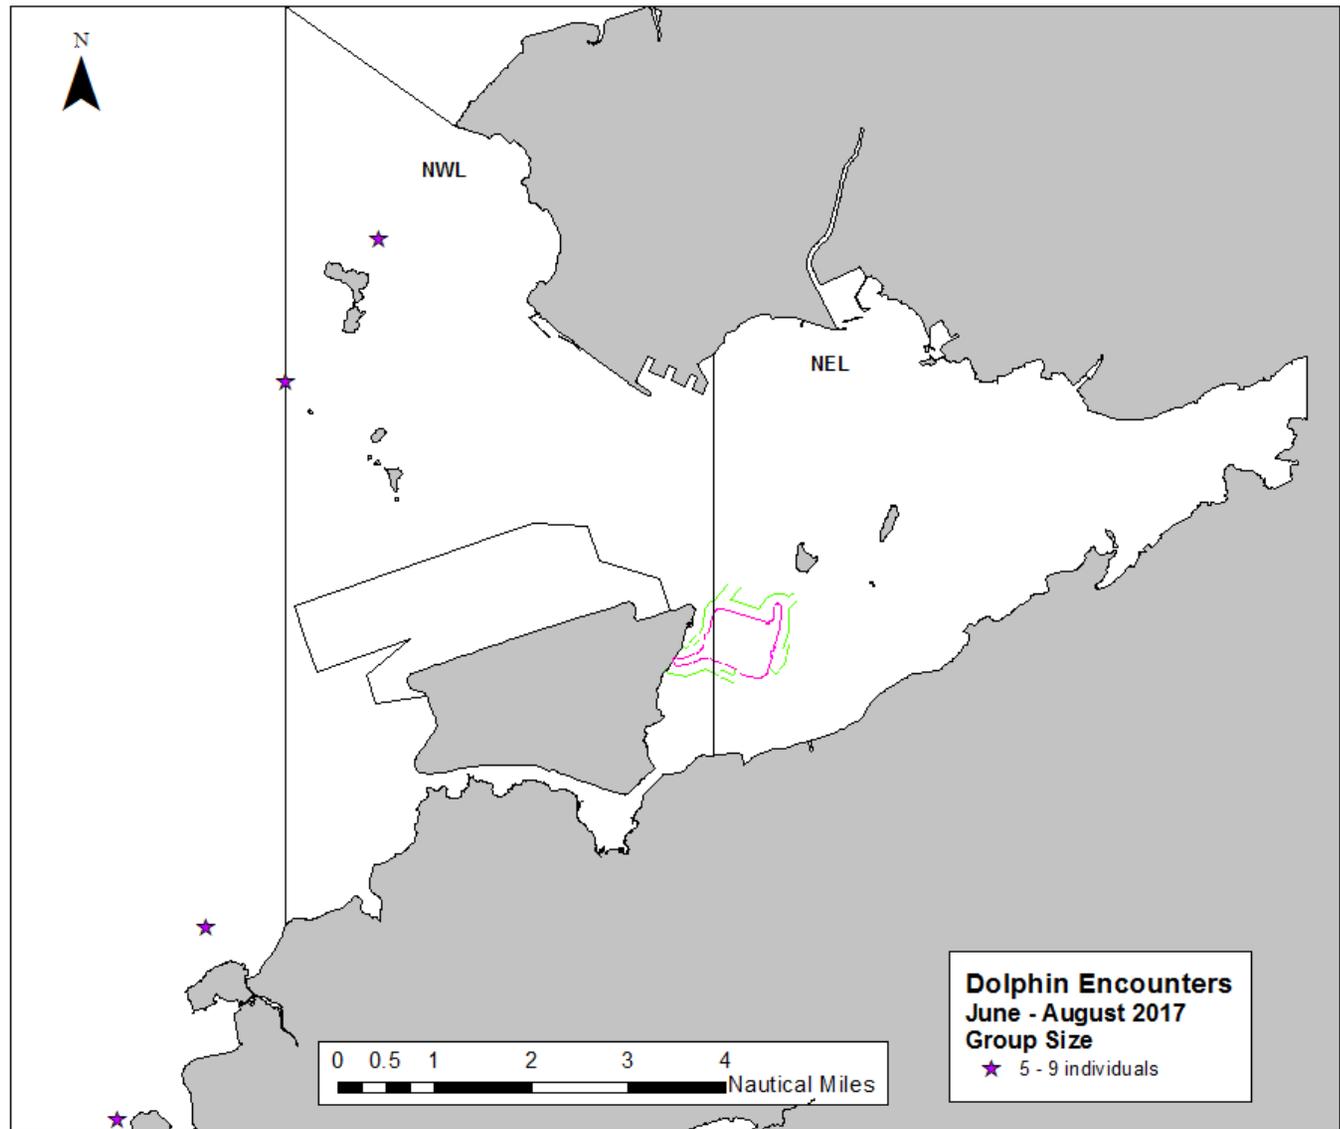
Figure 7. The Location of Dolphin Groups Numbering 5 and Above Individuals (June-August 2017)¹³

¹³ The silt curtain at HKBCF (green) was removed in phases throughout this quarter and the lines depicted here shows the maximum extent of the silt curtain coverage during the reporting period

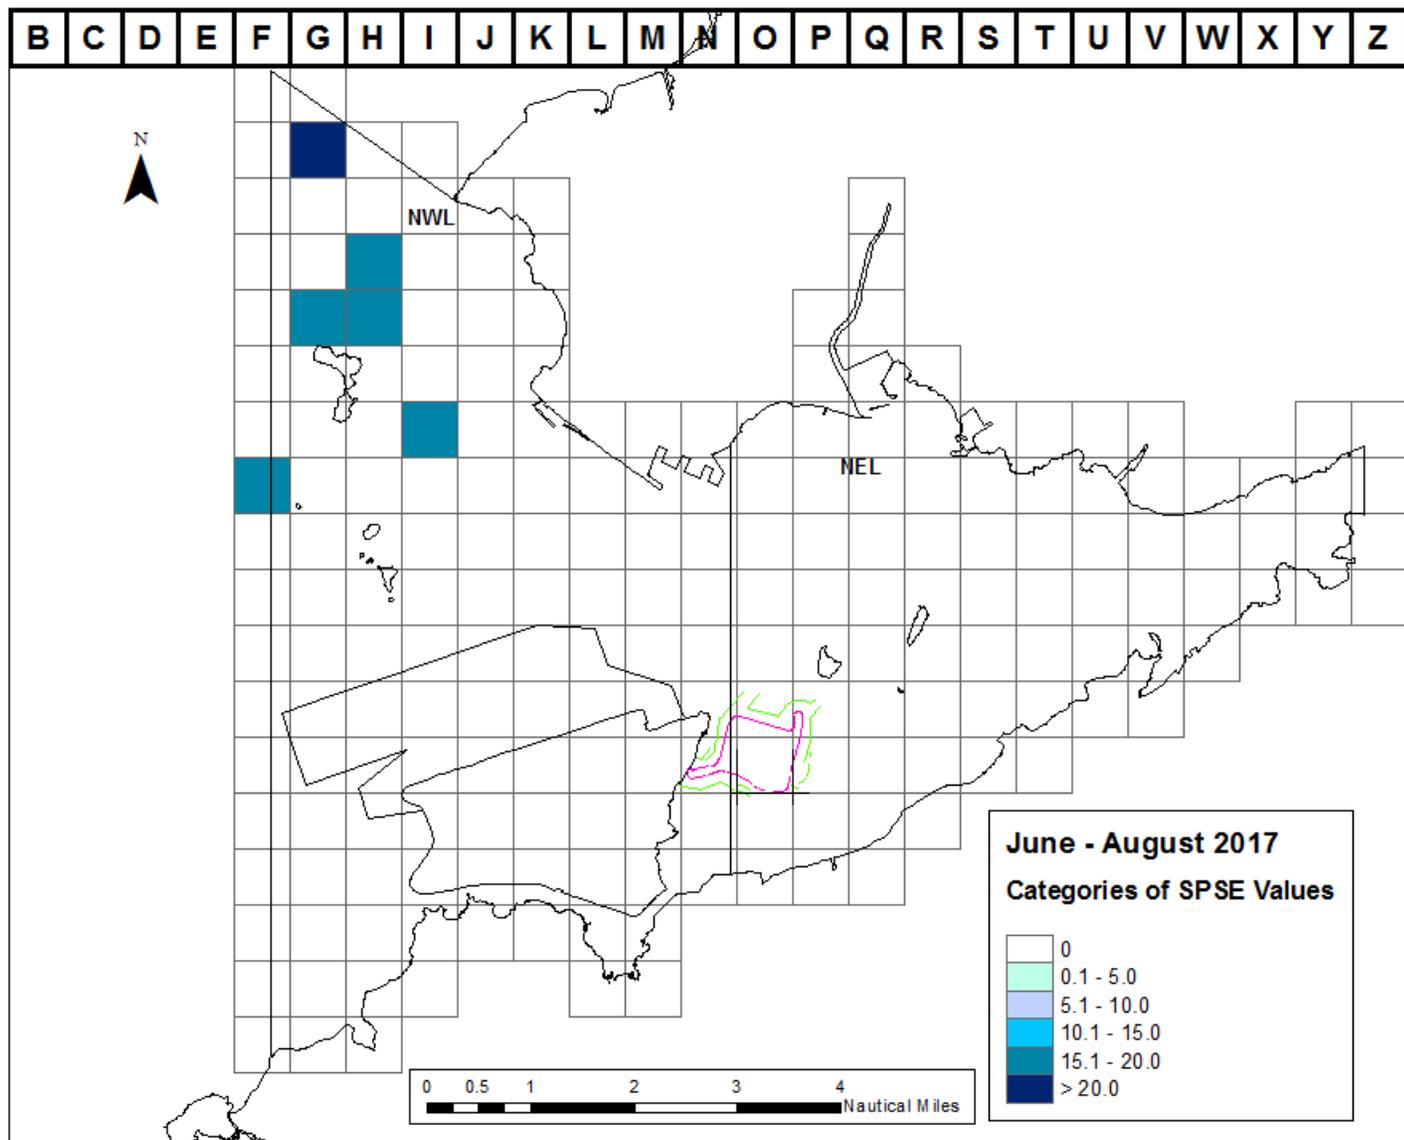
Figure 8. Sighting density SPSE (number of on-effort sightings per 100 units of survey effort) for June - August 2017¹⁴.

¹⁴ The silt curtain at HKBCF (green) was removed in phases throughout this quarter and the lines depicted here shows the maximum extent of the silt curtain coverage during the reporting period

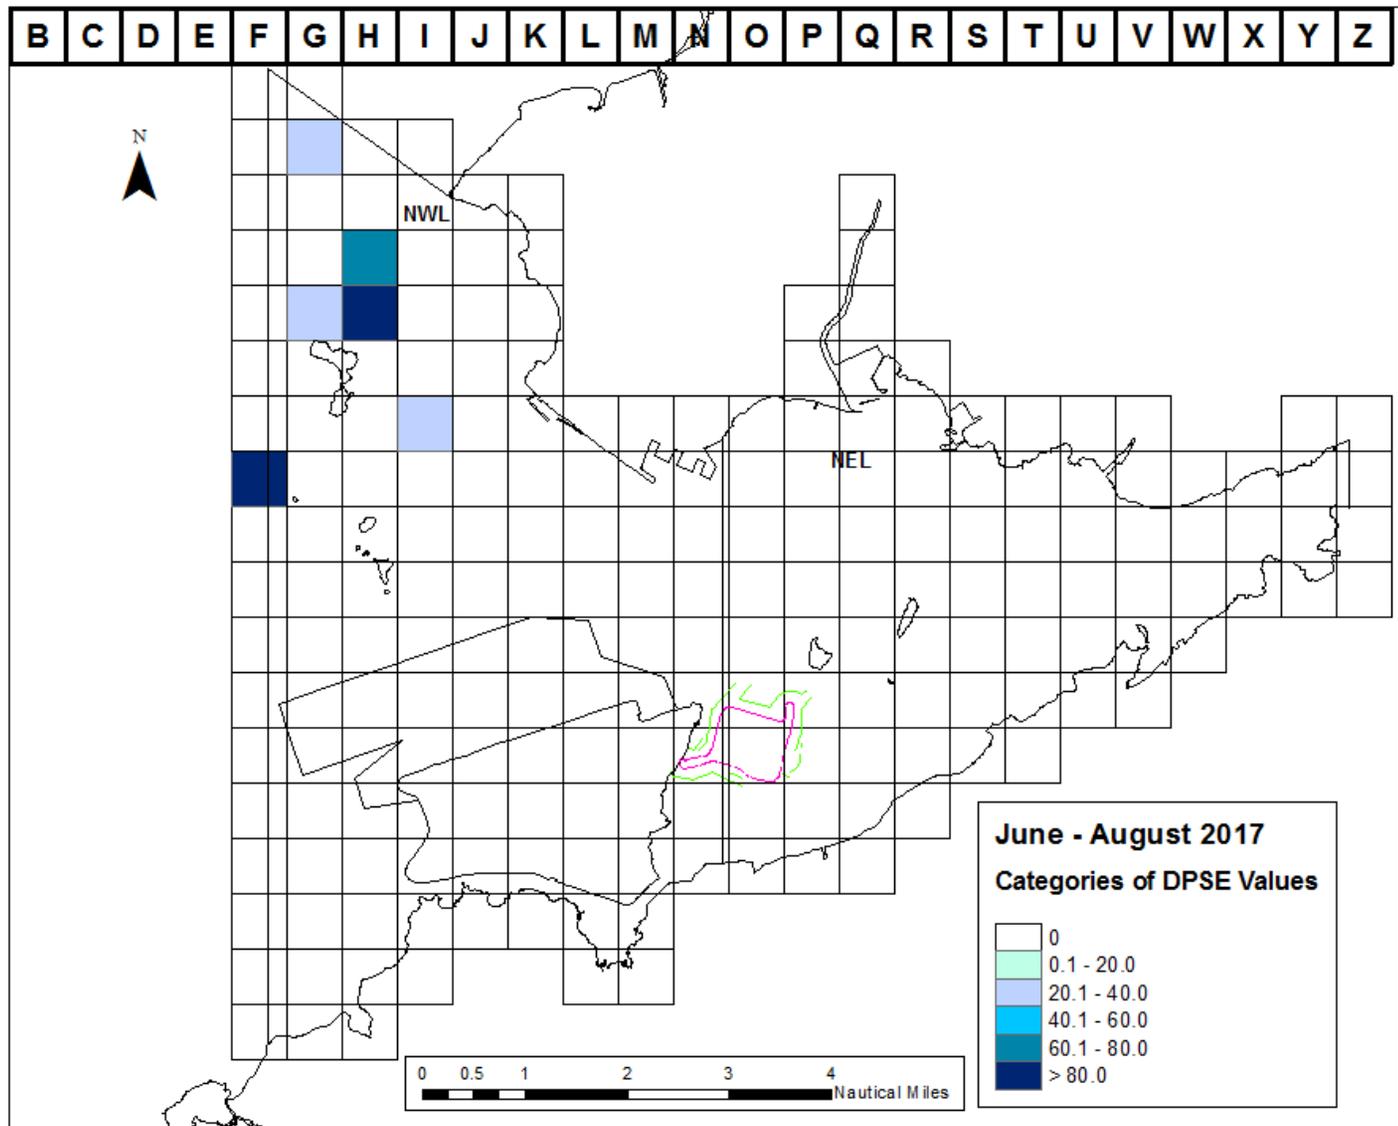
Figure 9. Dolphin density DPSE (number of dolphins per 100 units of survey effort) for June to August 2017¹⁵
