Contract No. HY/2010/02

**Hong Kong – Zhuhai – Macao Bridge
Hong Kong Boundary Crossing
Facilities –
Reclamation Works**

**Quarterly EM&A Summary Report for
June 2017 – August 2017**

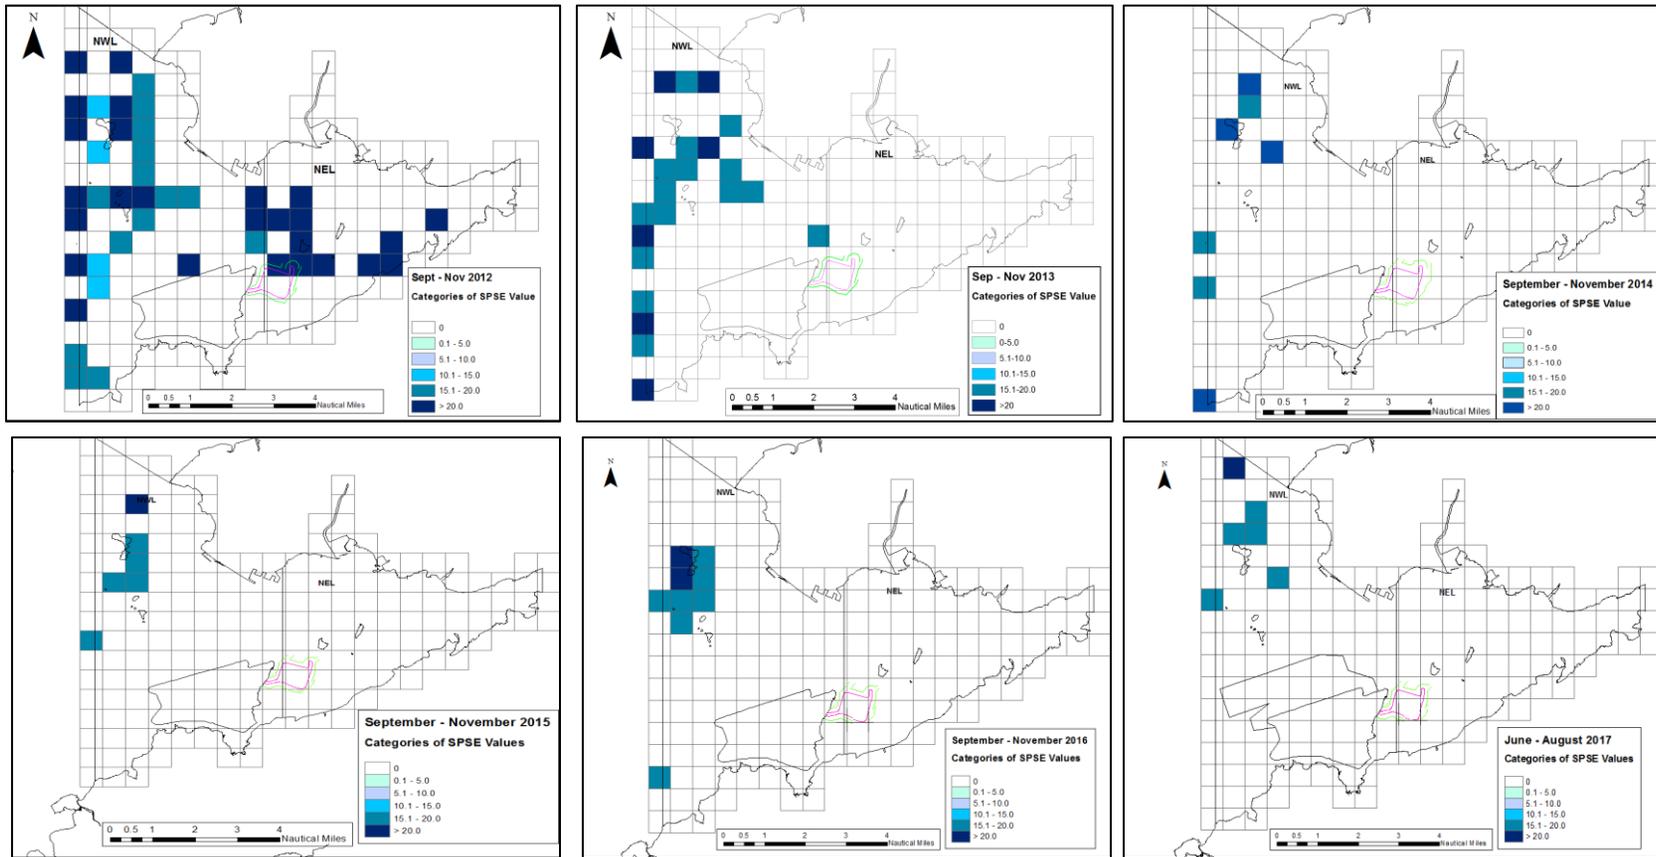
Figure 10. SPSE Grid Analysis for periods June – August 2012; 2013; 2014; 2015, 2016 and 2017¹⁶

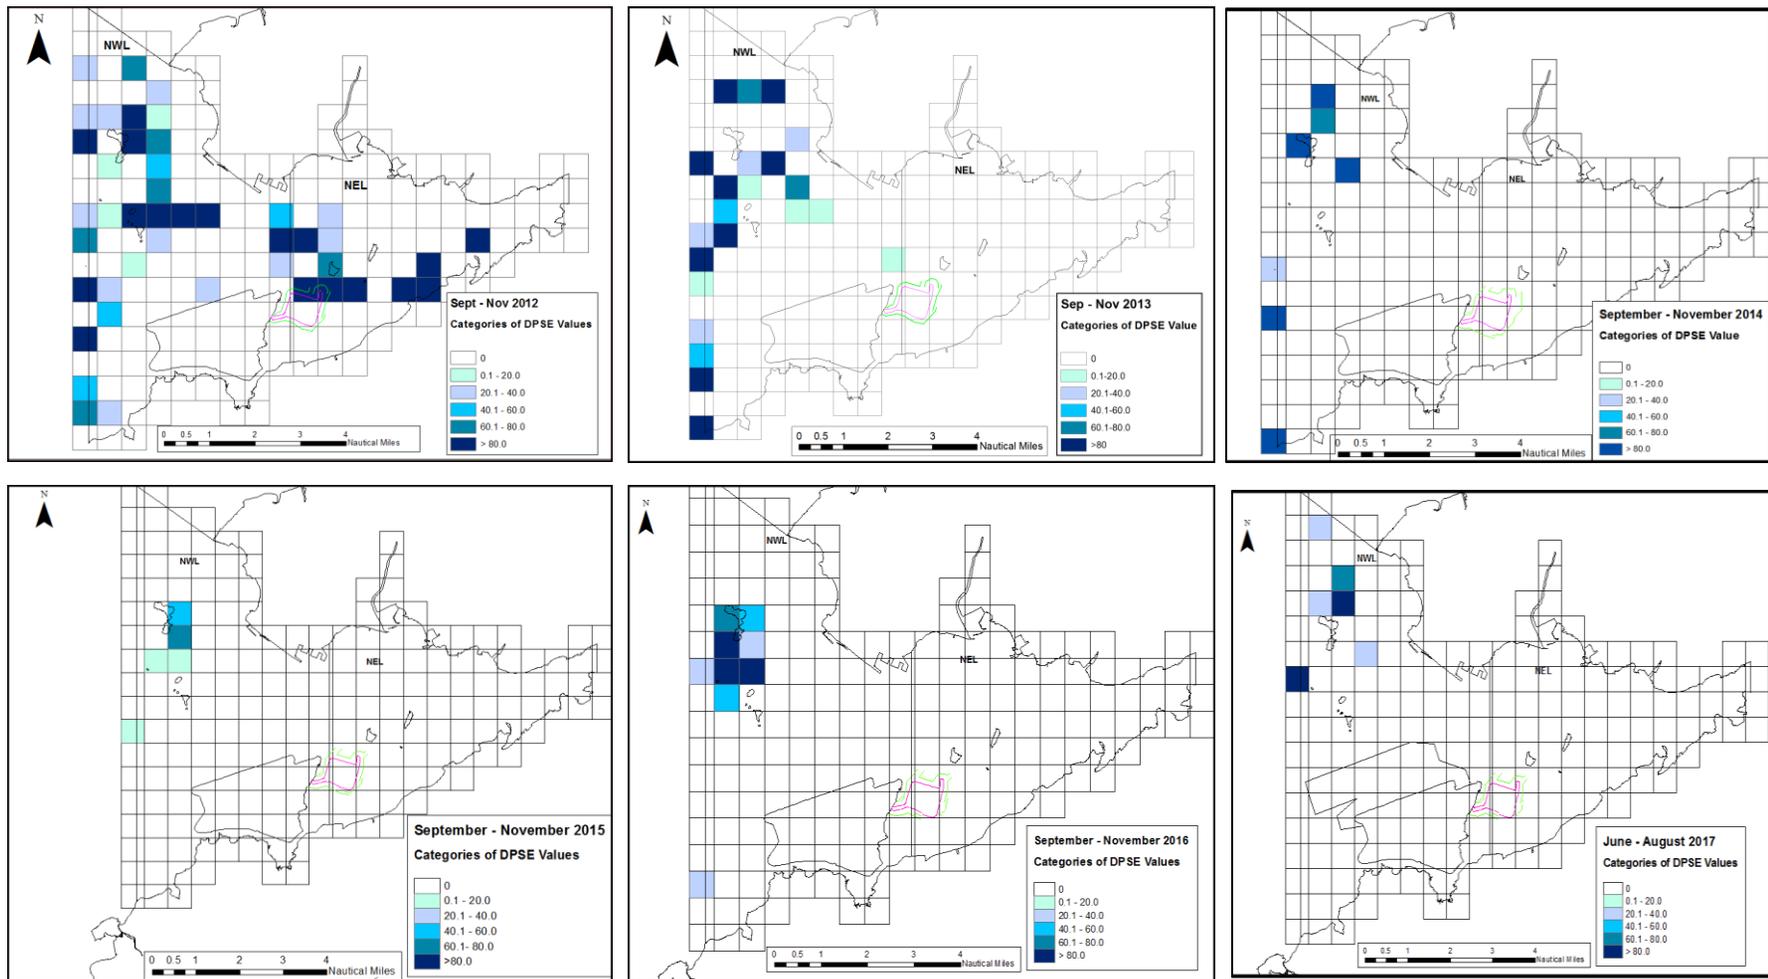
Figure 11. DPSE Grid Analysis for periods June – August 2012; 2013; 2014; 2015, 2016 and 2017¹⁷

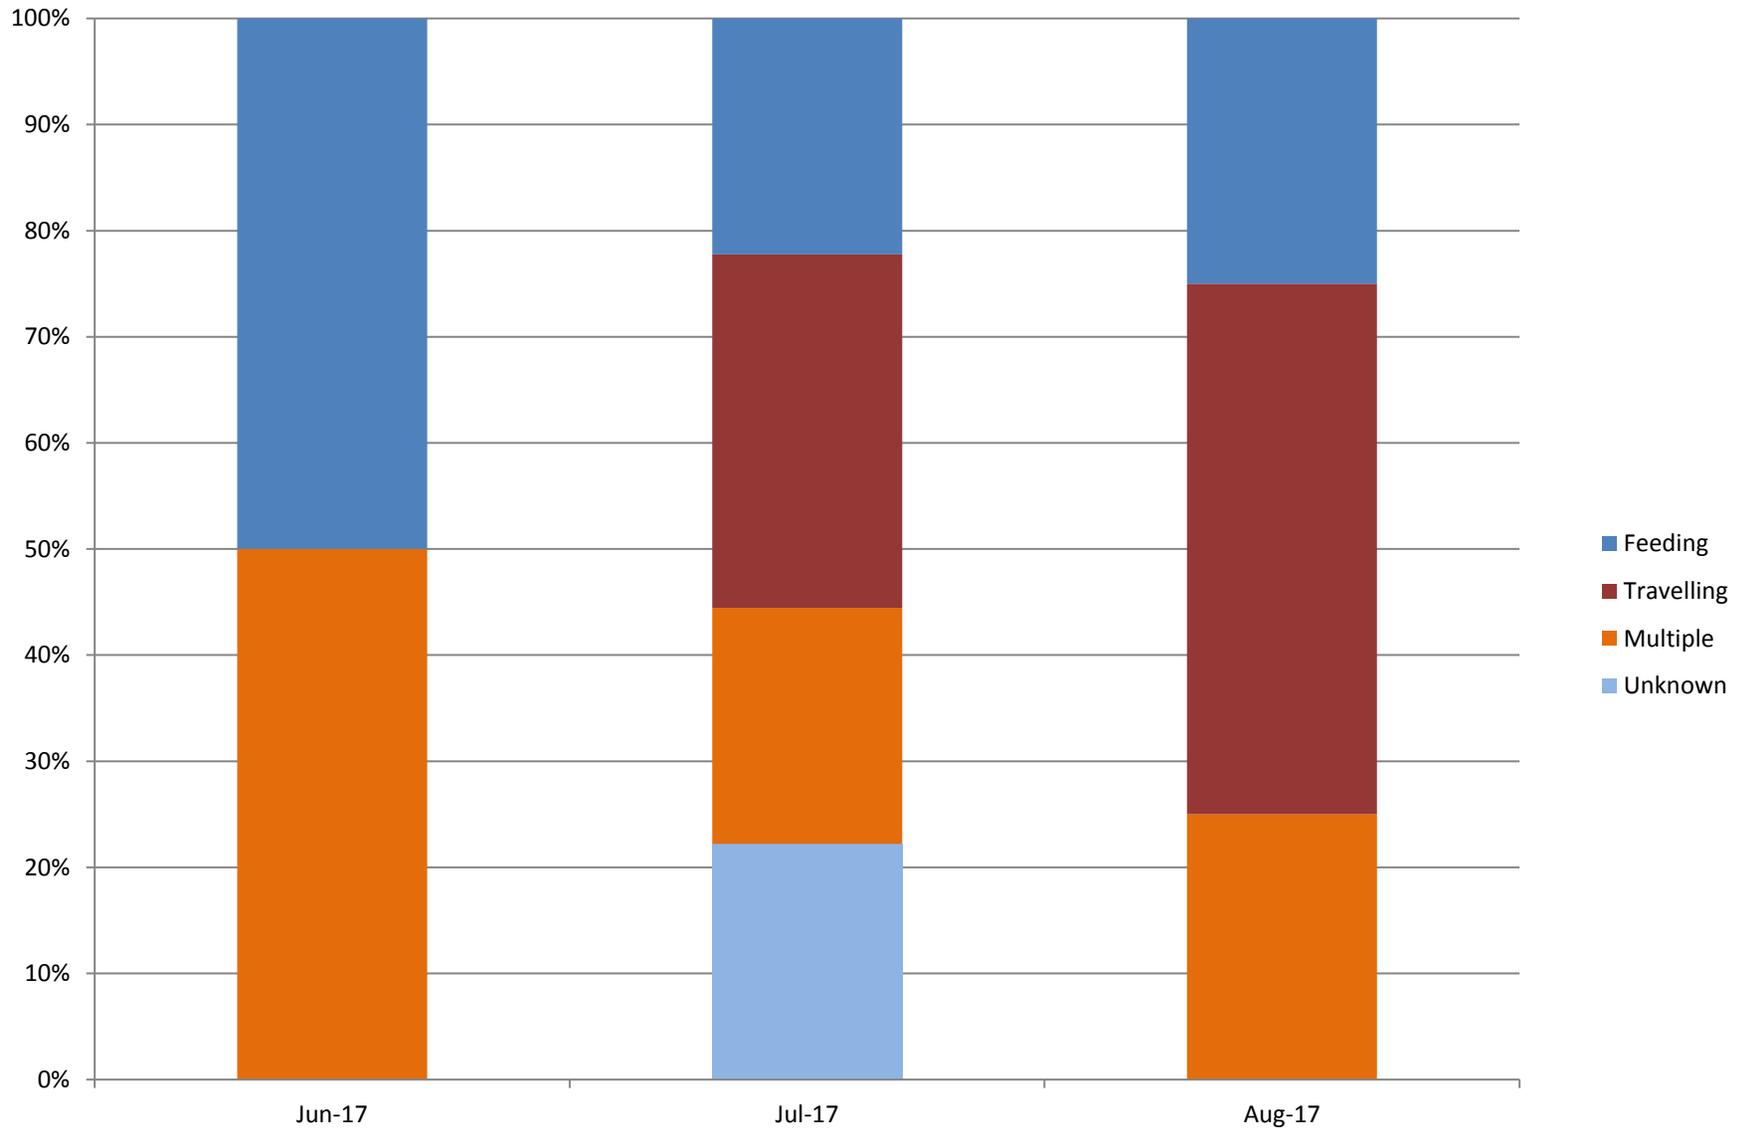
Figure 12. Activity Budget for Dolphin Behaviour June to August 2017.

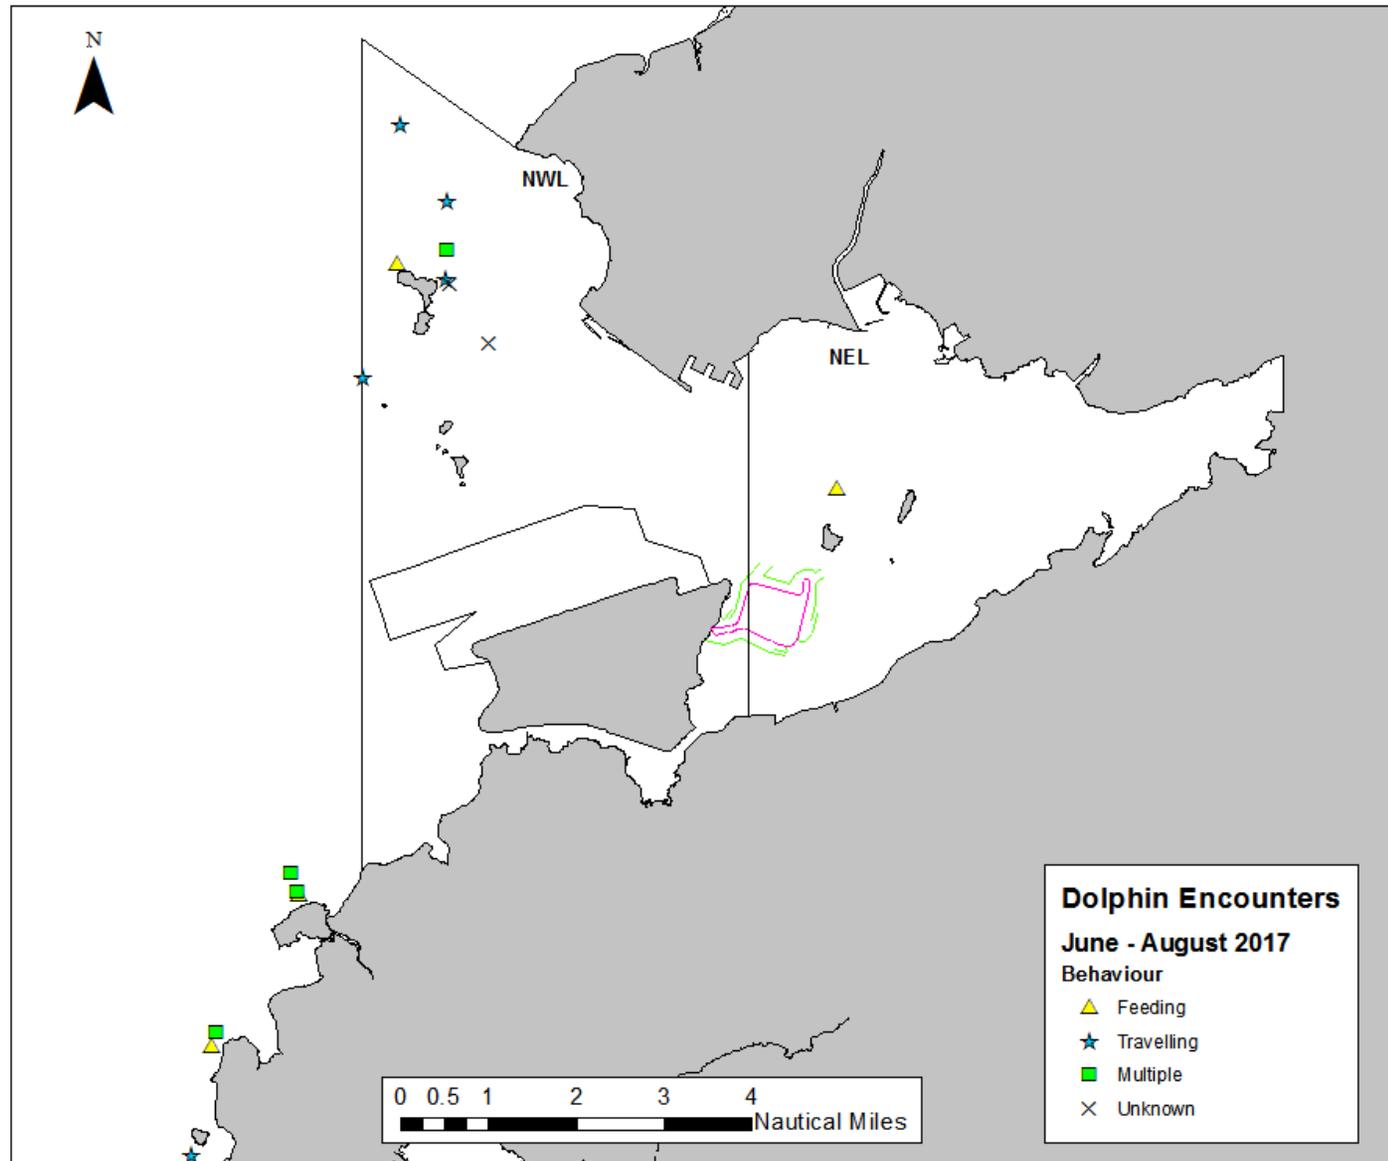
Figure 13. The Location of Different Behavioural Activities June to August 2017¹⁸

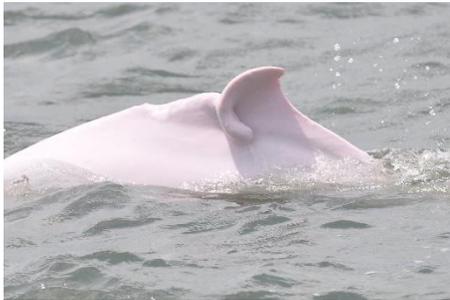
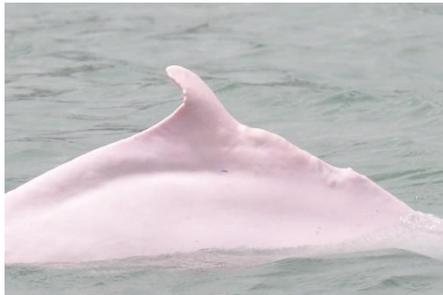
Figure 14. Kernel density estimate and plot for HZMB 054 [CH34] (March 2012-May 2017), with comparison to AFCD data of dolphin KDE prior to HZMB construction (top left; where red dots indicate sightings made in 2010 & 2011 and yellow dots made prior to 2011) (AFCD 2012; AFCD and Guangdong Pearl River Estuary Chinese White Dolphin National Nature Reserve 2015).

HZMB 054 has been sighted on 16 different *days* since HKBCF dolphin monitoring began, and HZMB 022 on 15 different *days*. For HZMB 022, there is no update in re-sightings since last quarterly reporting period (March-May 2017) HZMB 054 is known as CH34 in the AFCD catalogue. This dolphin is well-known and the AFCD's long term monitoring programme has this individual in NEL, NWL, WL and adjacent mainland Chinese waters. The impact monitoring for the HKBCF project is restricted to NEL and NWL waters and kernel range analysis for HZMB 054 [CH34] indicates core habitat use in both areas. The area calculated for impact range monitoring overlaps that calculated for the wider analyses of this individual's ranging patterns in Hong Kong and mainland Chinese waters ((using data to 2013 as this is all that is available from the AFCD website⁷) (Fig 14).
