Contract No. HY/2010/02

## Hong Kong – Zhuhai – Macao Bridge Hong Kong Boundary Crossing Facilities – Reclamation Works

### Quarterly EM&A Summary Report for December 2017 – February 2018

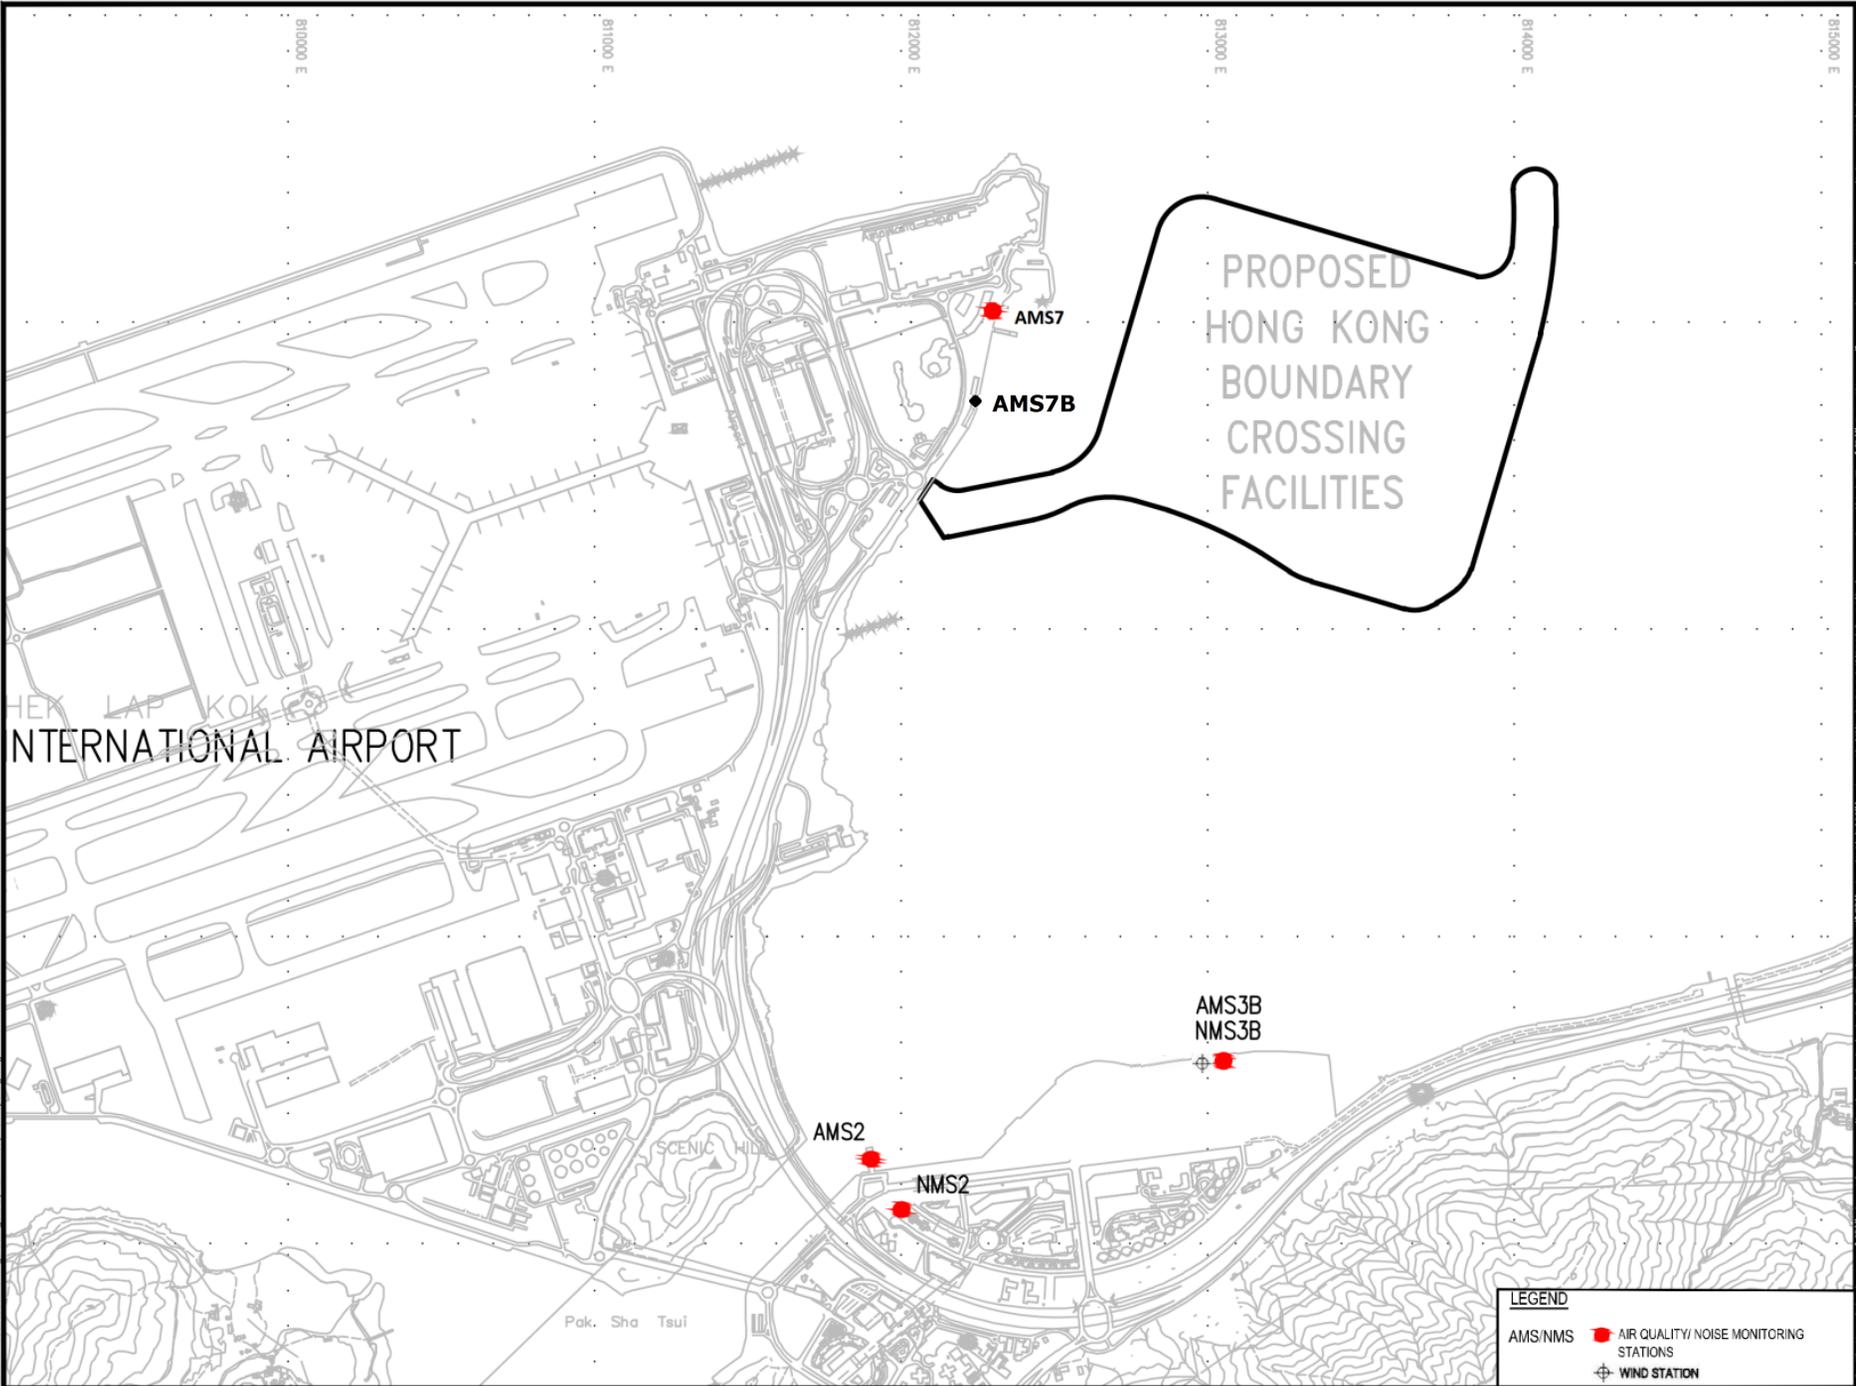
Remarks: Alternative air quality monitoring station AMS7B IS adopted effective from 6 February 2018 with the authority's consent.

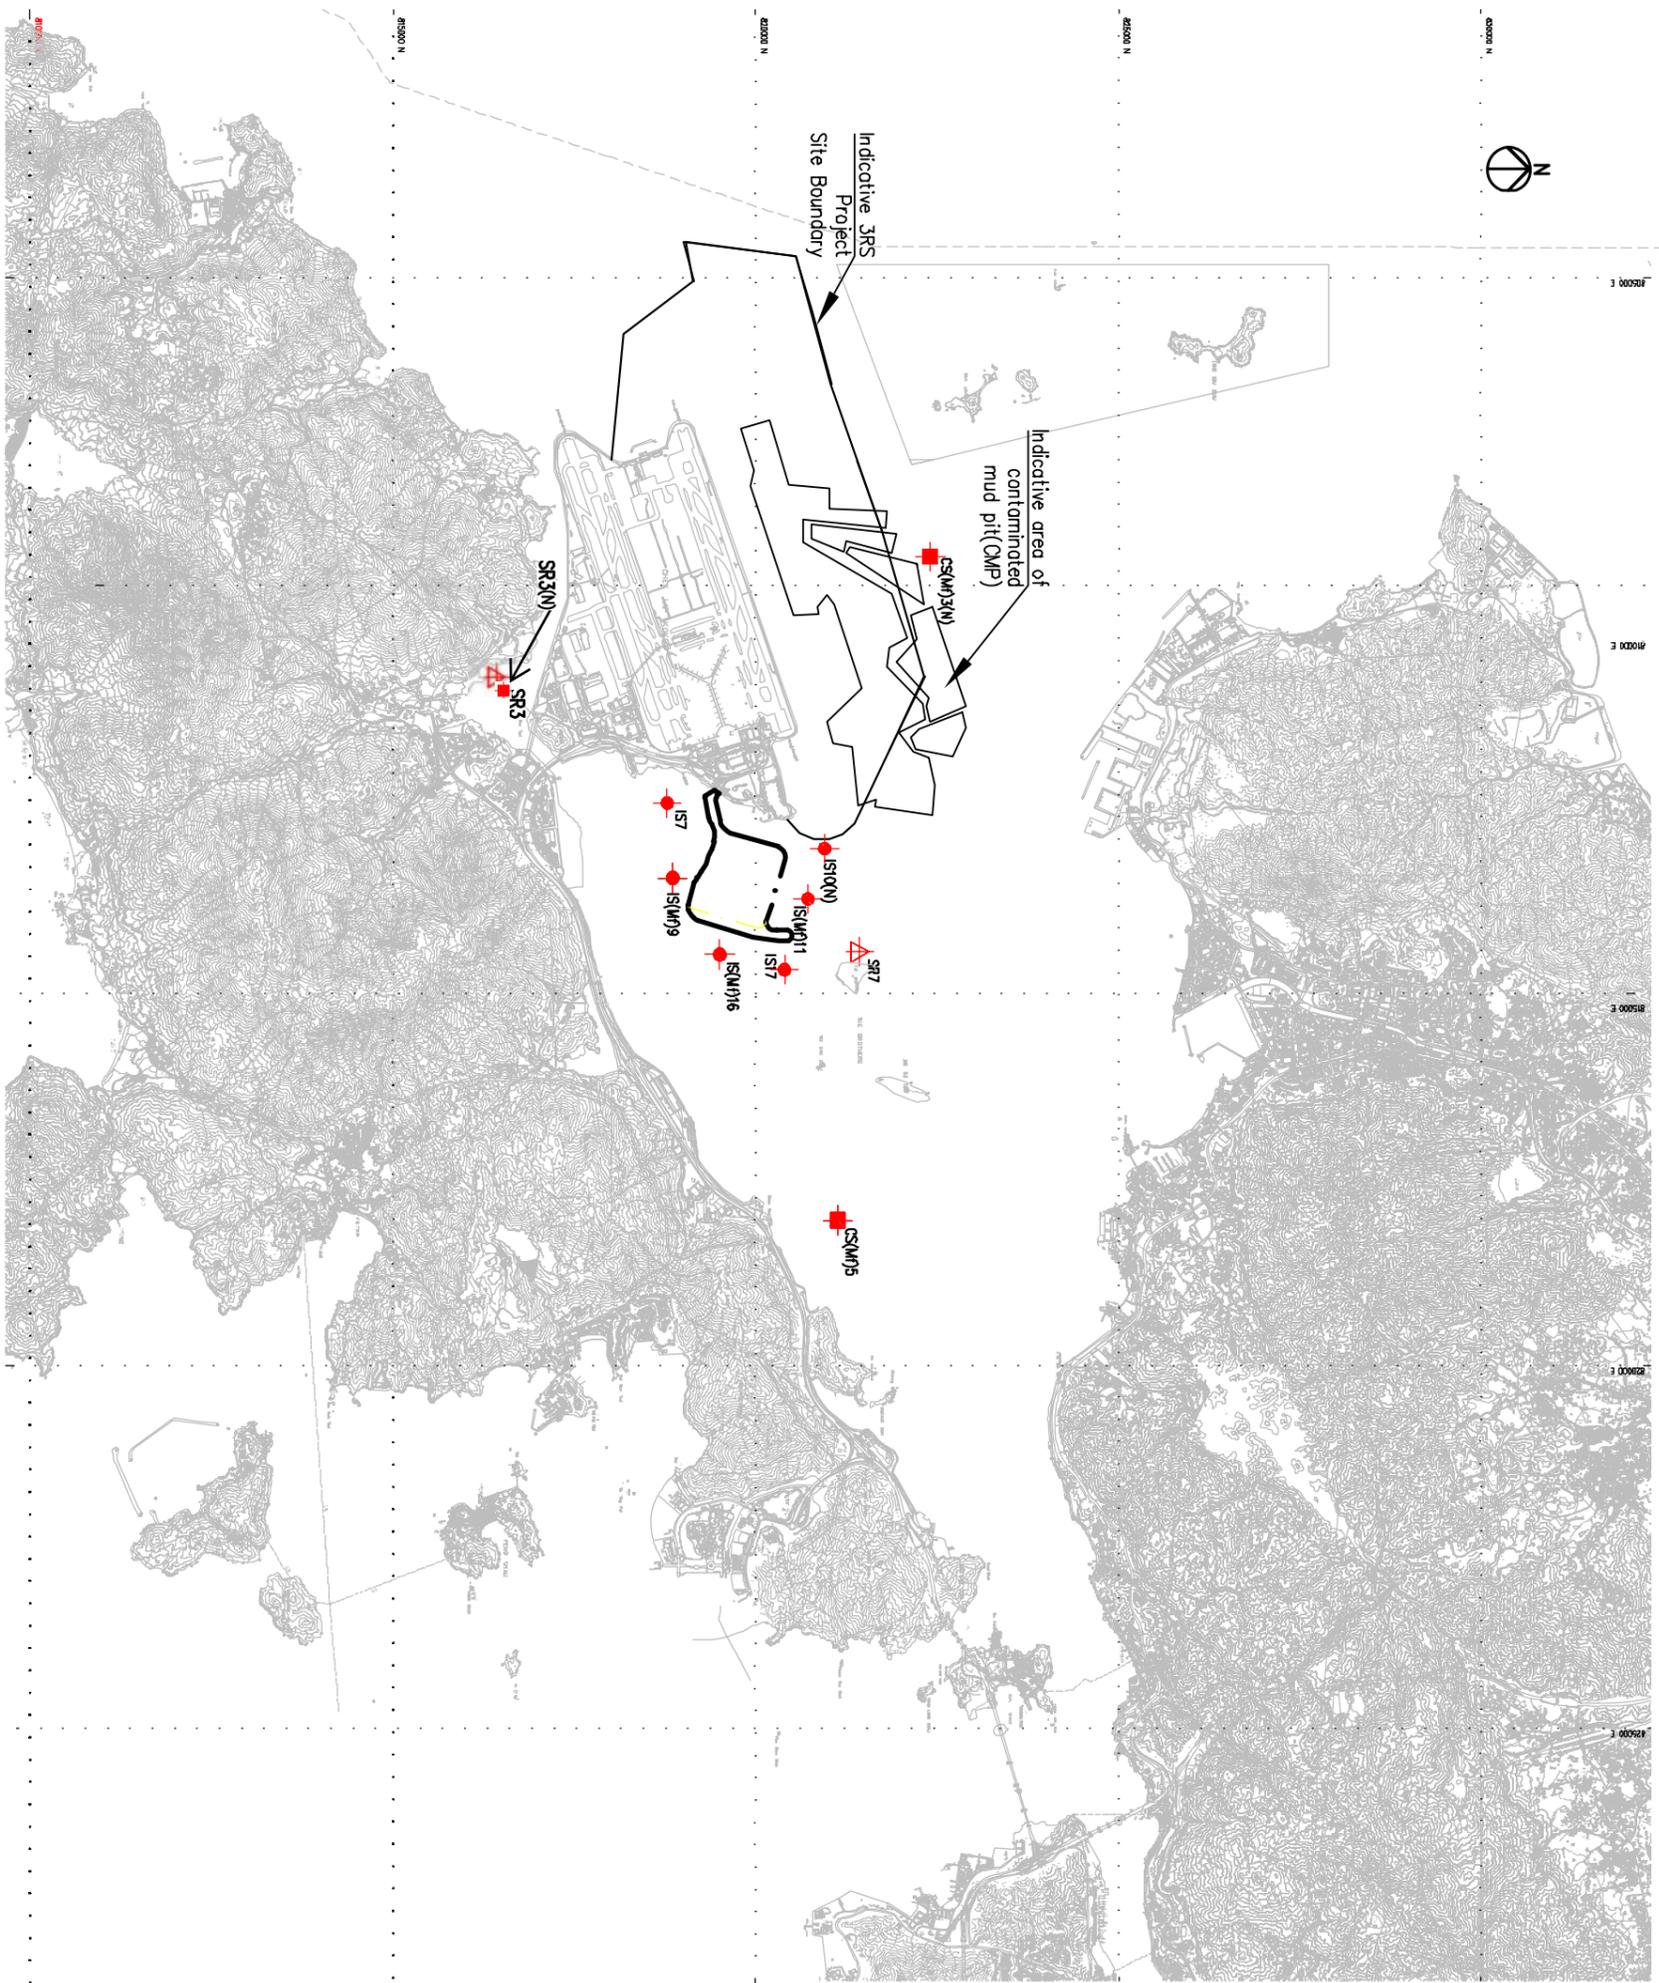
- LEGEND**
- IS IMPACT STATIONS
  - CS CONTROL / FAR FIELD STATIONS
  - SR SENSITIVE RECEIVERS STATIONS

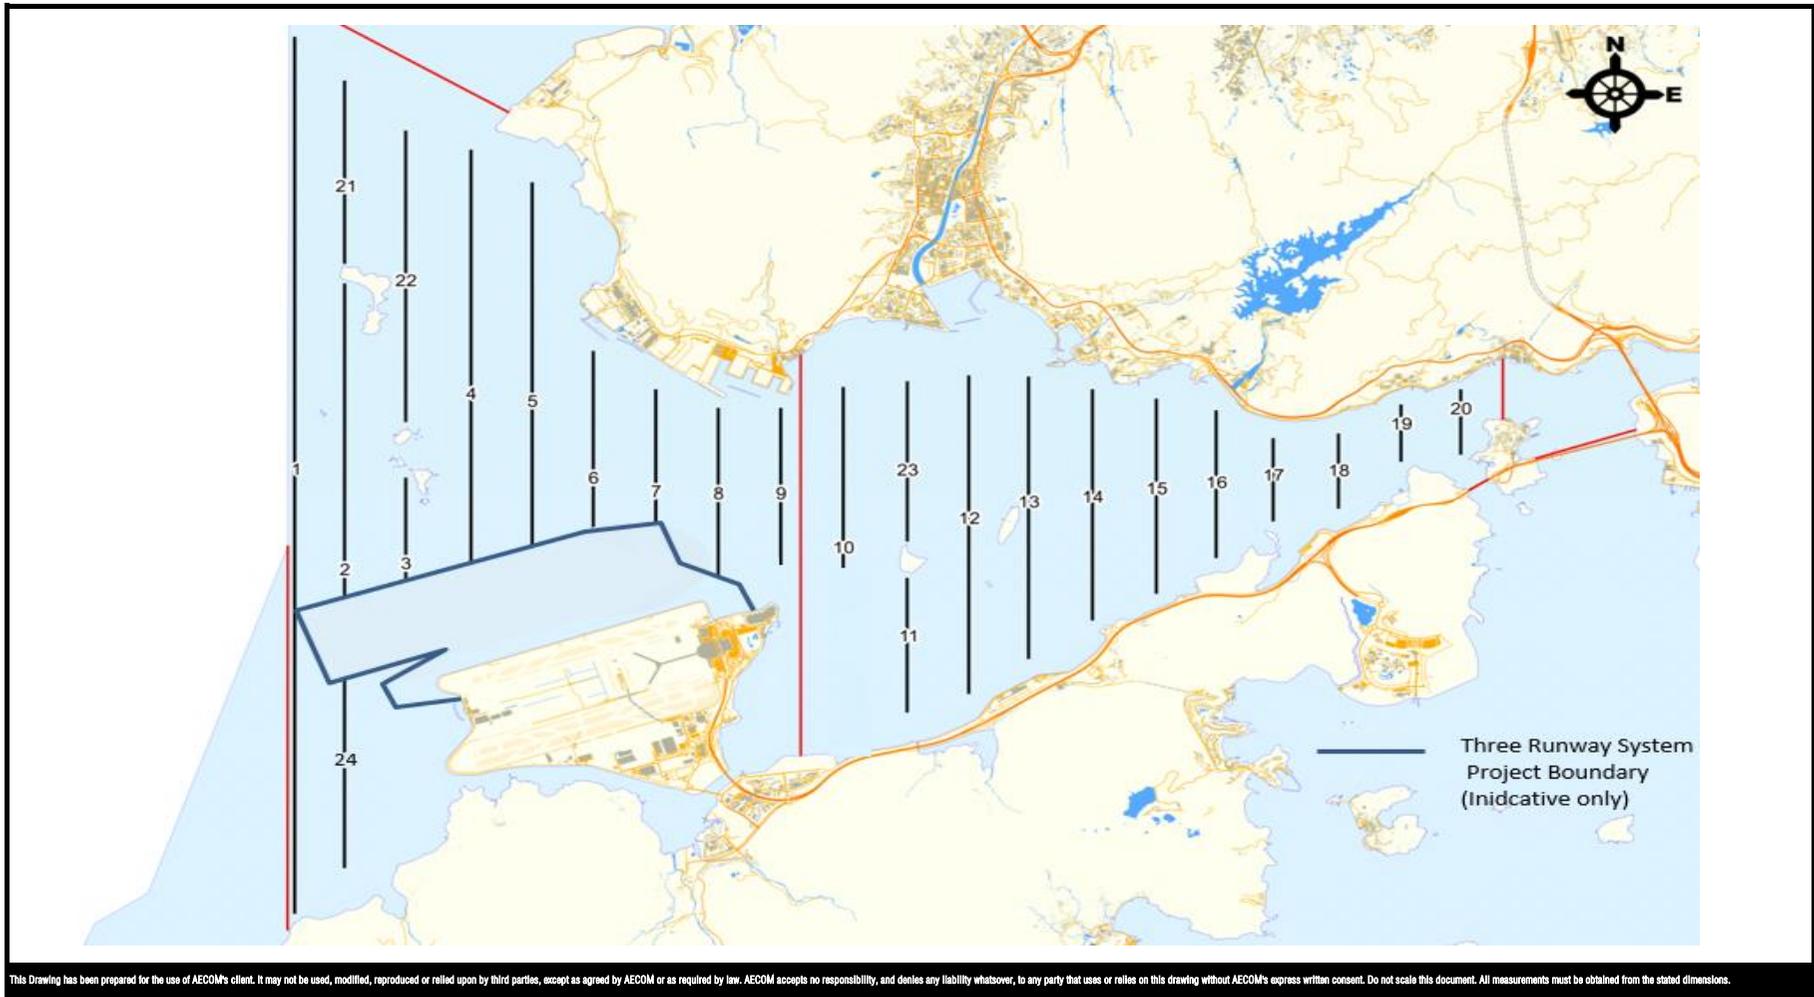
**Figure 4**

^Coordinates for transect lines 2, 3, 4, 5, 6 and 7 have been updated and line 24 was added in respect to the Proposal for Alteration of Transect Line of Dolphin Monitoring and Alternative Monitoring Location for Impact Water Quality Monitoring (IWQM) Stations due to Commencement of Third Runway Project (3RS) which was approved by EPD on 12 May 2017. The total transect length for both NEL and NWL combined is reduced to approximately 99km.
