**Contract No. HY/2013/04 Hong Kong-Zhuhai-Macao Bridge (HZMB)
Hong Kong Boundary Crossing Facilities – Infrastructure Works Stage II
(Southern Portion)**

Final EM&A Review Report (Revision 0)

**Contract No. HY/2013/04
HZMB HKBCF – Infrastructure Works Stage II (Southern Portion)
Final Environmental Monitoring & Audit Review Report**

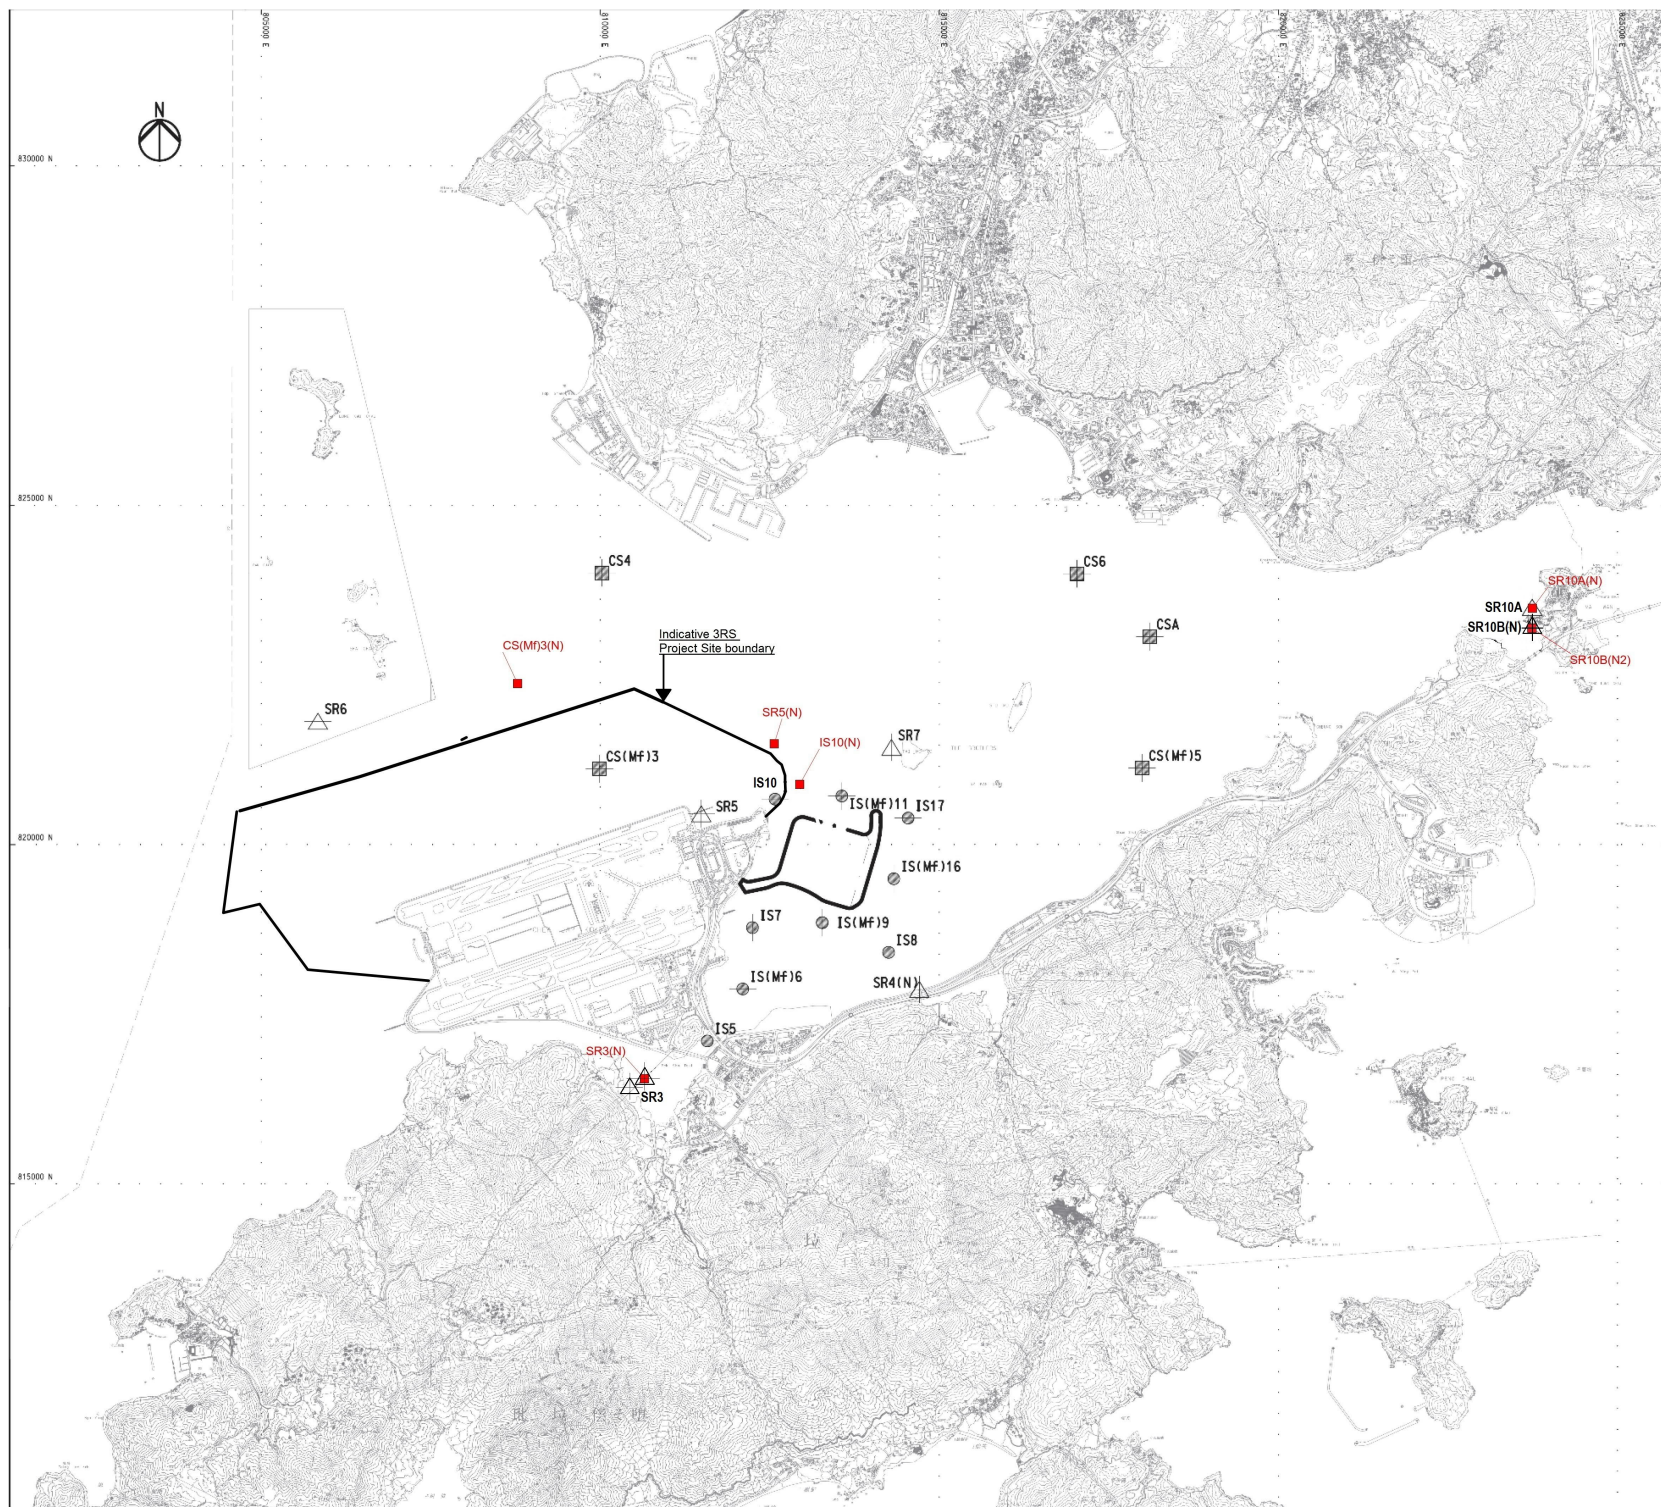
FIGURE 3.1— LOCATION OF WATER QUALITY MONITORING STATIONS (CONSTRUCTION PHASE)

Station	East	North
IS5	811579	817106
IS(Mf)6	812101	817873
IS7	812244	818777
IS8	814251	818412
IS(Mf)9	813273	818850
IS10	812577	820670
IS10(N)	812942	820881
IS(Mf)11	813562	820716
IS(Mf)16	814328	819497
IS17	814539	820391
SR3	810525	816456
SR3(N)	810689	816591
SR4(N)	814705	817859
SR5	811489	820455
SR5(N)	812569	821475
SR6	805837	821818
SR7	814293	821431
SR10A	823741	823495
SR10A(N)	823644	823484
SR10B(N)	823683	823187
SR10B(N2)	823689	823159
CS(Mf)3	809989	821117
CS(Mf)3(N)	808814	822355
CS(Mf)5	817990	821129
CS4	810025	824004
CS6	817028	823992
CSA	818103	823064

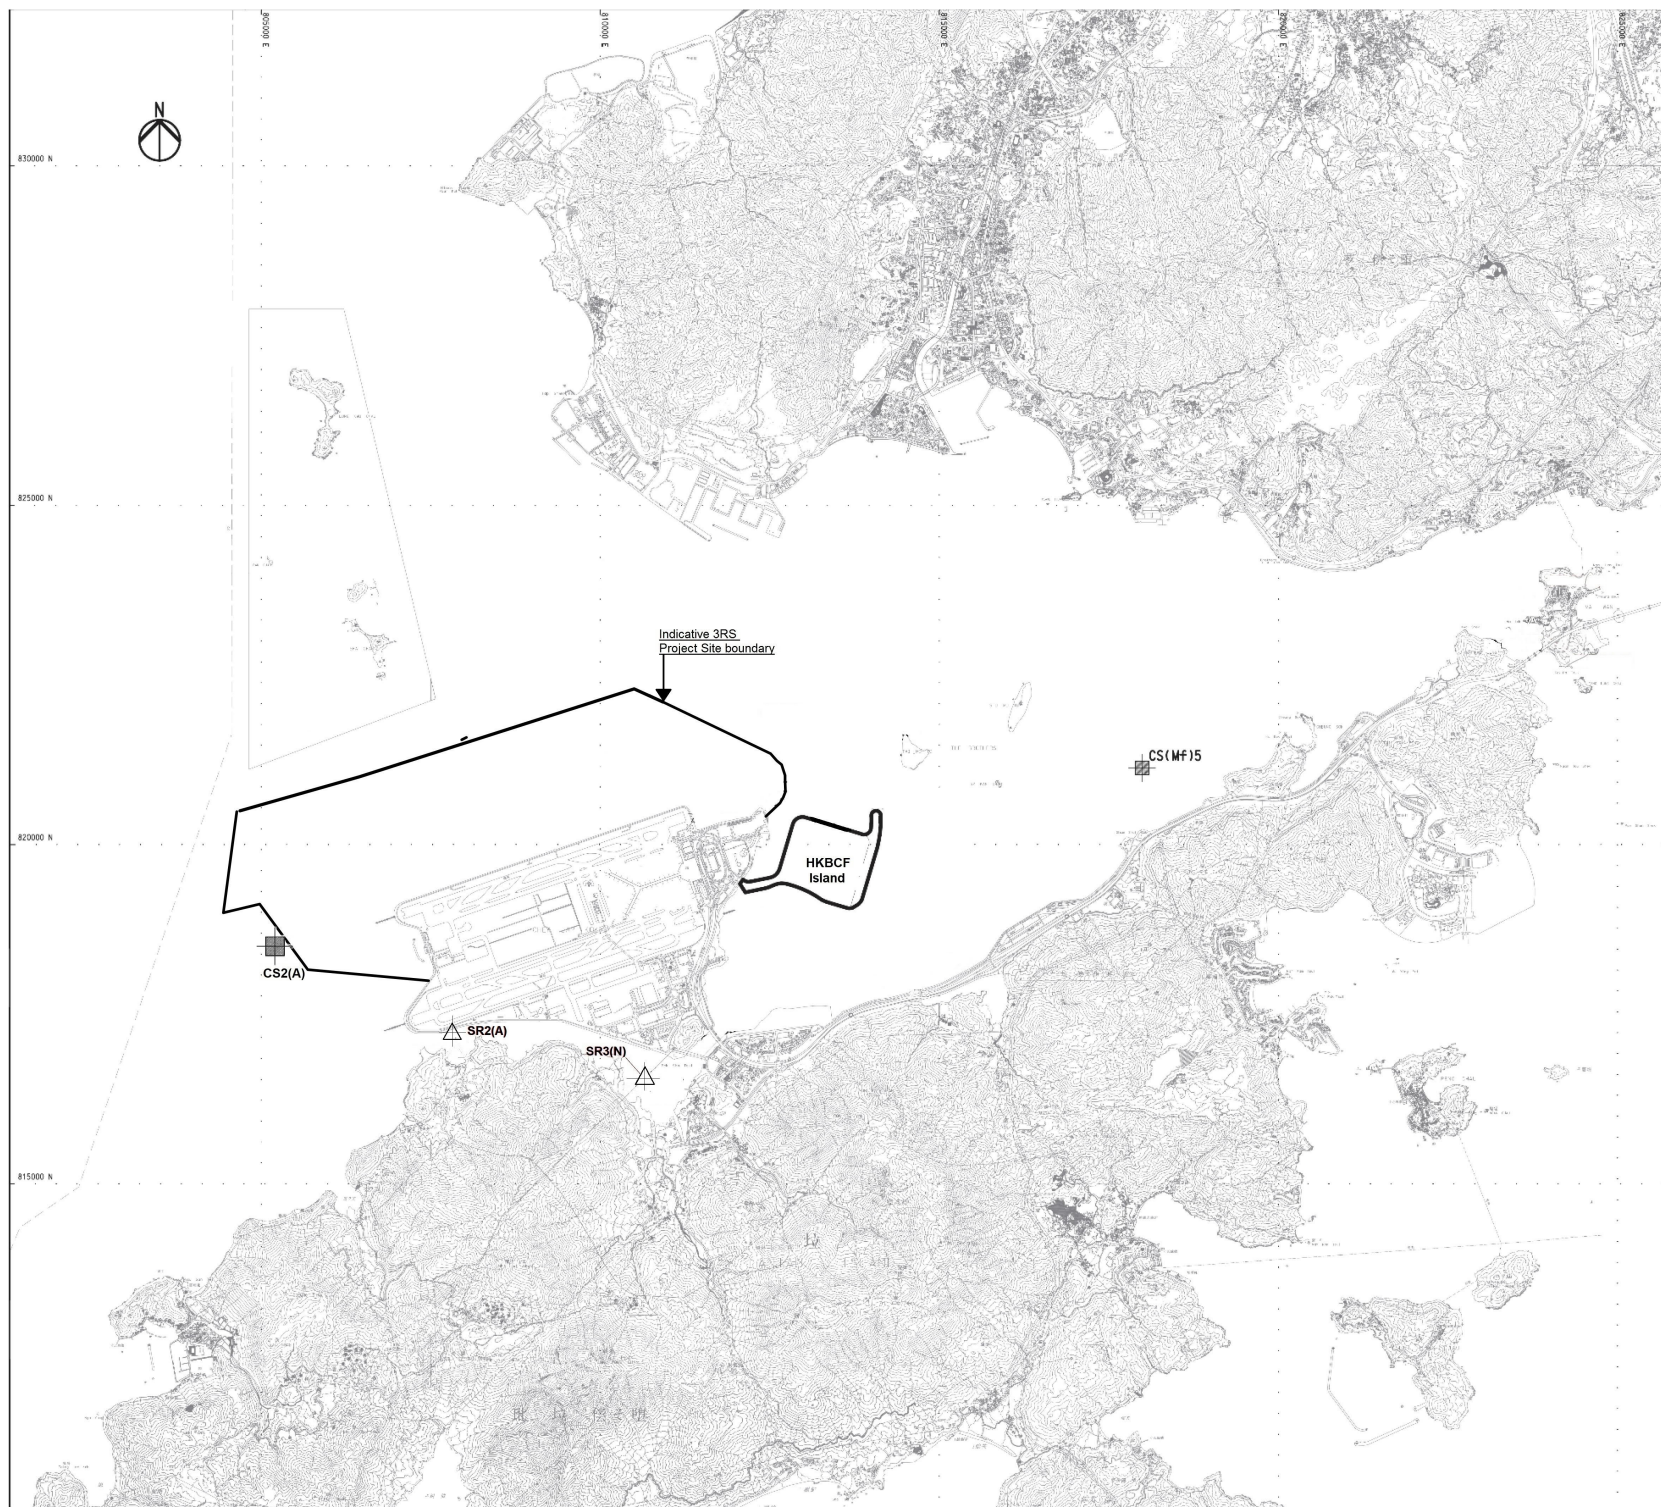
FIGURE 3.3 – LOCATION OF WATER QUALITY MONITORING STATIONS (IMPACT OPERATIONAL PHASE)

Station	East	North
SR2(A)	807810	817189
SR3(N)	810689	816591
CS2(A)	805232	818606
CS(Mf)5	817990	821129

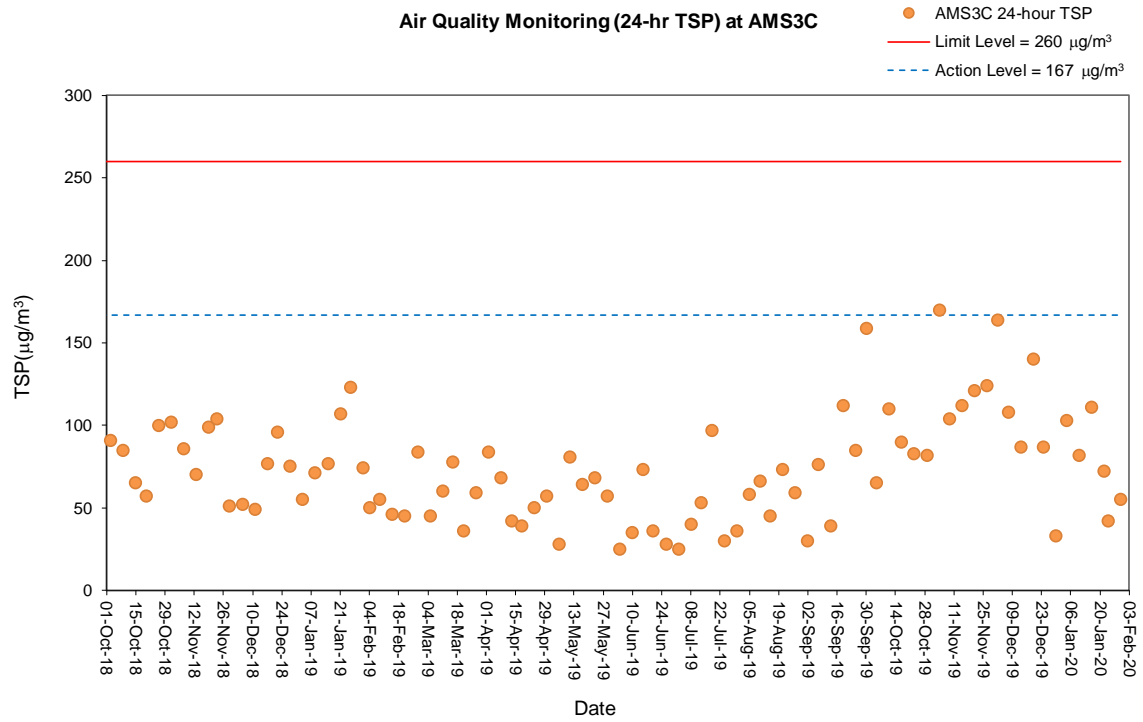
Air Quality Monitoring (24-hr TSP) at AMS3C

- Site formation and site office construction (Jul 2015 to Mar 2016)
- Pre-drilling and piling works (Jul 2015 to Apr 2017)
- Generation of excavated marine sediment (Feb 2016 to Feb 2017)
- Construction of loading and unloading point (May 2016 to Sep 2016)
- Bridge segment delivery (Jan 2017 to Jan 2018)
- Bridge segment erection (Feb 2017 to Nov 2019)
- Box culvert construction (Apr 2017 to Jan 2018)
- Seawall reinstatement at box culvert outfall (Aug 2018 to Jul 2019)
- Bridge deck construction and roadworks (Aug 2018 to Nov 2019)
- Drainage works, watermain laying, U-channel construction (Aug 2018 to Jan 2020)
- Construction of fill slopes and road embankment (Sep 2018 to Jan 2020)
- Site clearance works (Dec 2019 to May 2020)

Construction phase air quality impacts from the Contract with respect to 1-hour and 24-hour TSP levels were compared to those predicted under the mitigated scenario in the approved EIA Report. From the impact monitoring results during the reporting period, the maximum 1-hour TSP levels were found to be less than those predicted in the approved EIA Report, while the maximum 24-hour TSP levels were found to be more than the predicted maximum levels.
