**Contract No. HY/2013/04 Hong Kong-Zhuhai-Macao Bridge (HZMB)  
Hong Kong Boundary Crossing Facilities – Infrastructure Works Stage II  
(Southern Portion)**

**Monthly EM&A Report for December 2019**

**Contract No. HY/2013/04  
HZMB HKBCF – Infrastructure Works Stage II (Southern Portion)  
Monthly Environmental Monitoring & Audit Report for December 2019**

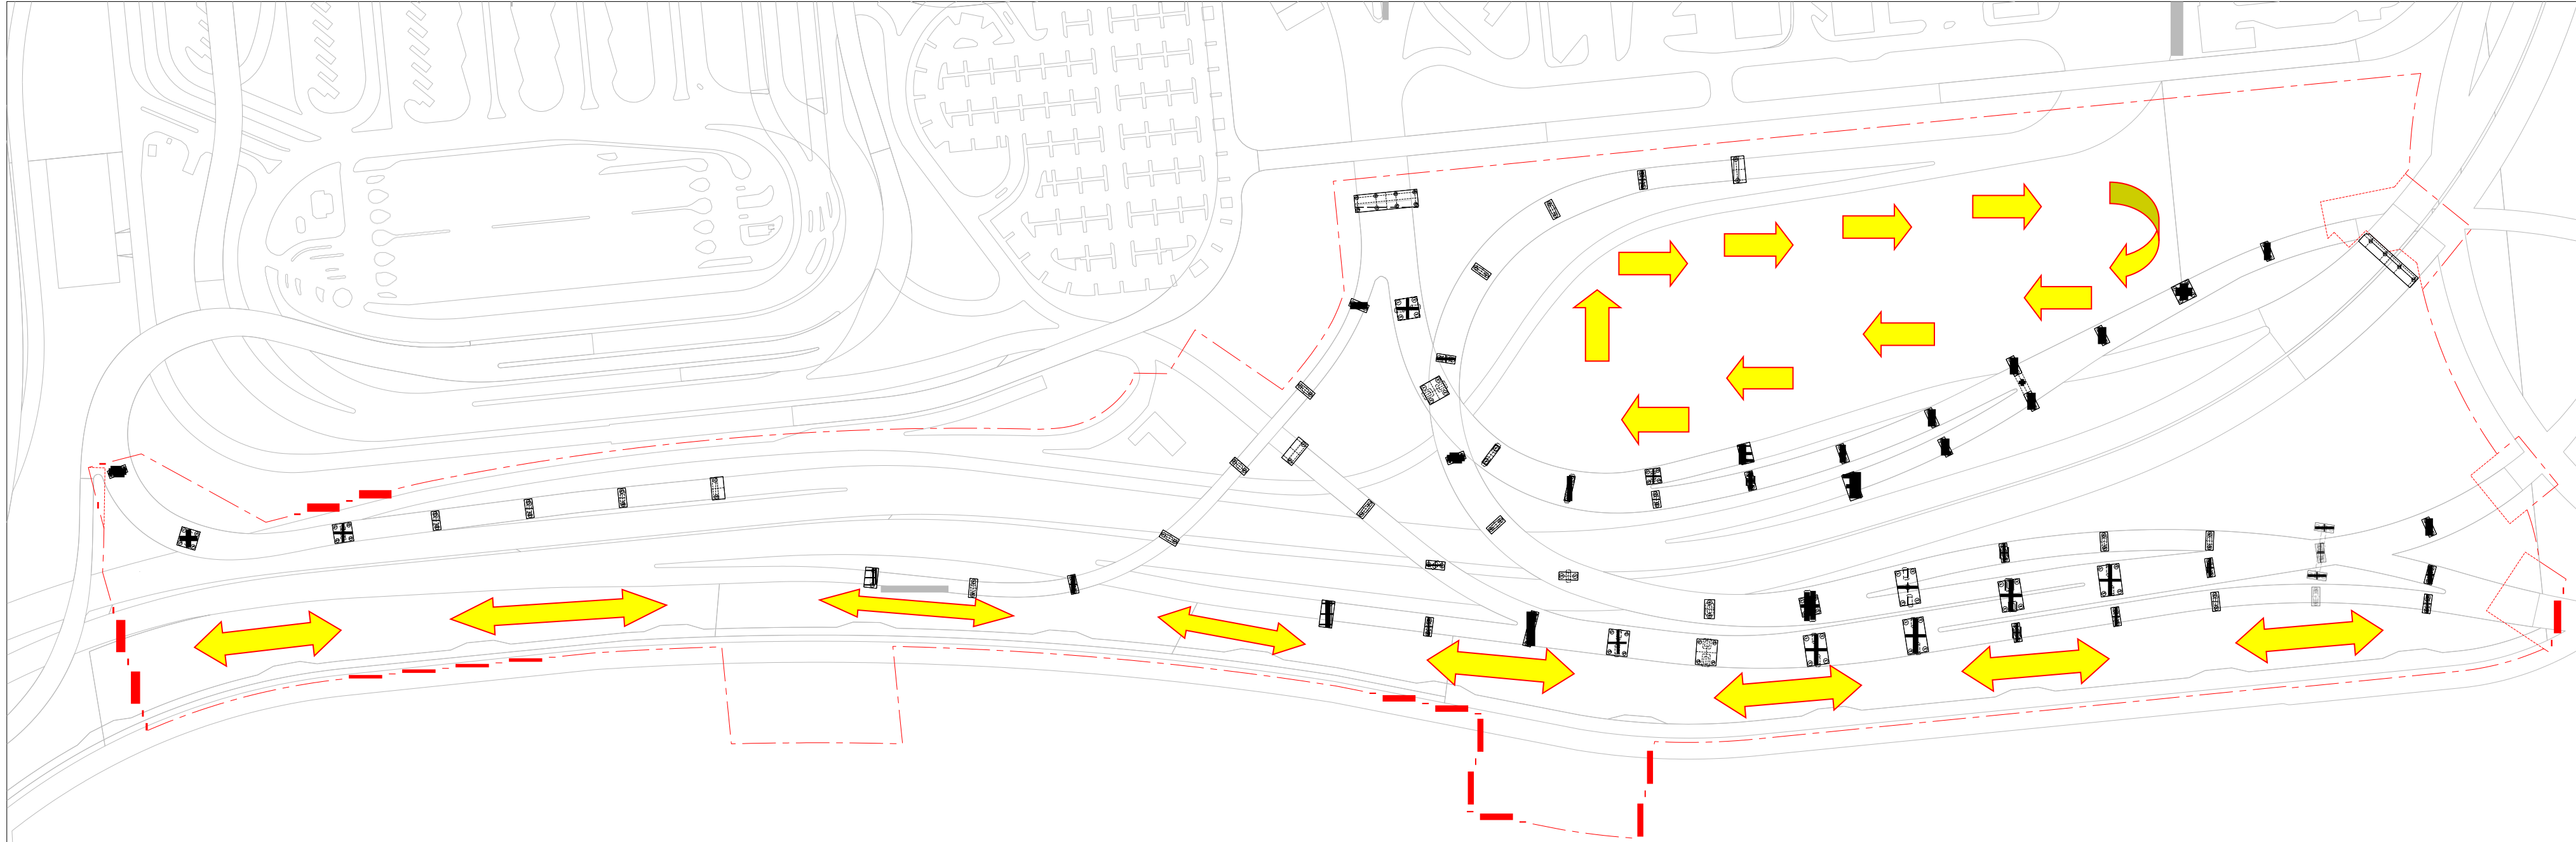
**HY/2013/04 Site Watering Plan**

As informed by the Contractor of HY/2013/04, watering of all main haul roads was provided in accordance with the HY/2013/04 site watering plan. This plan schedules water spraying for at least 8 times per day which follows the recommended mitigation measures in the EM&A Manual and Environmental Permit.

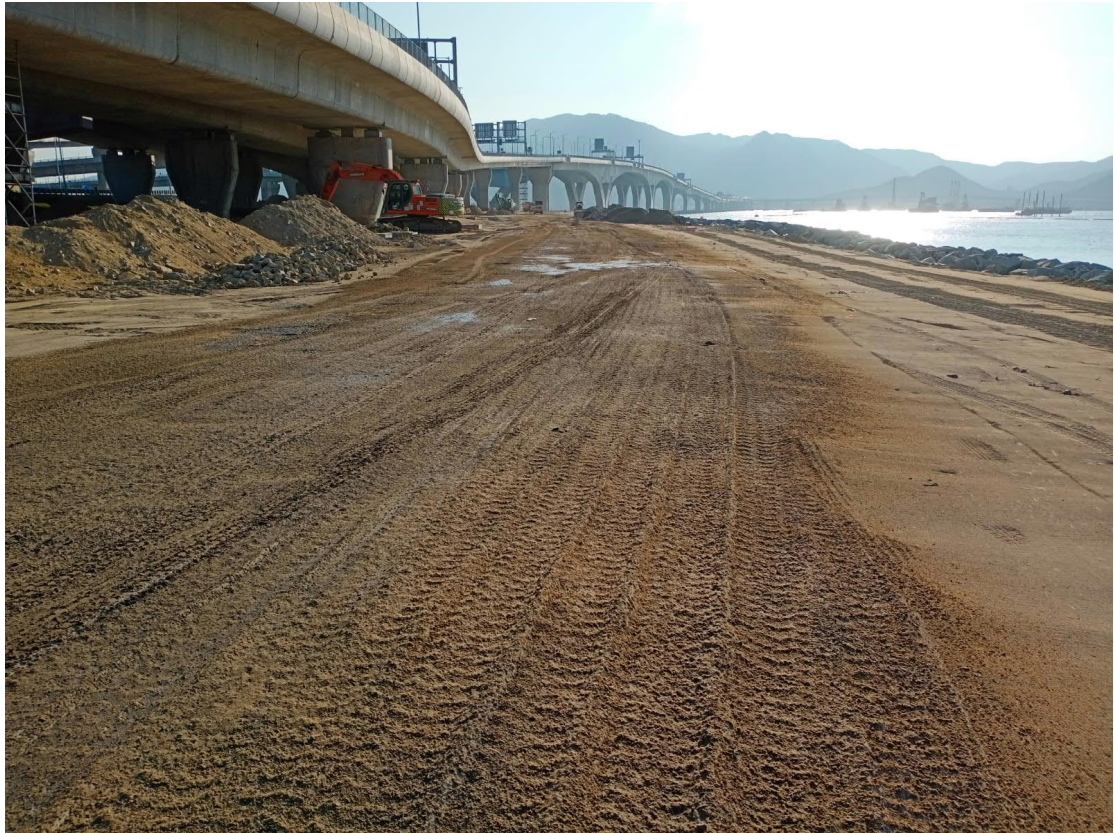
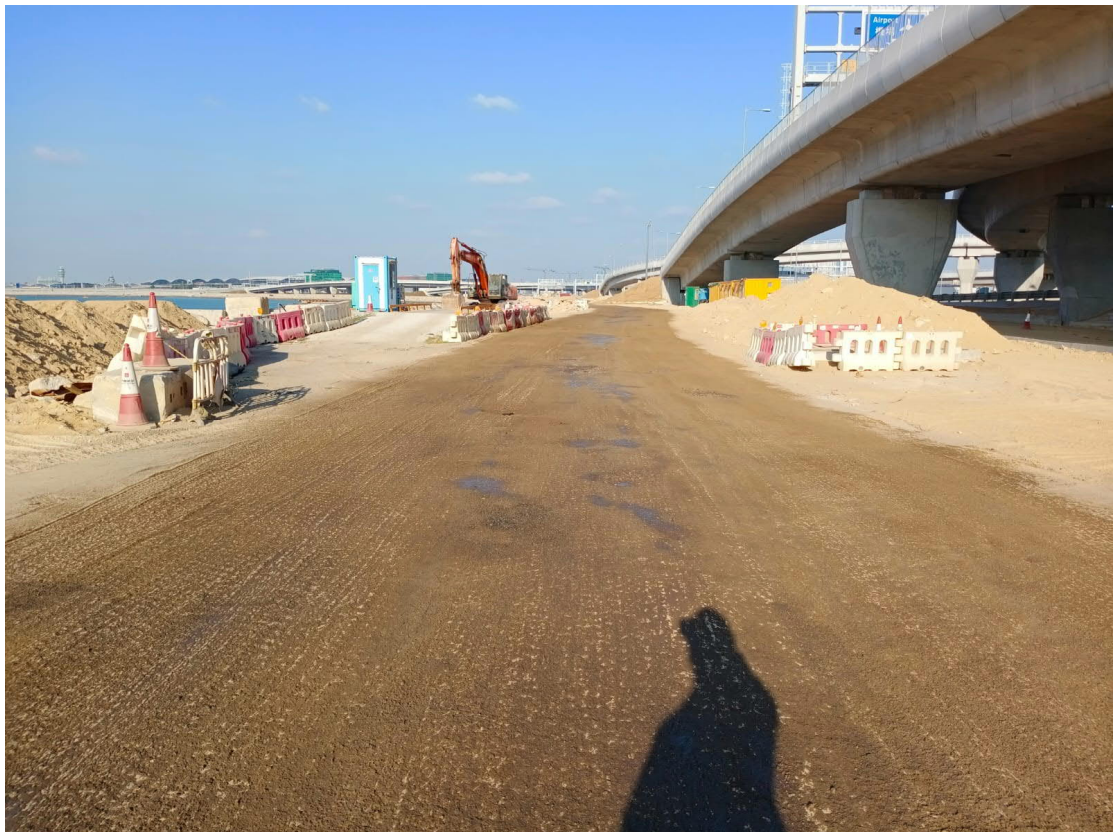
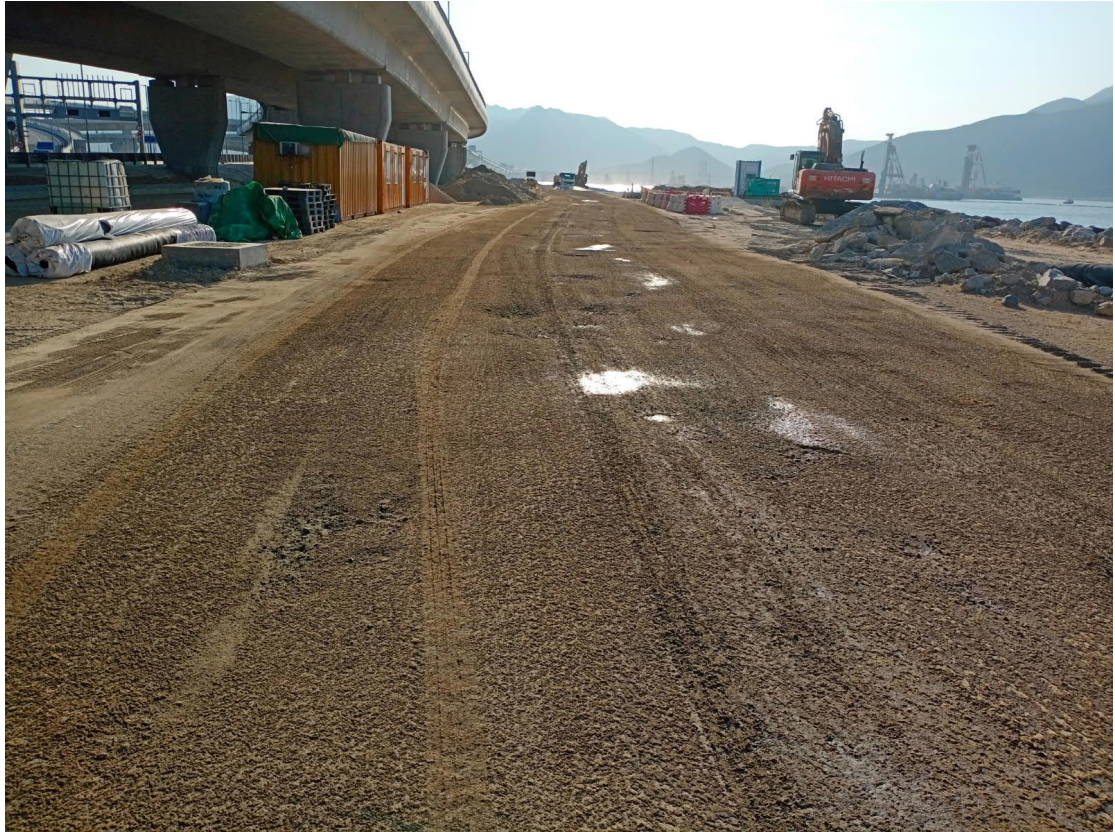
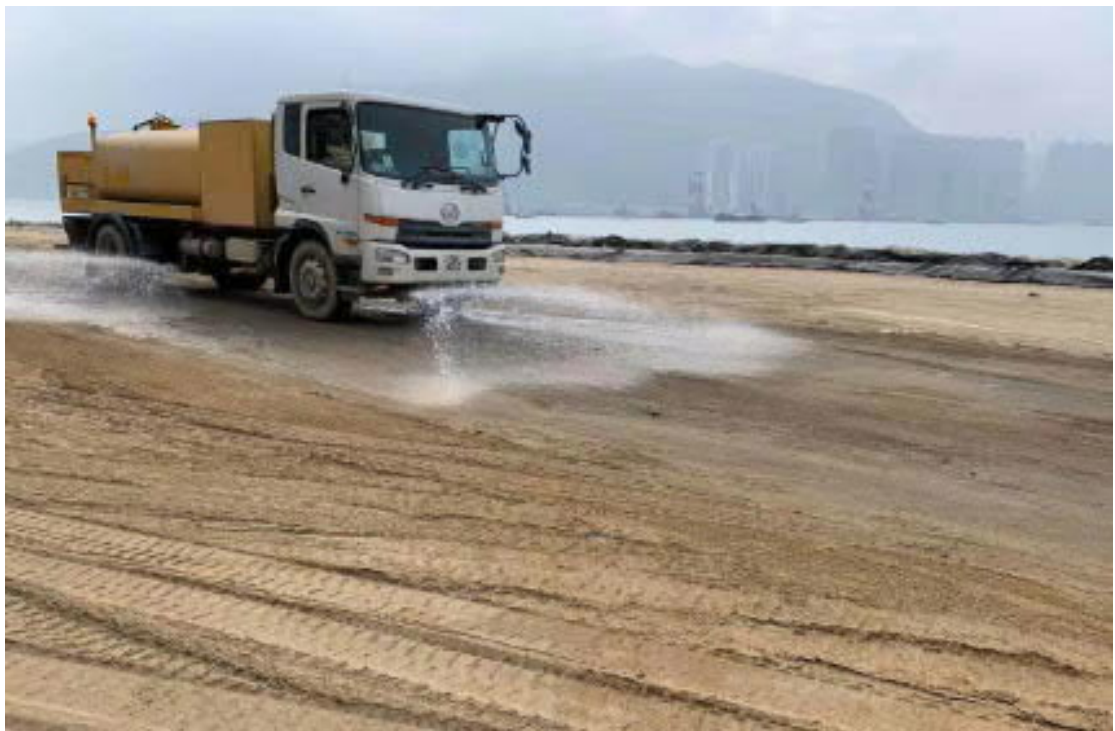
## Photos of dust mitigation measures

**Photo record of site mitigation measures and air quality observations  
during weekly environmental site inspection**

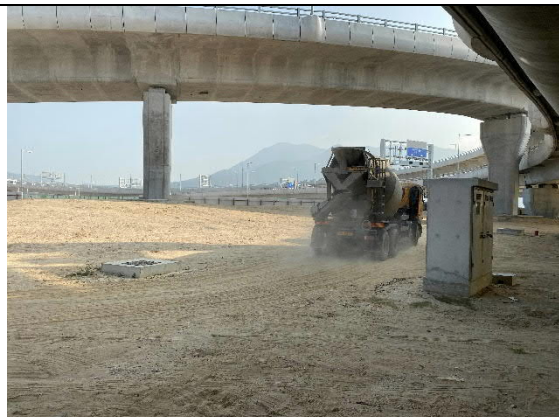
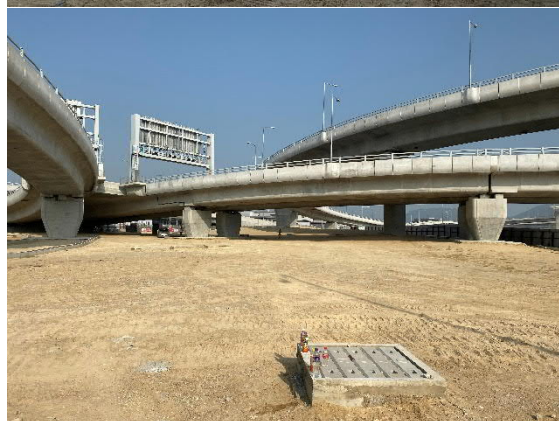
**27 November 2019**

During ET's regular weekly site inspections on 27 November 2019 (14:45-15:45) and 4 December 2019 (14:30-15:30), one air quality observation was recorded: namely, an exposed works area was observed dry and dusty.

1. Air quality observation: The exposed works area was observed dry and dusty.

- a. The exposed works area was observed dry and dusty. Subsequently, as informed by the Contractor, the dry exposed works areas were handed over to another works contract. The observation was closed on 16 December 2019.

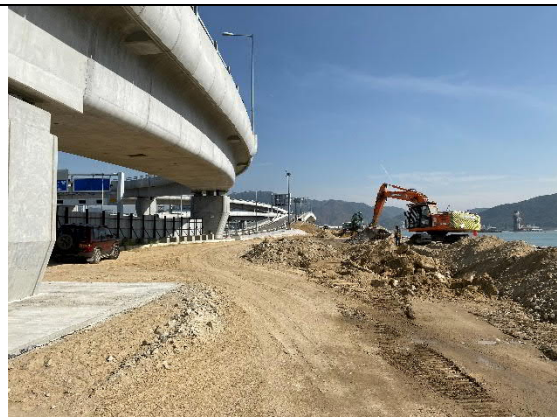
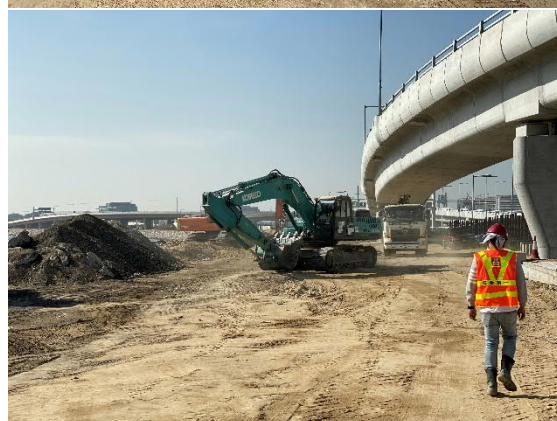
**4 December 2019**

1. Air quality observation: The exposed works area was observed dry and dusty.
