Contract No. HY/2013/04 Hong Kong-Zhuhai-Macao Bridge (HZMB)
Hong Kong Boundary Crossing Facilities – Infrastructure Works Stage II
(Southern Portion)

Quarterly EM&A Report for April 2018 to June 2018

Contract No. HY/2013/04 HZMB HKBCF –
Infrastructure Works Stage II (Southern Portion)
Quarterly EM&A Report for April 2018 to June 2018

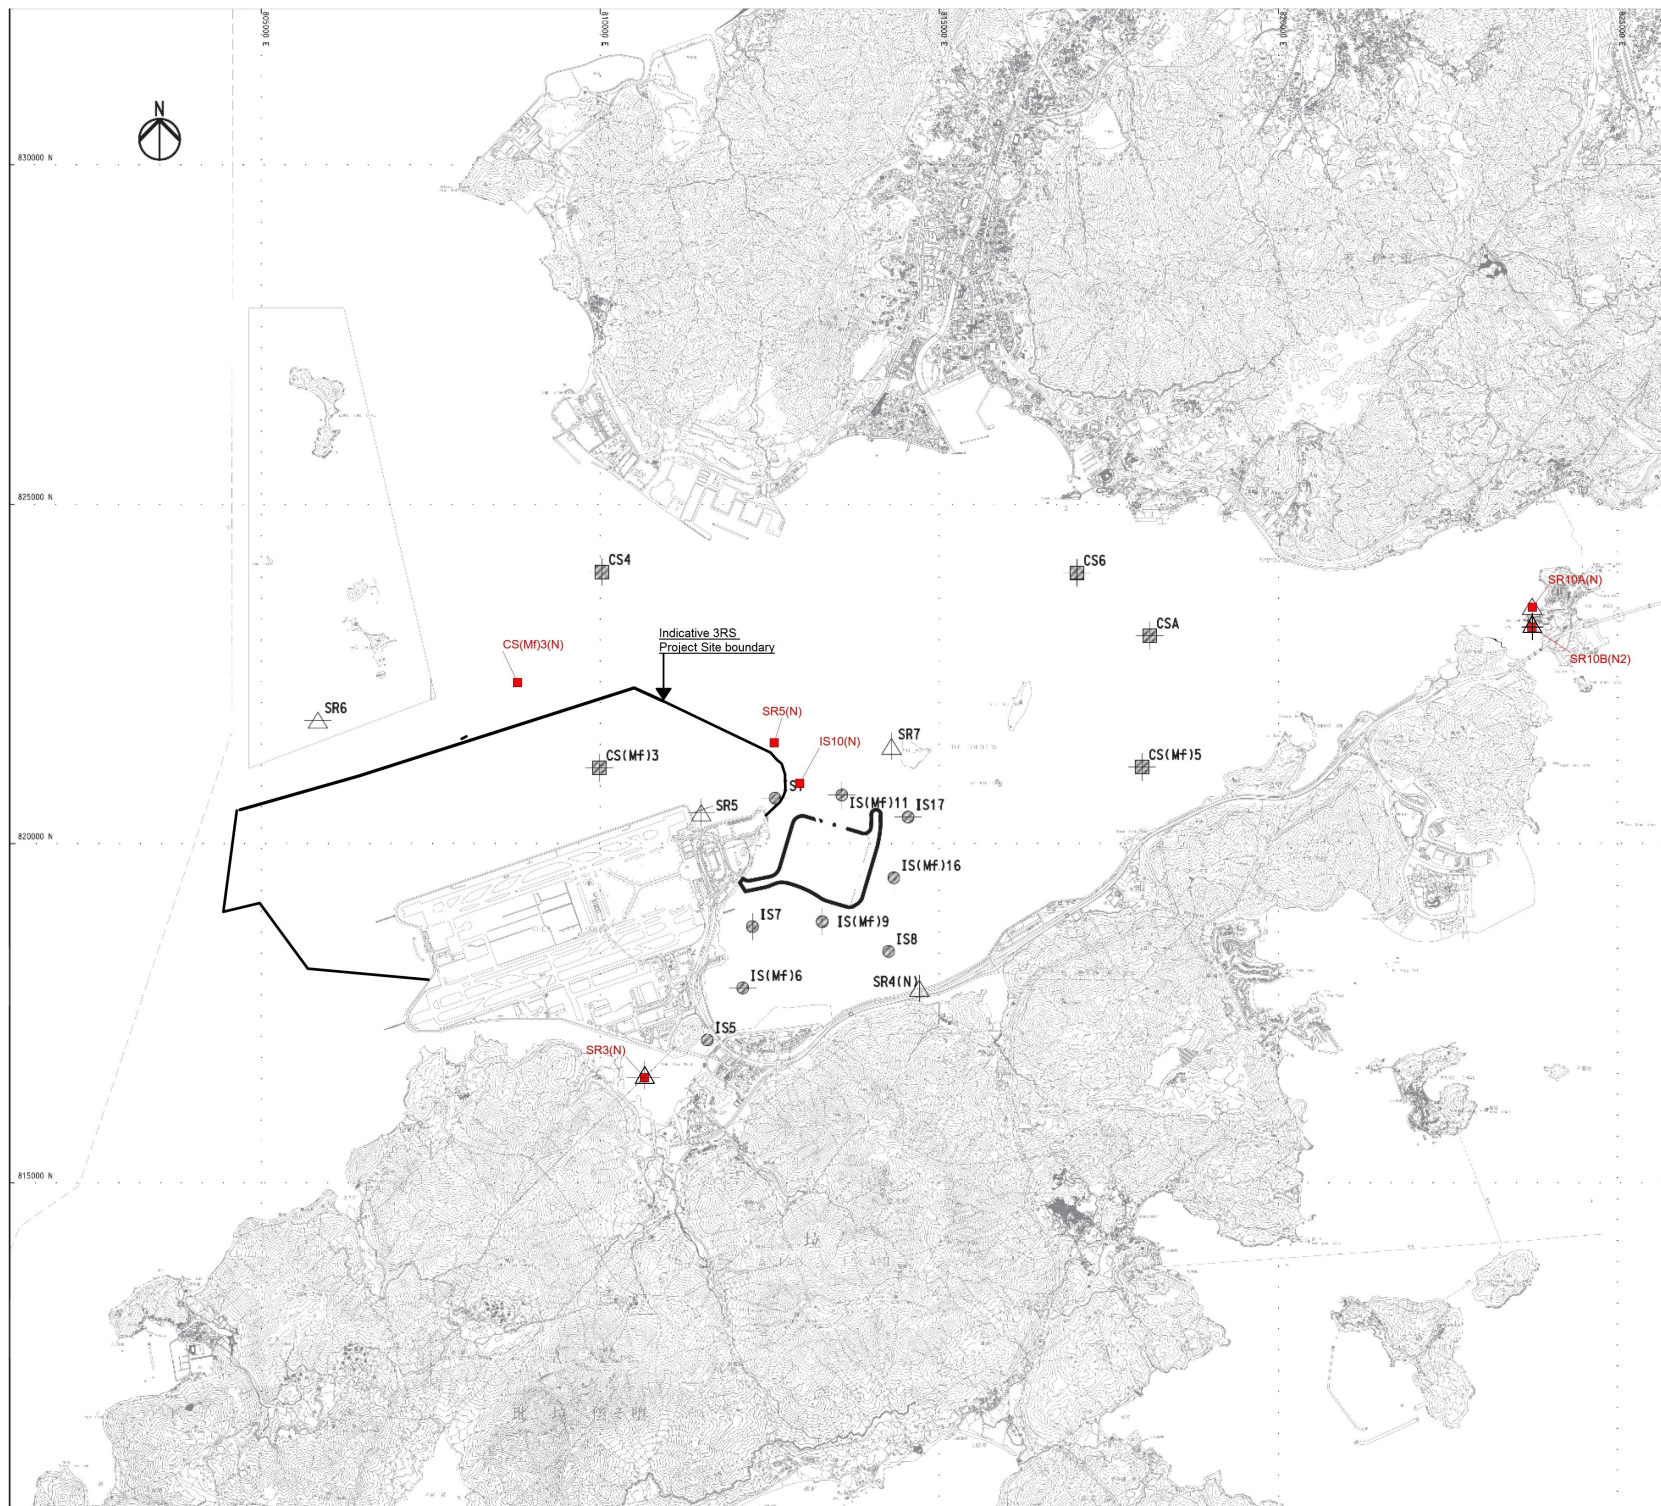
FIGURE 2.3 – LOCATION OF WATER QUALITY MONITORING STATIONS

Station	East	North
IS5	811579	817106
IS(Mf)6	812101	817873
IS7	812244	818777
IS8	814251	818412
IS(Mf)9	813273	818850
IS10(N)	812942	820881
IS(Mf)11	813562	820716
IS(Mf)16	814328	819497
IS17	814539	820391
SR3(N)	810689	816591
SR4(N)	814705	817859
SR5(N)	812569	821475
SR6	805837	821818
SR7	814293	821431
SR10A(N)	823644	823484
SR10B(N2)	823689	823159
CS(Mf)3(N)	808814	822355
CS(Mf)5	817990	821129
CS4	810025	824004
CS6	817028	823992
CSA	818103	823064
