**Contract No. HY/2013/04 Hong Kong-Zhuhai-Macao Bridge (HZMB)
Hong Kong Boundary Crossing Facilities – Infrastructure Works Stage II
(Southern Portion)**

Quarterly EM&A Report for December 2018 to February 2019 (Revision 1)

Quarterly EM&A Report for December 2018 to
February 2019

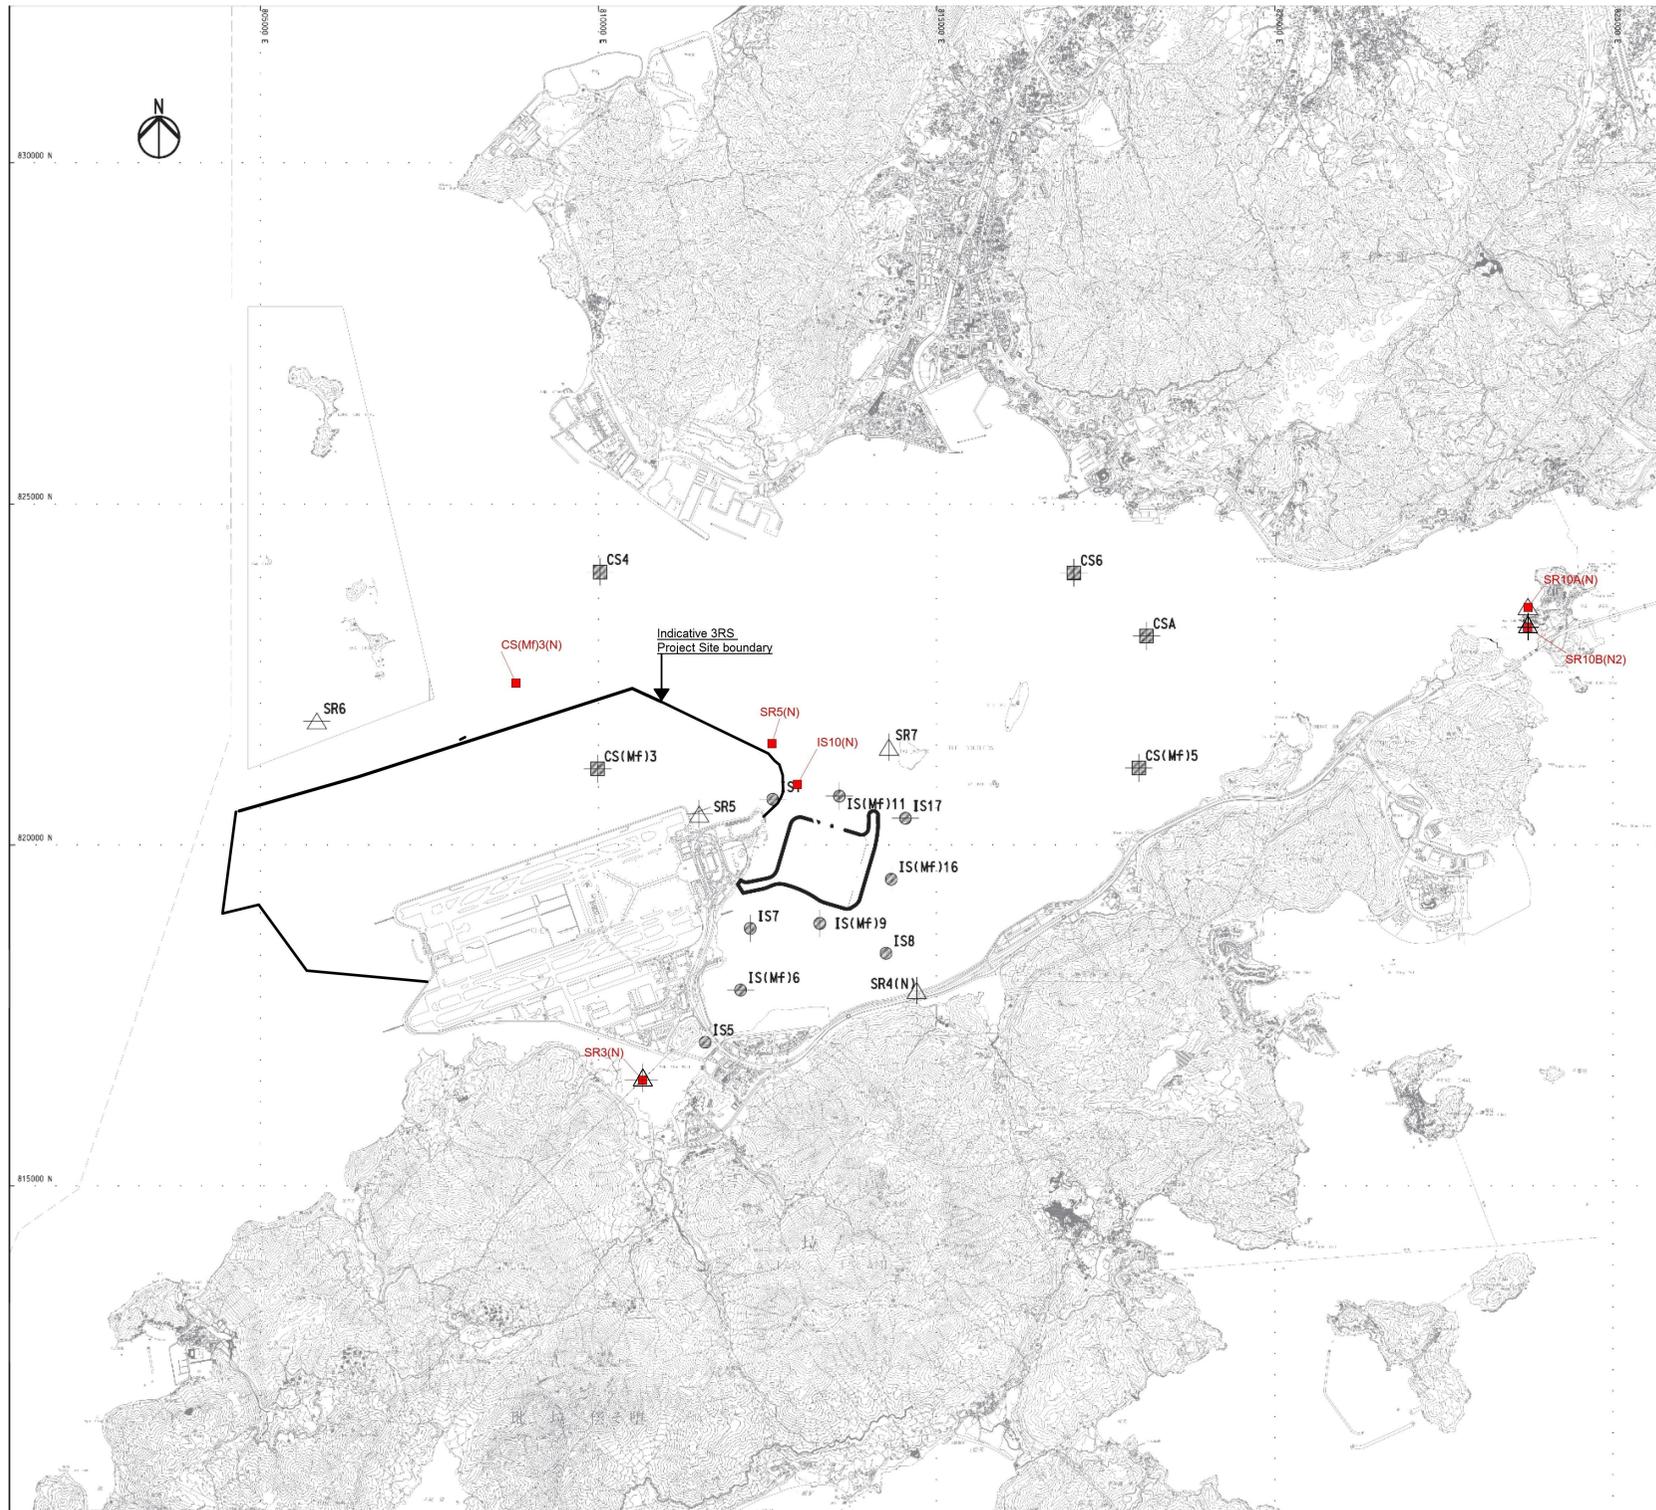
FIGURE 2.3 – LOCATION OF WATER QUALITY MONITORING STATIONS

Station	East	North
IS5	811579	817106
IS(Mf)6	812101	817873
IS7	812244	818777
IS8	814251	818412
IS(Mf)9	813273	818850
IS10(N)	812942	820881
IS(Mf)11	813562	820716
IS(Mf)16	814328	819497
IS17	814539	820391
SR3(N)	810689	816591
SR4(N)	814705	817859
SR5(N)	812569	821475
SR6	805837	821818
SR7	814293	821431
SR10A(N)	823644	823484
SR10B(N2)	823689	823159
CS(Mf)3(N)	808814	822355
CS(Mf)5	817990	821129
CS4	810025	824004
CS6	817028	823992
CSA	818103	823064

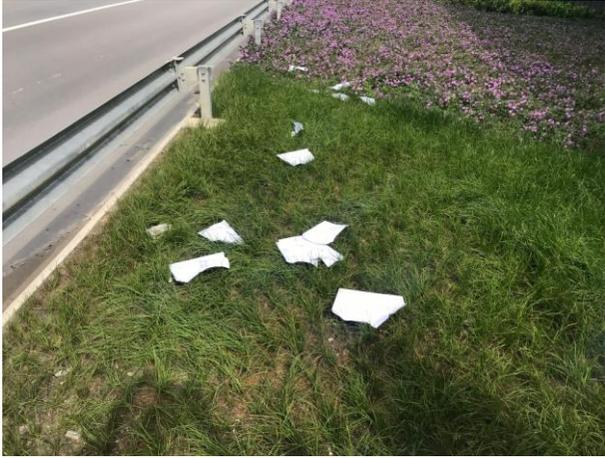
<p data-bbox="674 858 1207 890">Item 1 – Improper disposal of general refuse</p>
