**Contract No. HY/2013/04 Hong Kong-Zhuhai-Macao Bridge (HZMB)  
Hong Kong Boundary Crossing Facilities – Infrastructure Works Stage II  
(Southern Portion)**

**Quarterly EM&A Report for September to November 2019 (Revision 0)**

**Contract No. HY/2013/04 – HZMB HKBCF – Infrastructure Works Stage II  
(Southern Portion)  
Quarterly EM&A Report for September 2019 to November 2019**

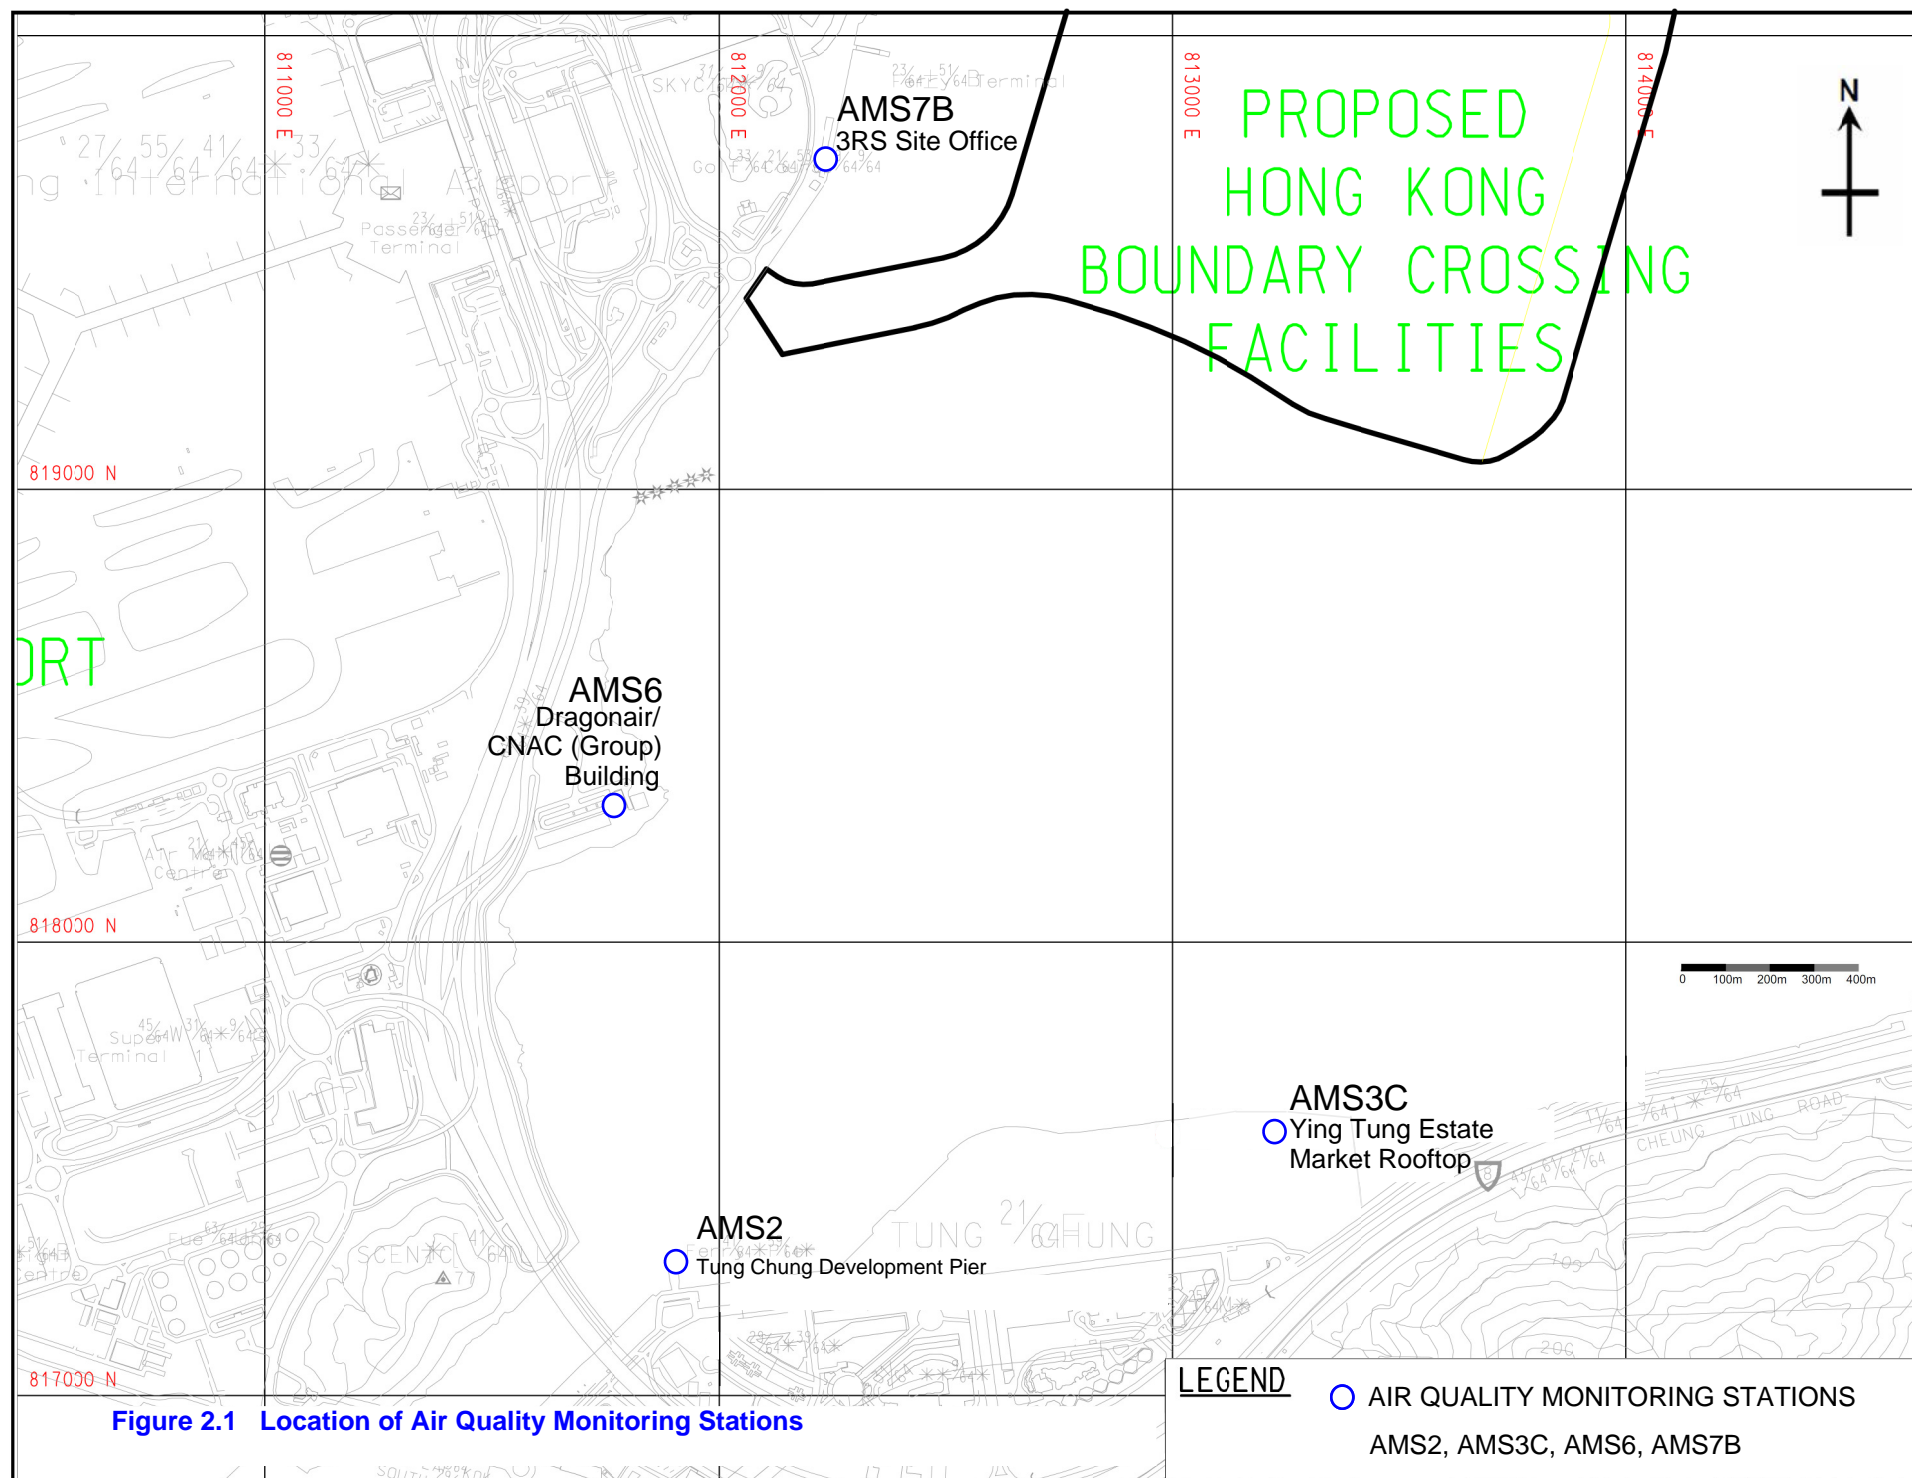
**Figure 2.1 Location of Air Quality Monitoring Stations**

- AIR QUALITY MONITORING STATIONS  
AMS2, AMS3C, AMS6, AMS7B

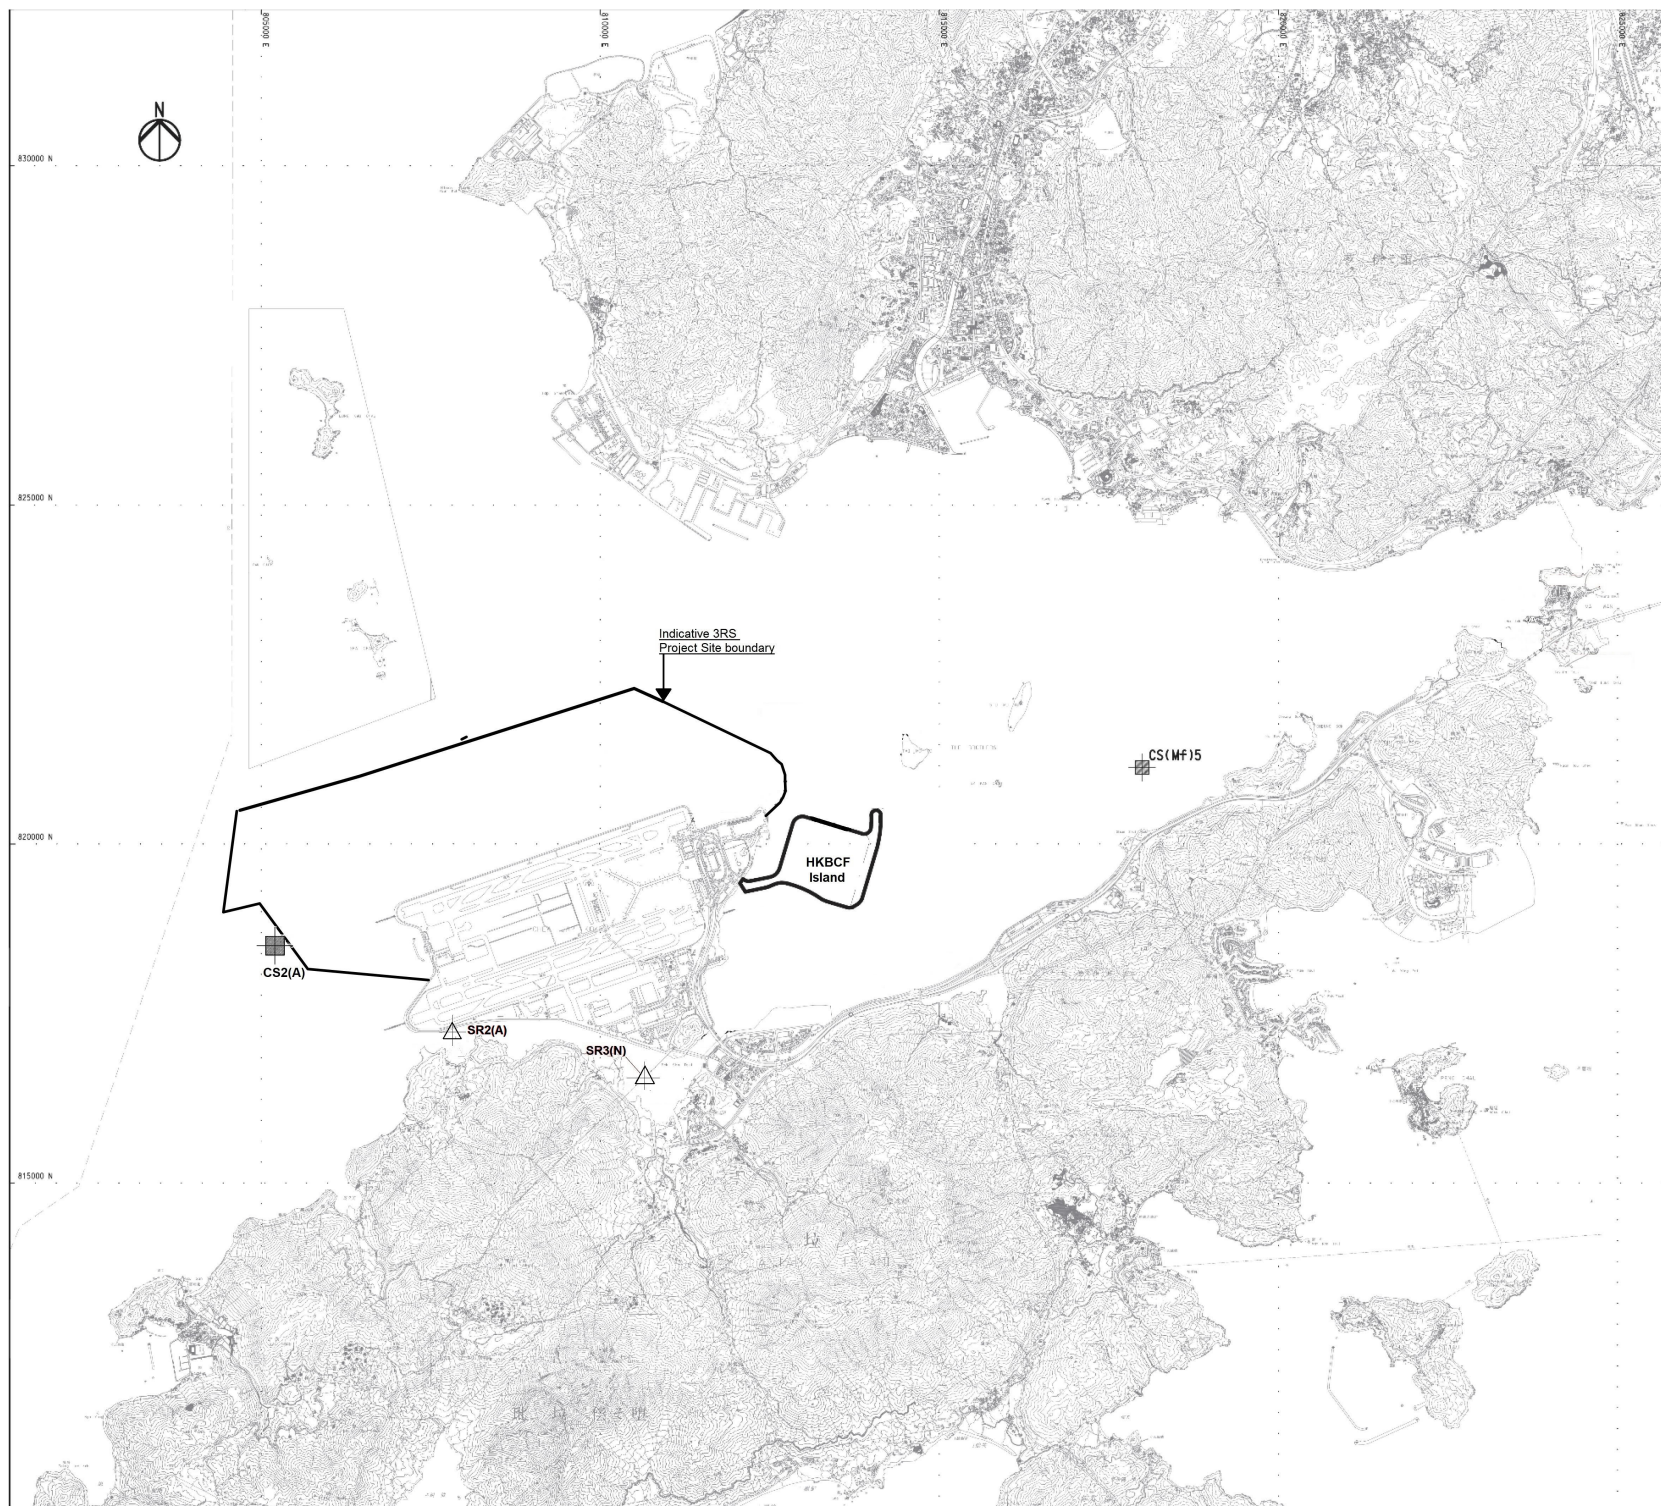
FIGURE 2.3 – LOCATION  
OF WATER QUALITY  
MONITORING STATIONS

Station	East	North
SR2(A)	807810	817189
SR3(N)	810689	816591
CS2(A)	805232	818606
CS(Mf)5	817990	821129

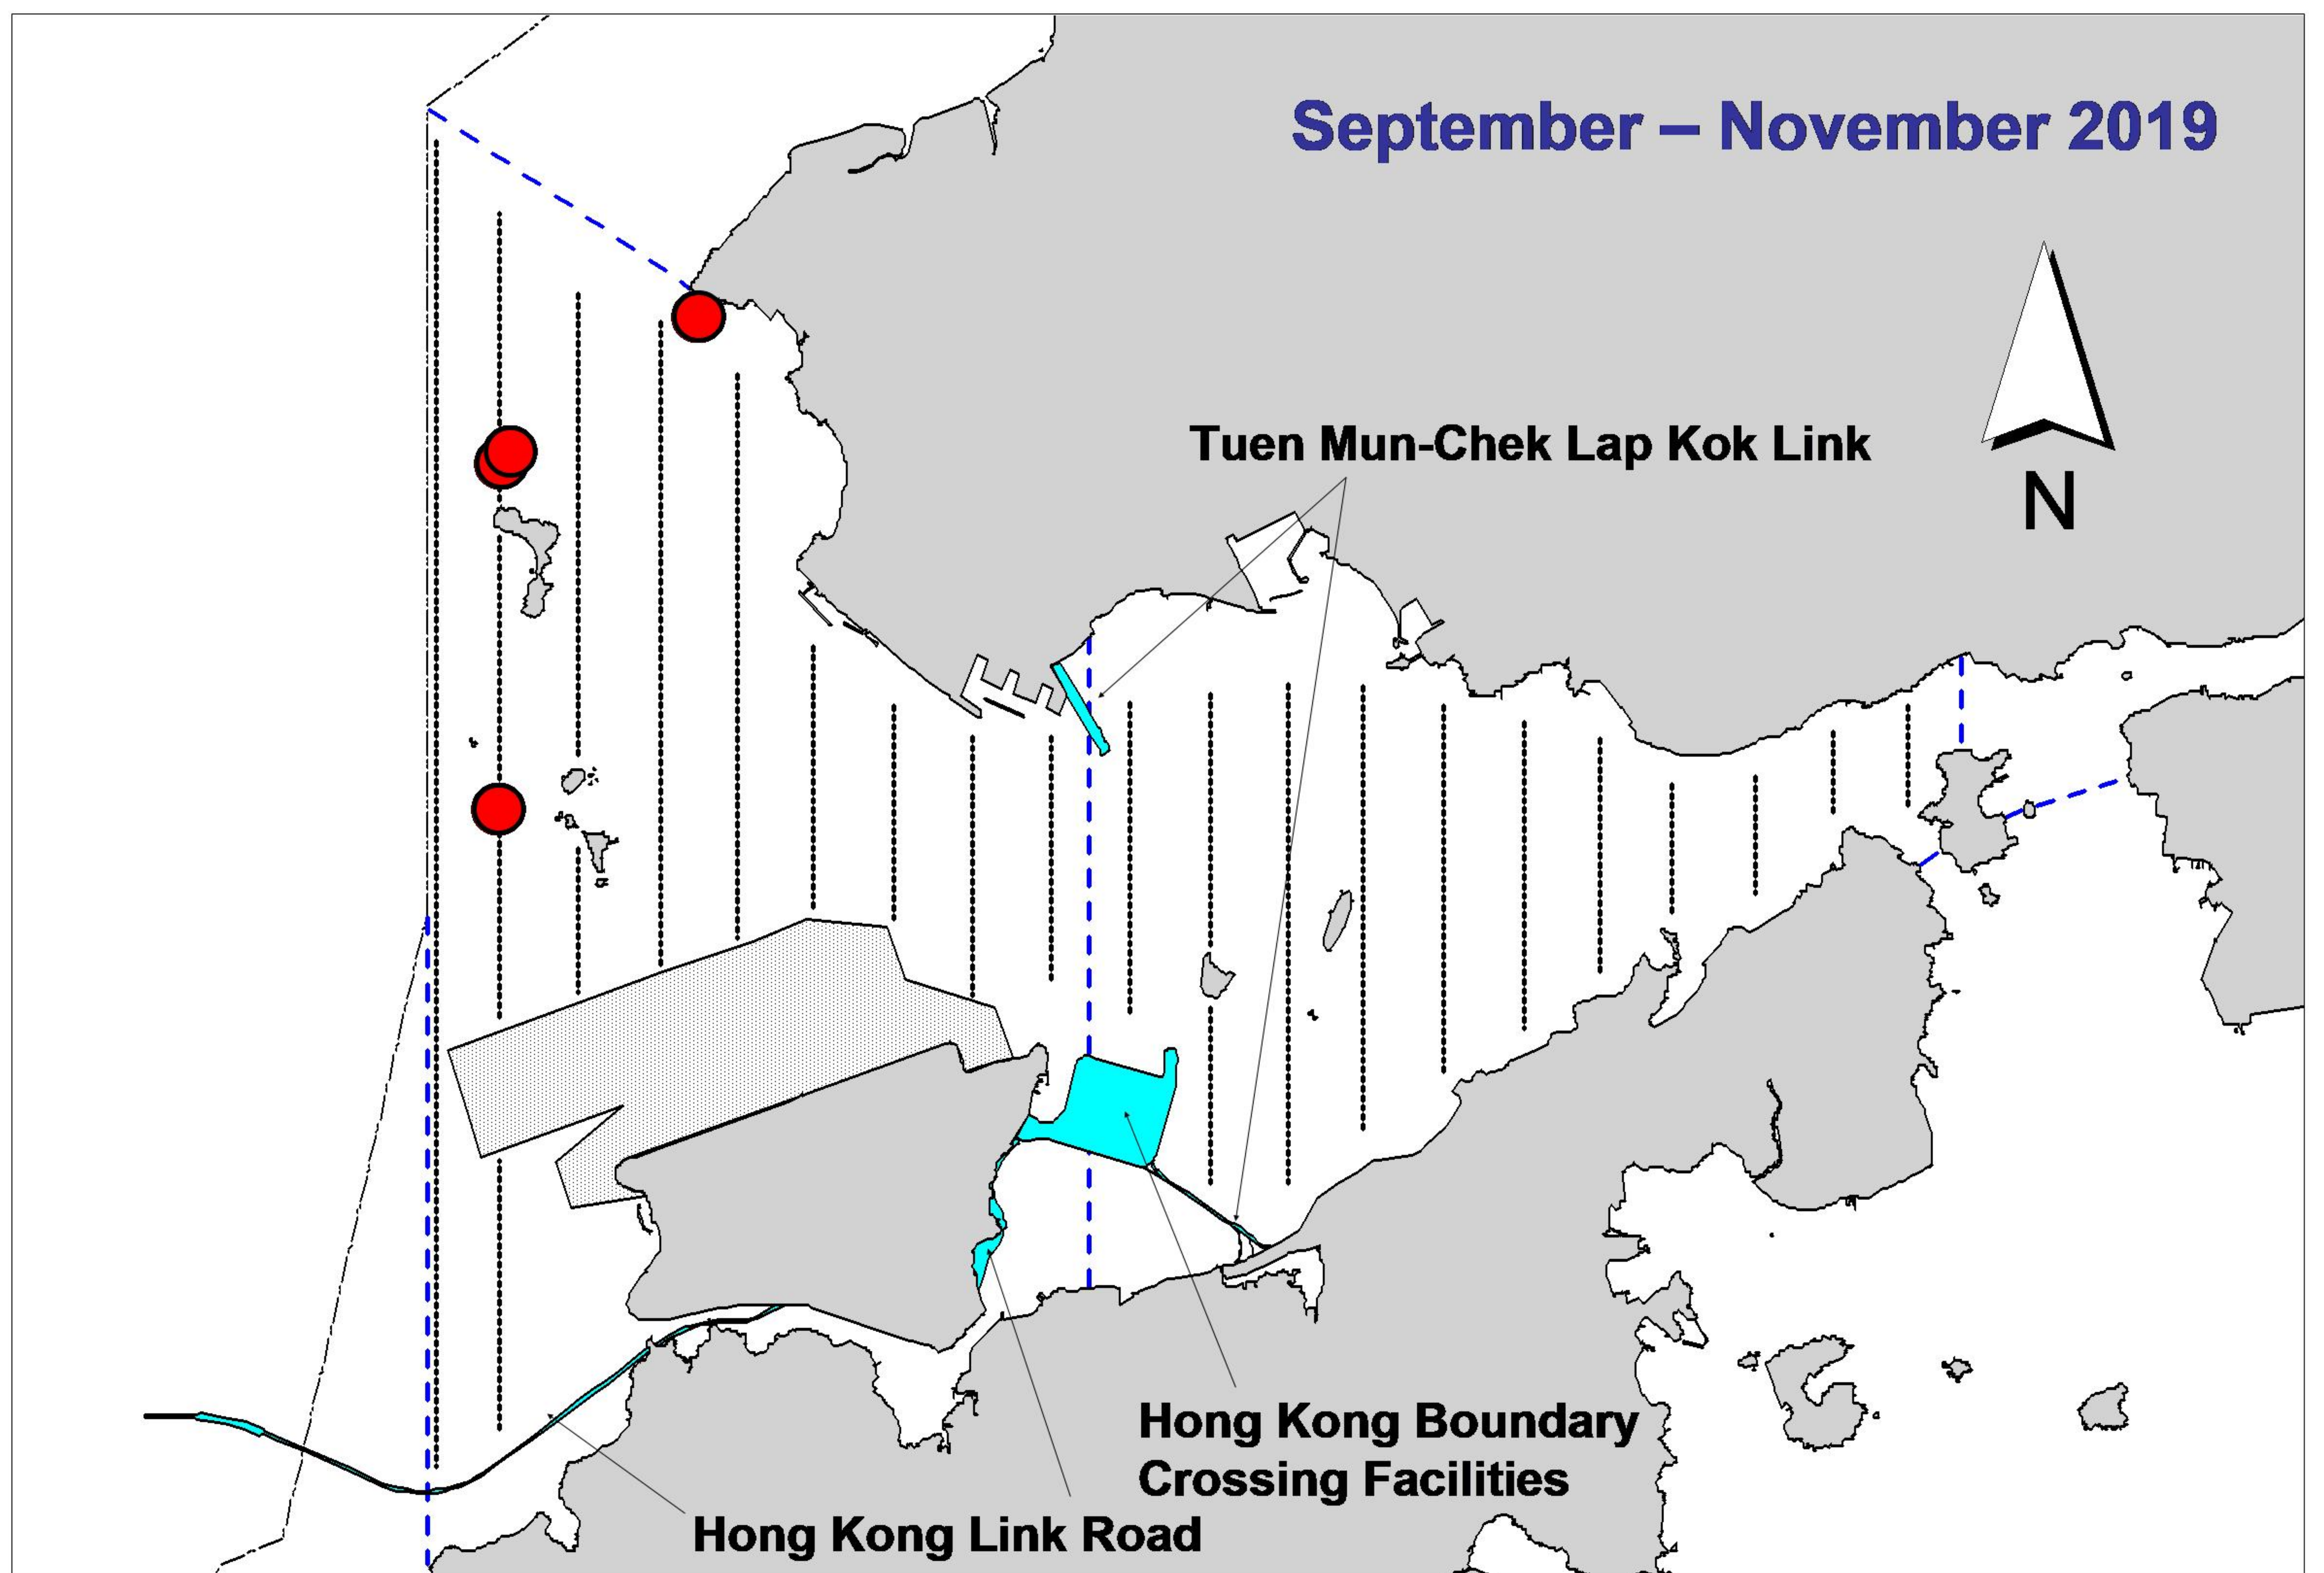
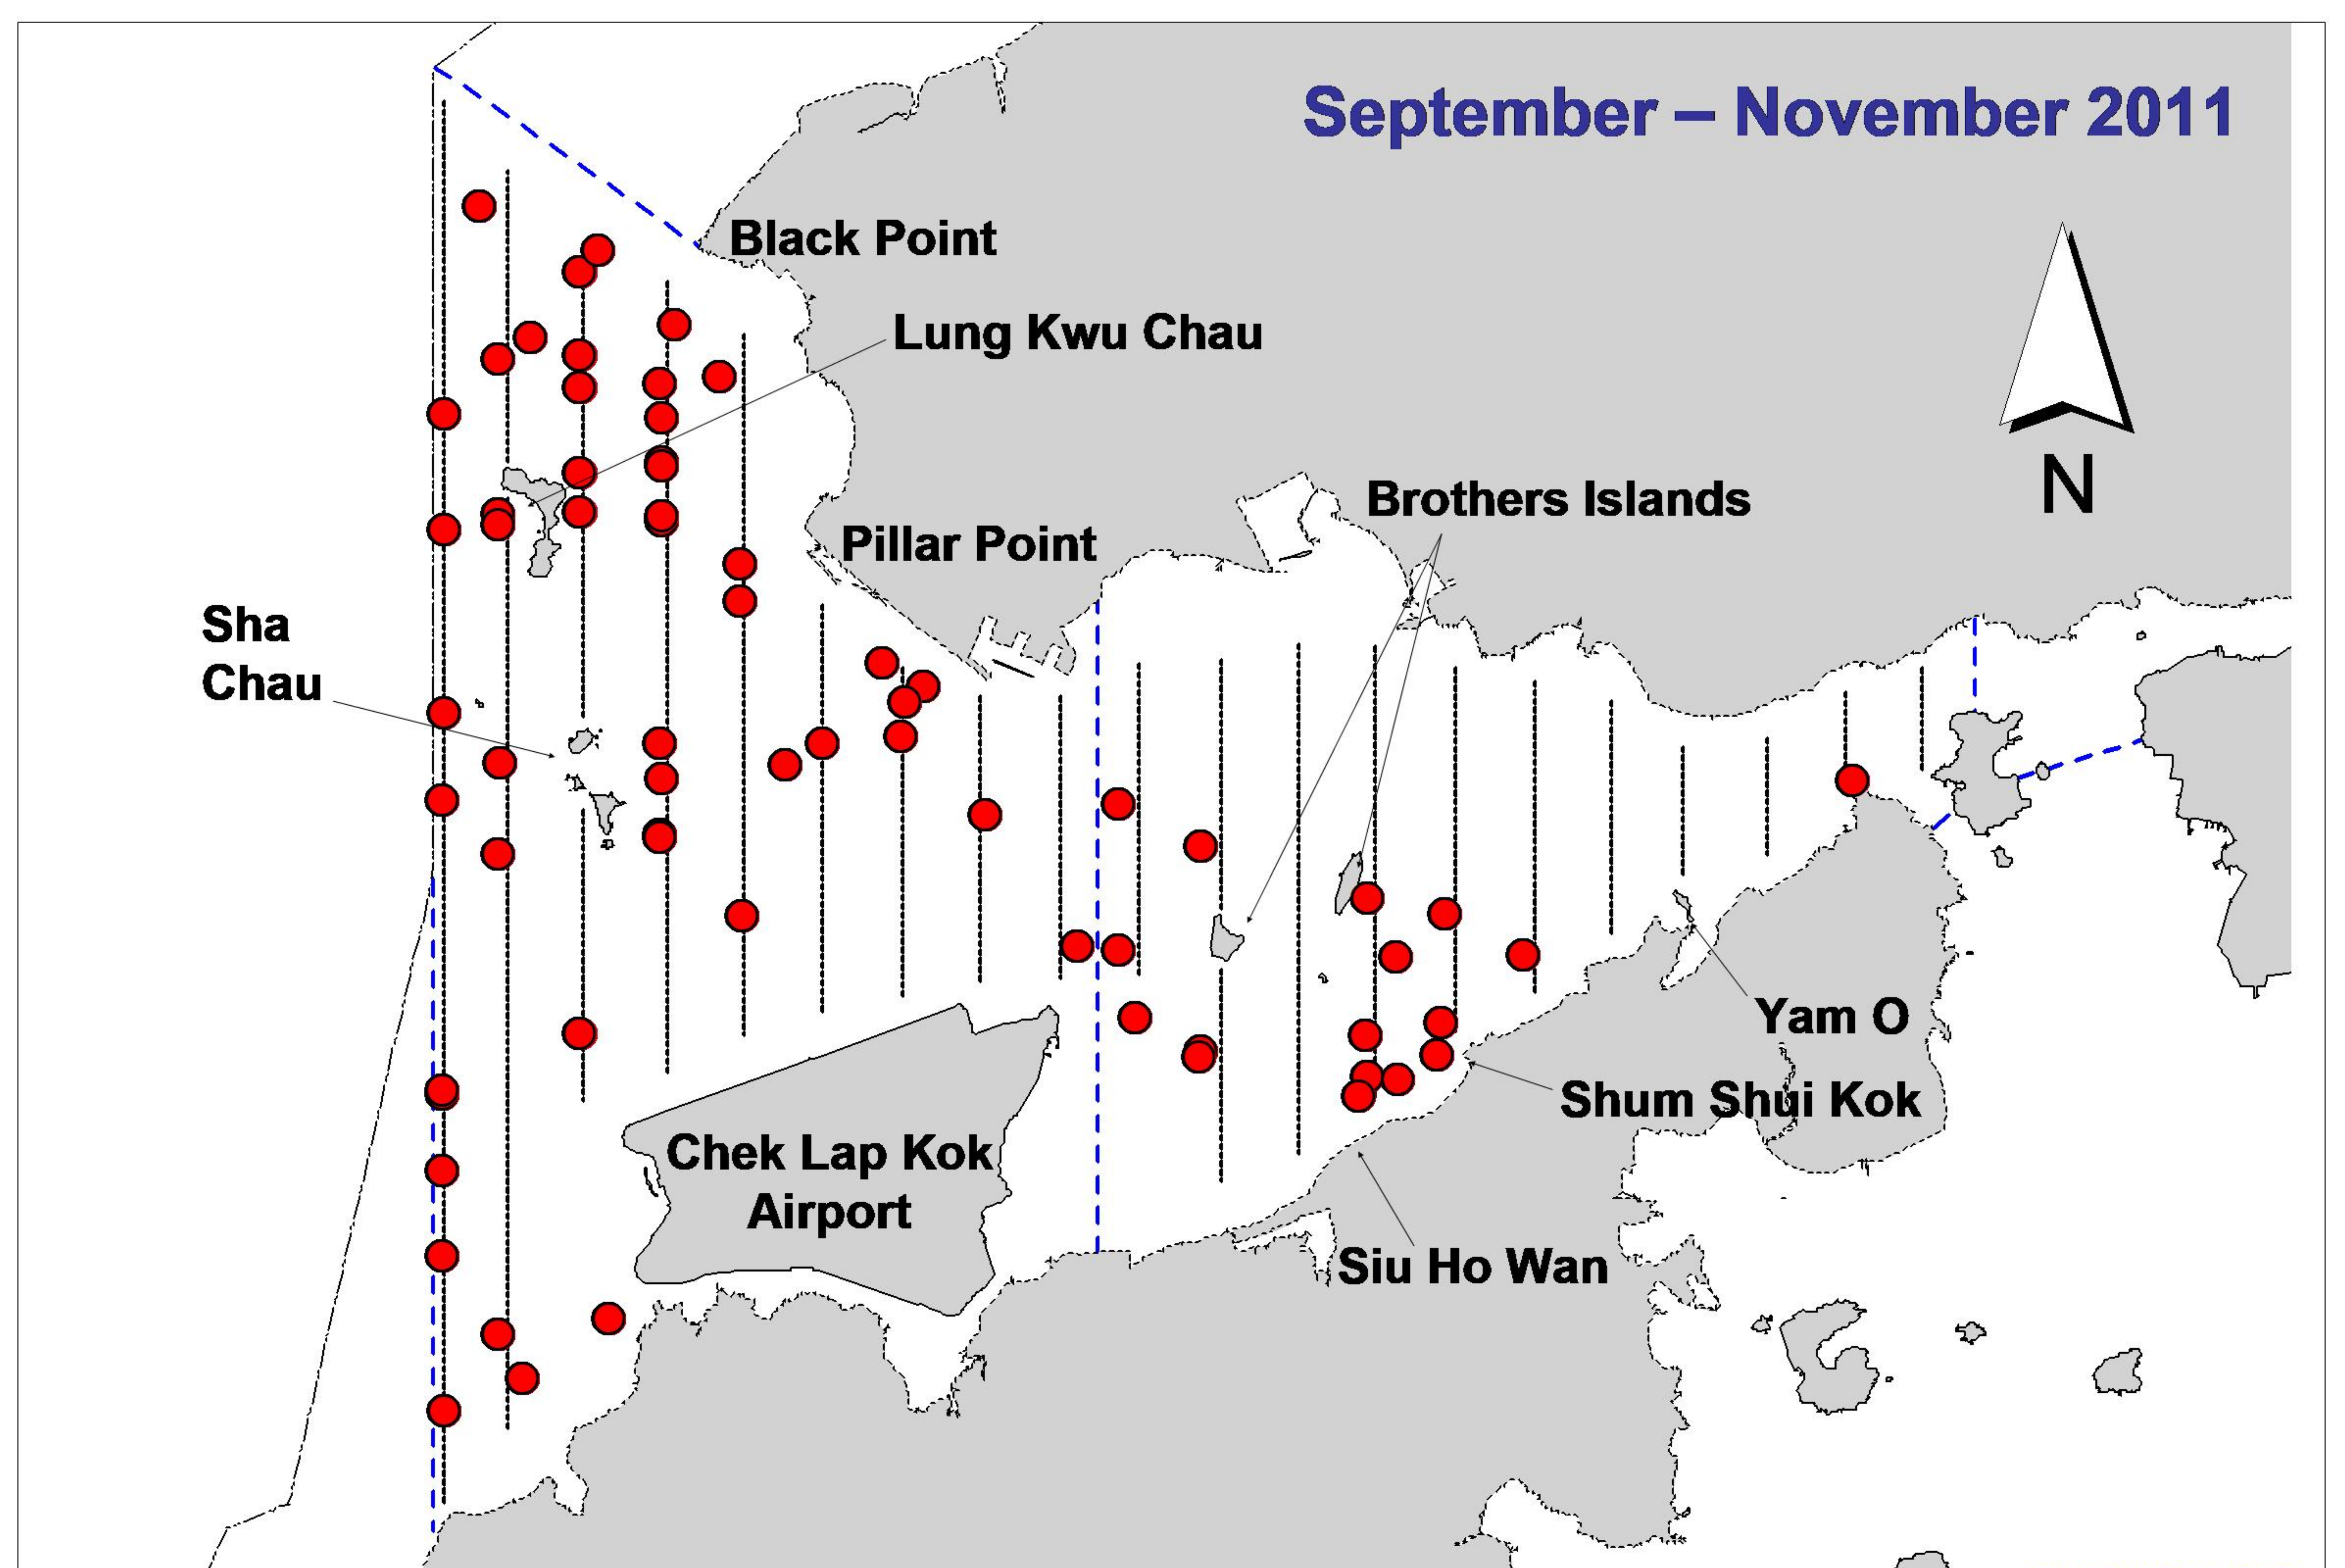
Figure 1. Distribution of Chinese white dolphin sighting in Northwest and Northeast Lantau during TMCLKL08/HKLR03 impact phase (top) and baseline monitoring surveys (bottom)
