**Contract No. HY/2013/04 Hong Kong-Zhuhai-Macao Bridge (HZMB)  
Hong Kong Boundary Crossing Facilities – Infrastructure Works Stage II  
(Southern Portion)**

**Quarterly EM&A Report for September to November 2019 (Revision 0)**

**Contract No. HY/2013/04 – HZMB HKBCF – Infrastructure Works Stage II  
(Southern Portion)  
Quarterly EM&A Report for September 2019 to November 2019**

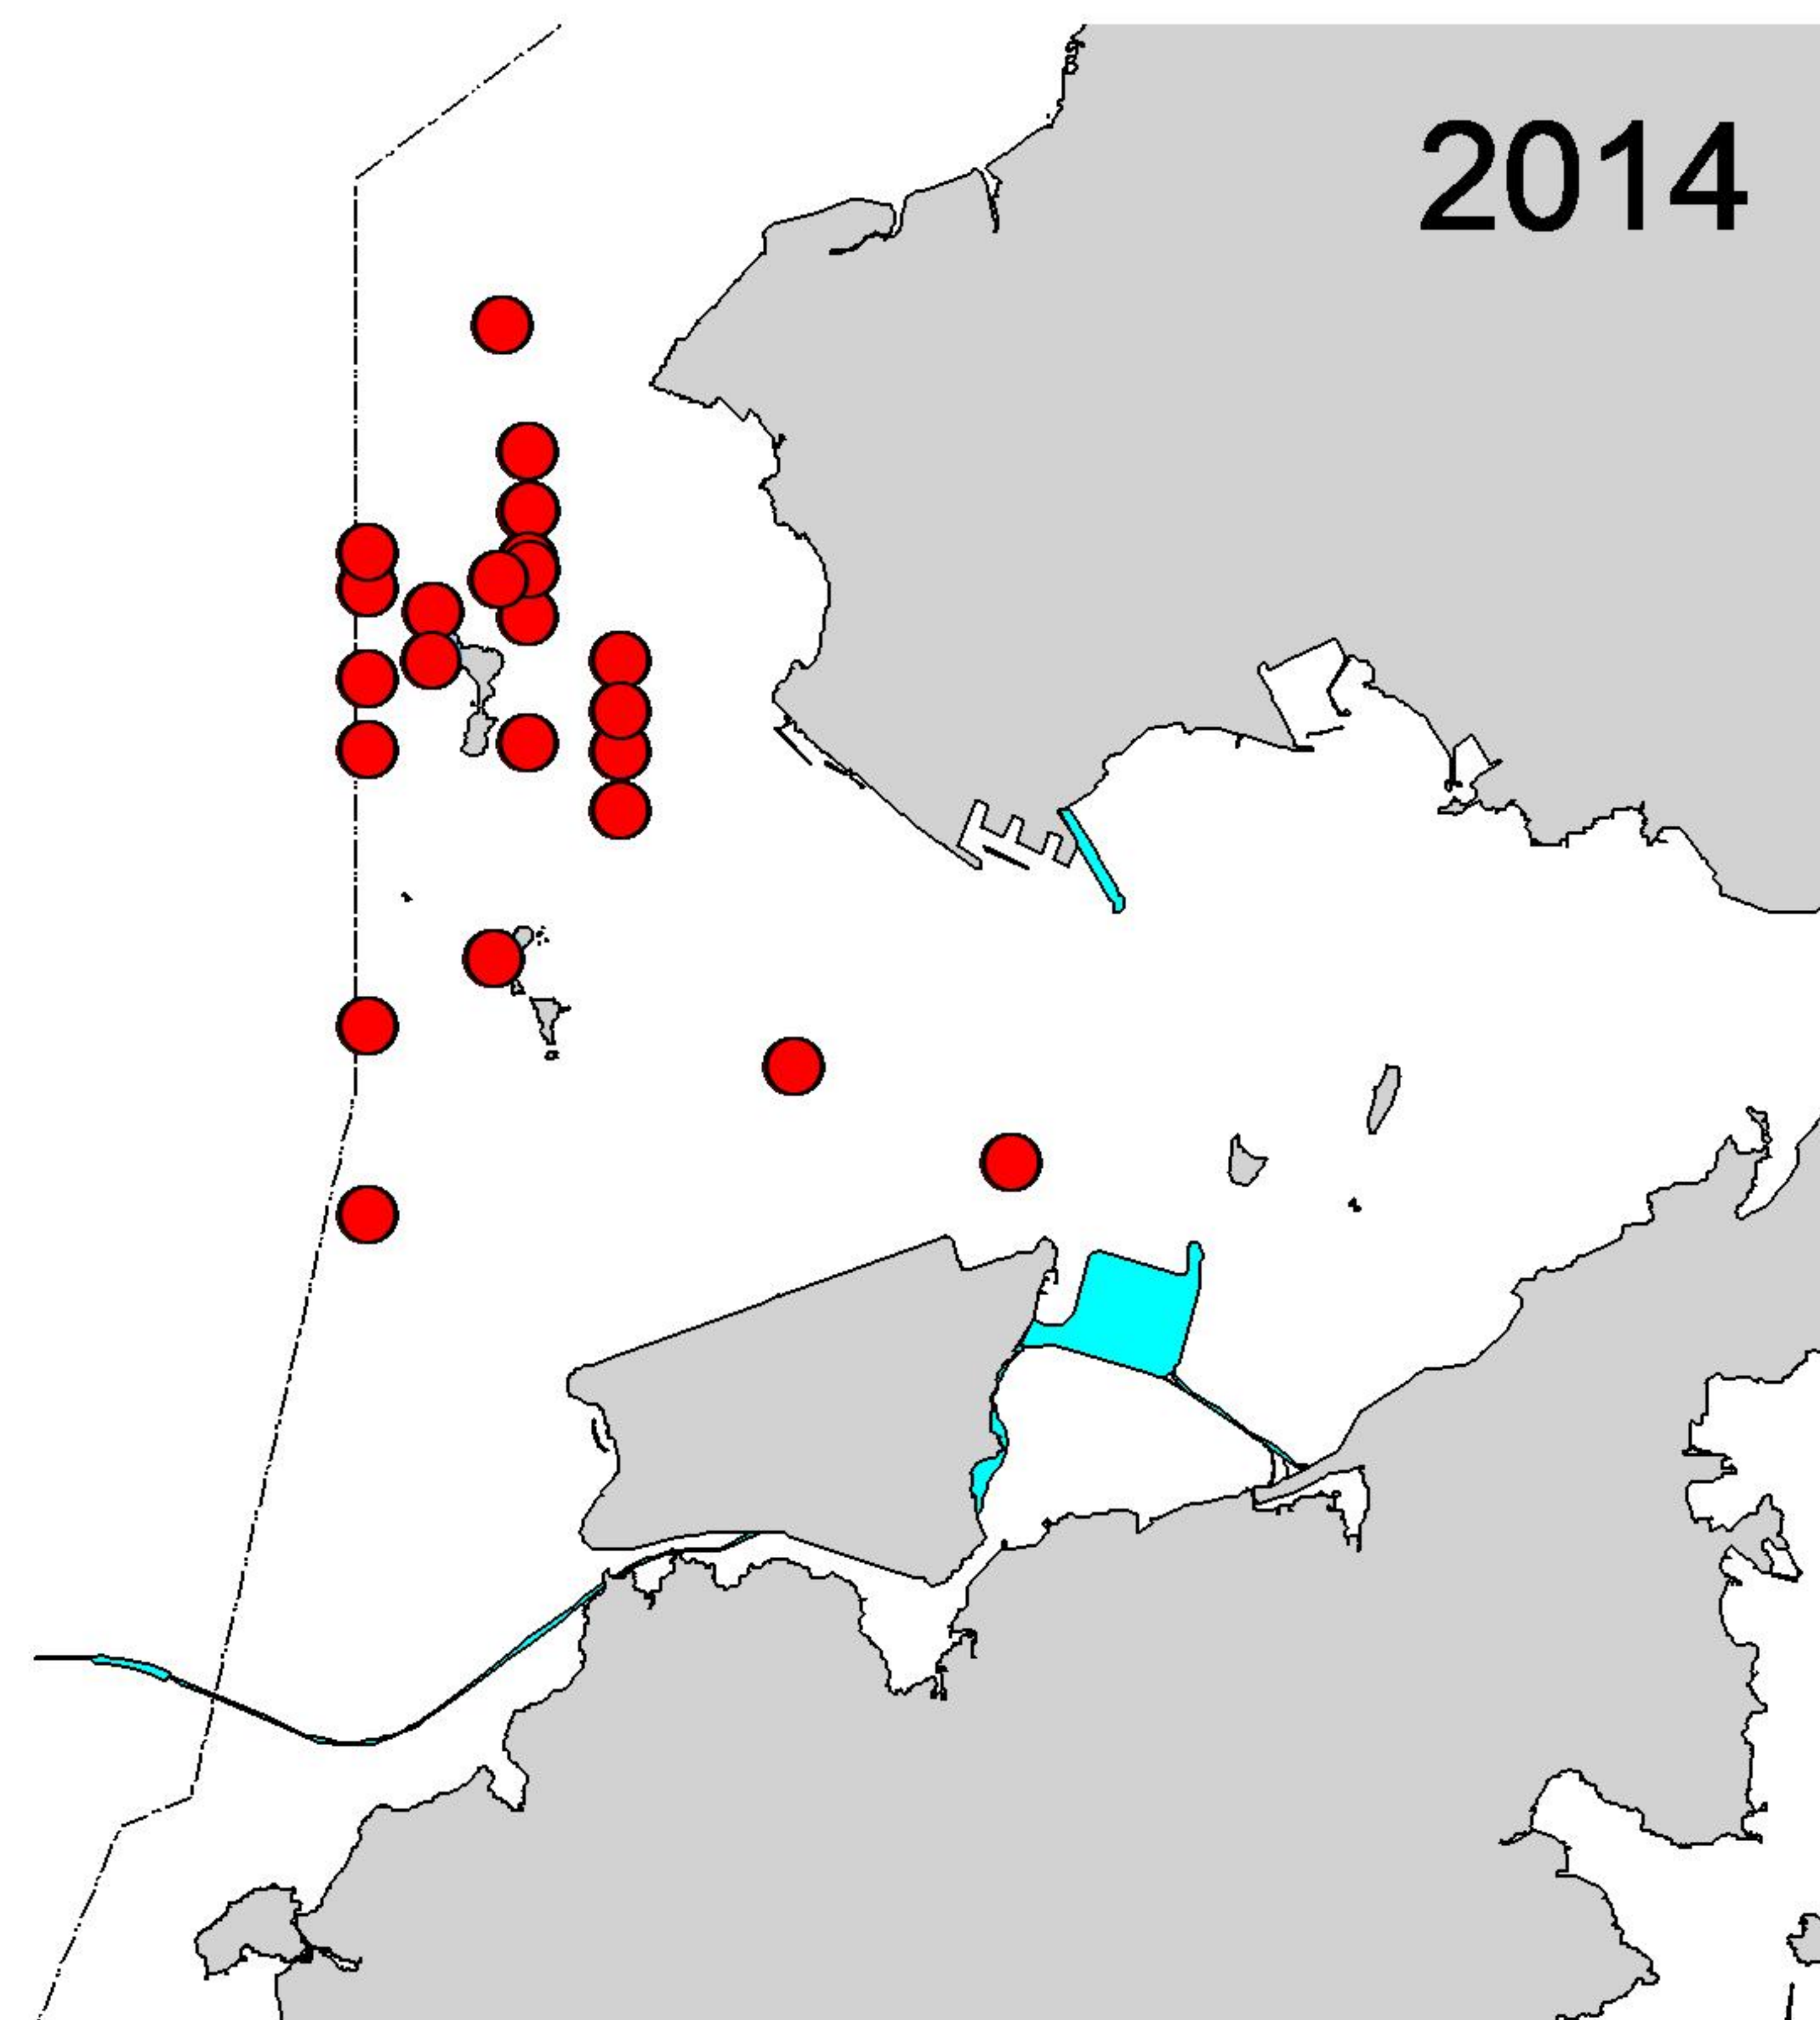
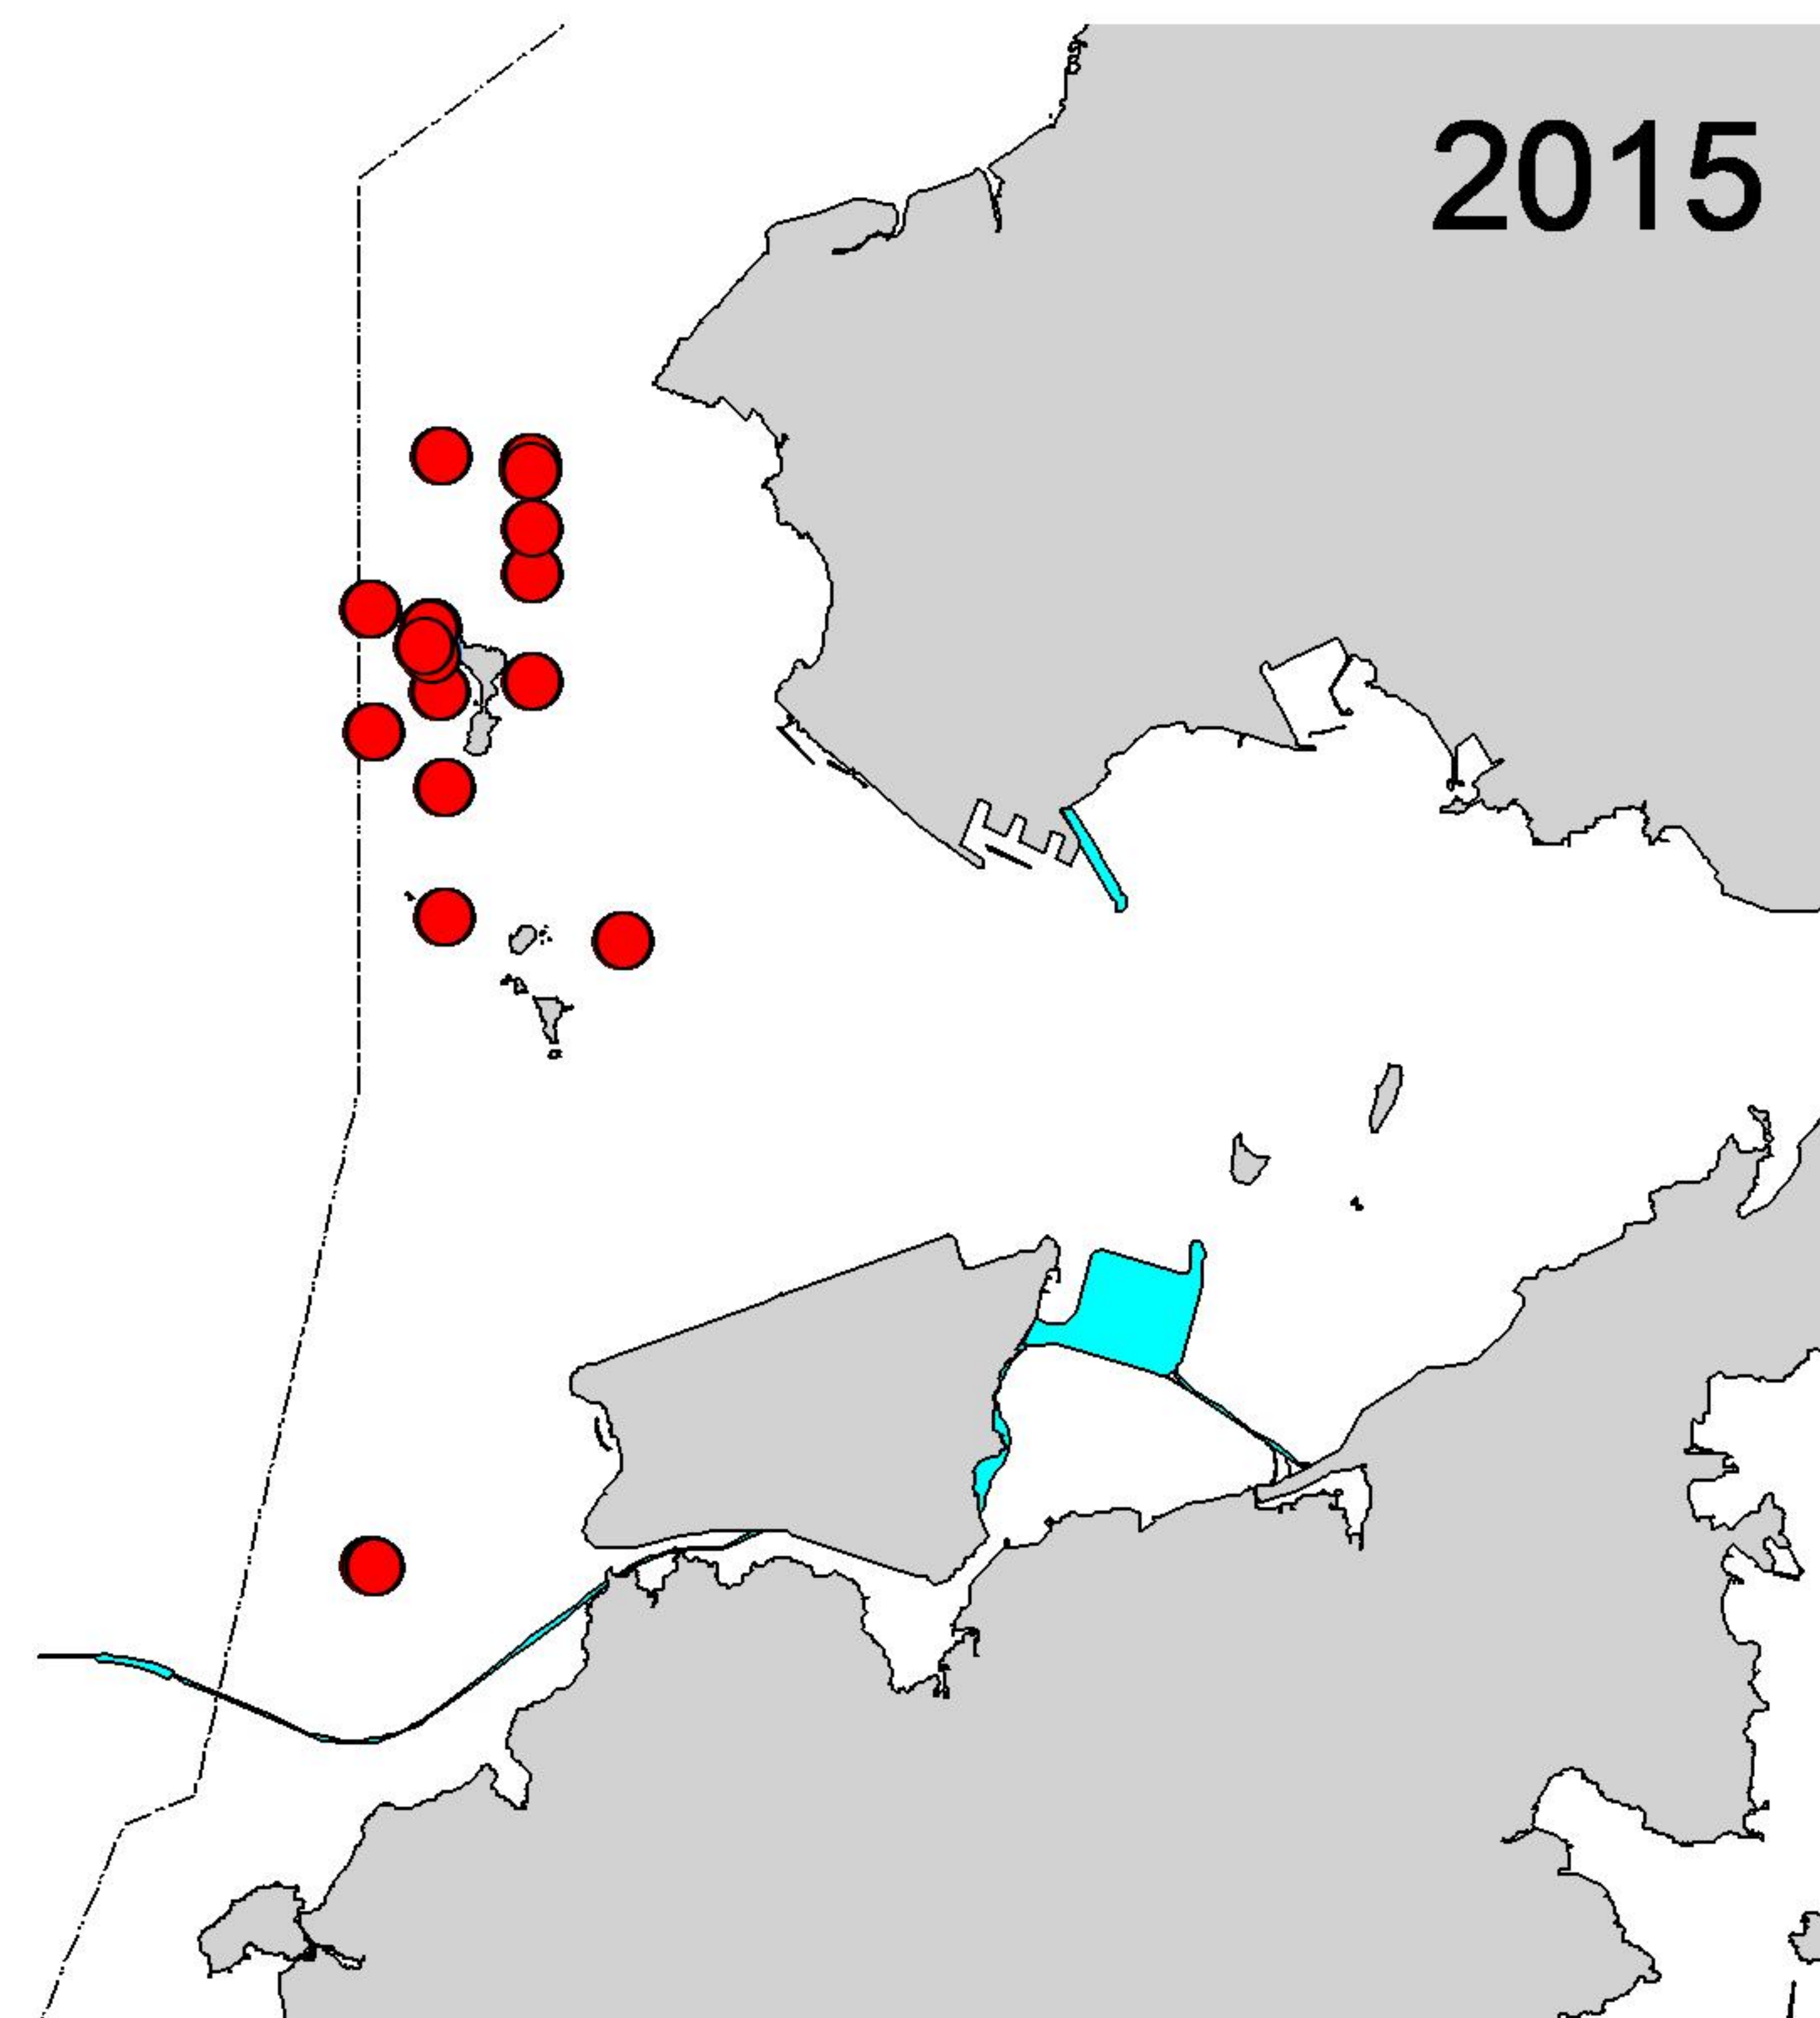
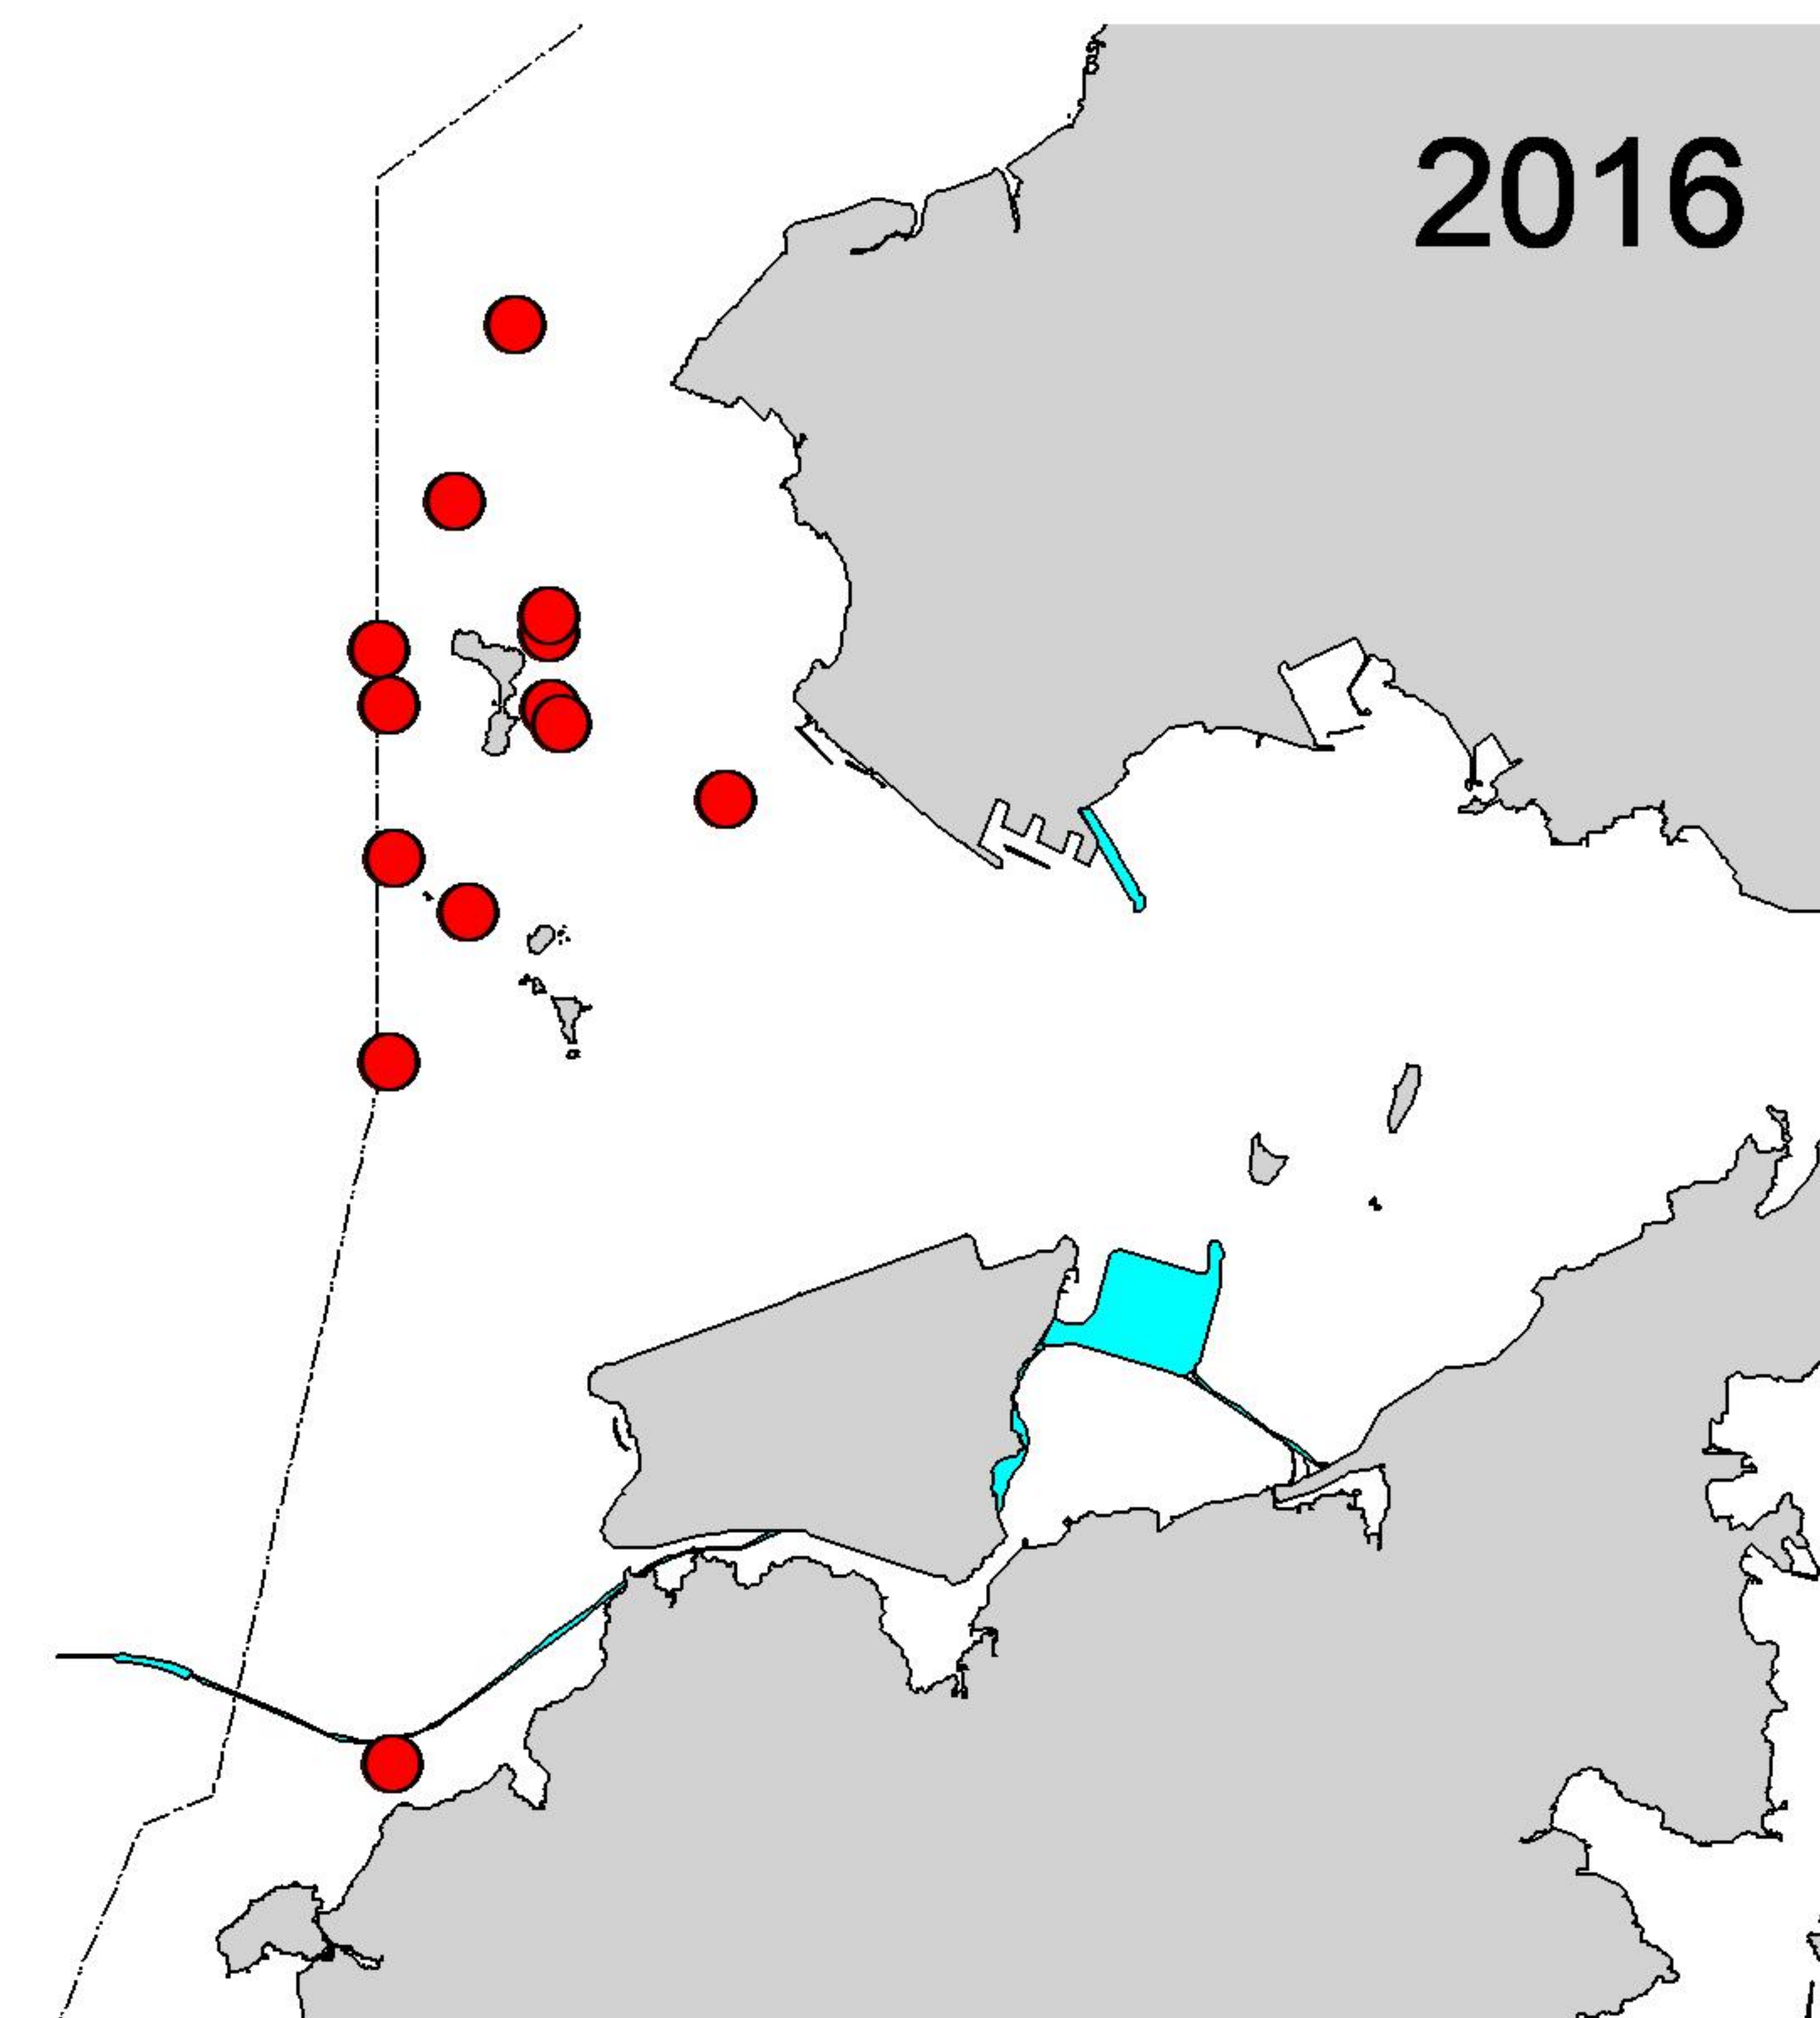
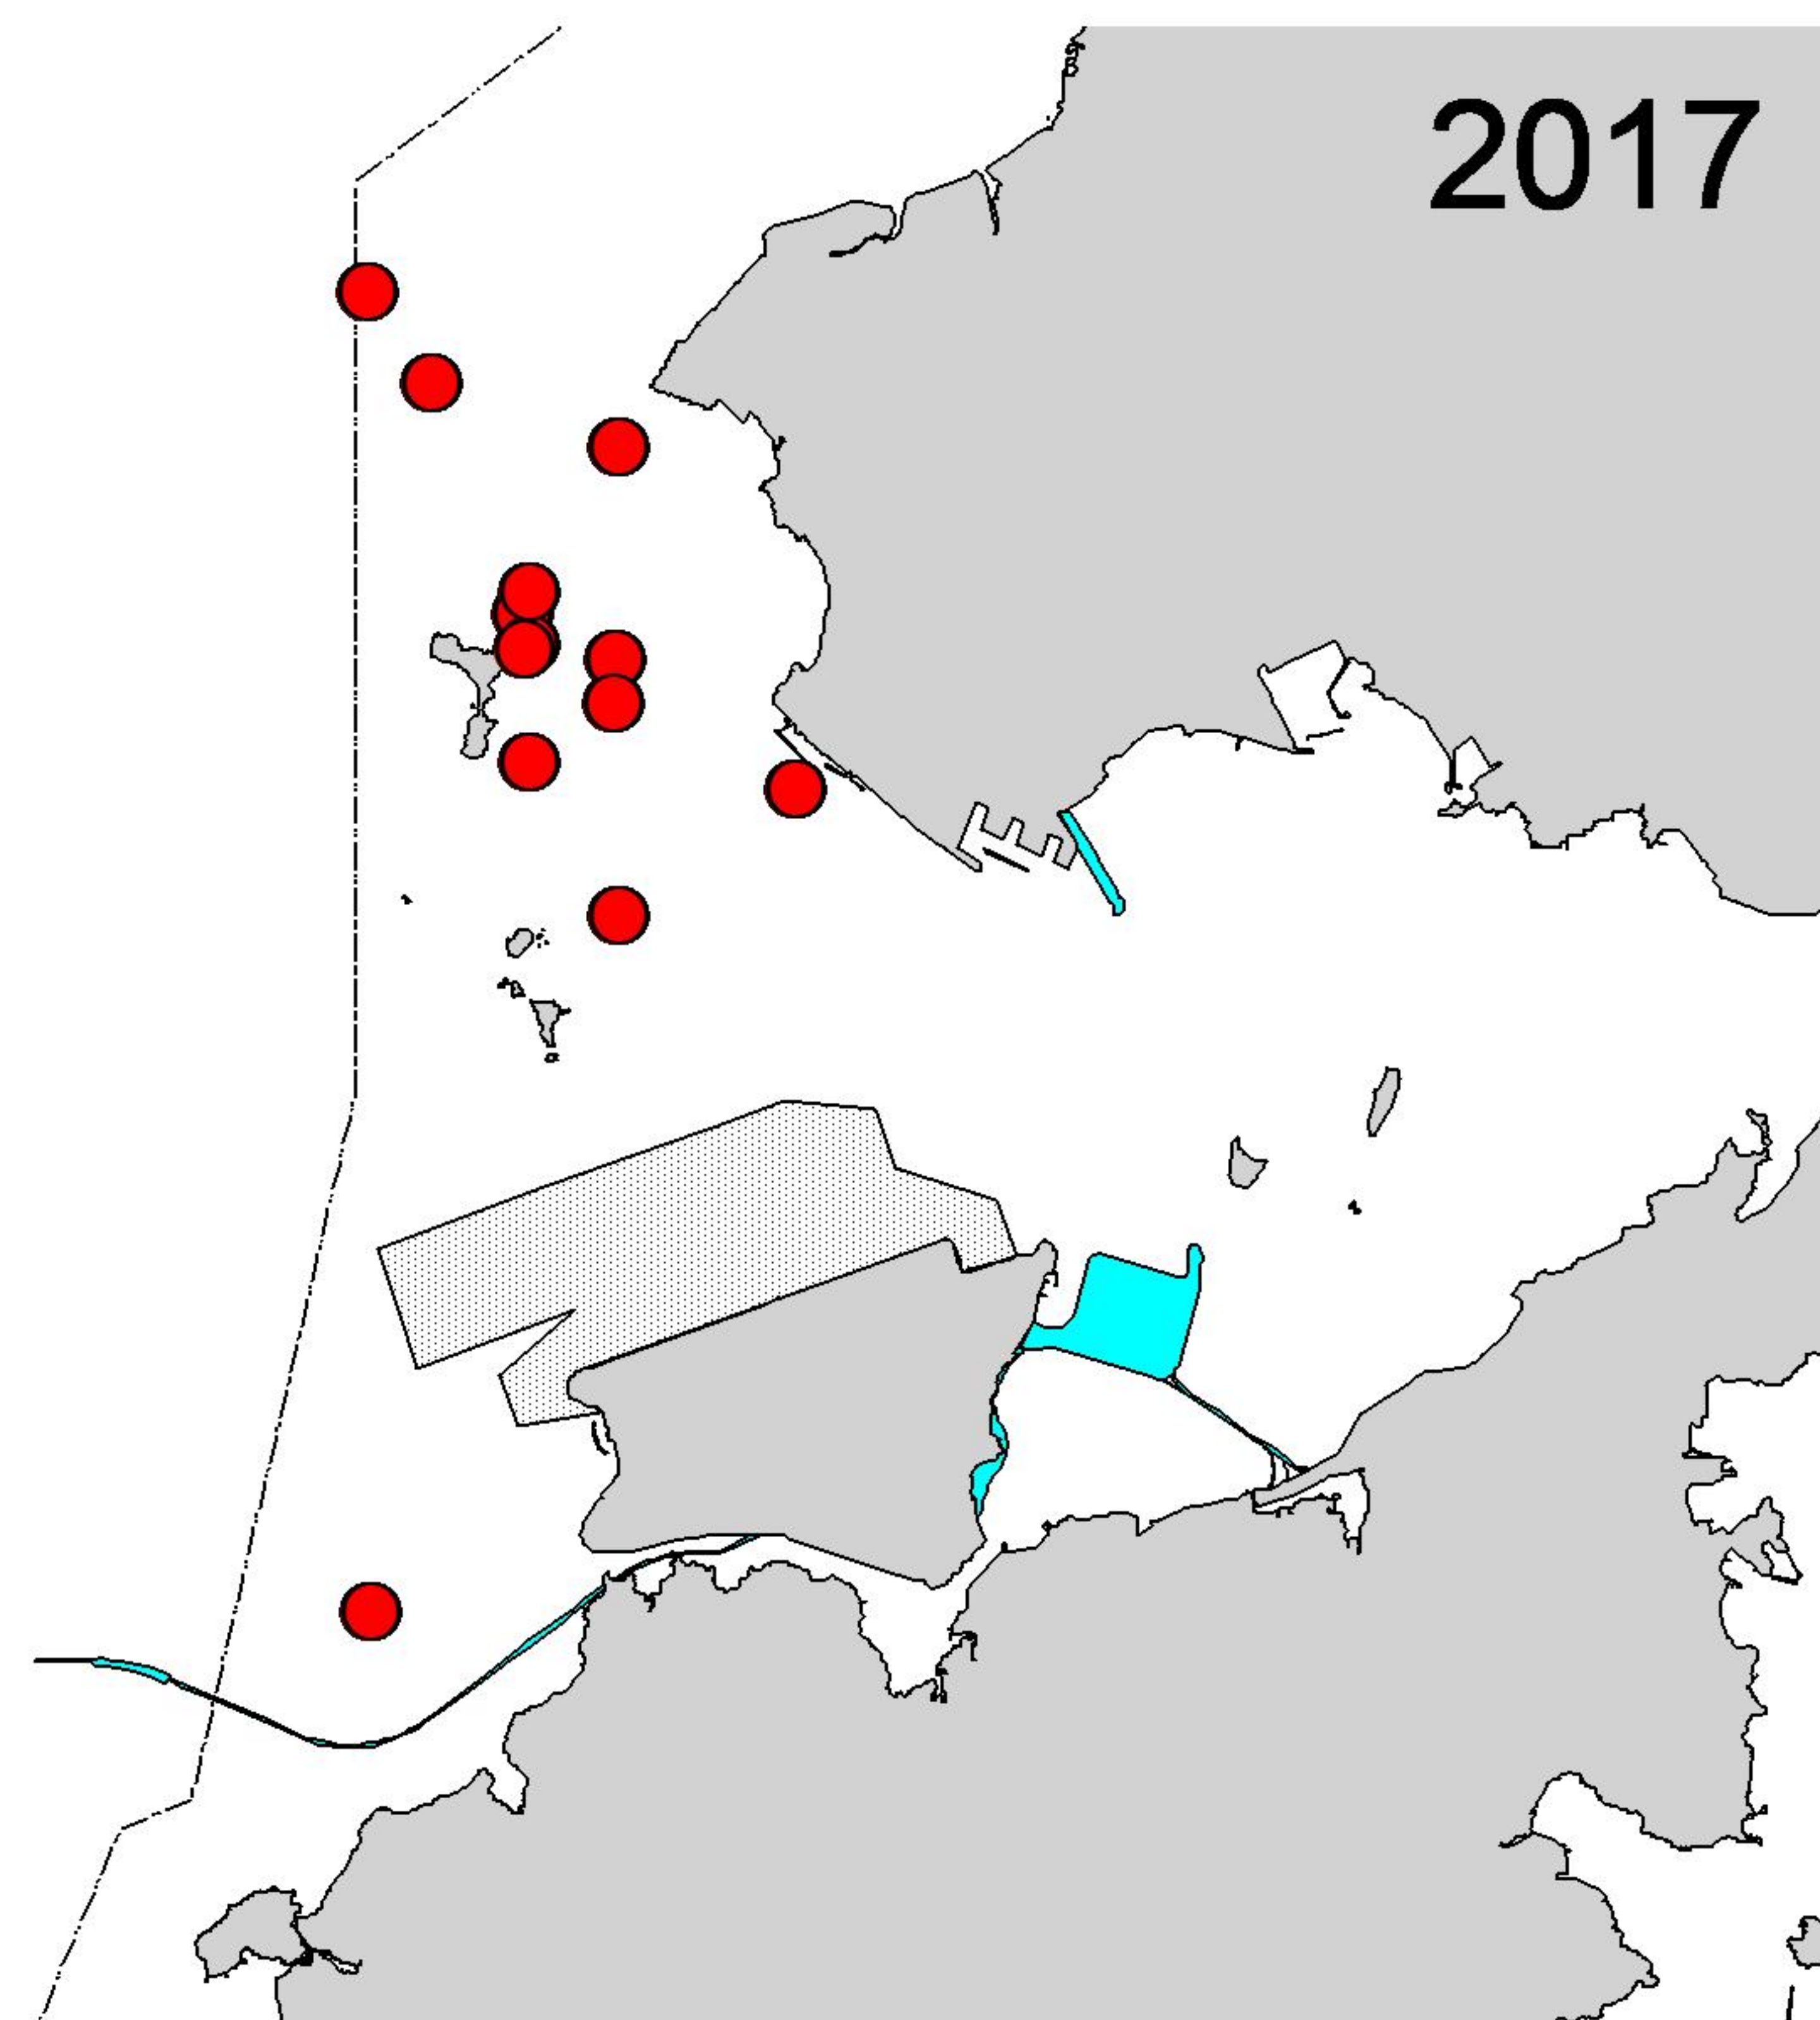
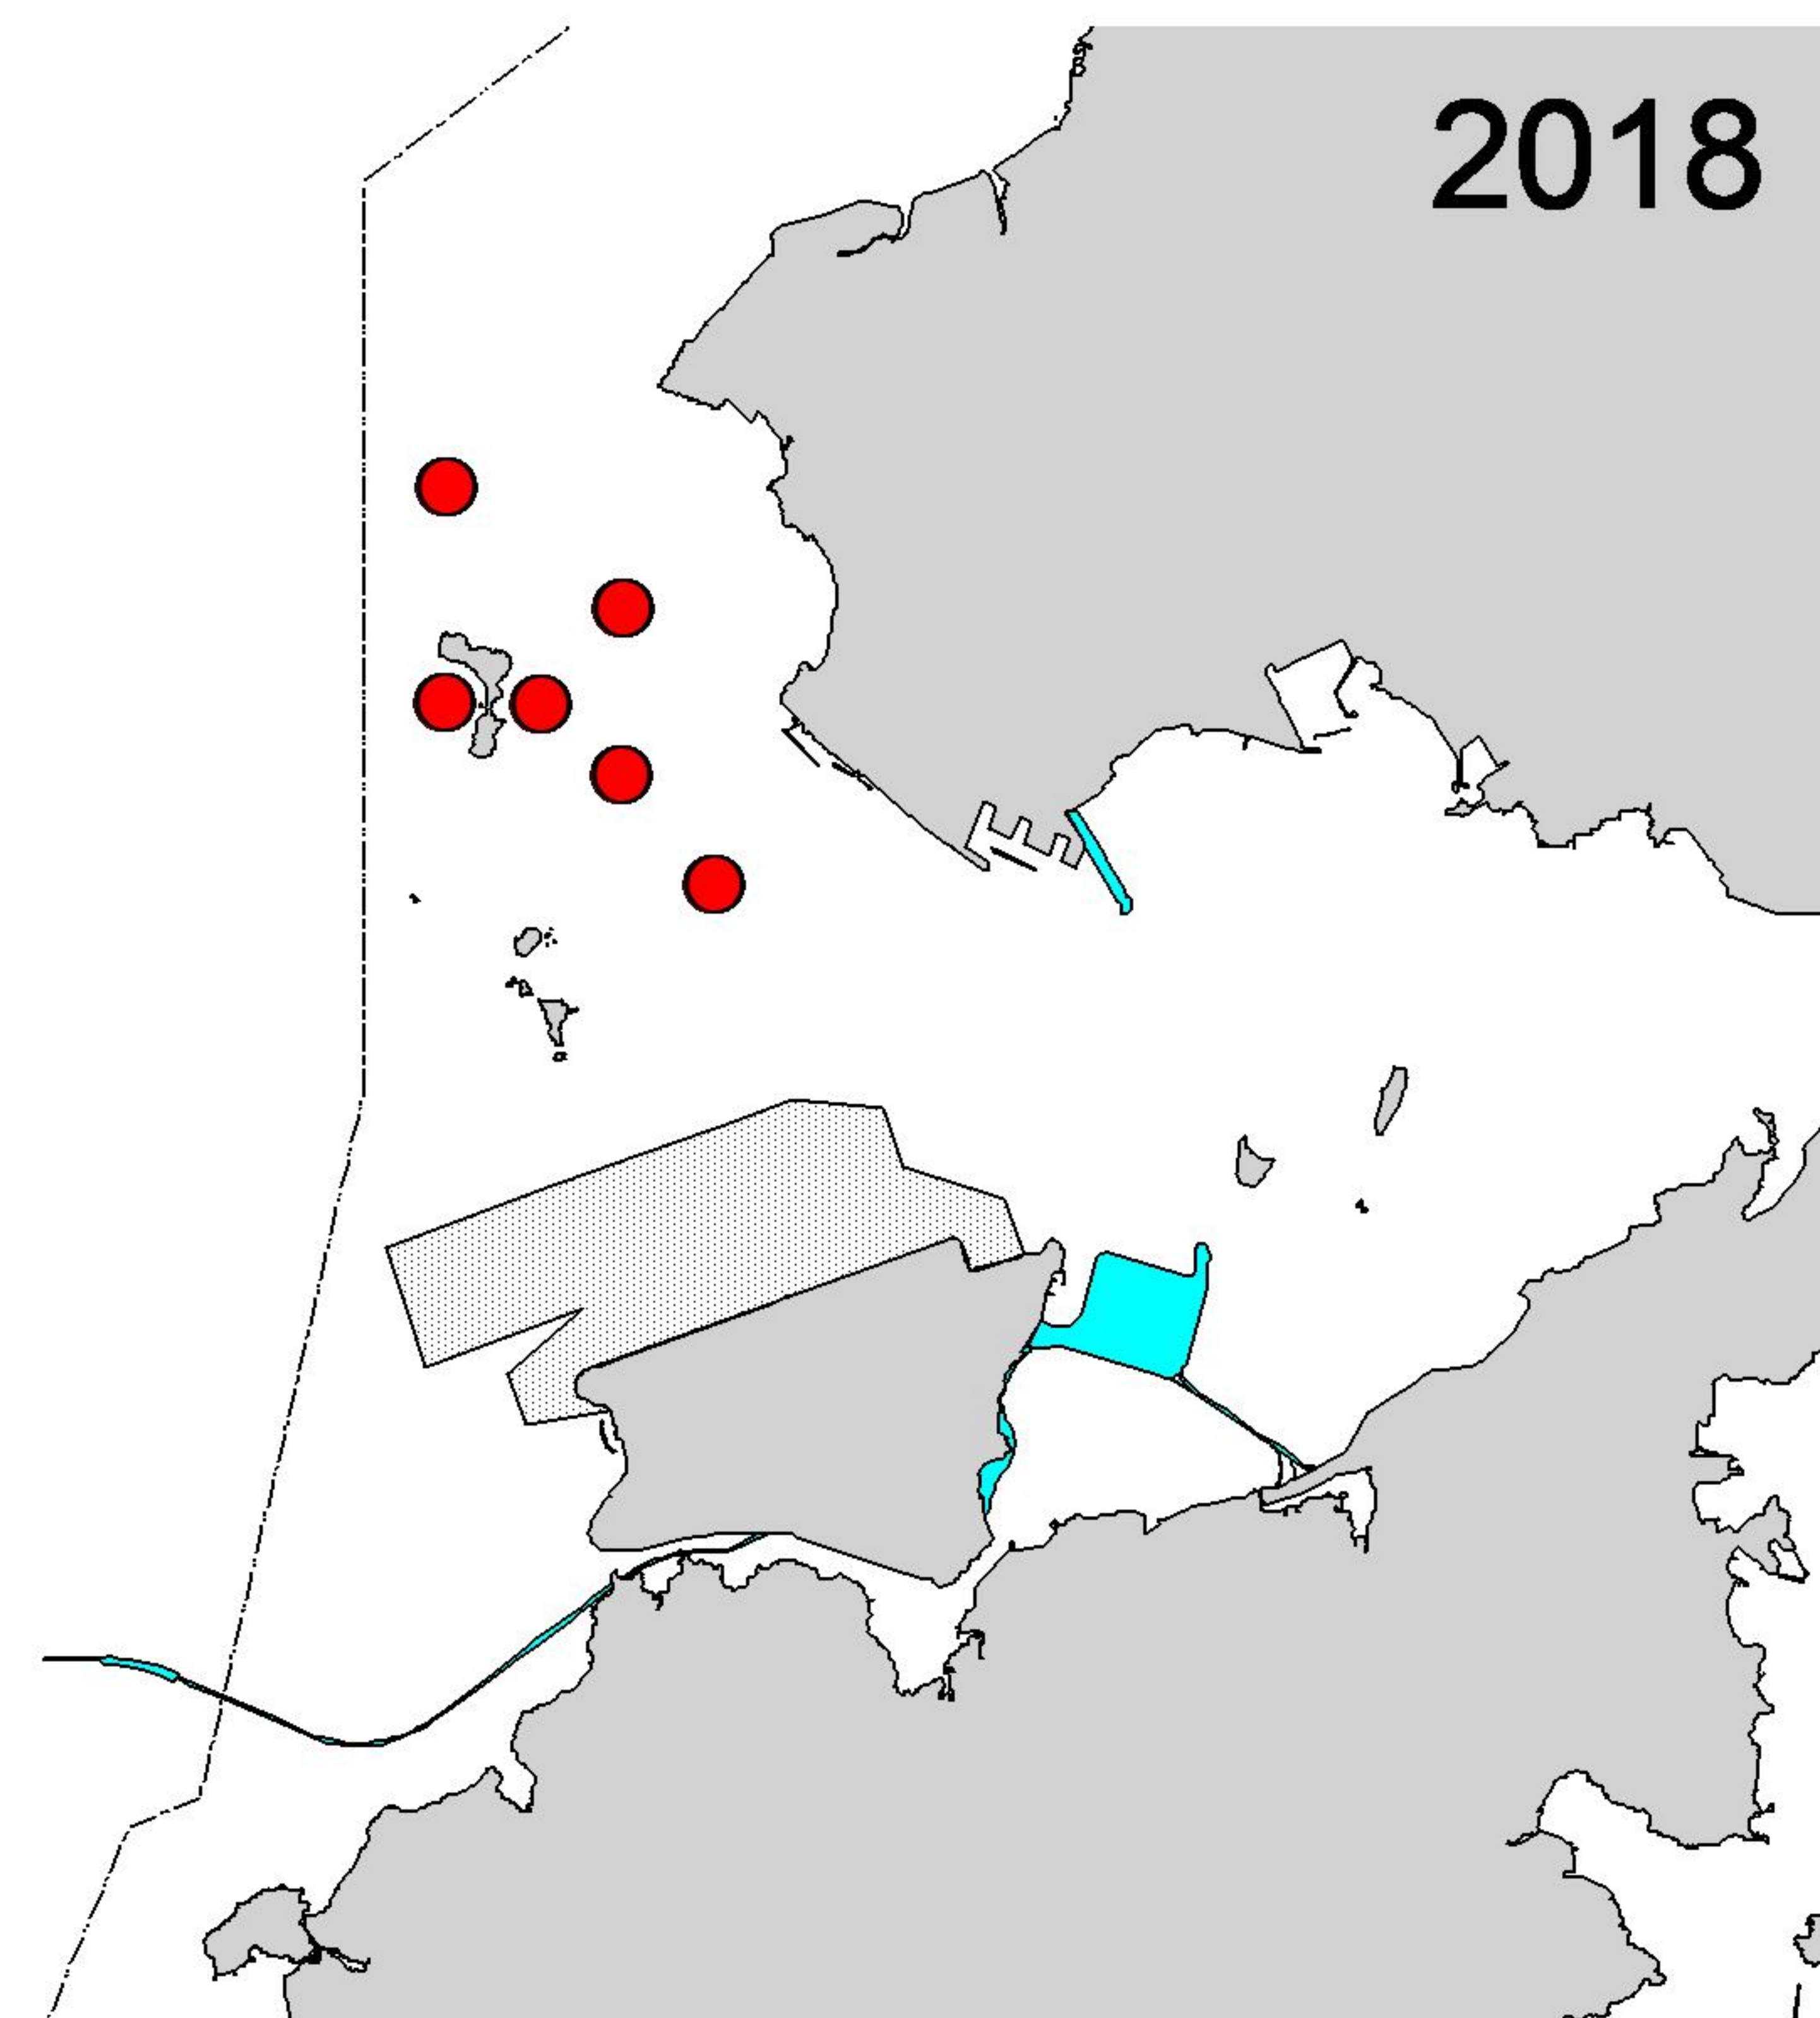
Figure 2. Distribution of Chinese white dolphin sightings in Northwest and Northeast Lantau during the past six autumn quarters (September-November) of TMCLKL08/HKLR03 impact phase in 2014-19

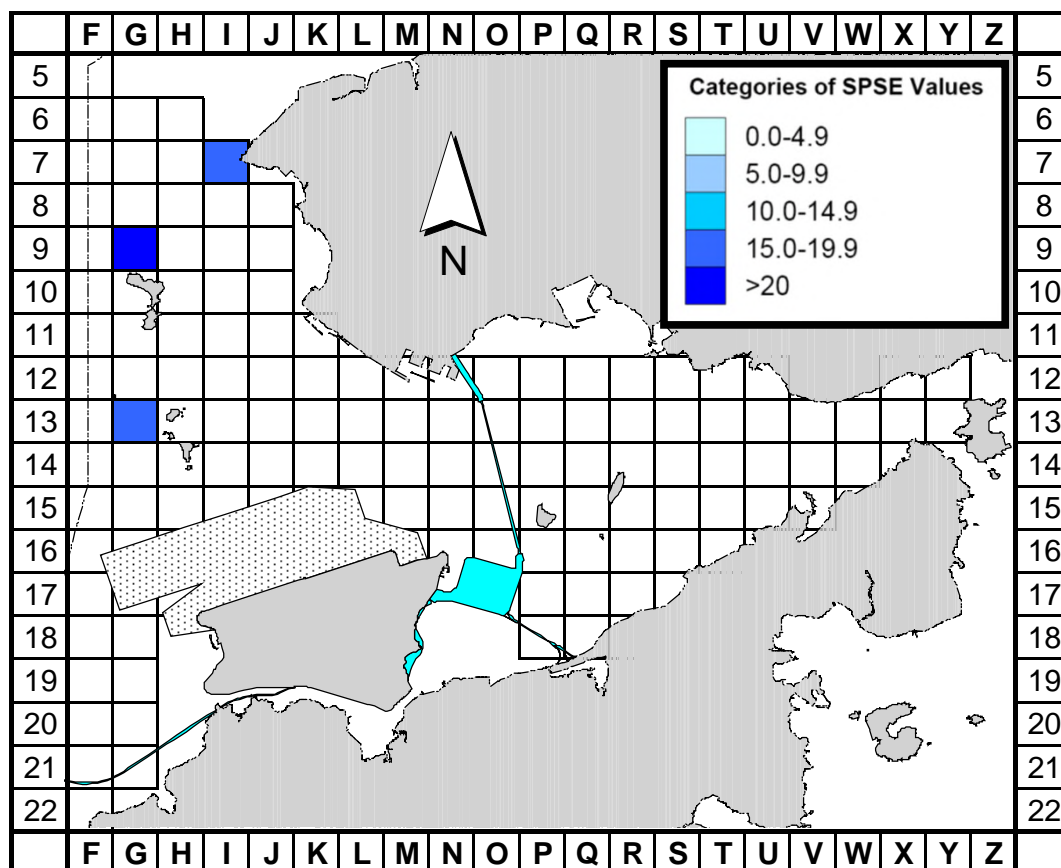
Figure 3a. Sighting density of Chinese white dolphins with corrected survey effort per km<sup>2</sup> in Northeast and Northwest Lantau survey areas, using data collected during TMCLKL08/HKLR03 impact monitoring period (September-November 2019) (SPSE = no. of on-effort sightings per 100 units of survey effort)

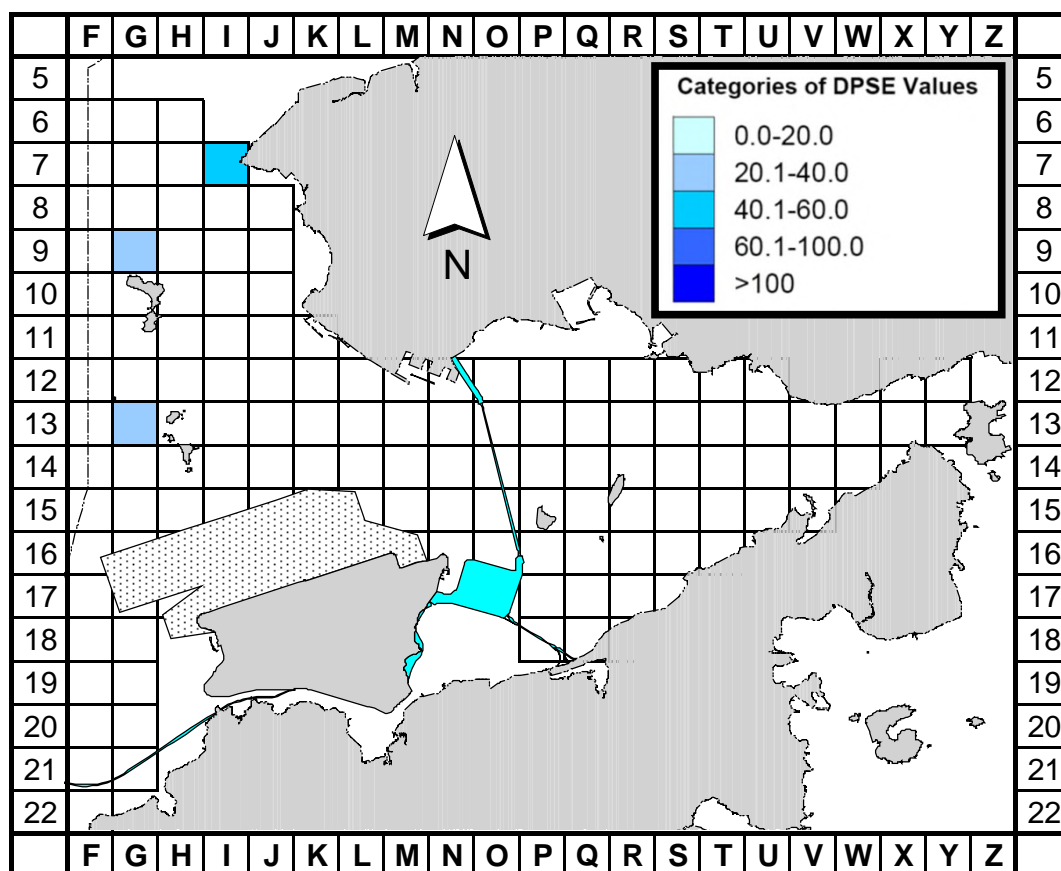
Figure 3b. Density of Chinese white dolphins with corrected survey effort per km<sup>2</sup> in Northeast and Northwest Lantau survey areas, using data collected during TMCLKL08/HKLR03 impact monitoring period (September-November 2019) (DPSE = no. of dolphins per 100 units of survey effort)

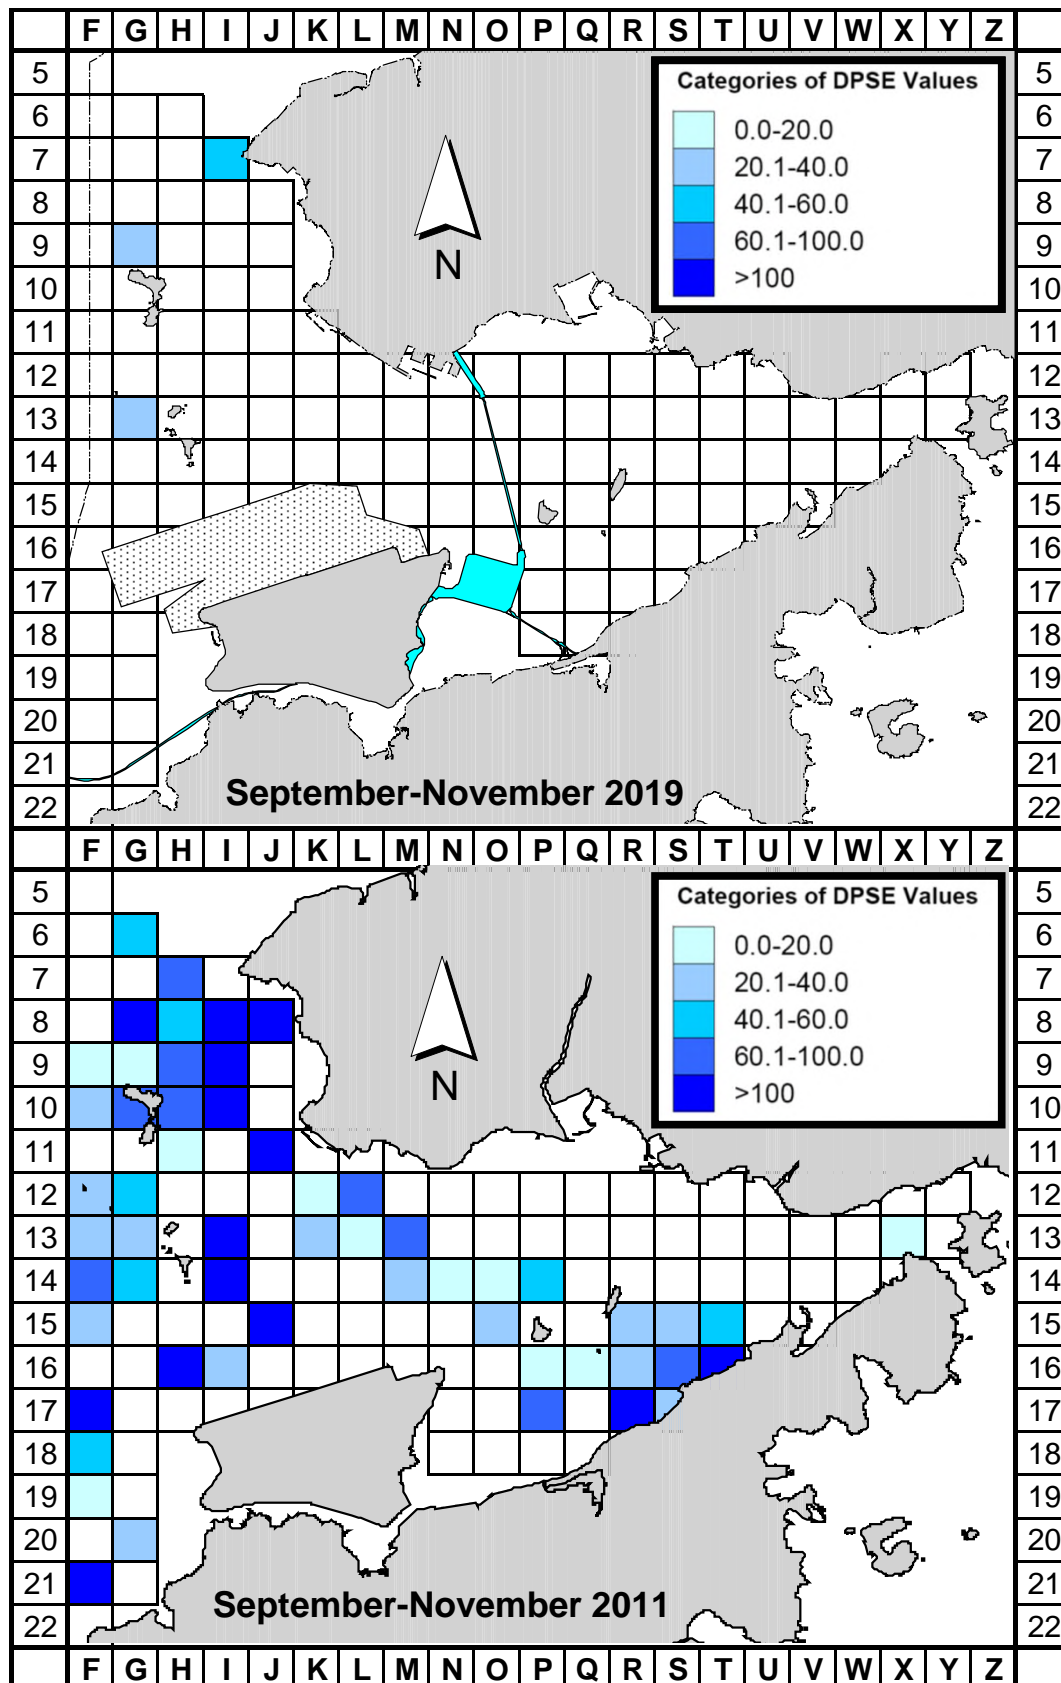
Figure 4. Comparison of density of Chinese white dolphins with corrected survey effort per km<sup>2</sup> in Northwest and Northeast Lantau survey area between the impact monitoring period (September - November 2019) and baseline monitoring period (September-November 2011) (DPSE = no. of dolphins per 100 units of survey effort)
