**Contract No. HY/2013/04 Hong Kong-Zhuhai-Macao Bridge (HZMB)  
Hong Kong Boundary Crossing Facilities – Infrastructure Works Stage II  
(Southern Portion)**

**Quarterly EM&A Report for September to November 2019 (Revision 0)**

**Contract No. HY/2013/04 – HZMB HKBCF – Infrastructure Works Stage II  
(Southern Portion)  
Quarterly EM&A Report for September 2019 to November 2019**

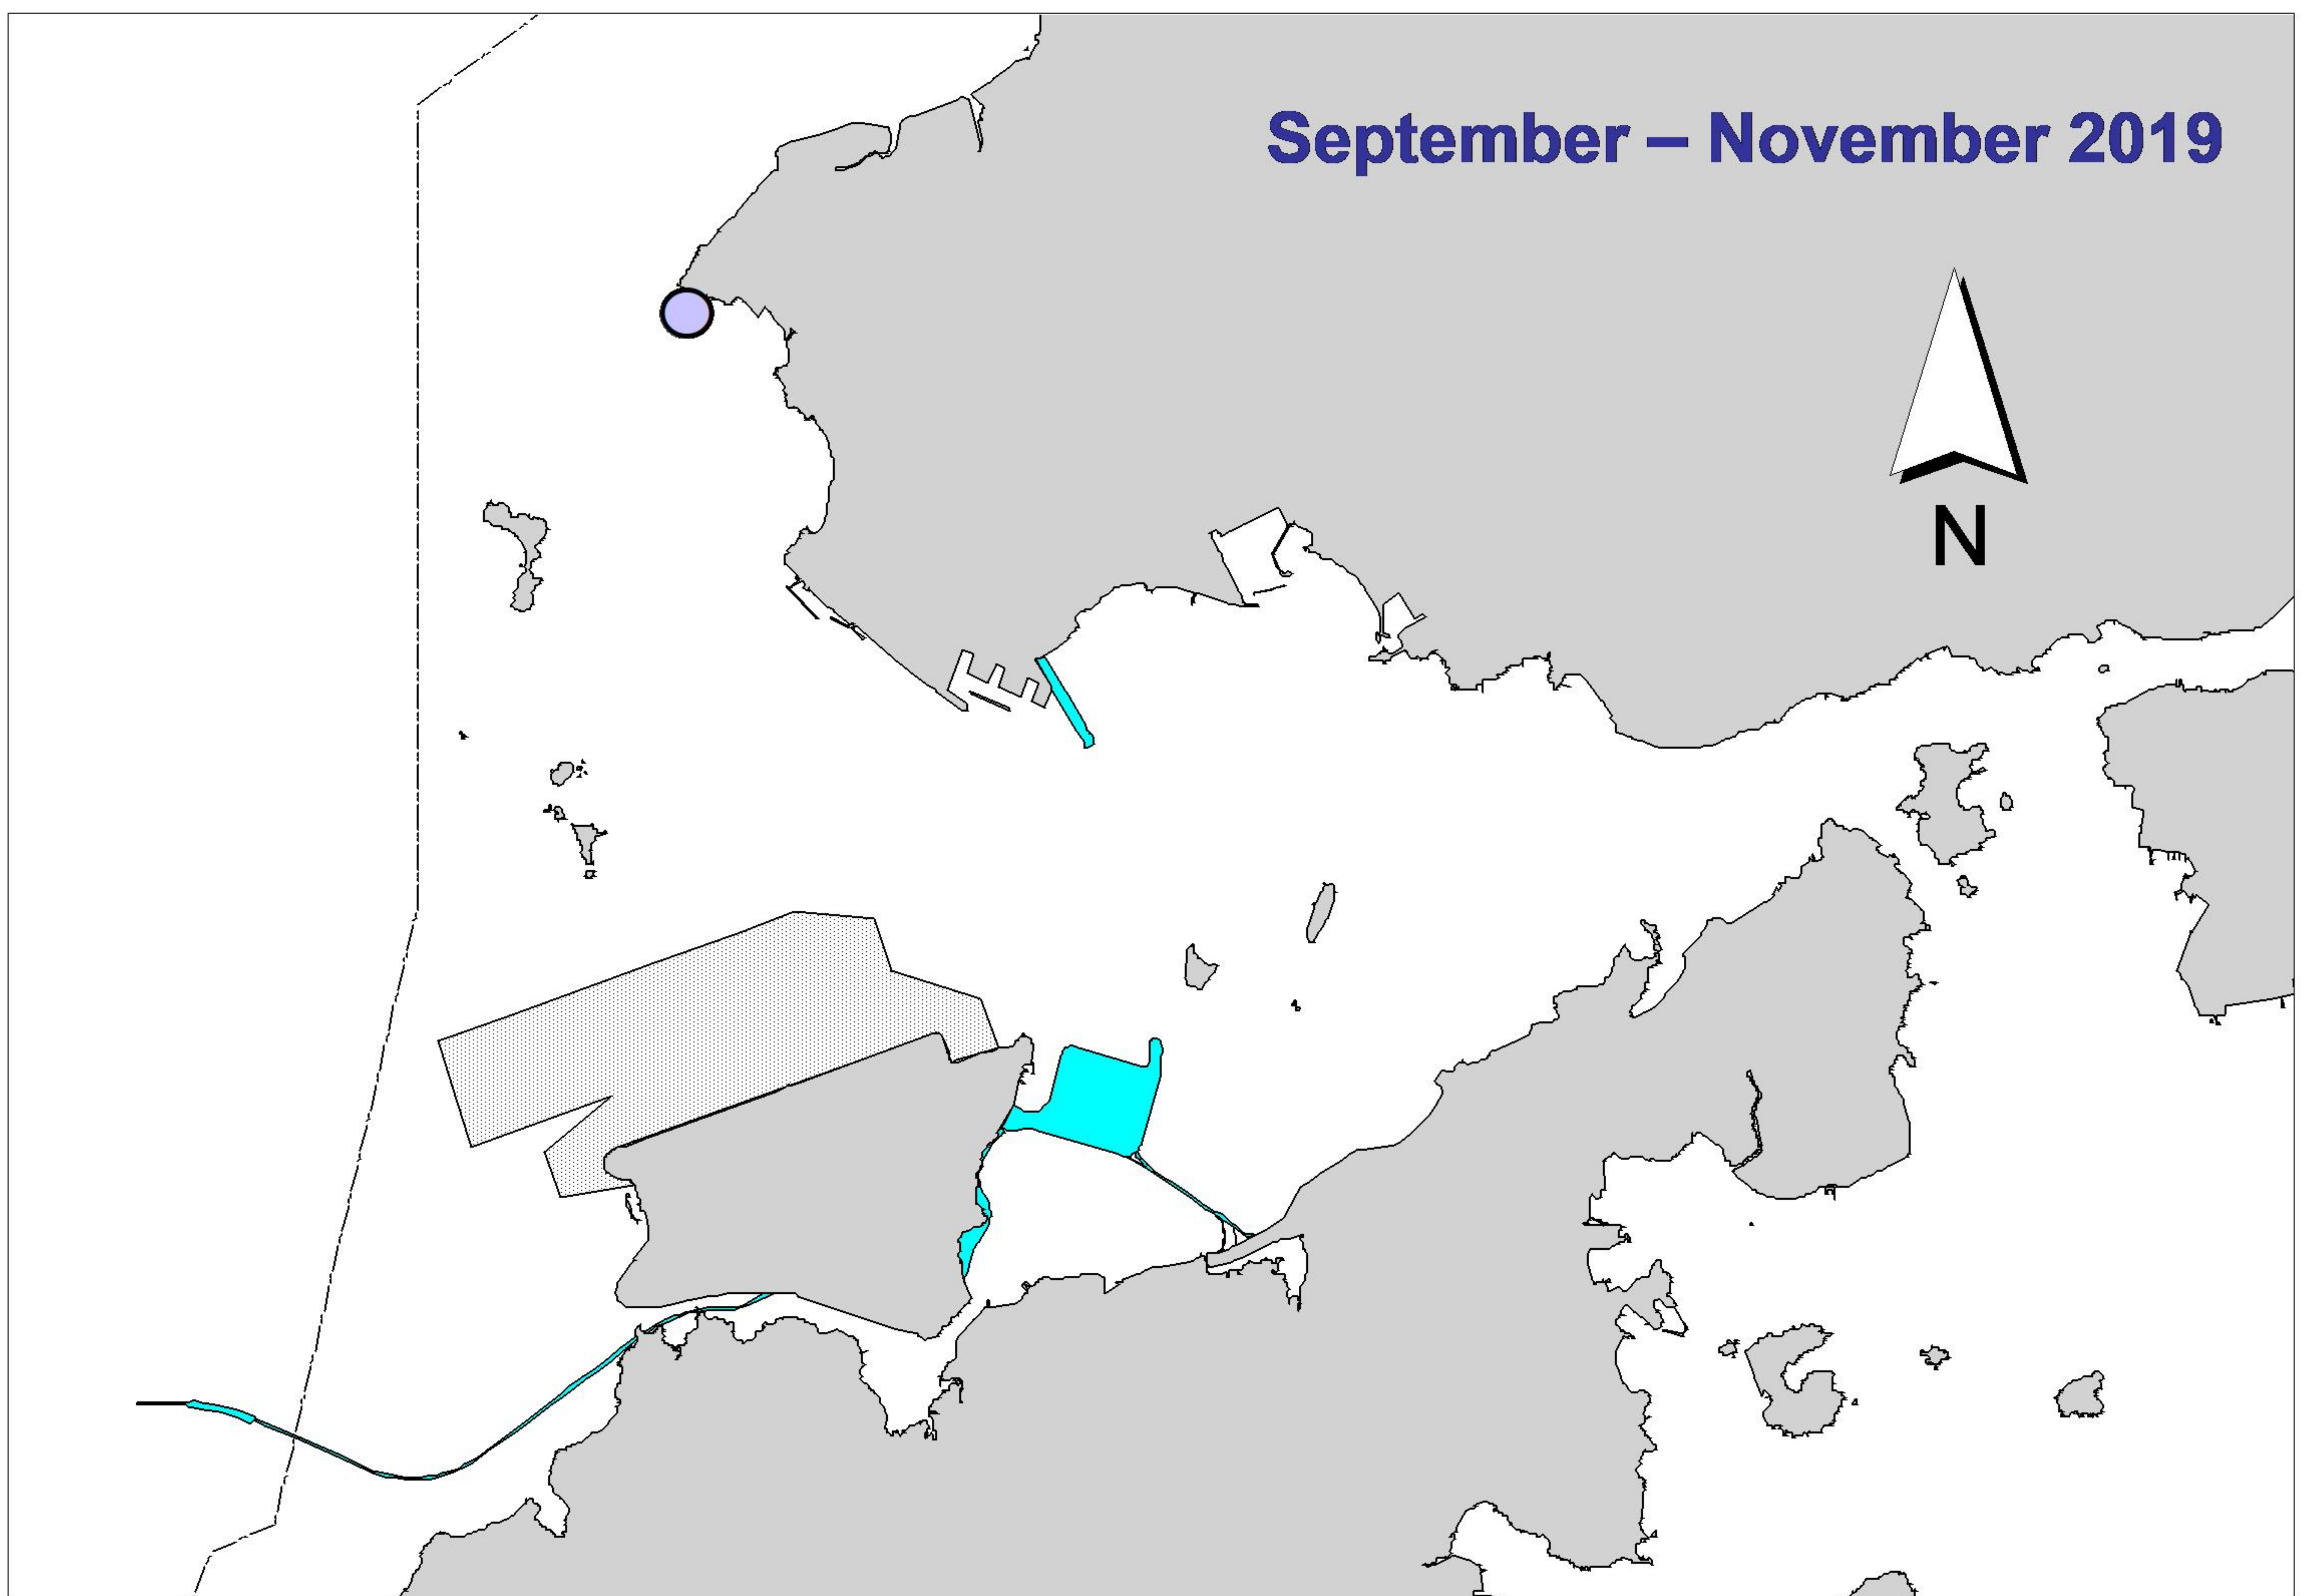
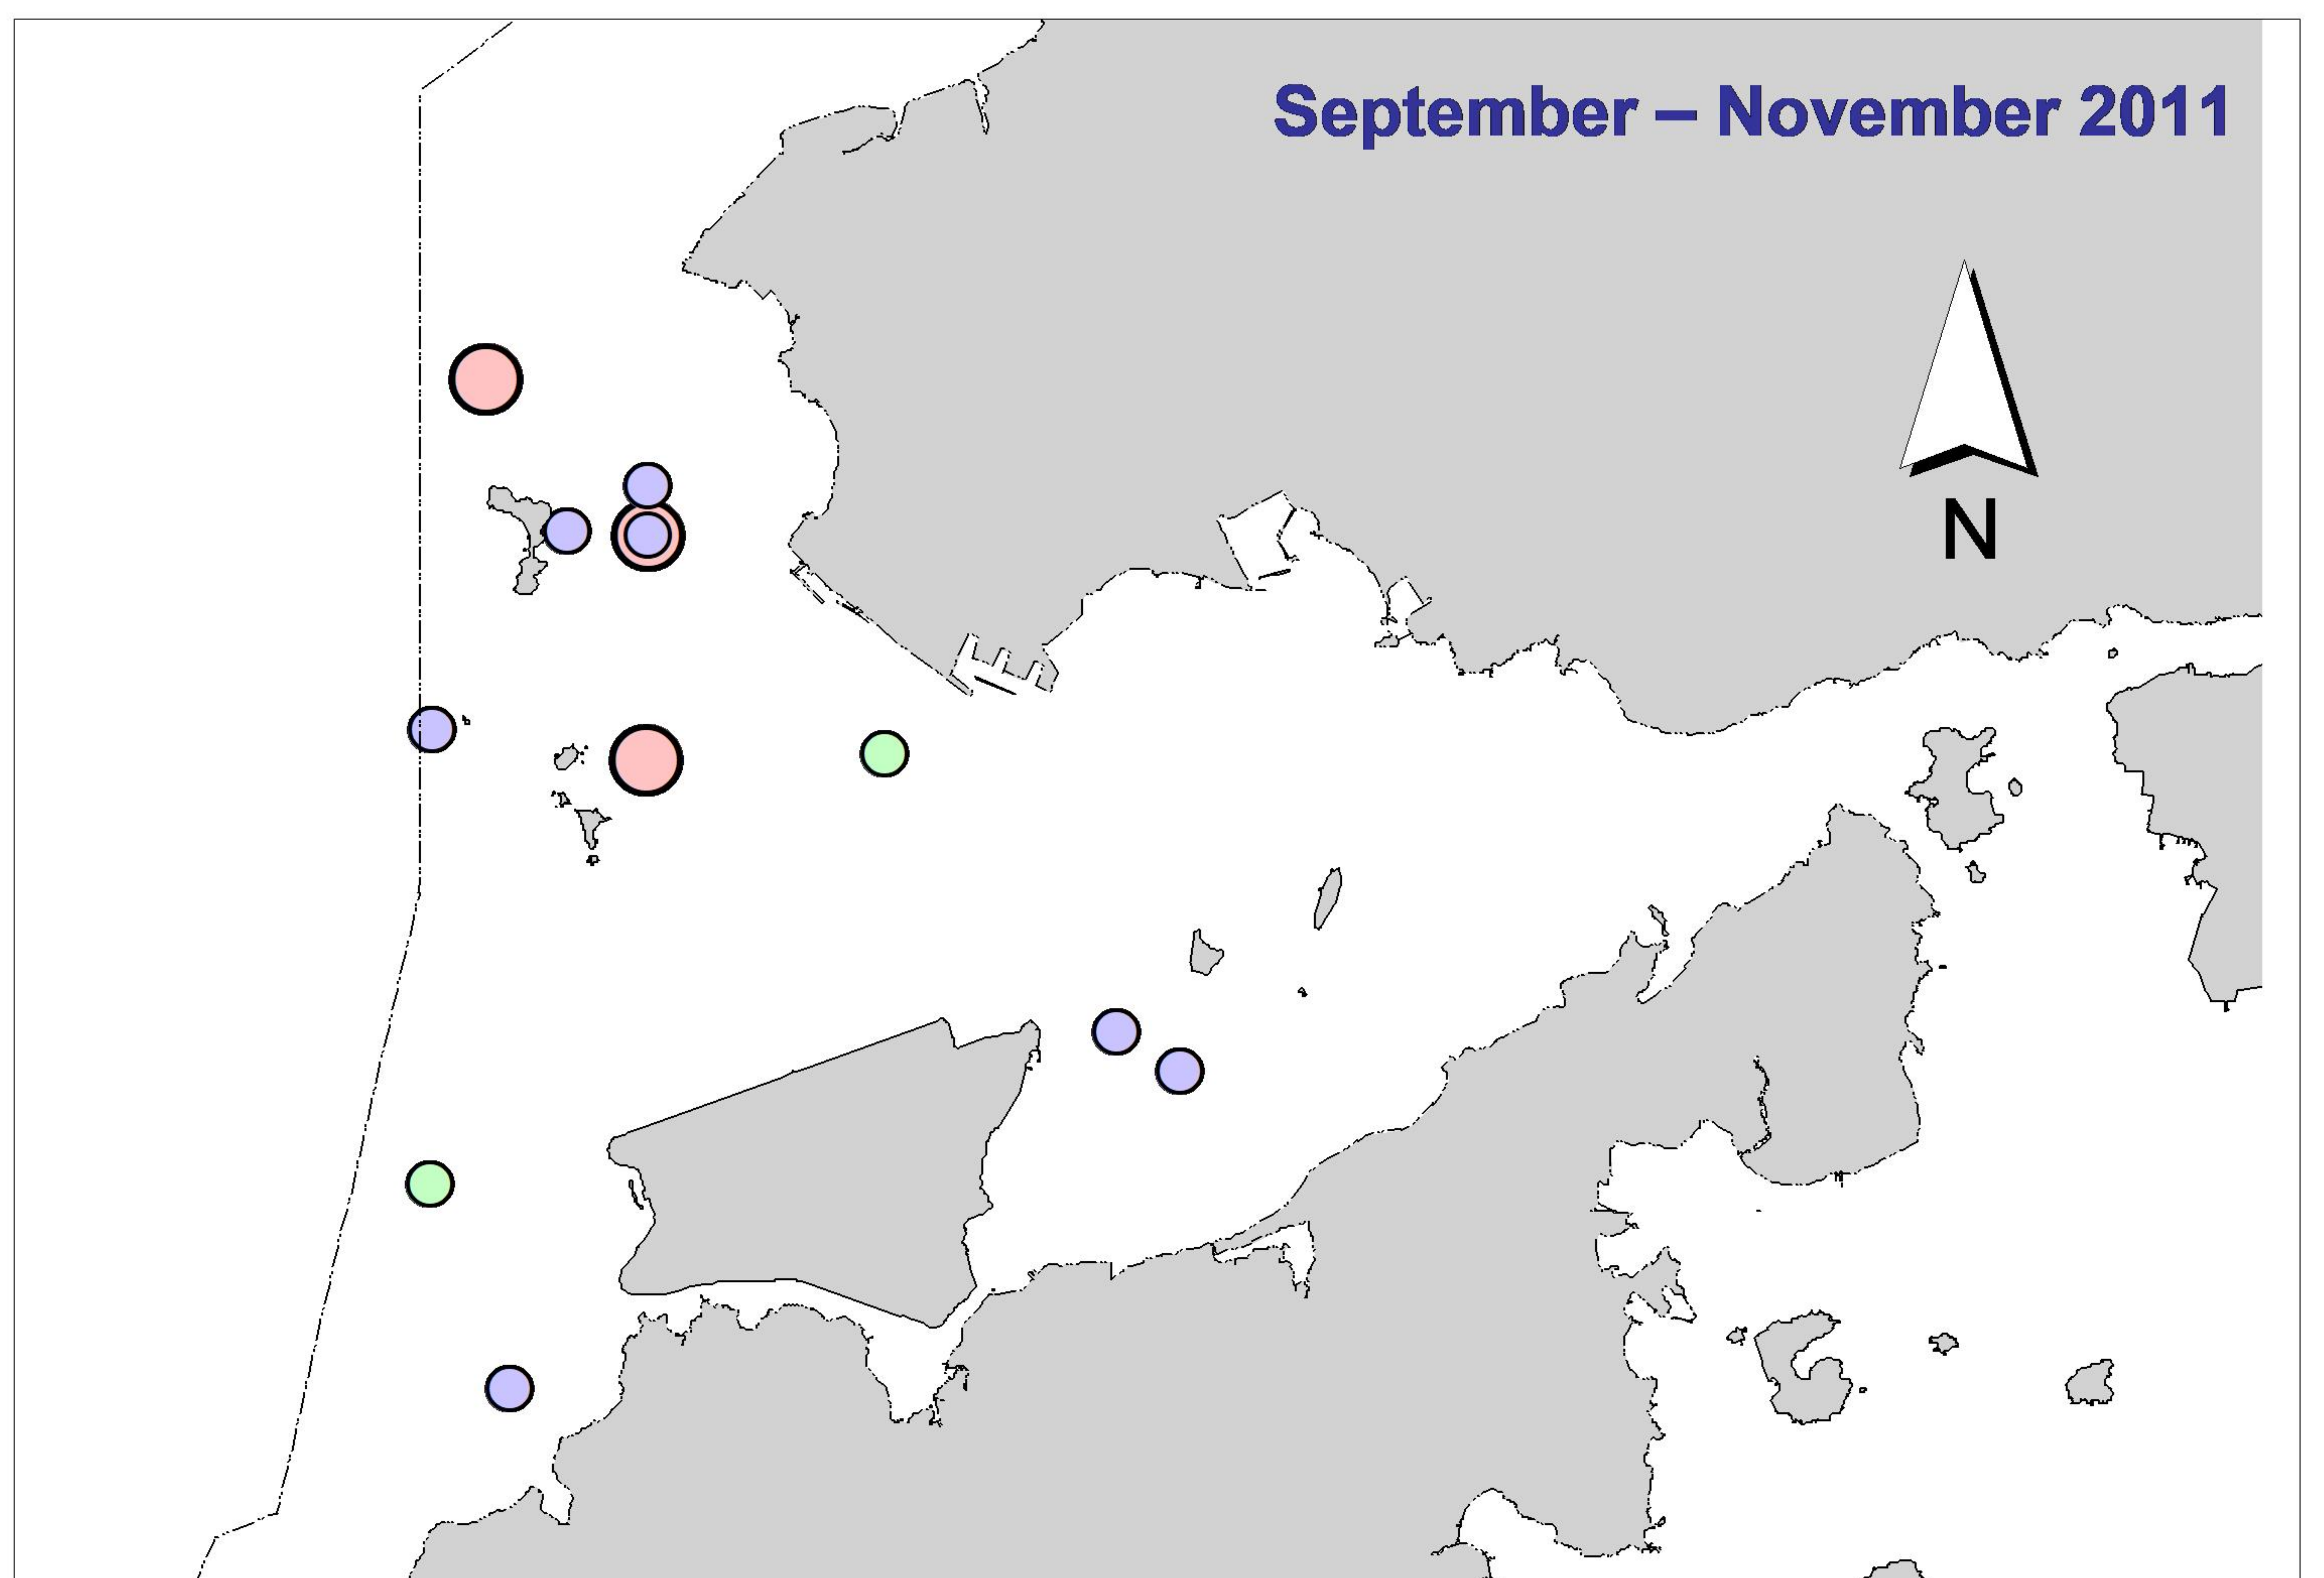
Figure 5. Distribution of Chinese white dolphins engaged in feedings (purple dots), socializing (pink dots) and traveling (green dots) activities during TMCLKL08/HKLR03 impact phase (top) and baseline monitoring surveys (bottom)

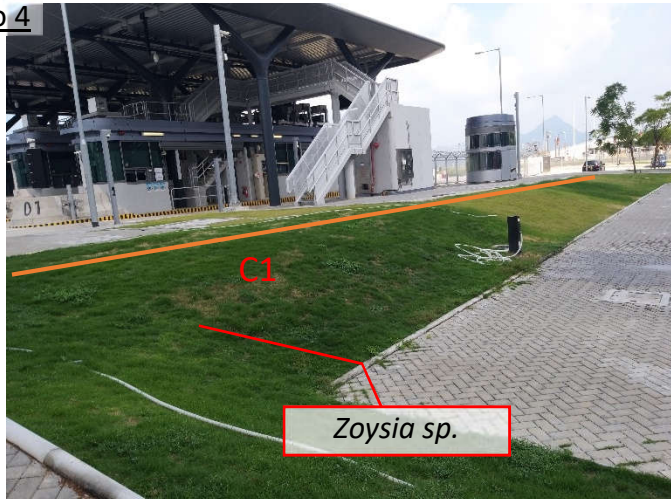
Location	Photo Record									
	<p>Photo 4</p>

Location	Photo Record	
<b>At-grade planting of Passenger Clearance Building</b>	<p><u>Photo 1</u></p>  	<p><u>Photo 2</u></p>  
	<p><u>Photo 3</u></p>

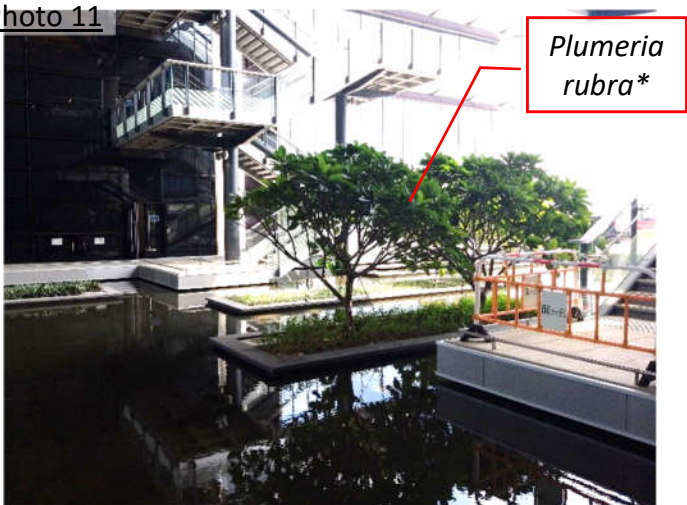
<p><i>Wedelia trilobata</i></p> <p><i>Plumeria rubra*</i></p> <p><i>Rhoeo discolor</i></p> <p><i>Lantana montevidensis</i></p>	<p><u>Photo 11</u></p>

<p><i>Plumeria rubra*</i></p>

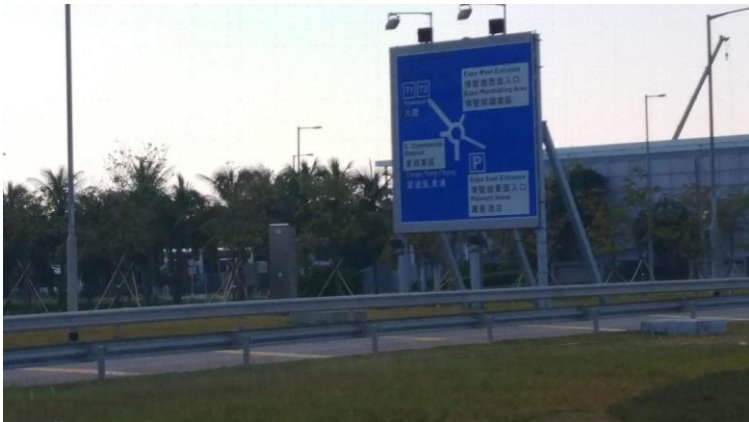
Location	Species	Photo Record	
Zone 3	<ul style="list-style-type: none"><li>- <i>Bauhinia variegata</i></li><li>- <i>Zoysia sp.</i></li></ul>

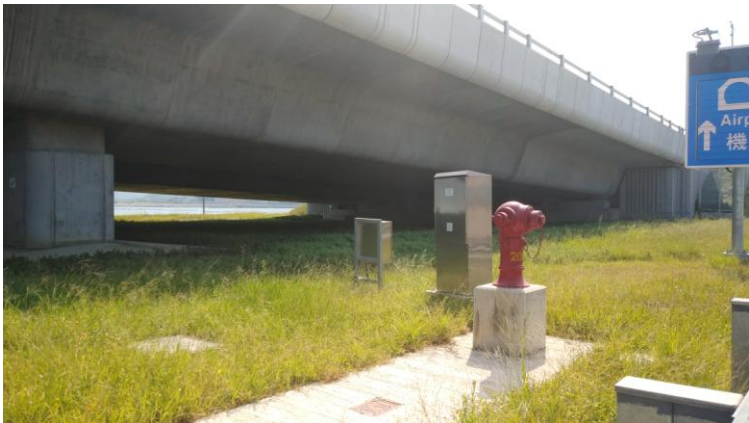
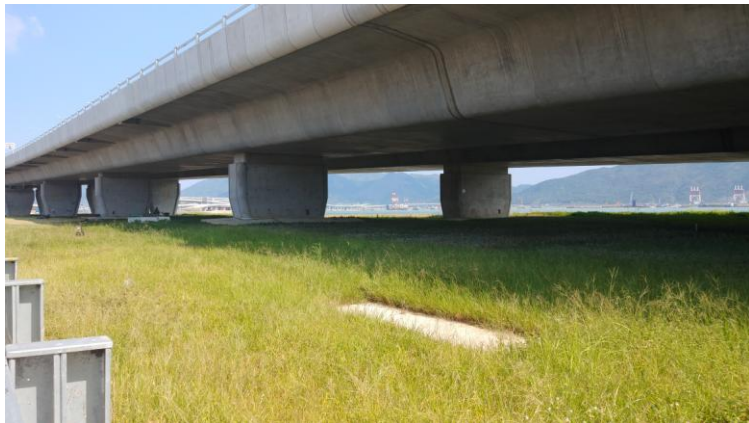
Zone 4	<ul style="list-style-type: none"><li>- <i>Zephyranthes candida</i></li><li>- <i>Lantana montevidensis</i></li></ul>

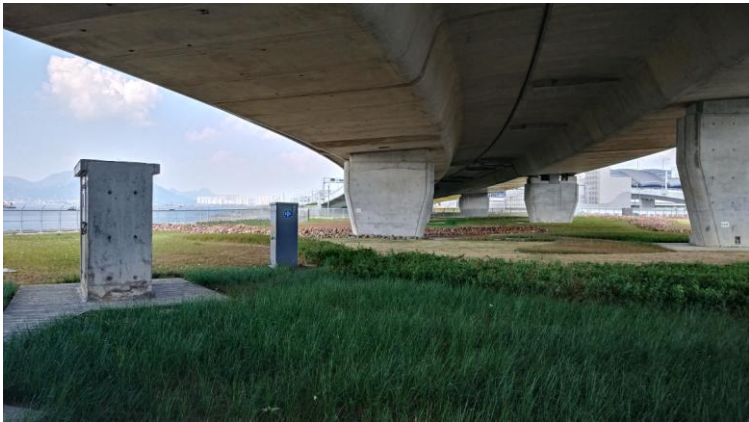
Location	Species	Photo Record	
Zone 5	<ul style="list-style-type: none"><li>- <i>Zoysia sp.</i></li><li>- <i>Zephyranthes candida</i></li></ul>

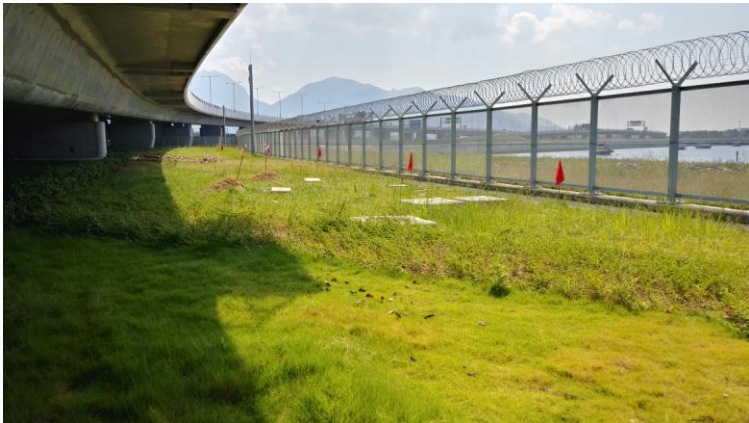
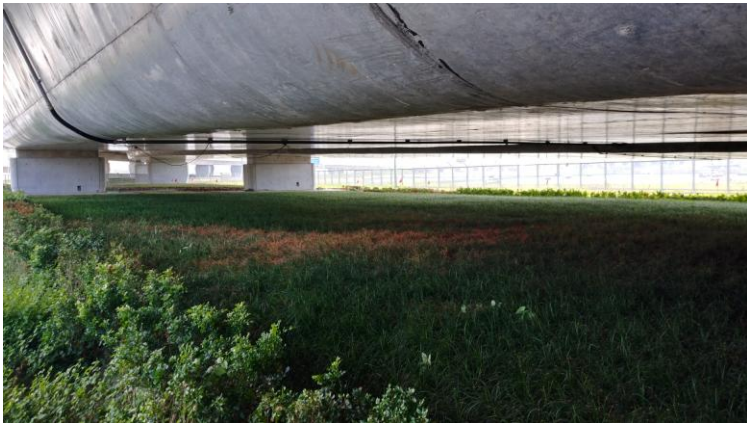
Zone 6	<ul style="list-style-type: none"><li>- <i>Aglaia odorata</i></li><li>- <i>Liriope spicata</i></li><li>- <i>Lantana montevidensis</i></li><li>- <i>Zoysia sp.</i></li></ul>

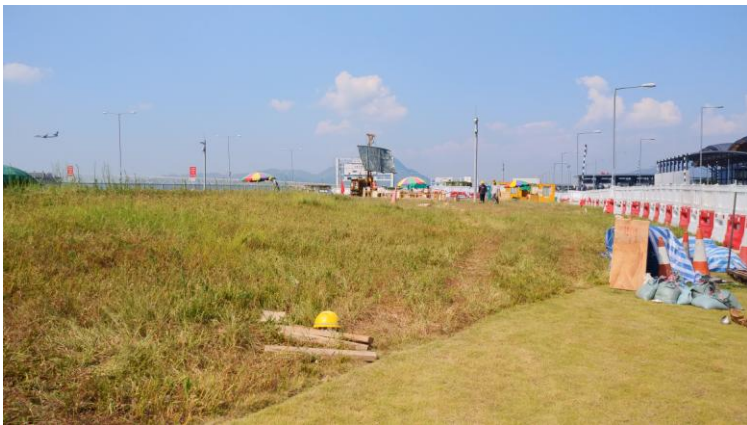
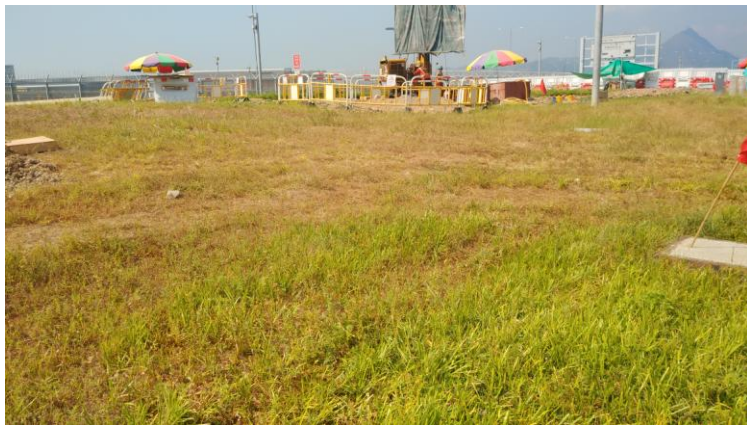
Location	Species	Photo Record	
Zone 7	<ul style="list-style-type: none"> <li>- <i>Zoysia sp.</i></li> <li>- <i>Zephyranthes rosea</i></li> </ul>

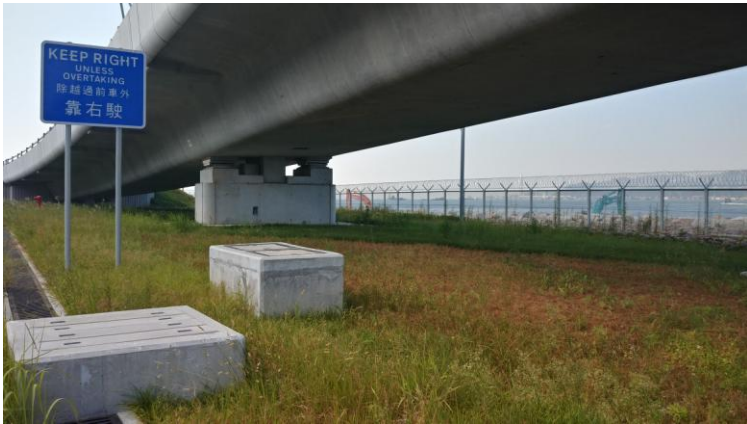
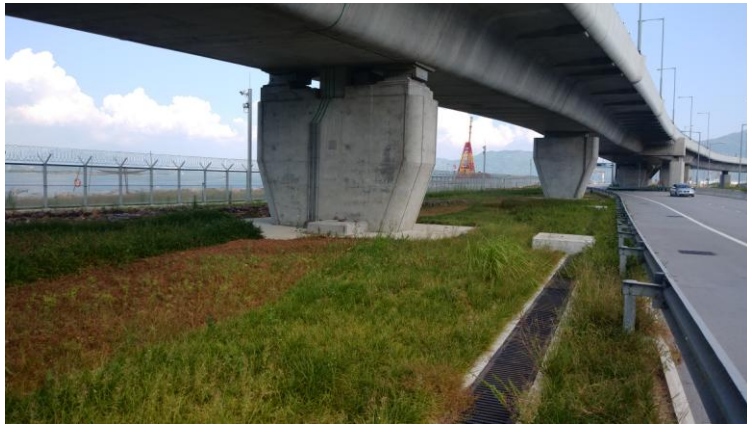
As confirmed and clarified with RSS on site, the pre-construction works (ground investigation works) as shown in photos were not belonging to any HZMB HKBCF contracts.	
Zone 8	<ul style="list-style-type: none"> <li>- <i>Zephyranthes candida</i></li> <li>- <i>Liriope spicata</i></li> </ul>

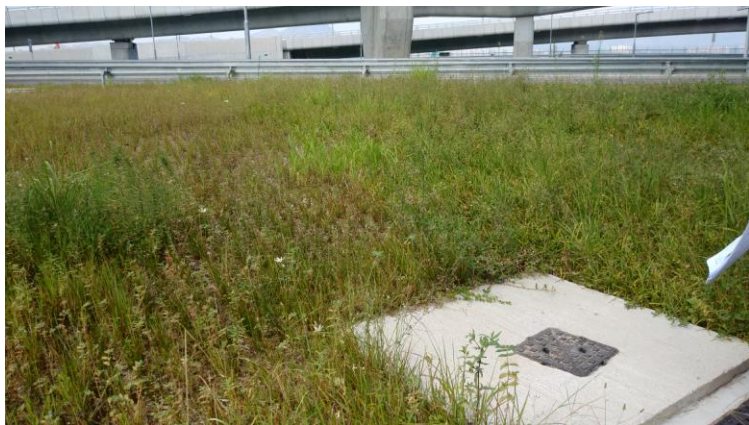
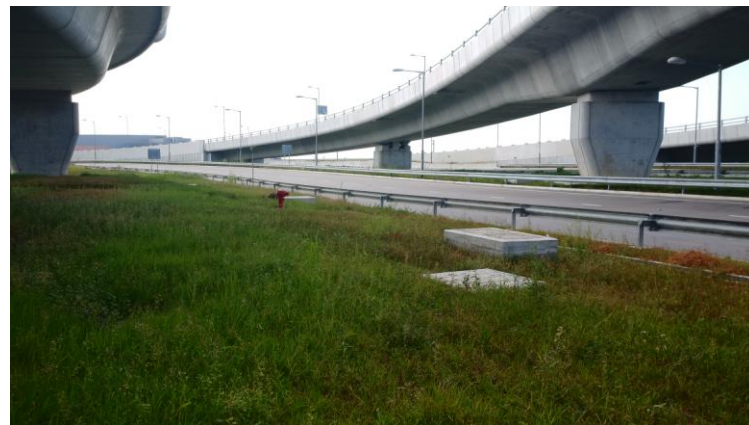
Zone 10	<ul style="list-style-type: none"><li>- <i>Zephyranthes rosea</i></li><li>- <i>Zephyrsnthes candida</i></li></ul>

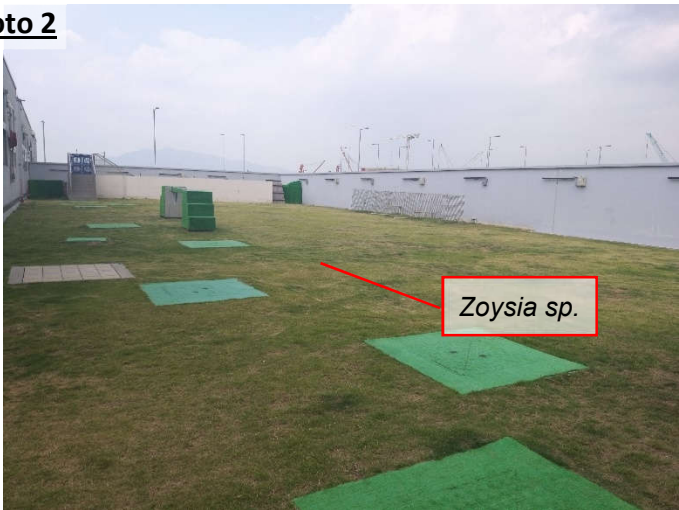
<p><b>Photo 2</b></p>

Location	Photo Record	
<b>Building 022 at-grade planting</b> (Photo 1 and Photo 2)	<p><b>Photo 1</b></p>

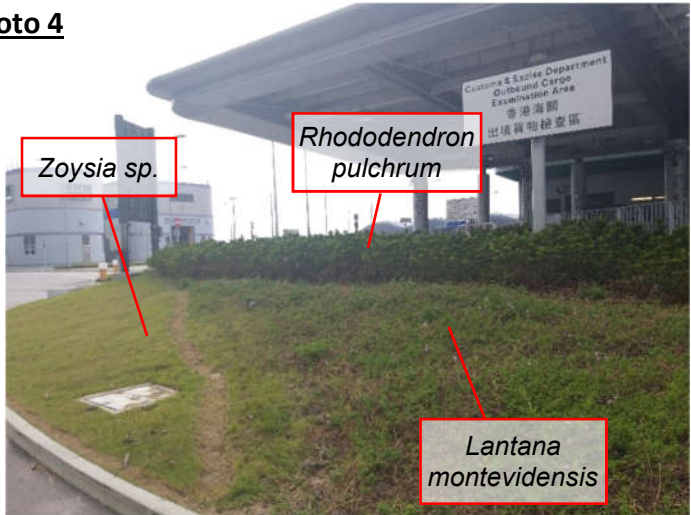
<p><b>Photo 4</b></p>

<b>Building 023 at-grade planting</b> (Photo 3 and Photo 4)	<p><b>Photo 3</b></p>

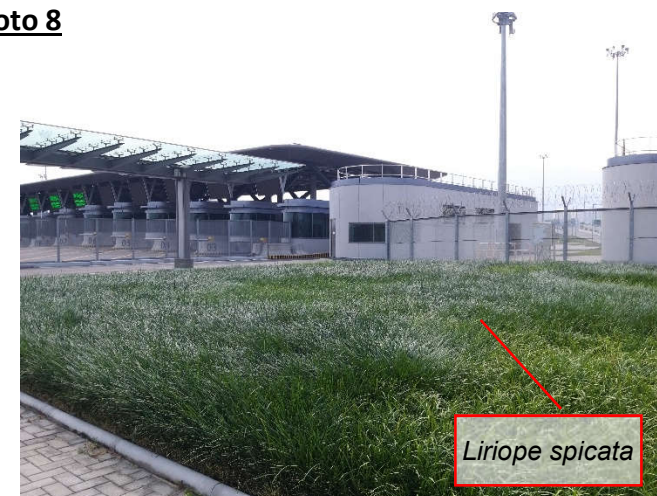
**Photo 8**

**Building 025 at-grade  
planting  
(Photo 7 and Photo 8)**

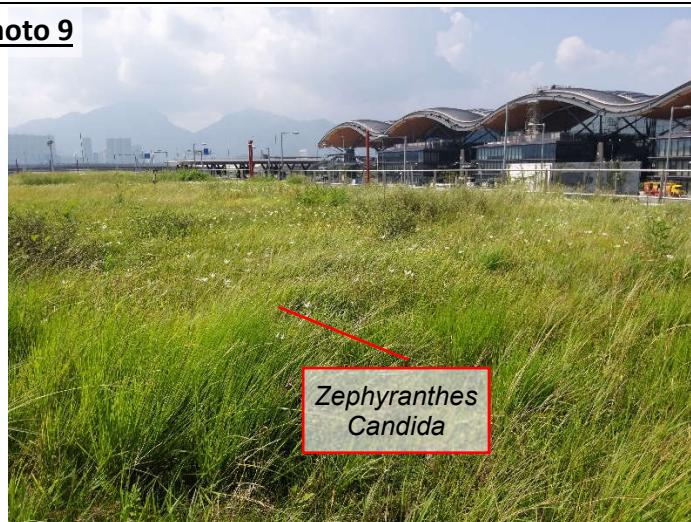
**Photo 9**

**Building 025 roof  
greening  
(Photo 9 and Photo  
10)**

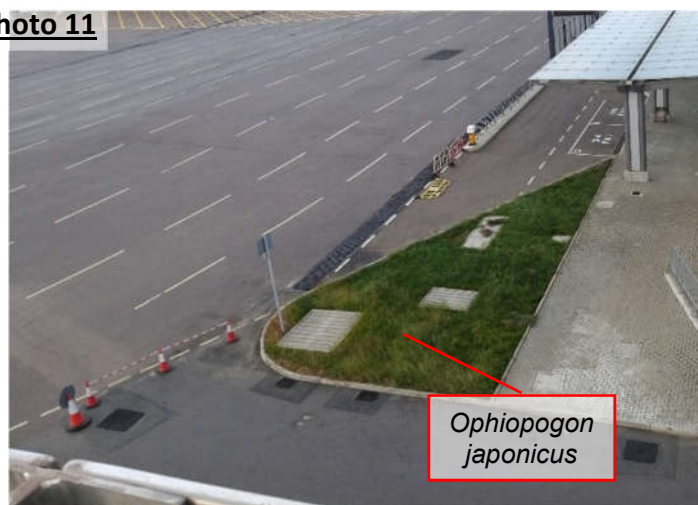
**Photo 11**

**Building 032 at-grade  
planting  
(Photo 11 and Photo  
12)**

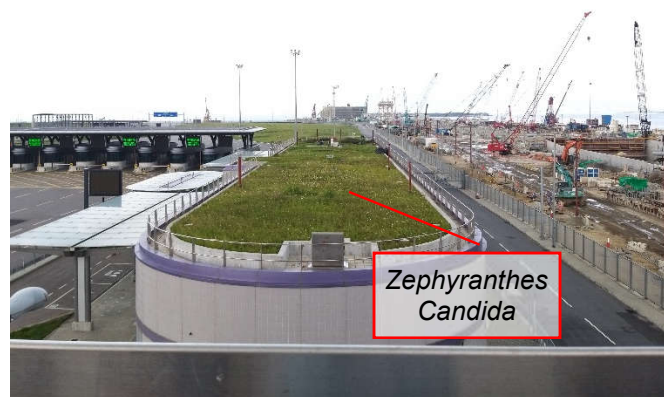
**Photo 13**

**Building 032 roof  
greening  
(Photo 13 and Photo  
14)**

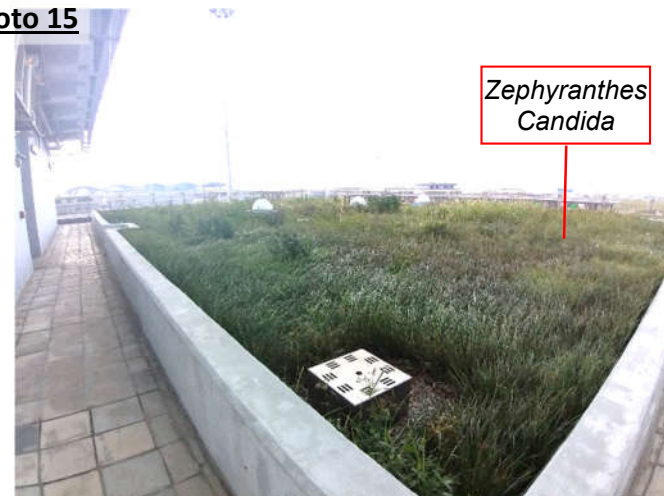
**Photo 15**

**Building 044 roof  
greening  
(Photo 15 and Photo  
16)**

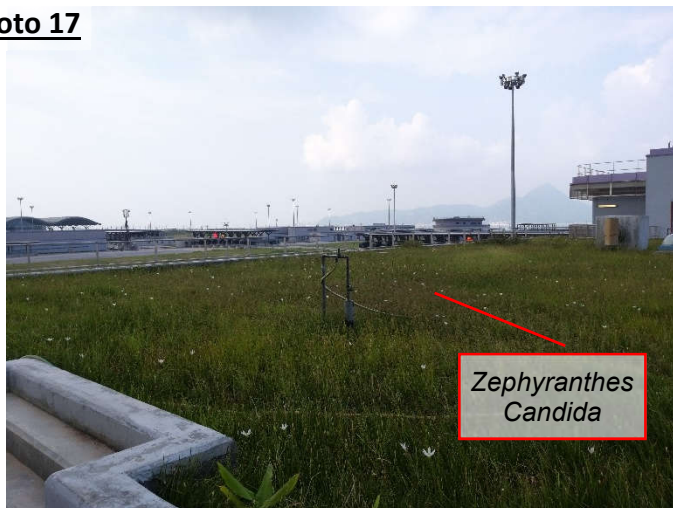
**Photo 17**

**Building 045 roof  
greening  
(Photo 17 and Photo  
18)**
