**Contract No. HY/2013/04 Hong Kong-Zhuhai-Macao Bridge (HZMB)  
Hong Kong Boundary Crossing Facilities – Infrastructure Works Stage II  
(Southern Portion)**

**Quarterly EM&A Report for December 2019 to February 2020 (Revision 0)**

Quarterly EM&A Report for December 2019 to  
February 2020

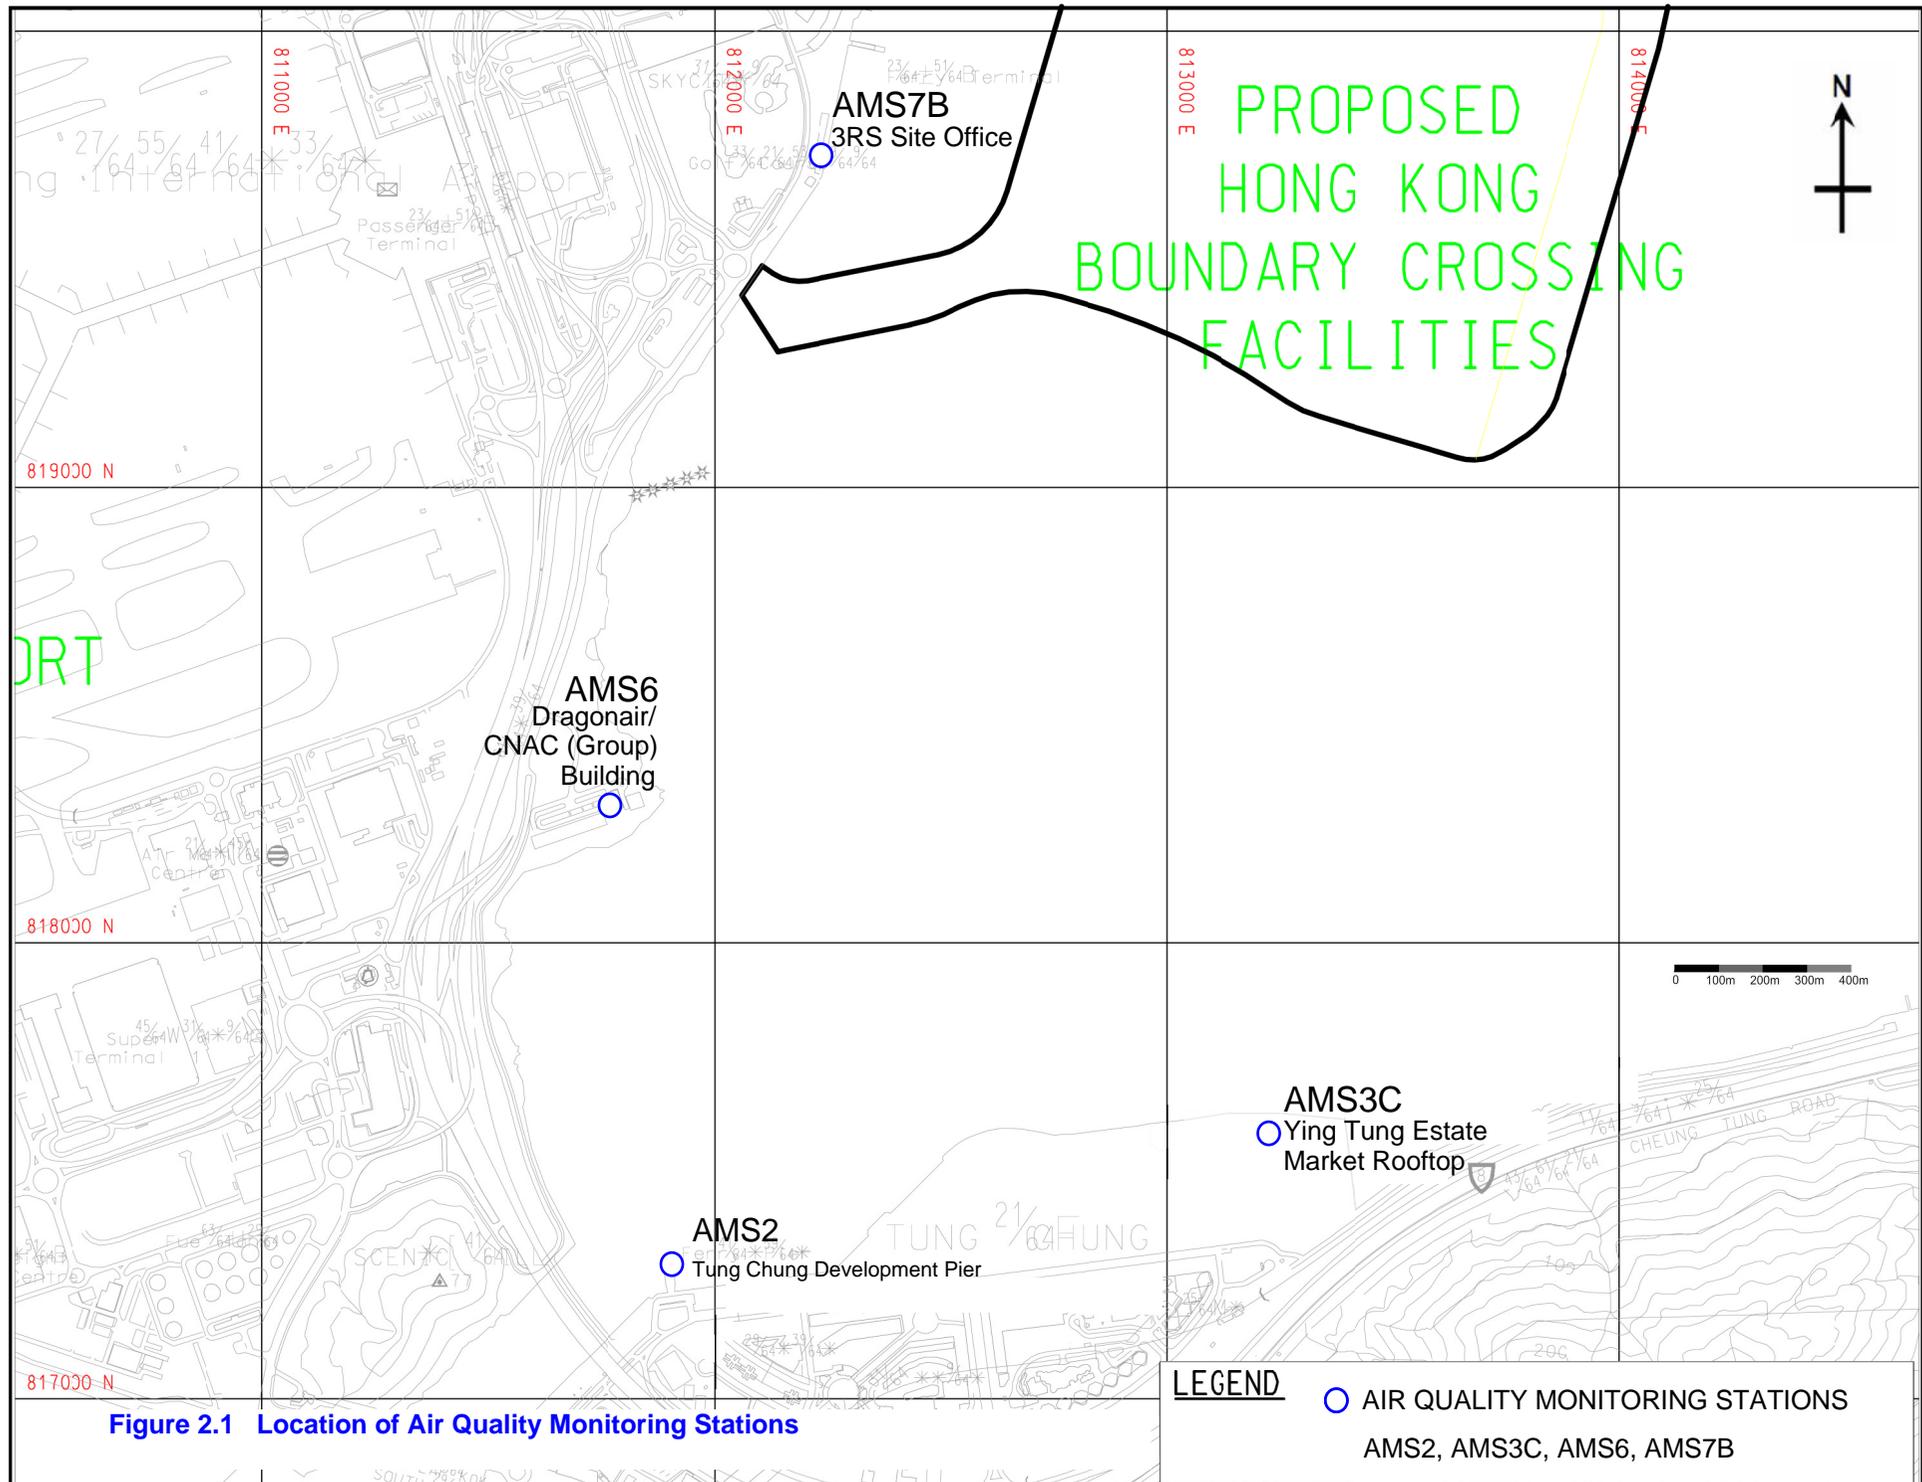
**Figure 2.1 Location of Air Quality Monitoring Stations**

**LEGEND** ○ AIR QUALITY MONITORING STATIONS  
AMS2, AMS3C, AMS6, AMS7B

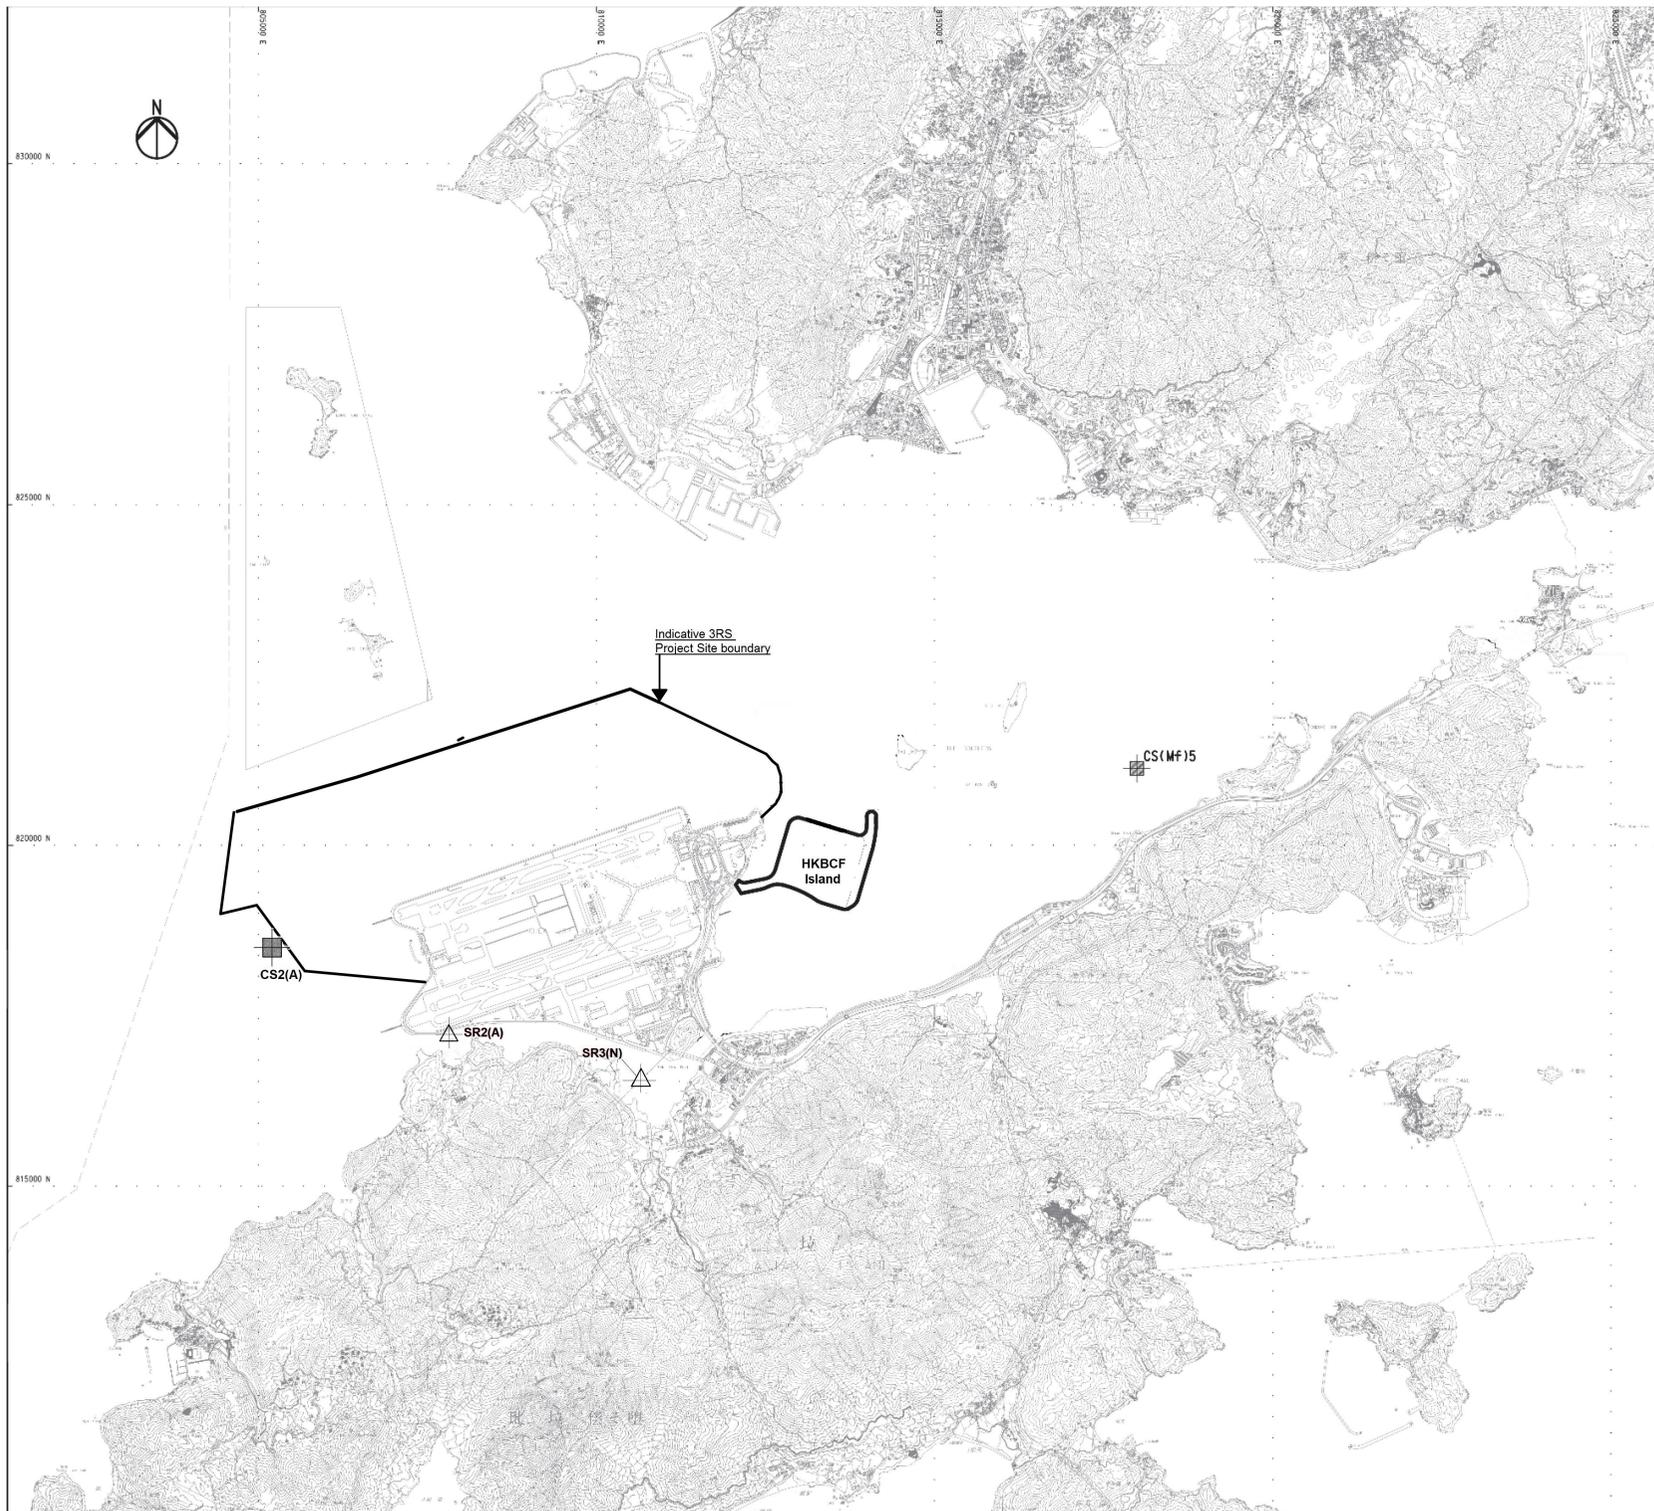
FIGURE 2.3 – LOCATION OF WATER QUALITY MONITORING STATIONS

Station	East	North
SR2(A)	807810	817189
SR3(N)	810689	816591
CS2(A)	805232	818606
CS(Mf)5	817990	821129

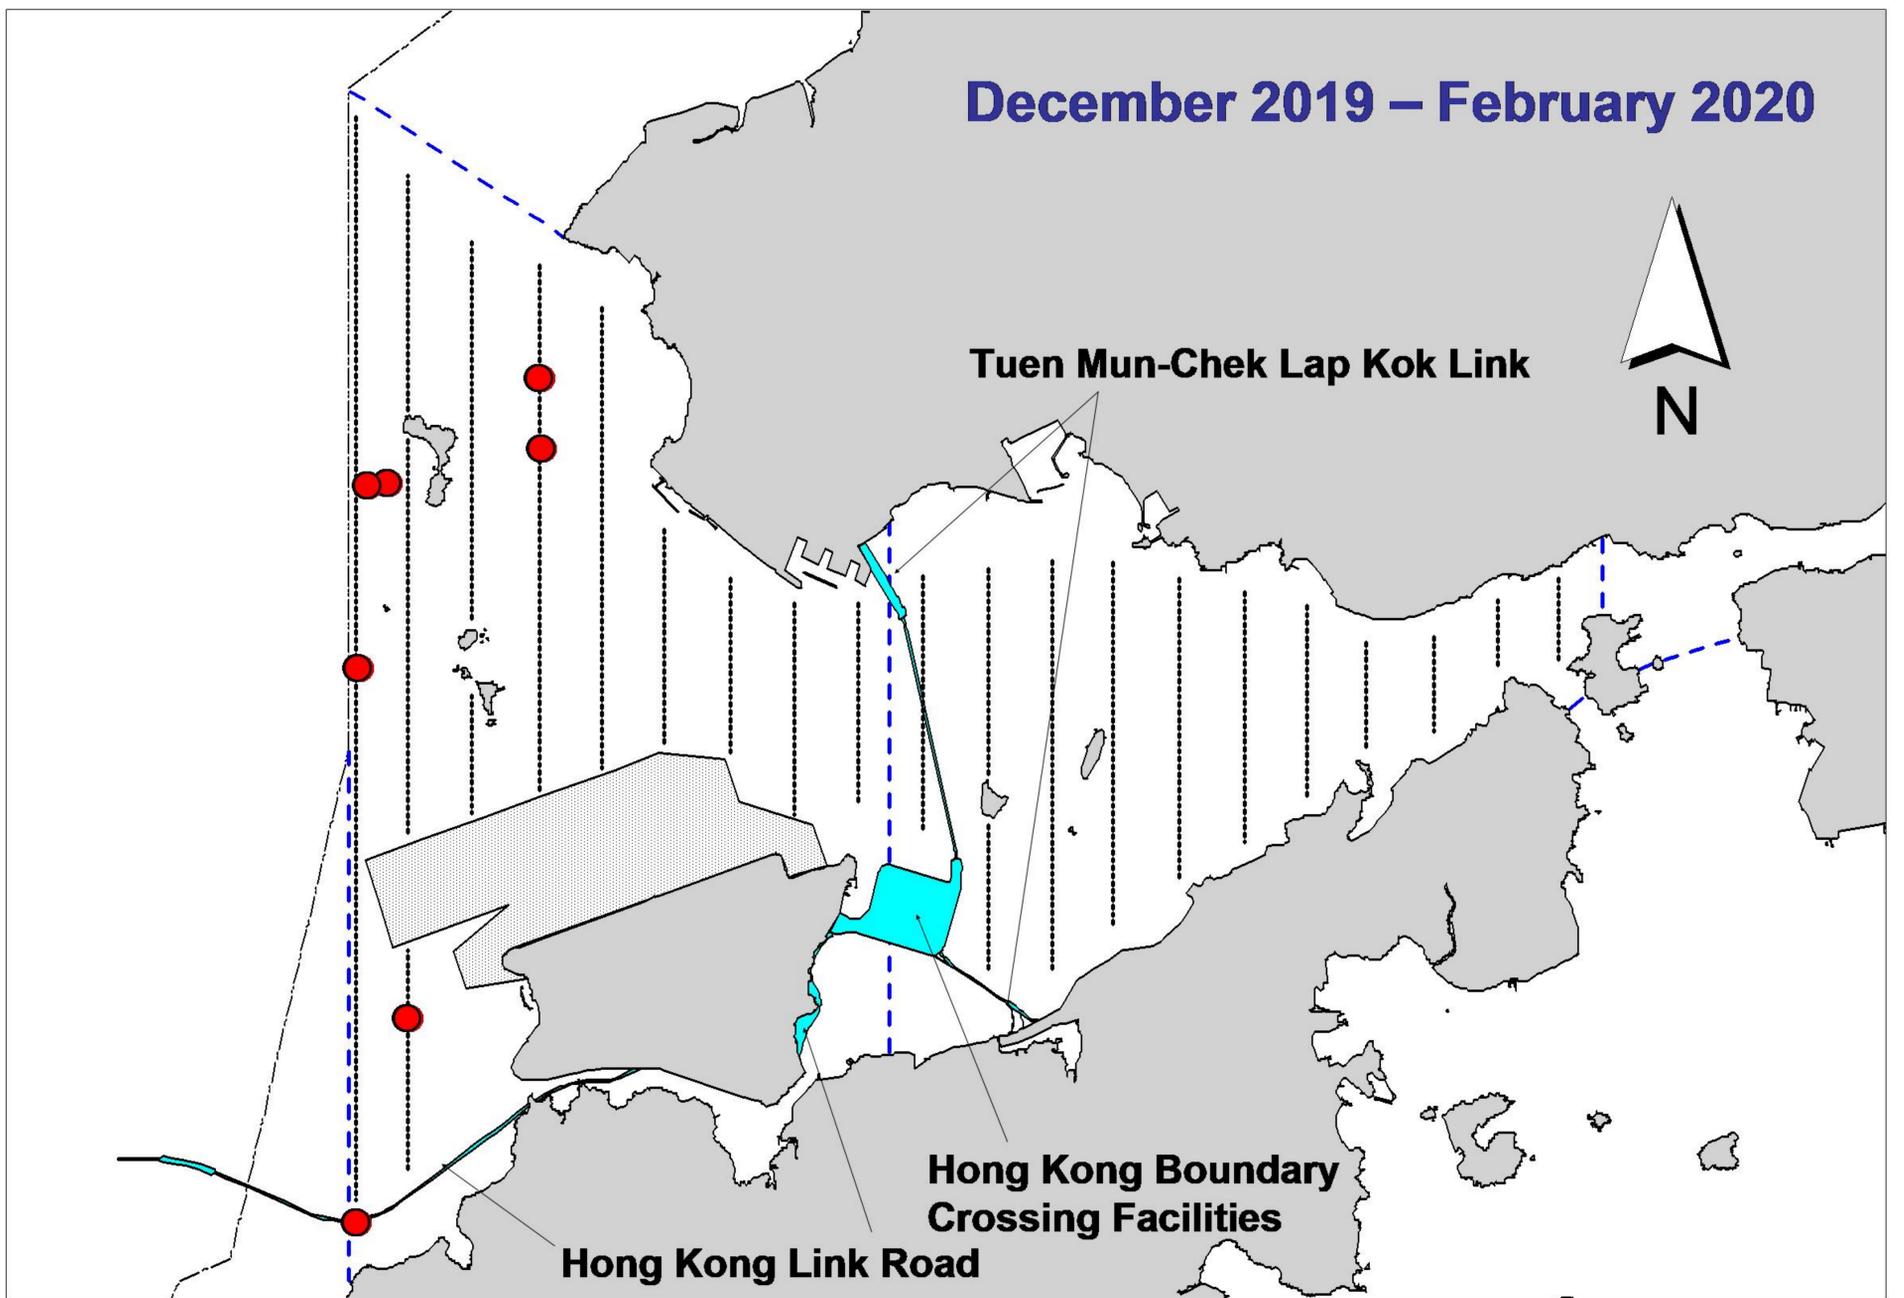
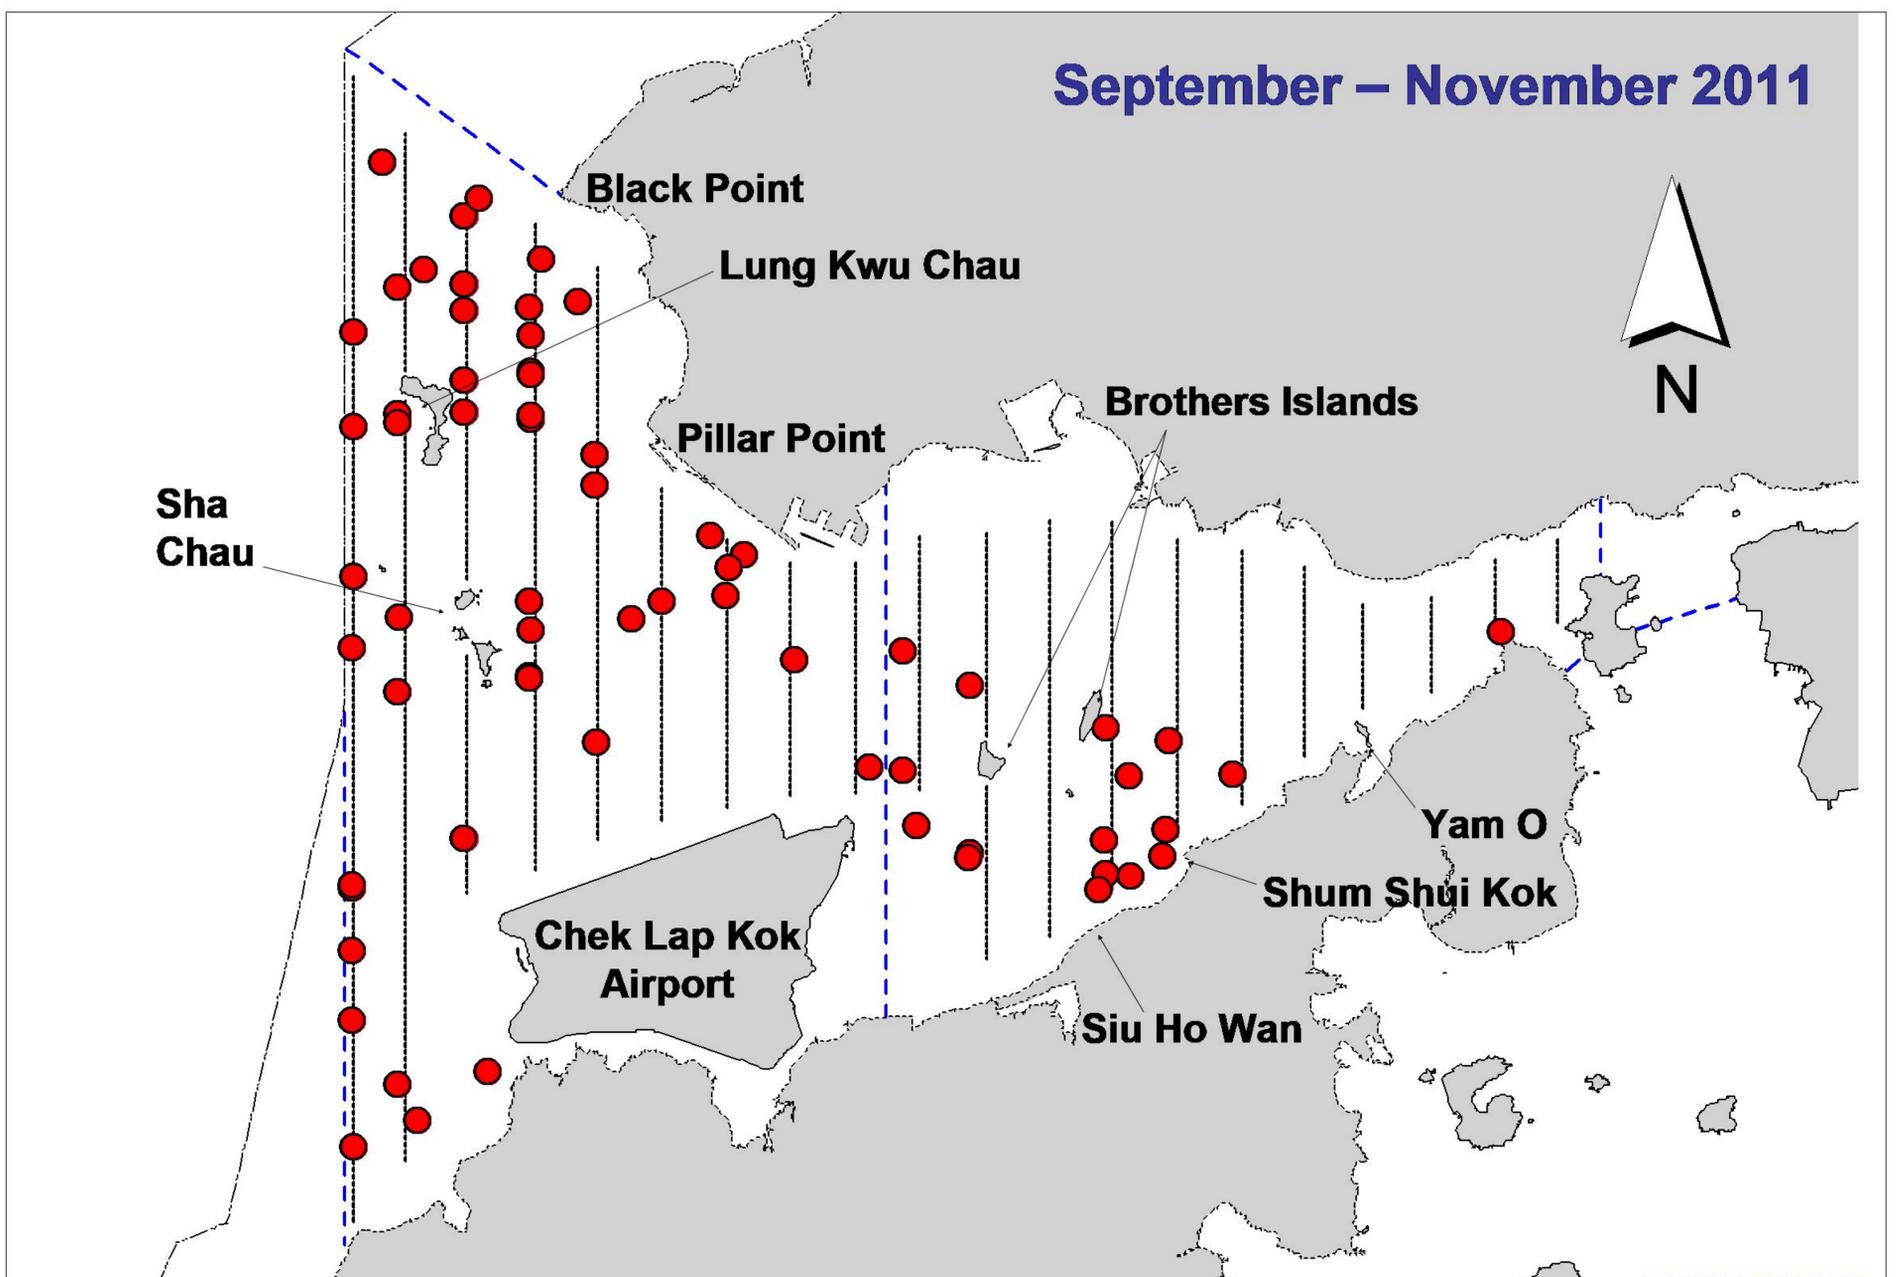
Figure 1. Distribution of Chinese white dolphin sighting in Northwest and Northeast Lantau during TMCLKL08 impact phase (top) and baseline monitoring surveys (bottom)

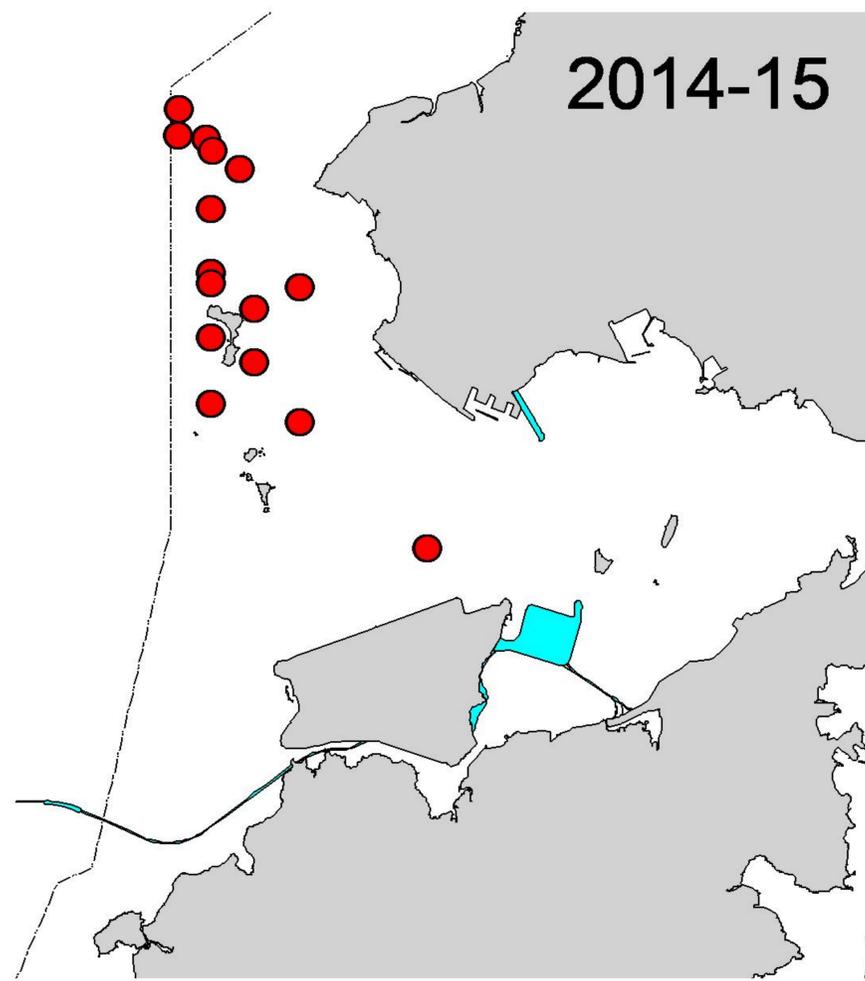
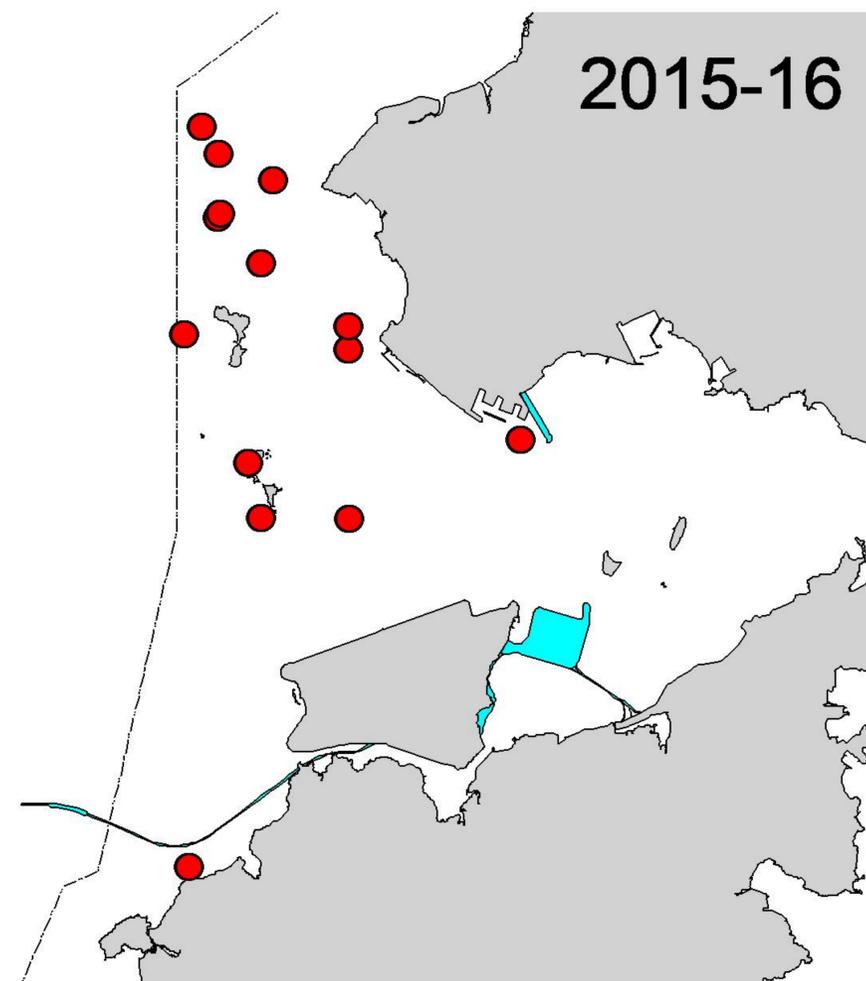
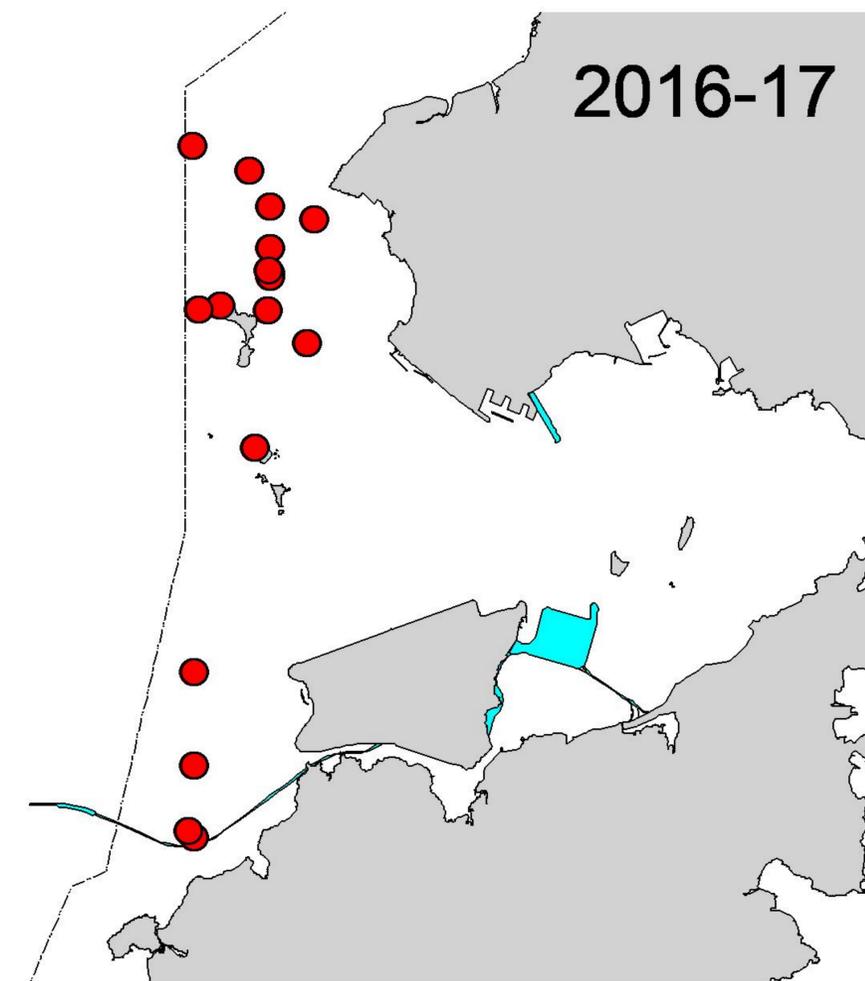
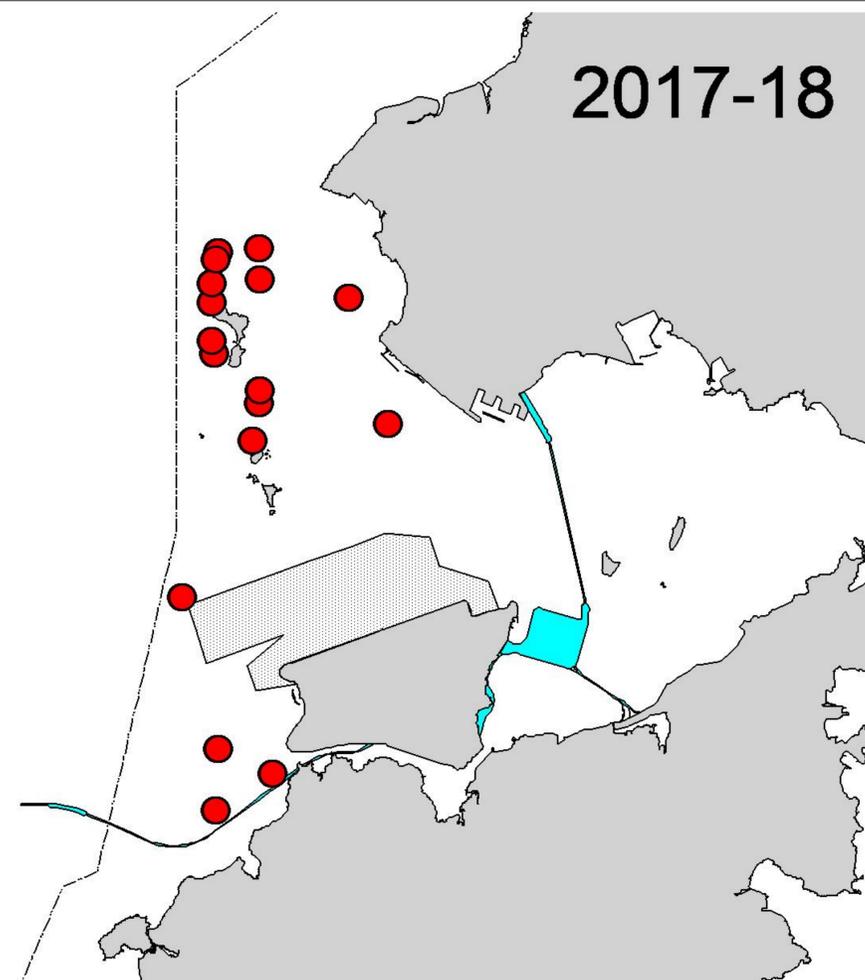
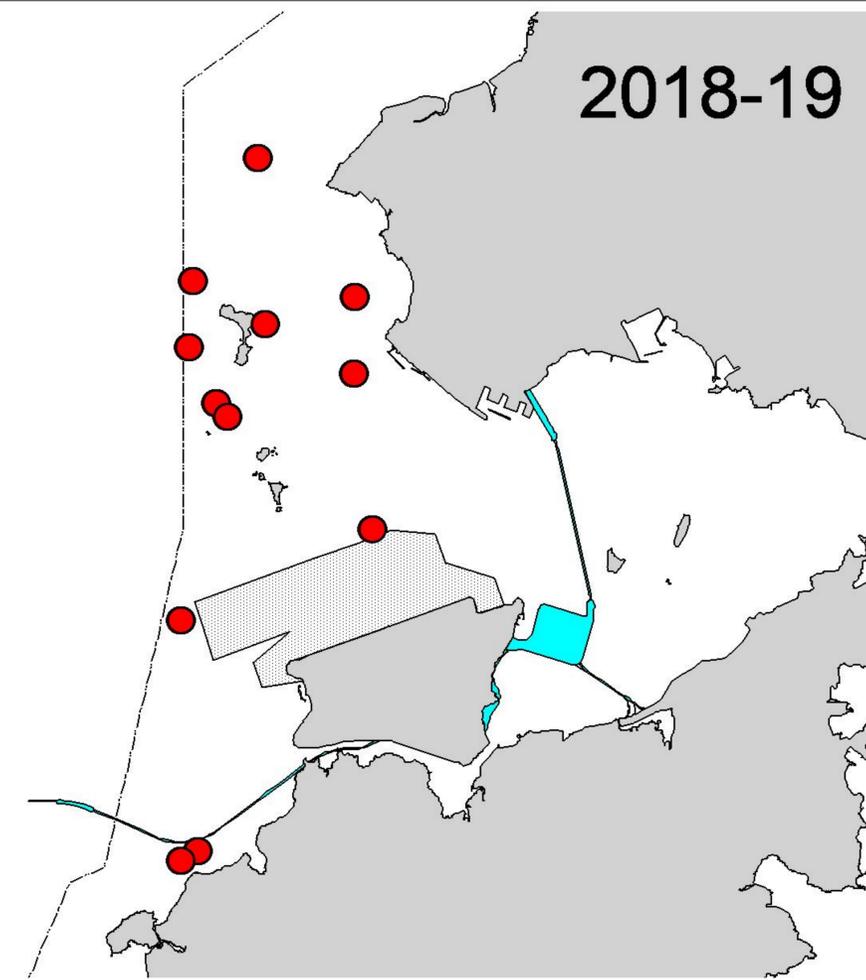
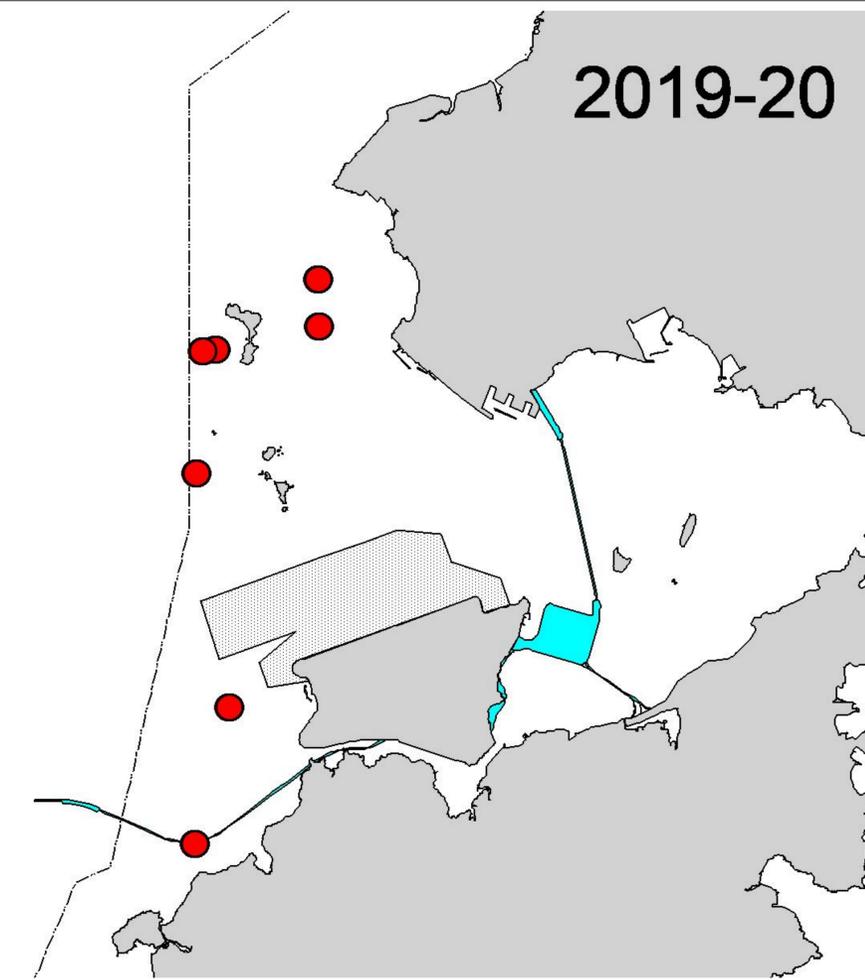
Figure 2. Distribution of Chinese white dolphin sightings in Northwest and Northeast Lantau during the past six winter quarters (December-February) of HKLR03/TMCLKL08 impact phase in 2014-20

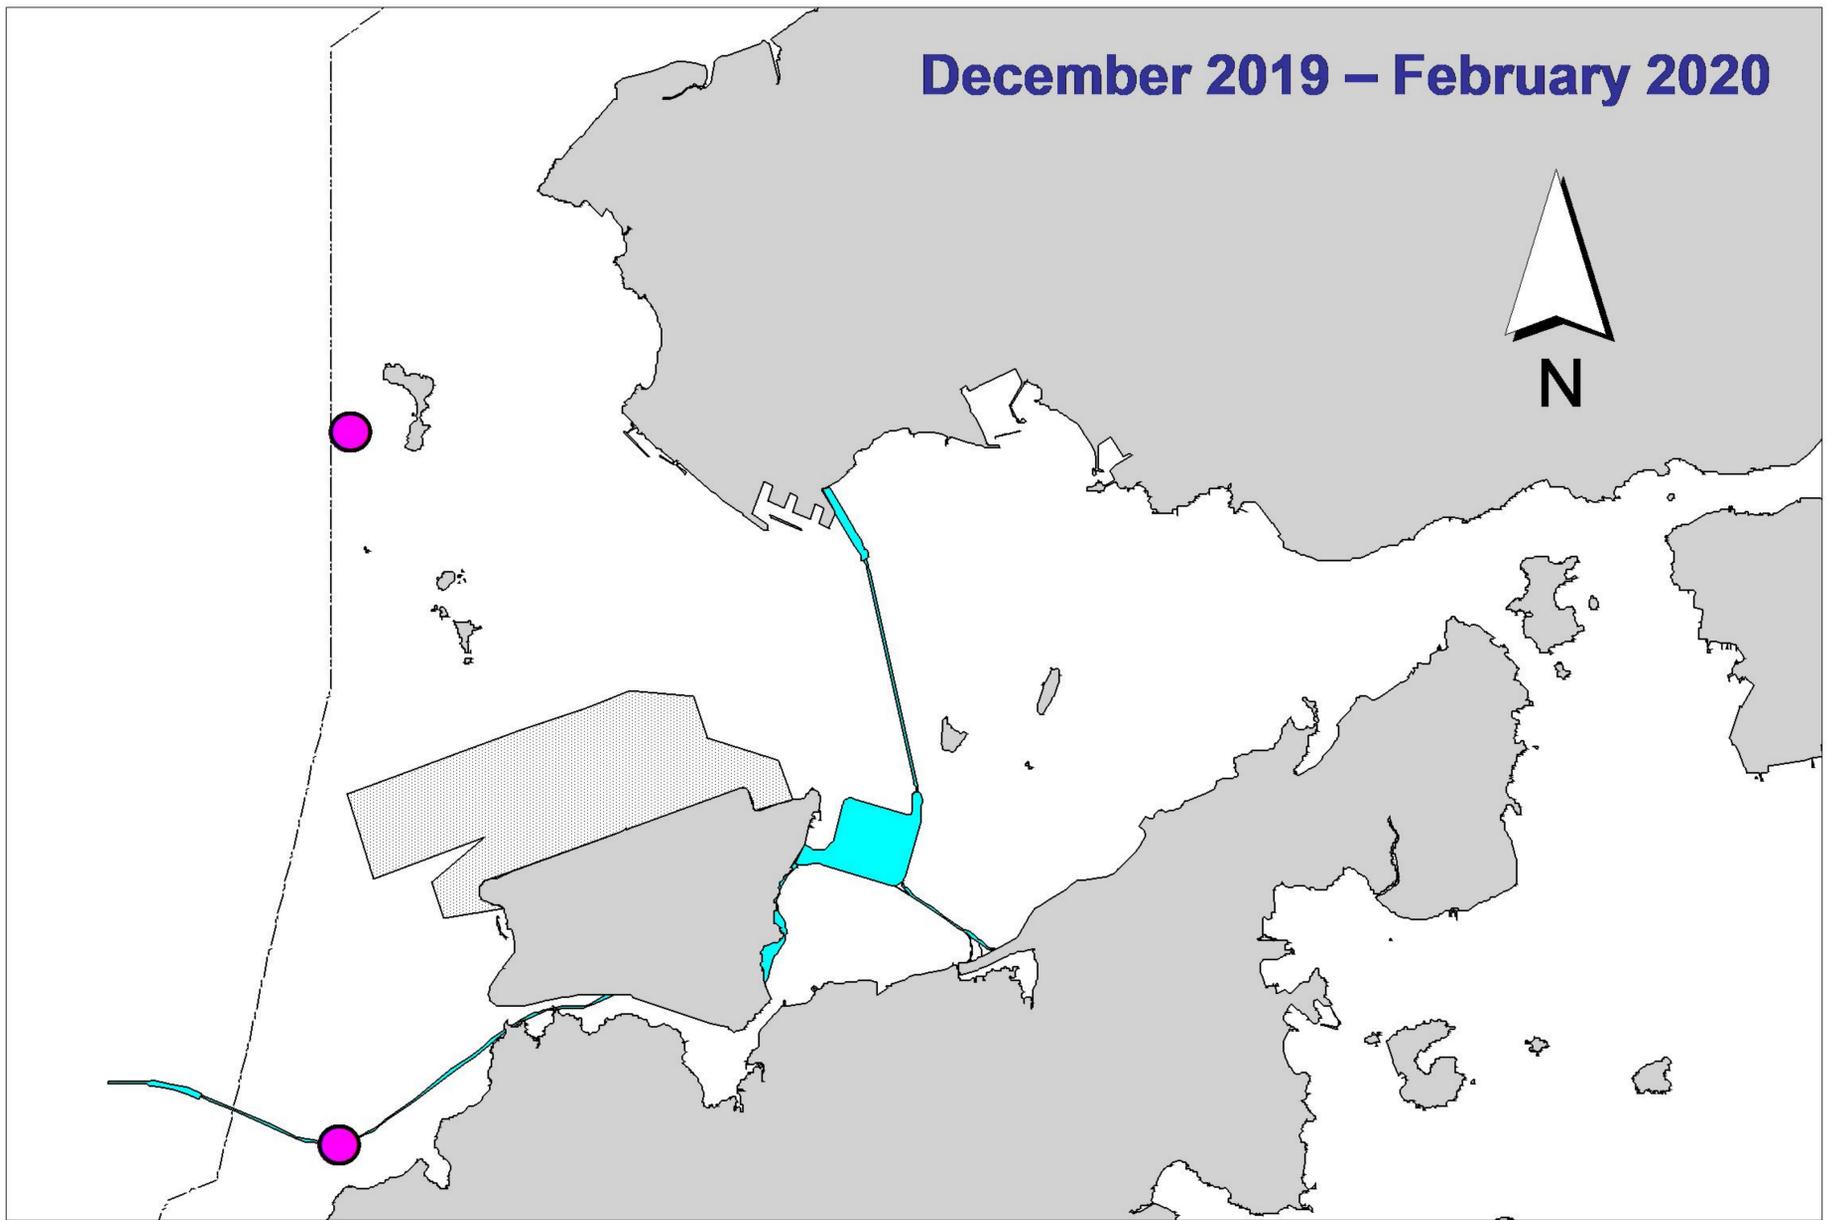
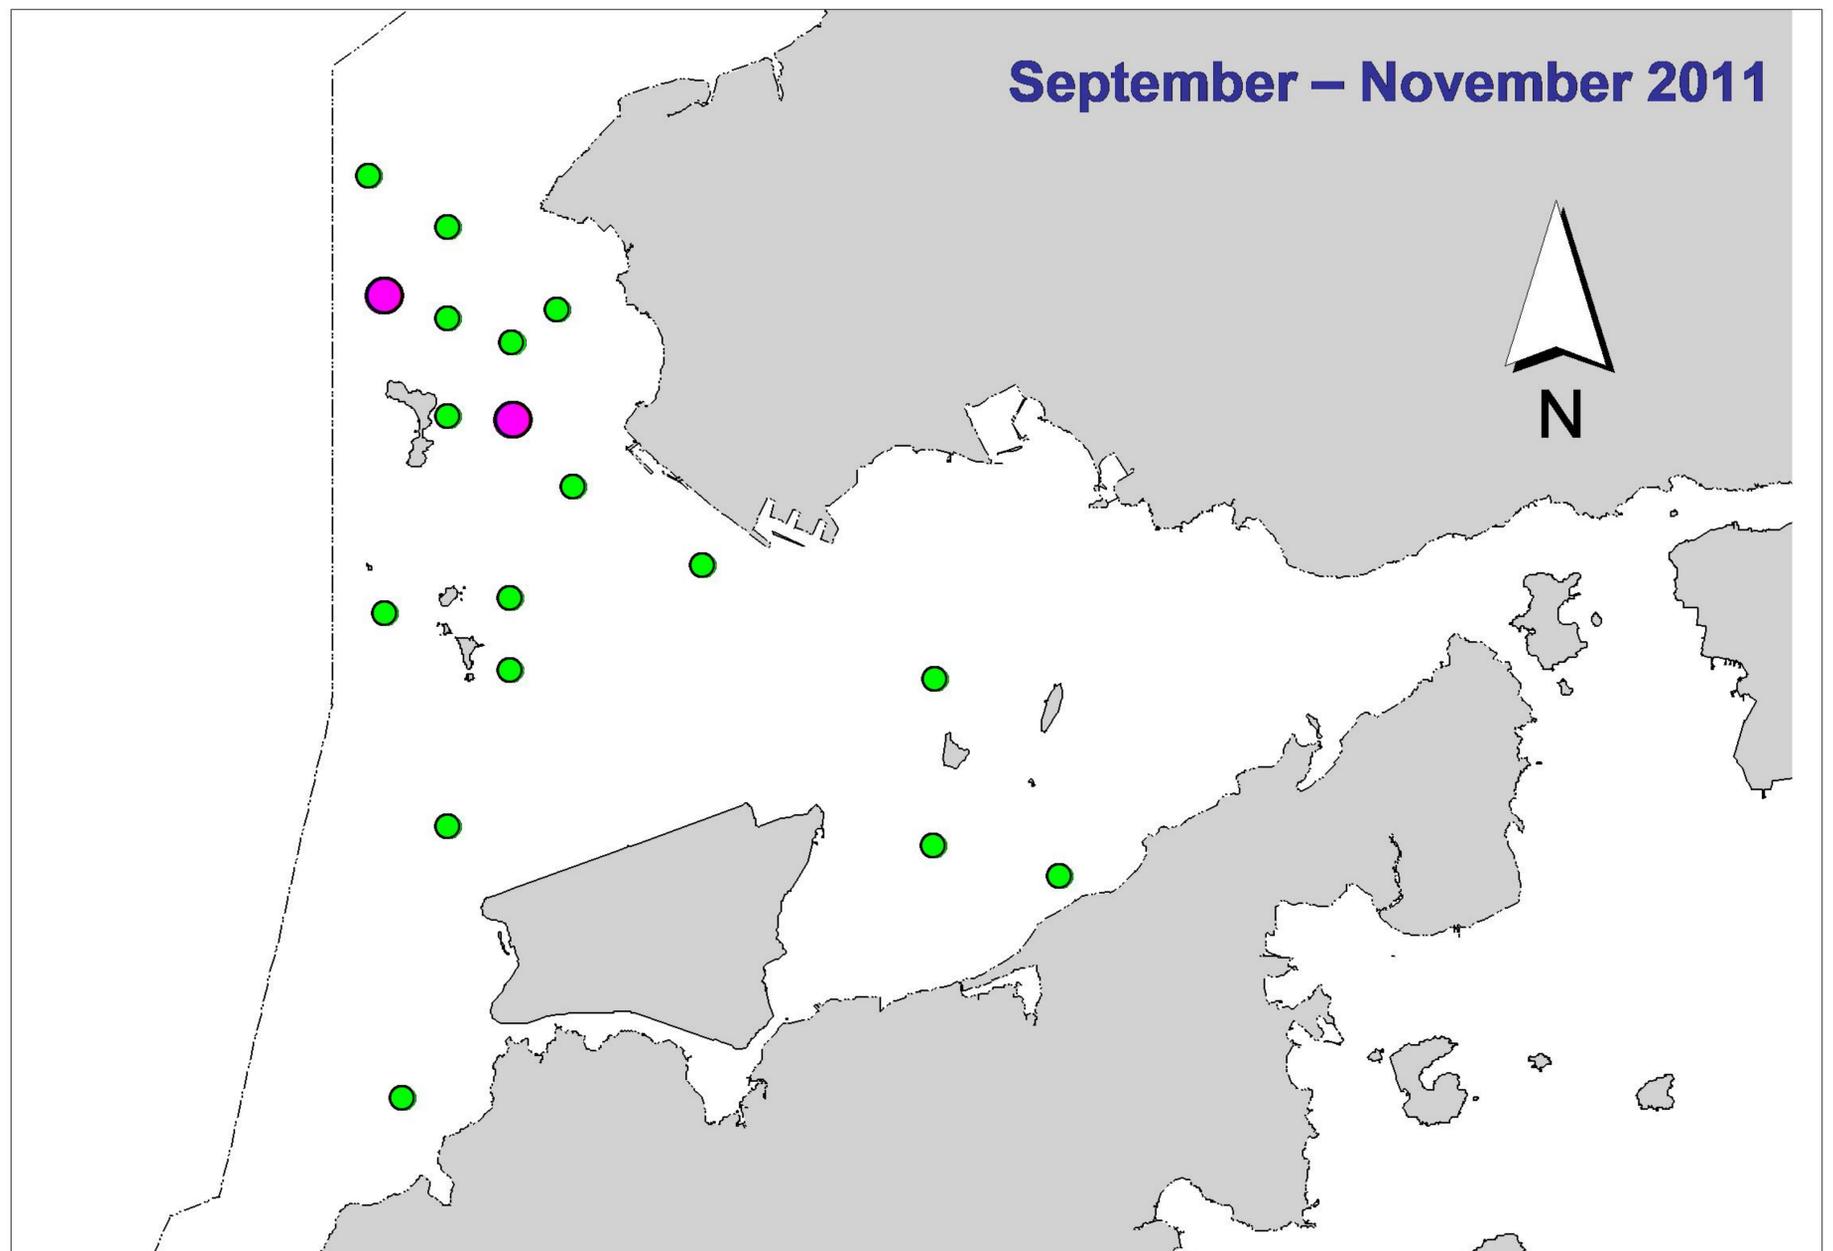
Figure 3. Distribution of Chinese white dolphins with larger group sizes during TMCLKL08 impact phase (top) and baseline monitoring surveys (bottom) (green dots: group sizes of 5 or more; purple dots: group sizes of 10 or more)

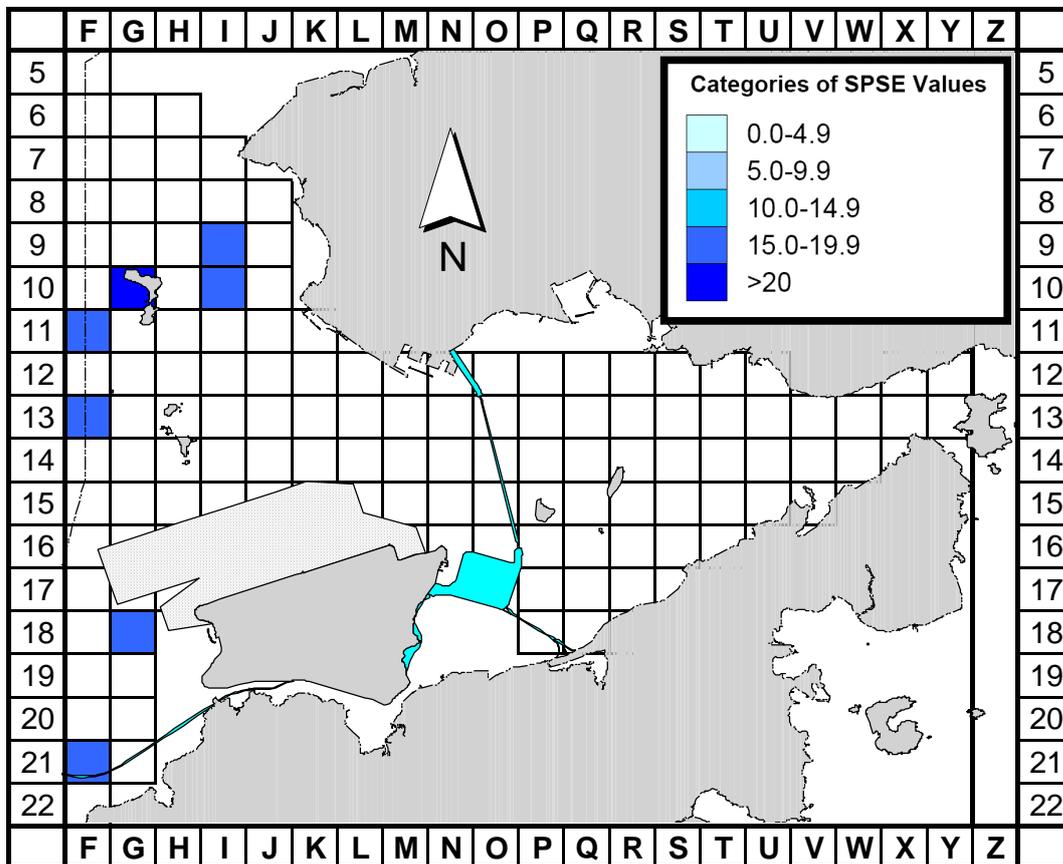
Figure 4a. Sighting density of Chinese white dolphins with corrected survey effort per km<sup>2</sup> in Northeast and Northwest Lantau survey areas, using data collected during TMCLKL08 impact monitoring period (December 2019-February 2020) (SPSE = no. of on-effort sightings per 100 units of survey effort)

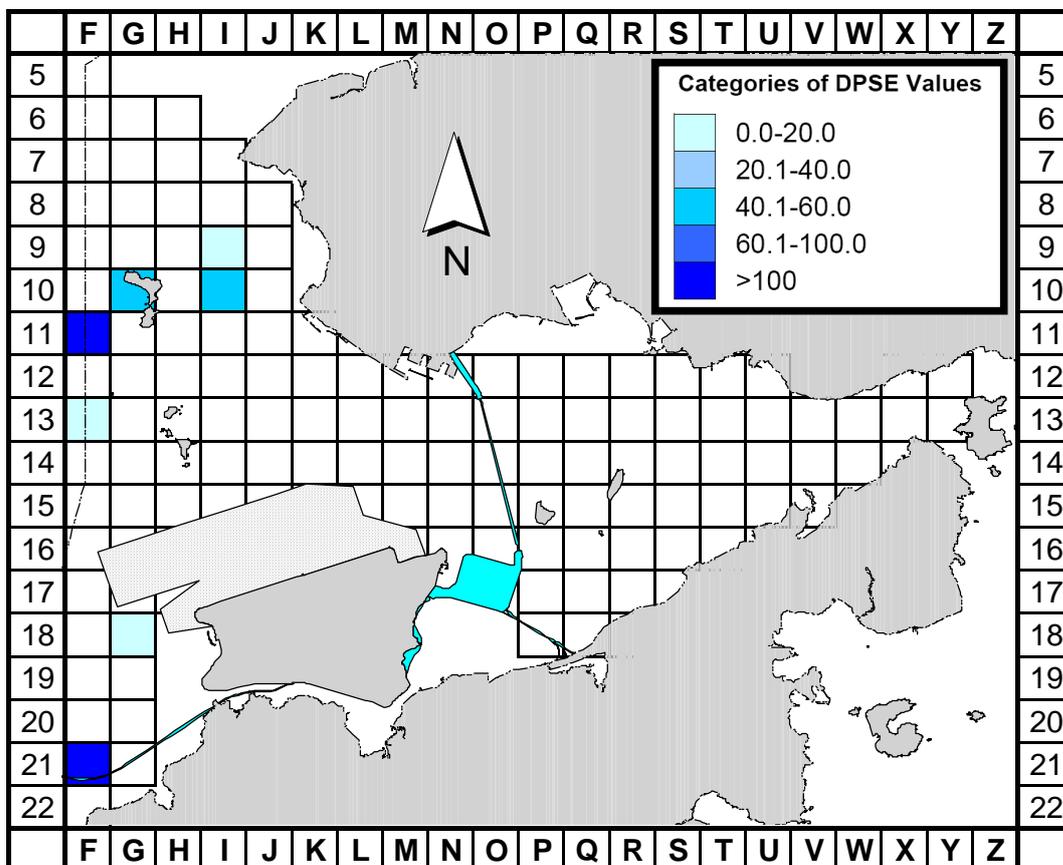
Figure 4b. Density of Chinese white dolphins with corrected survey effort per km<sup>2</sup> in Northeast and Northwest Lantau survey areas, using data collected during TMCLKL08 impact monitoring period (December 2019-February 2020) (DPSE = no. of dolphins per 100 units of survey effort)
