**Contract No. HY/2013/04 Hong Kong-Zhuhai-Macao Bridge (HZMB)  
Hong Kong Boundary Crossing Facilities – Infrastructure Works Stage II  
(Southern Portion)**

**Quarterly EM&A Report for December 2019 to February 2020 (Revision 0)**

Quarterly EM&A Report for December 2019 to  
February 2020

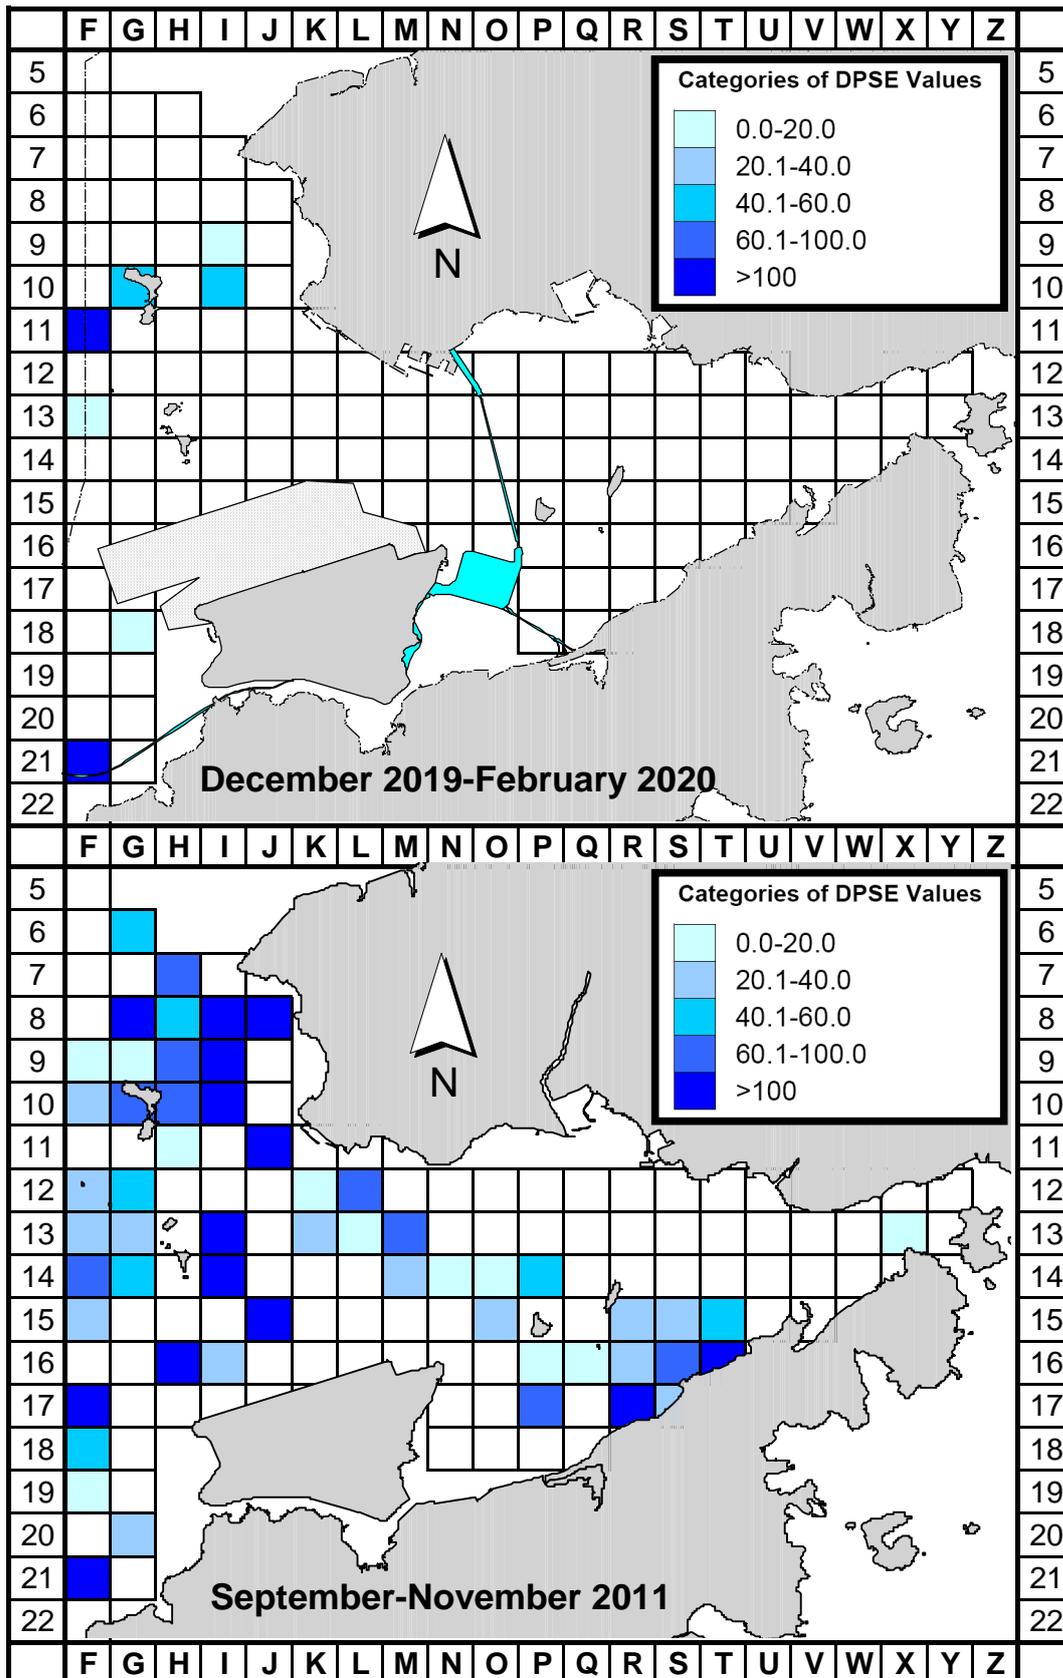
Figure 5. Comparison of density of Chinese white dolphins with corrected survey effort per km<sup>2</sup> in Northwest and Northeast Lantau survey area between the TMCLKL08 impact monitoring period (December 2019 - February 2020) and baseline monitoring period (September-November 2011) (DPSE = no. of dolphins per 100 units of survey effort)

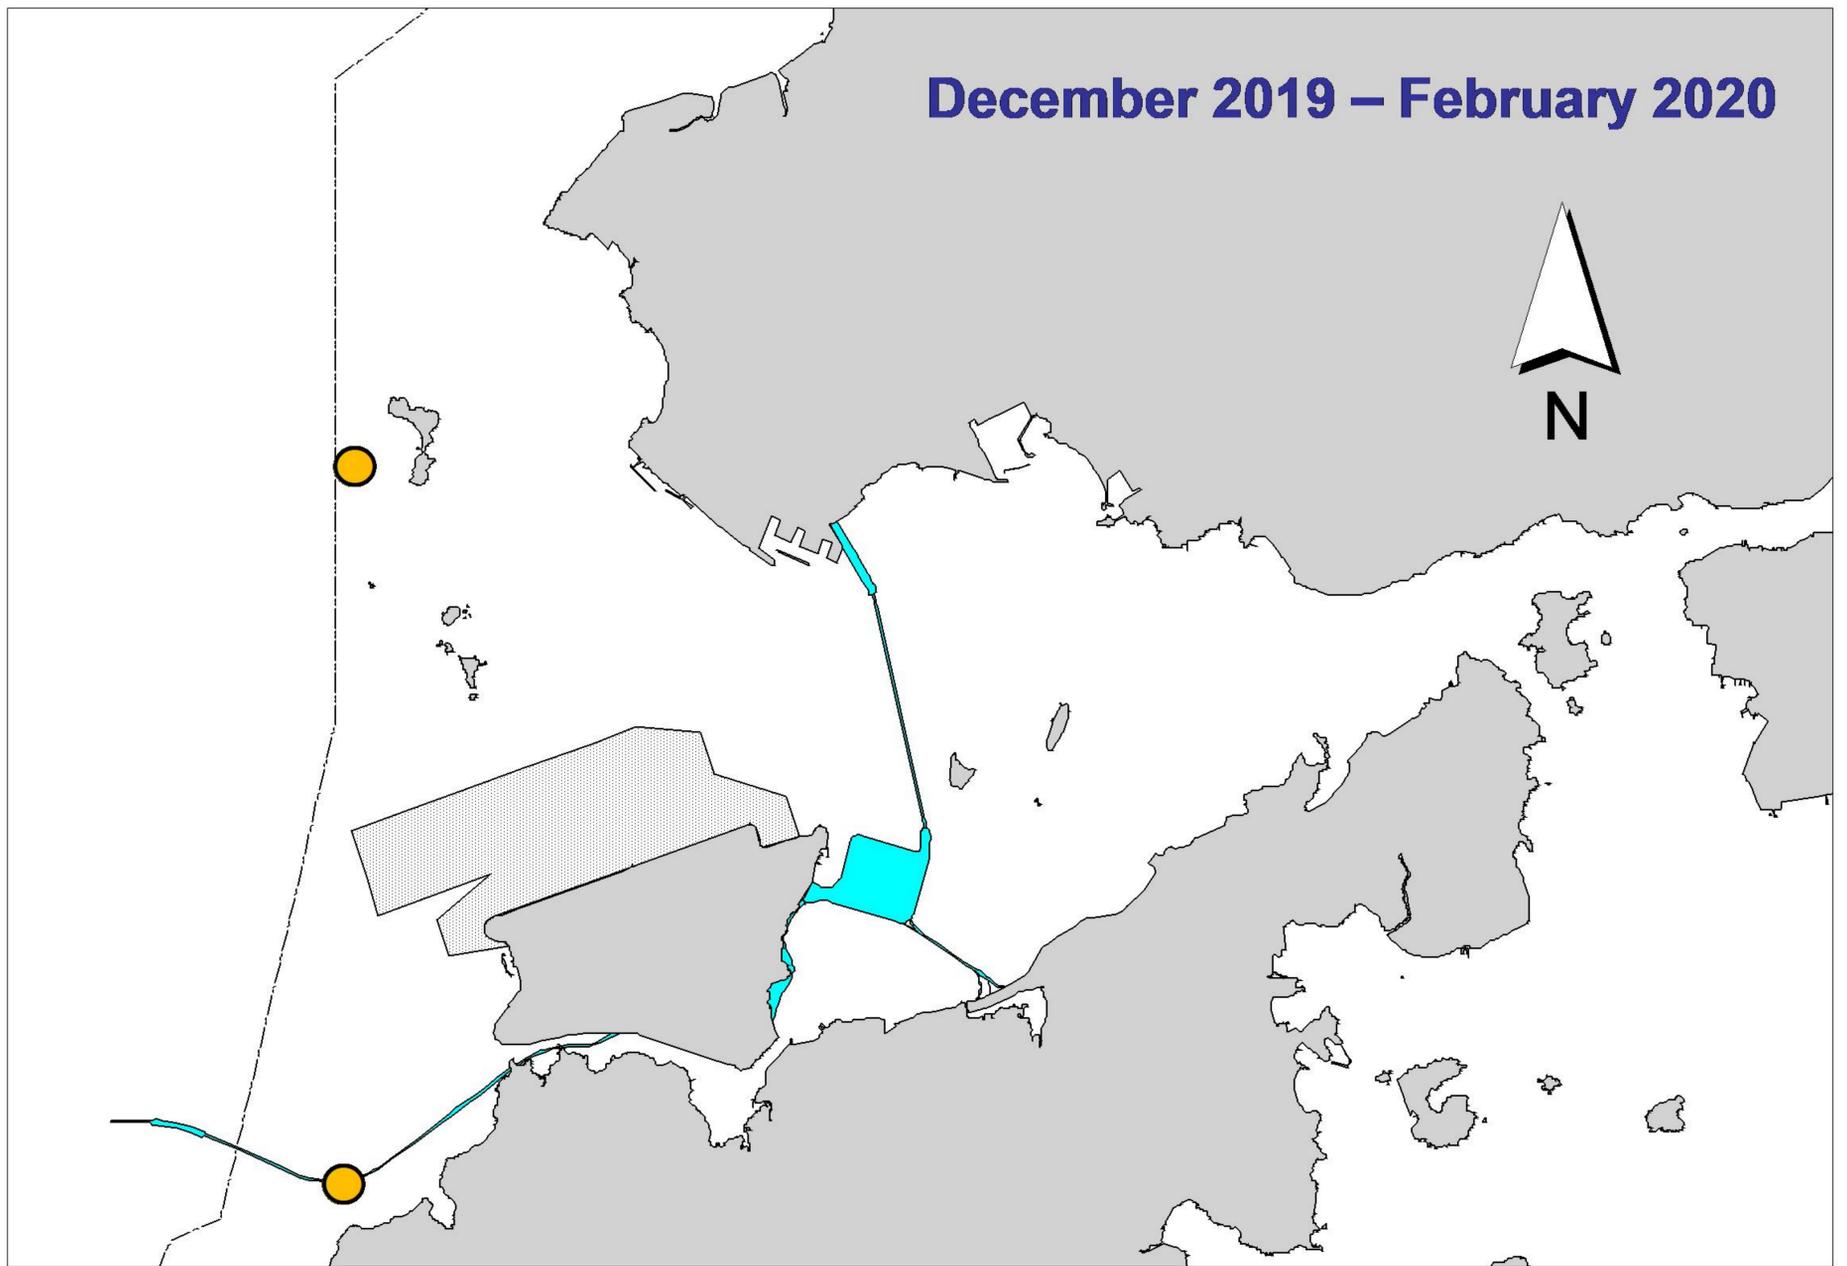
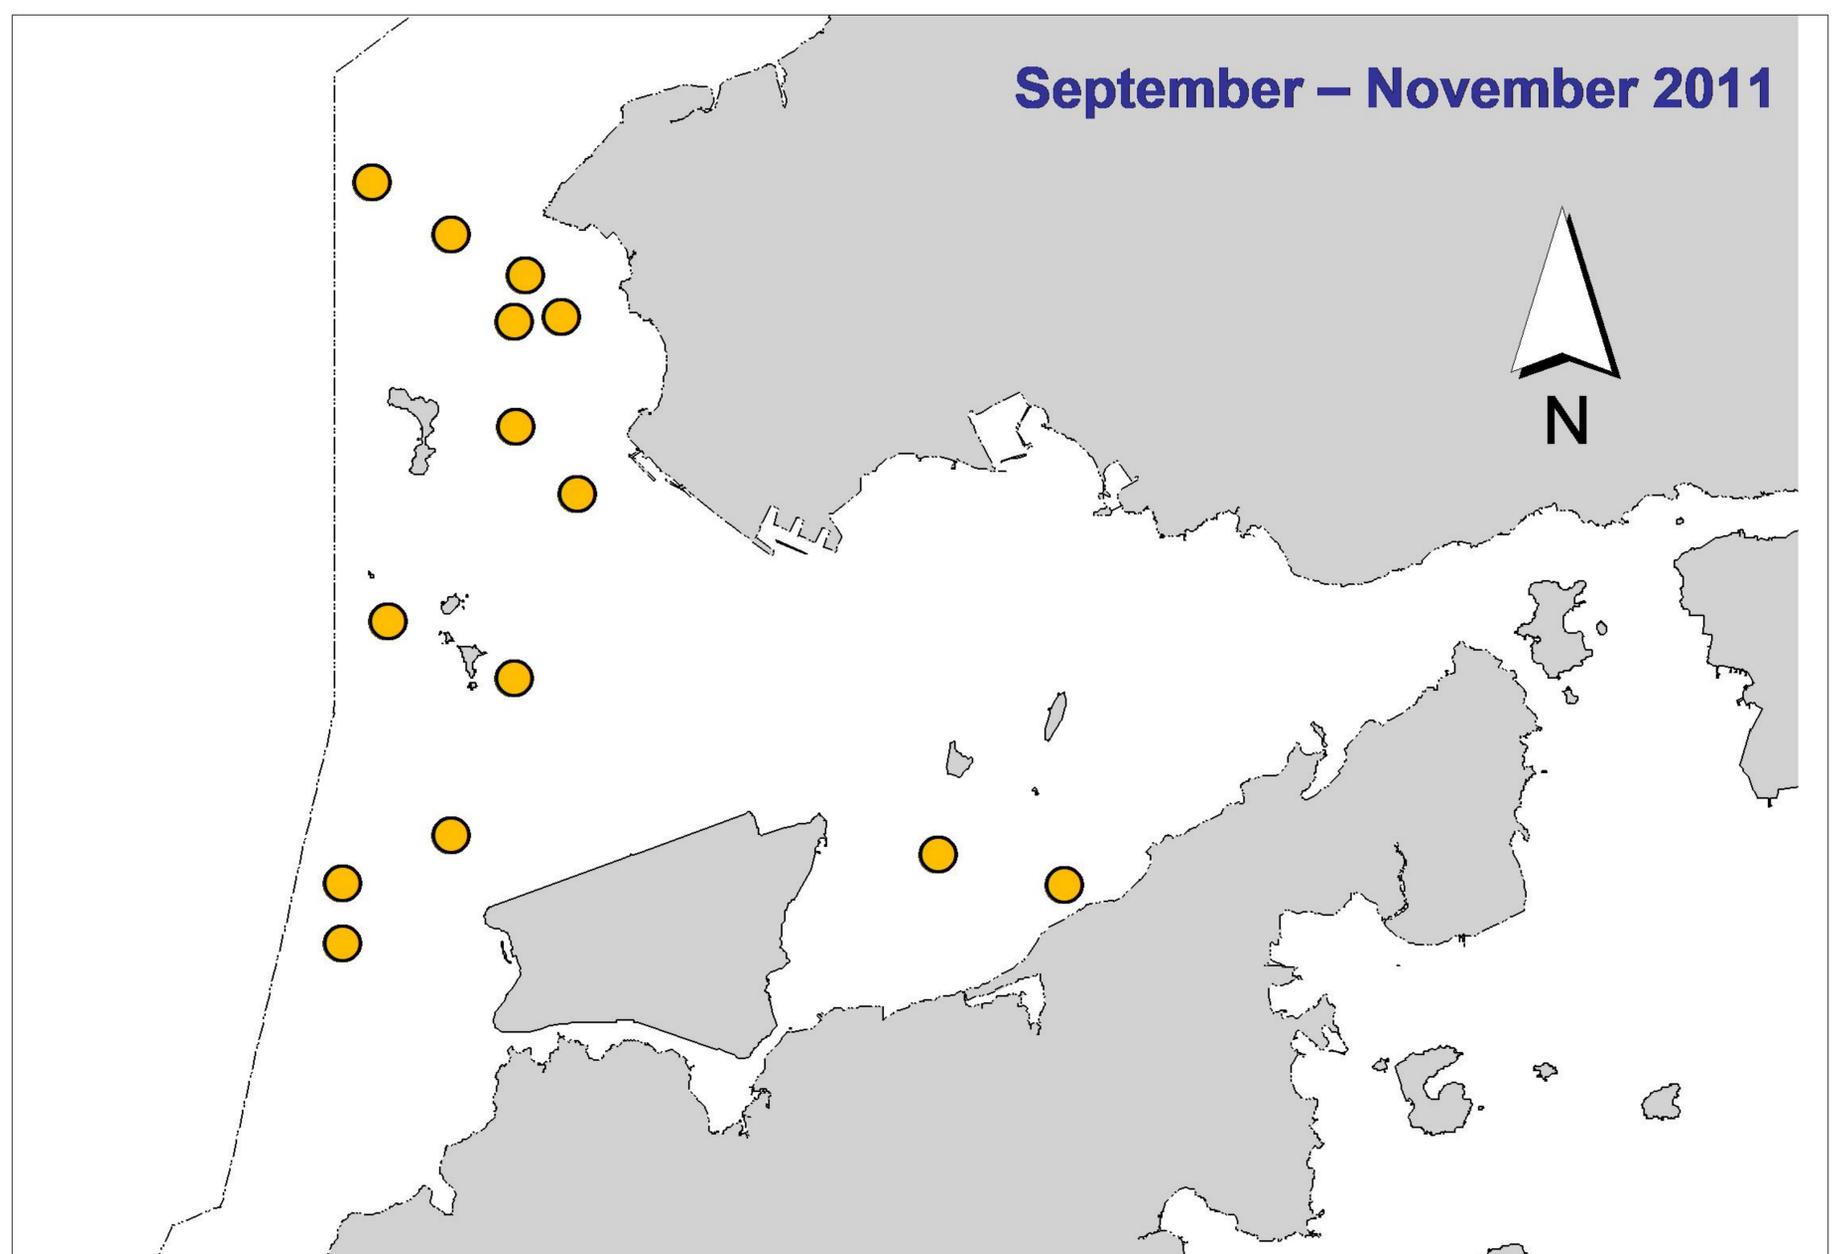
Figure 6. Distribution of young calves of Chinese white dolphins during TMCLKL08 impact phase (top) and baseline monitoring surveys (bottom)

- 3.6.1. During the present quarterly period, a total of three unspotted juveniles were sighted with their mothers to the west of Lung Kwu Chau and near the HKLR09 alignment in the NWL survey area (Figure 6).
- 3.6.2. It should be noted that the rare occurrence of young calves in the present quarter as well as in recent years of HZMB monitoring was very different from their regular occurrence in North Lantau waters during the baseline period (Figure 6).

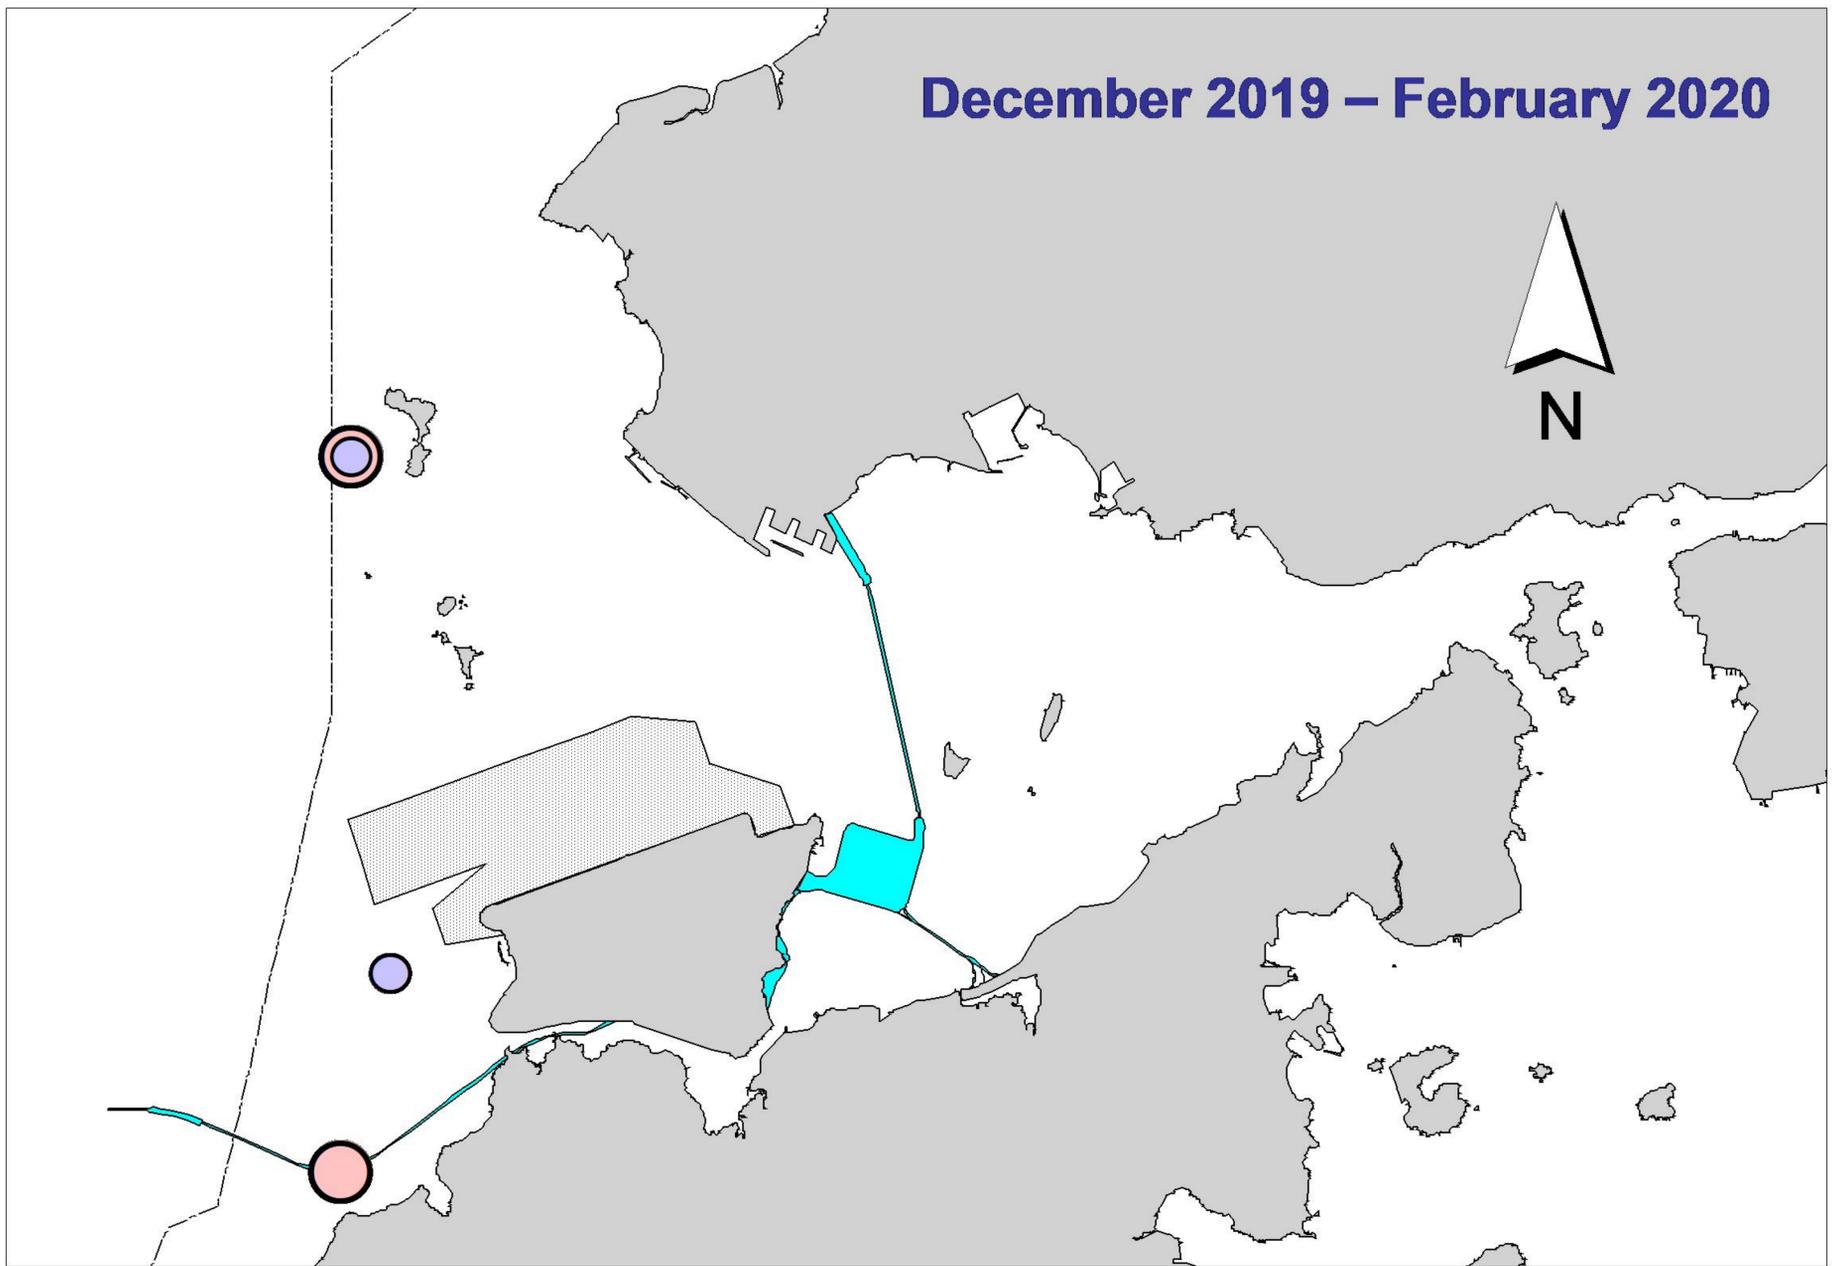
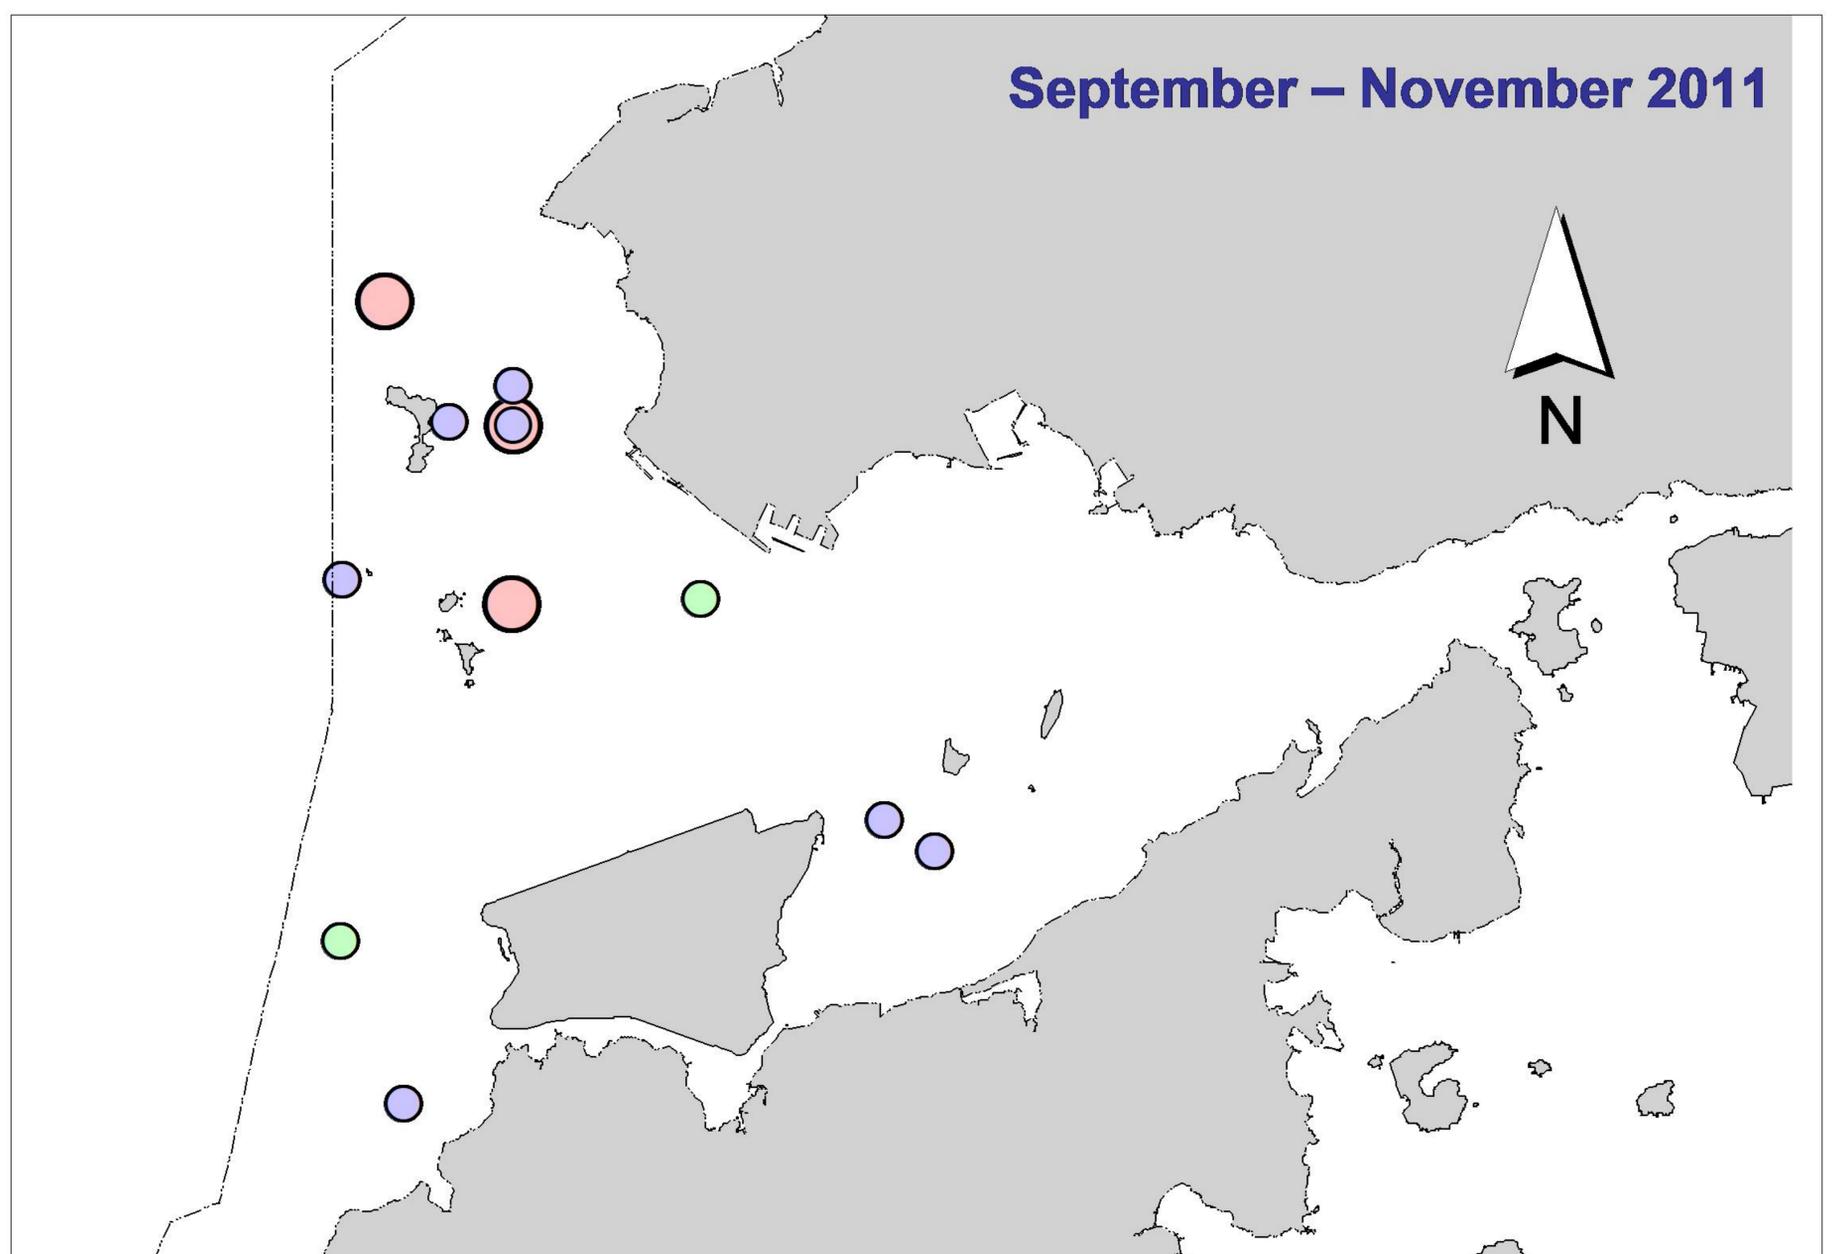
Figure 7. Distribution of Chinese white dolphins engaged in feeding (purple dots), socializing (pink dots) and traveling (green dots) activities during TMCLKL08 impact phase (top) and baseline monitoring surveys (bottom)
