Contract No. HY/2011/03 - Hong Kong- Zhuhai- Macao Bridge Hong Kong Link Road Section between Scenic Hill and Hong Kong Boundary Crossing Facilities Notifications of Environmental Quality Limits Exceedances <div>Notification No.: 307e</div>							
Date of Notification: 28 August 2024							
Works Inspected: Data collected from water sampling works on 21 August 2024 and the results were issued at 4:31 PM on 26 August 2024							
Monitoring Location: Water Quality Monitoring Stations (IS5, IS8(N), IS10(N), SR4(N3), SR5(N), SR10A(N), SR10B(N2) and IS(Mf)6)							
Parameter: Dissolved Oxygen (DO)/ Suspended Solids (SS) / Turbidity (TURB)							
Action & Limit Level (AL & LL) / Measured Level:							
PARAM	STATION	Level	Action Level (mg/L)	Limit Level (mg/L)	Measured At Mid-Ebb Tide (mg/L)		
DO (mg/L) (surface, middle and bottom)	IS5	Middle	Surface and Middle 5.0 (mg/L) Bottom 4.7 (mg/L)	Surface and Middle 4.2 except 5 for Fish Culture Zone Bottom 3.6(mg/L)	<i>5.0</i>

Hong Kong Link Road Section between Scenic Hill and Hong Kong Boundary Crossing Facilities

Investigation Report of Water Quality Exceedance(s)

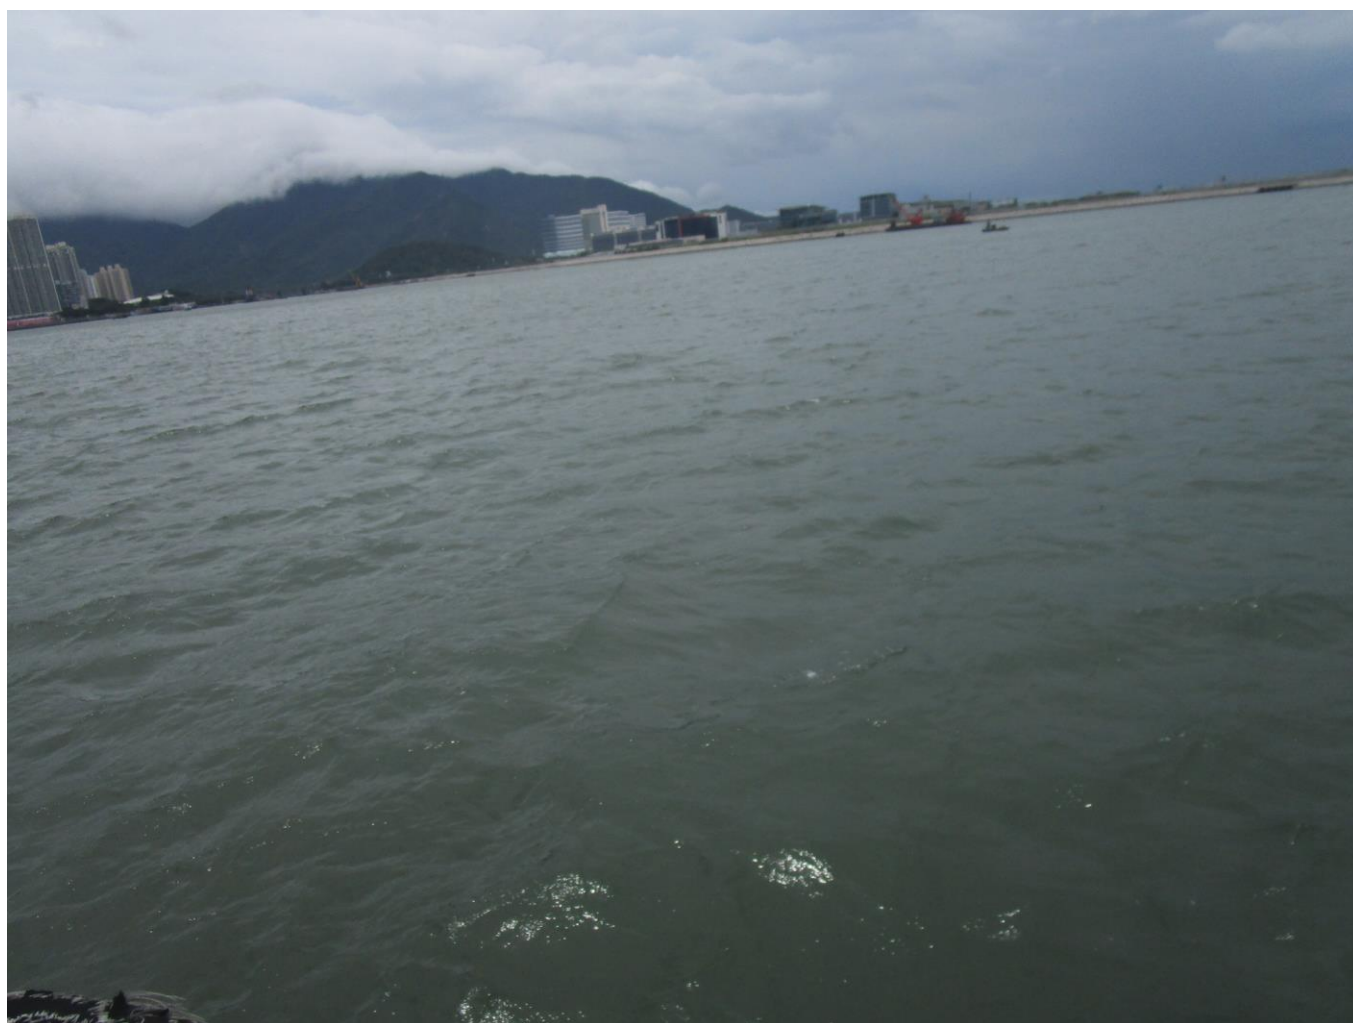
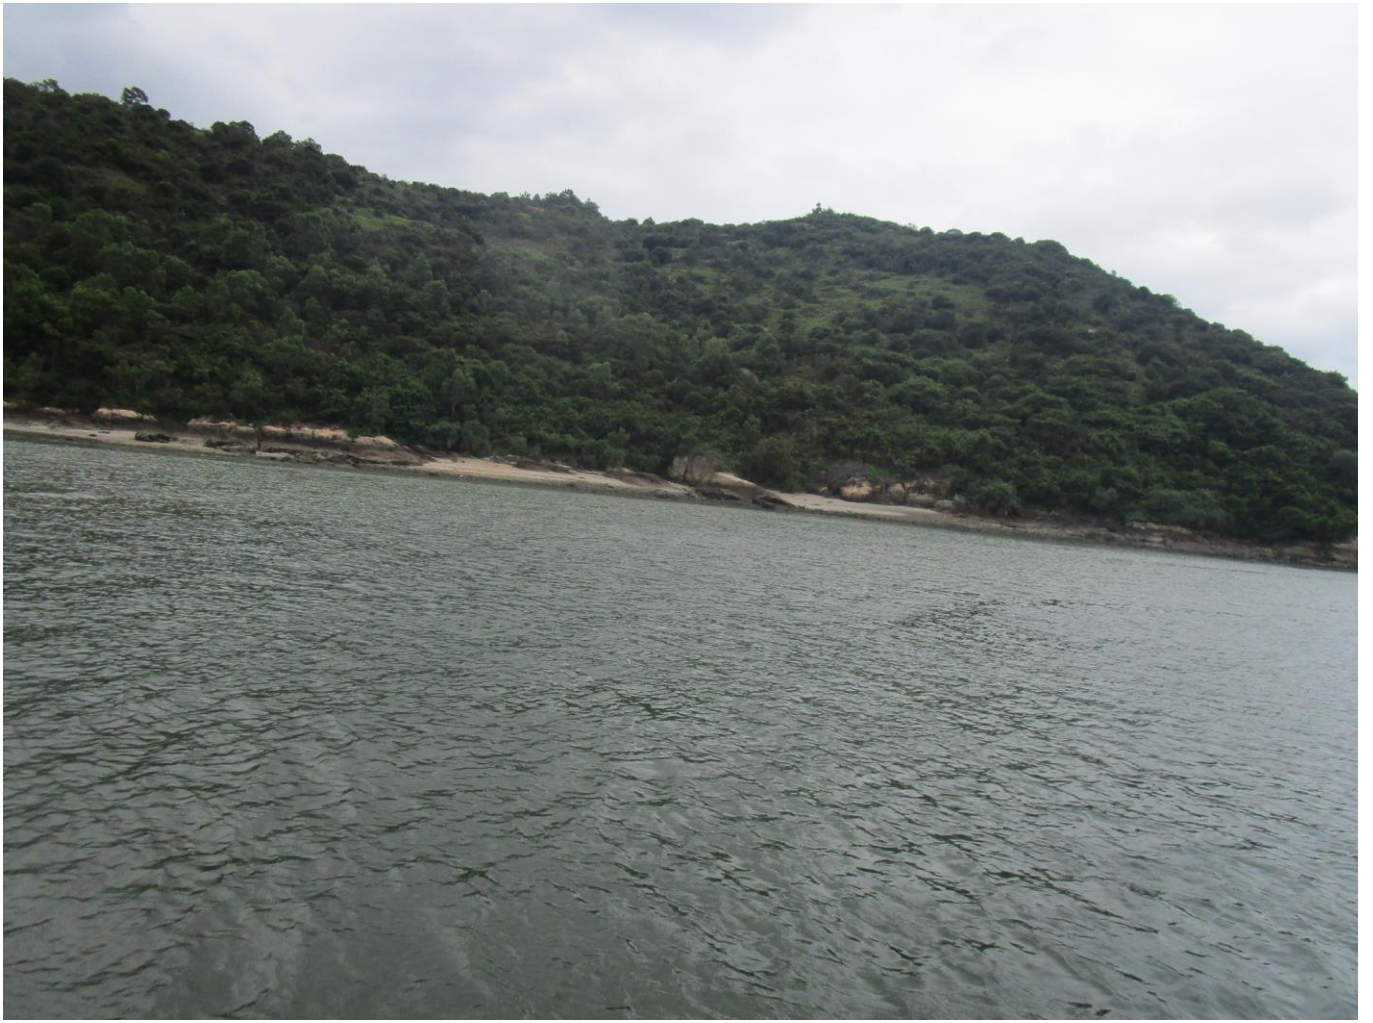
Monitoring Photo Record

1. No major marine works were carried out near the monitoring stations. Removal of temporary toe loading platform was being carried out within silt curtains within the limited shoreline area during the sampling period.

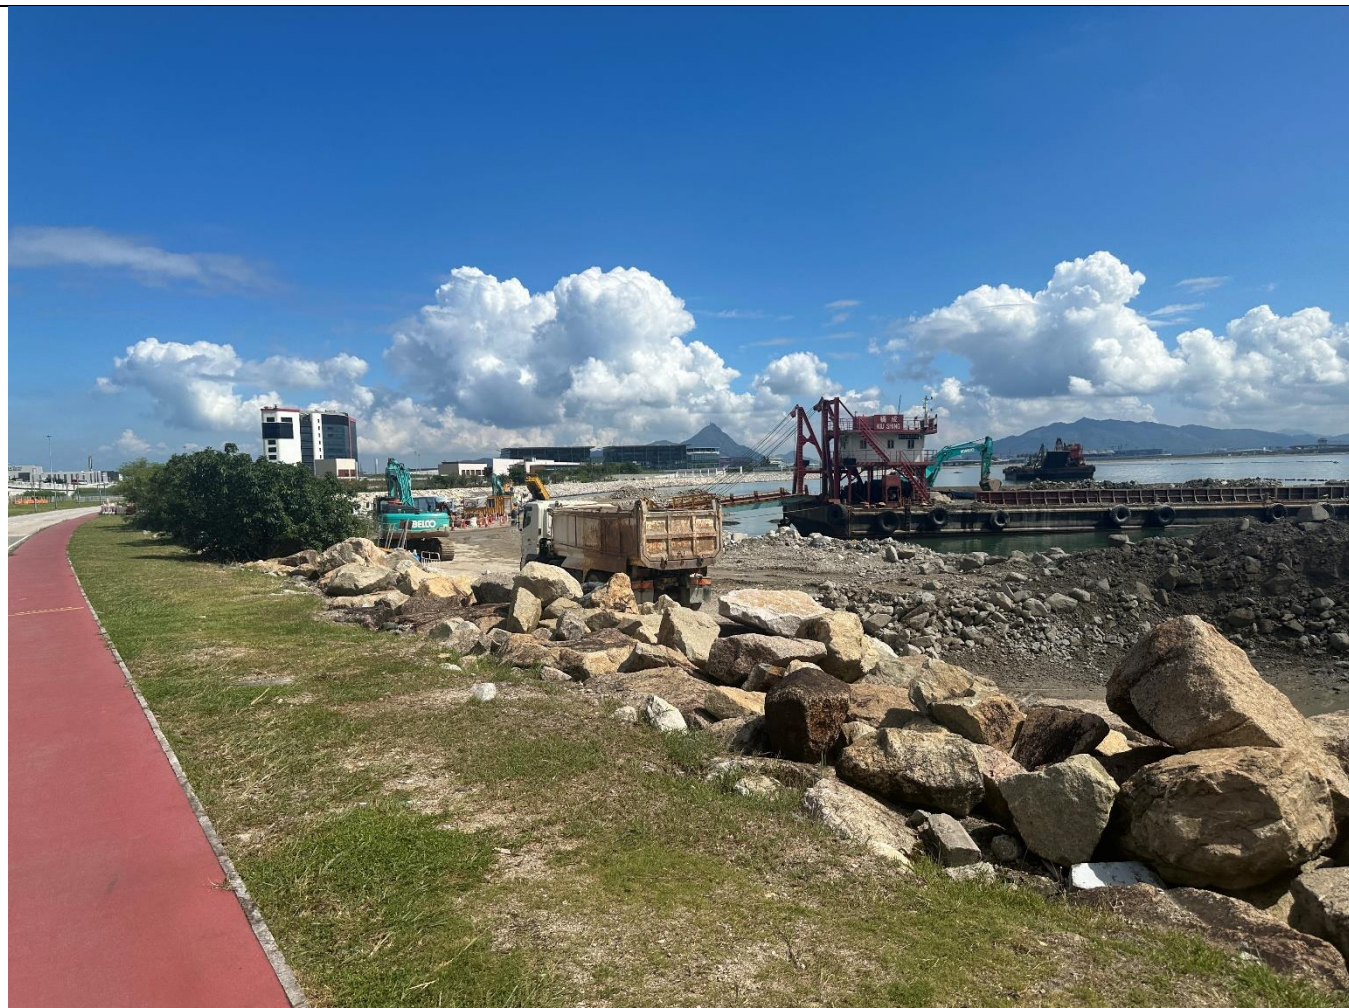
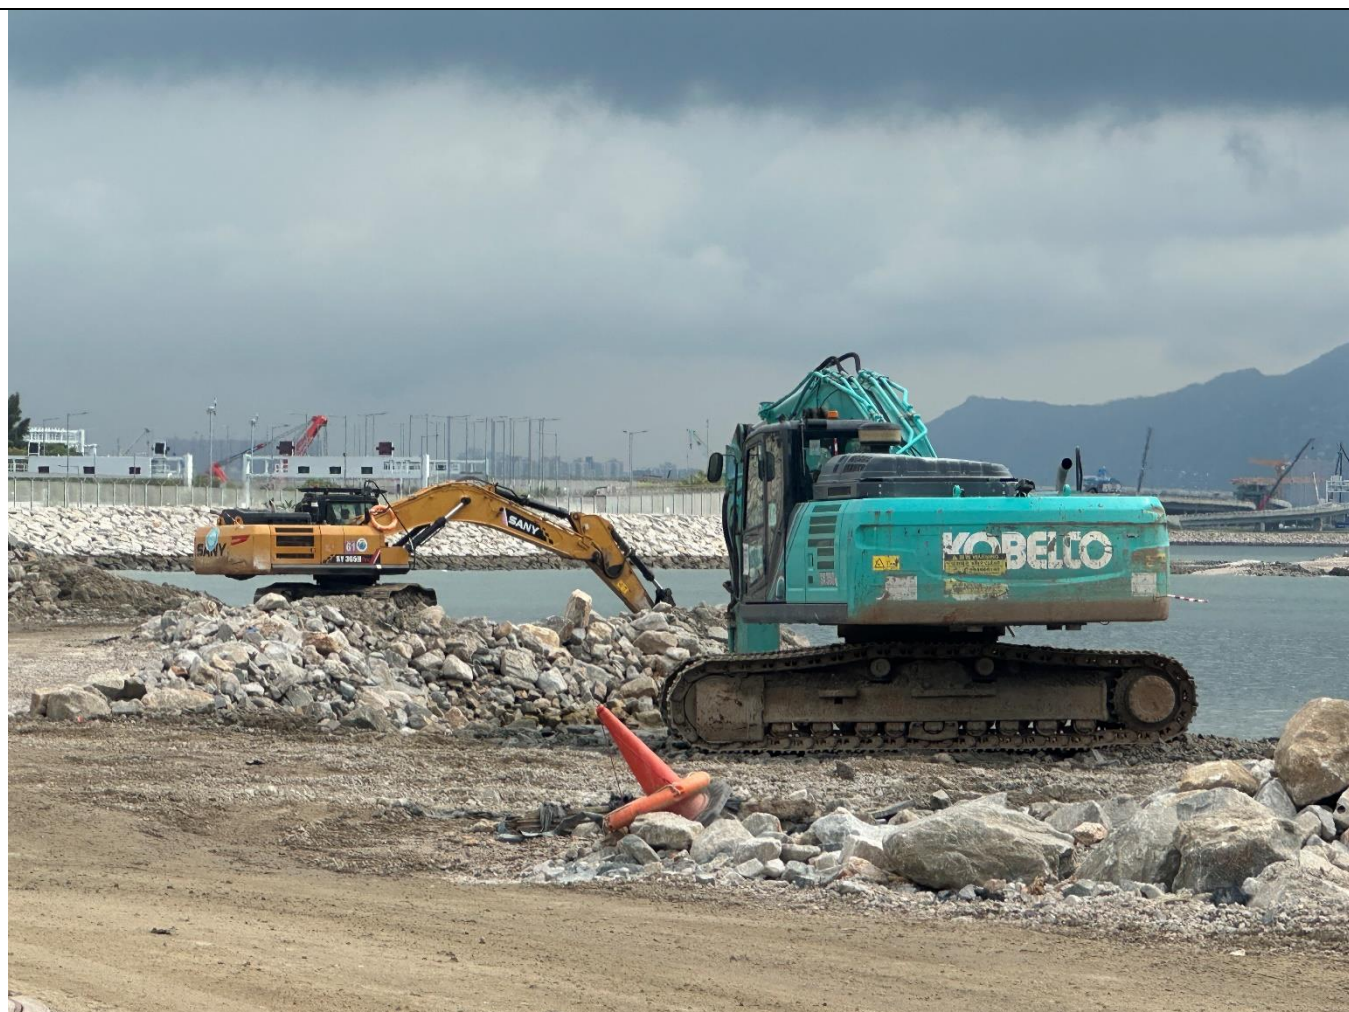
Site Observation Photos during Site Inspection on 23 August 2024

Construction activities carried out during the investigation period:	According to the information provided by the Contractor, the construction works carried out within the site area include removal of temporary toe loading platform during the reporting month.
Possible reason for the exceedance	<p>According to observations during the on-site water quality measurement and site inspection during the reporting month, no project related construction activities was observed next to the water quality monitoring station with DO exceedances. Also, the measured DO levels during mid-ebb tide at stations IS5 (Middle), IS8(N), IS10(N) (Middle), SR4(N3), SR10A(N), and IS(Mf)6 were within the ranges of dissolved oxygen during baseline monitoring.</p> <p>Therefore, natural fluctuation is considered to be attributed to low dissolved oxygen levels, rather than the contract works.</p>
Action taken / to be taken	As the exceedance was non-project related, no further investigation and specific remedial measure(s) would be recommended.
