Appendix J

Ref/Project number Contract No. HY/2017/10
Tuen Mun – Chek Lap Kok Link – Northern
Connection Tunnel Buildings, Electrical and
Mechanical Works

Subject Notification of Exceedance for Air Quality
Impact Monitoring

Notification of Exceedance

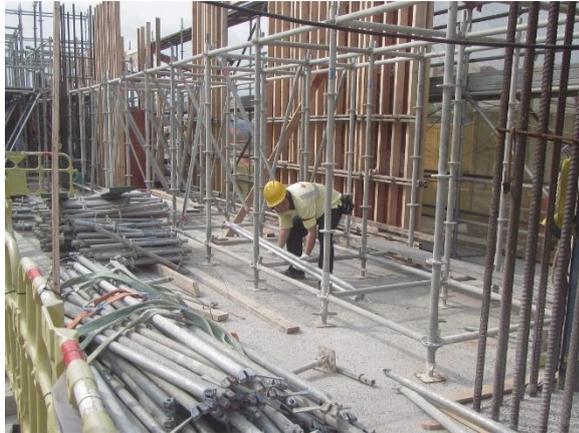
Photo 1 - Building structure was conducted at works area of Administration Building and Maintenance Depot

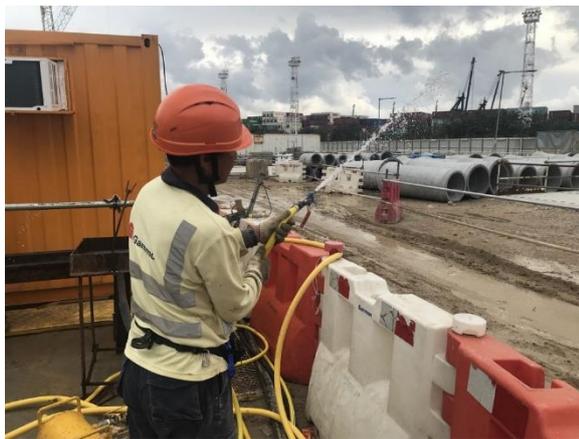
Photo 2- Watering of unpaved roads near Administration Building and Maintenance Depot

| Actions Taken/ To Be Taken | The Contractor has been reminded to ensure all dust suppression measures are implemented at the site area including water spraying at unpaved road. The ET will monitor for future trends in exceedances. | |

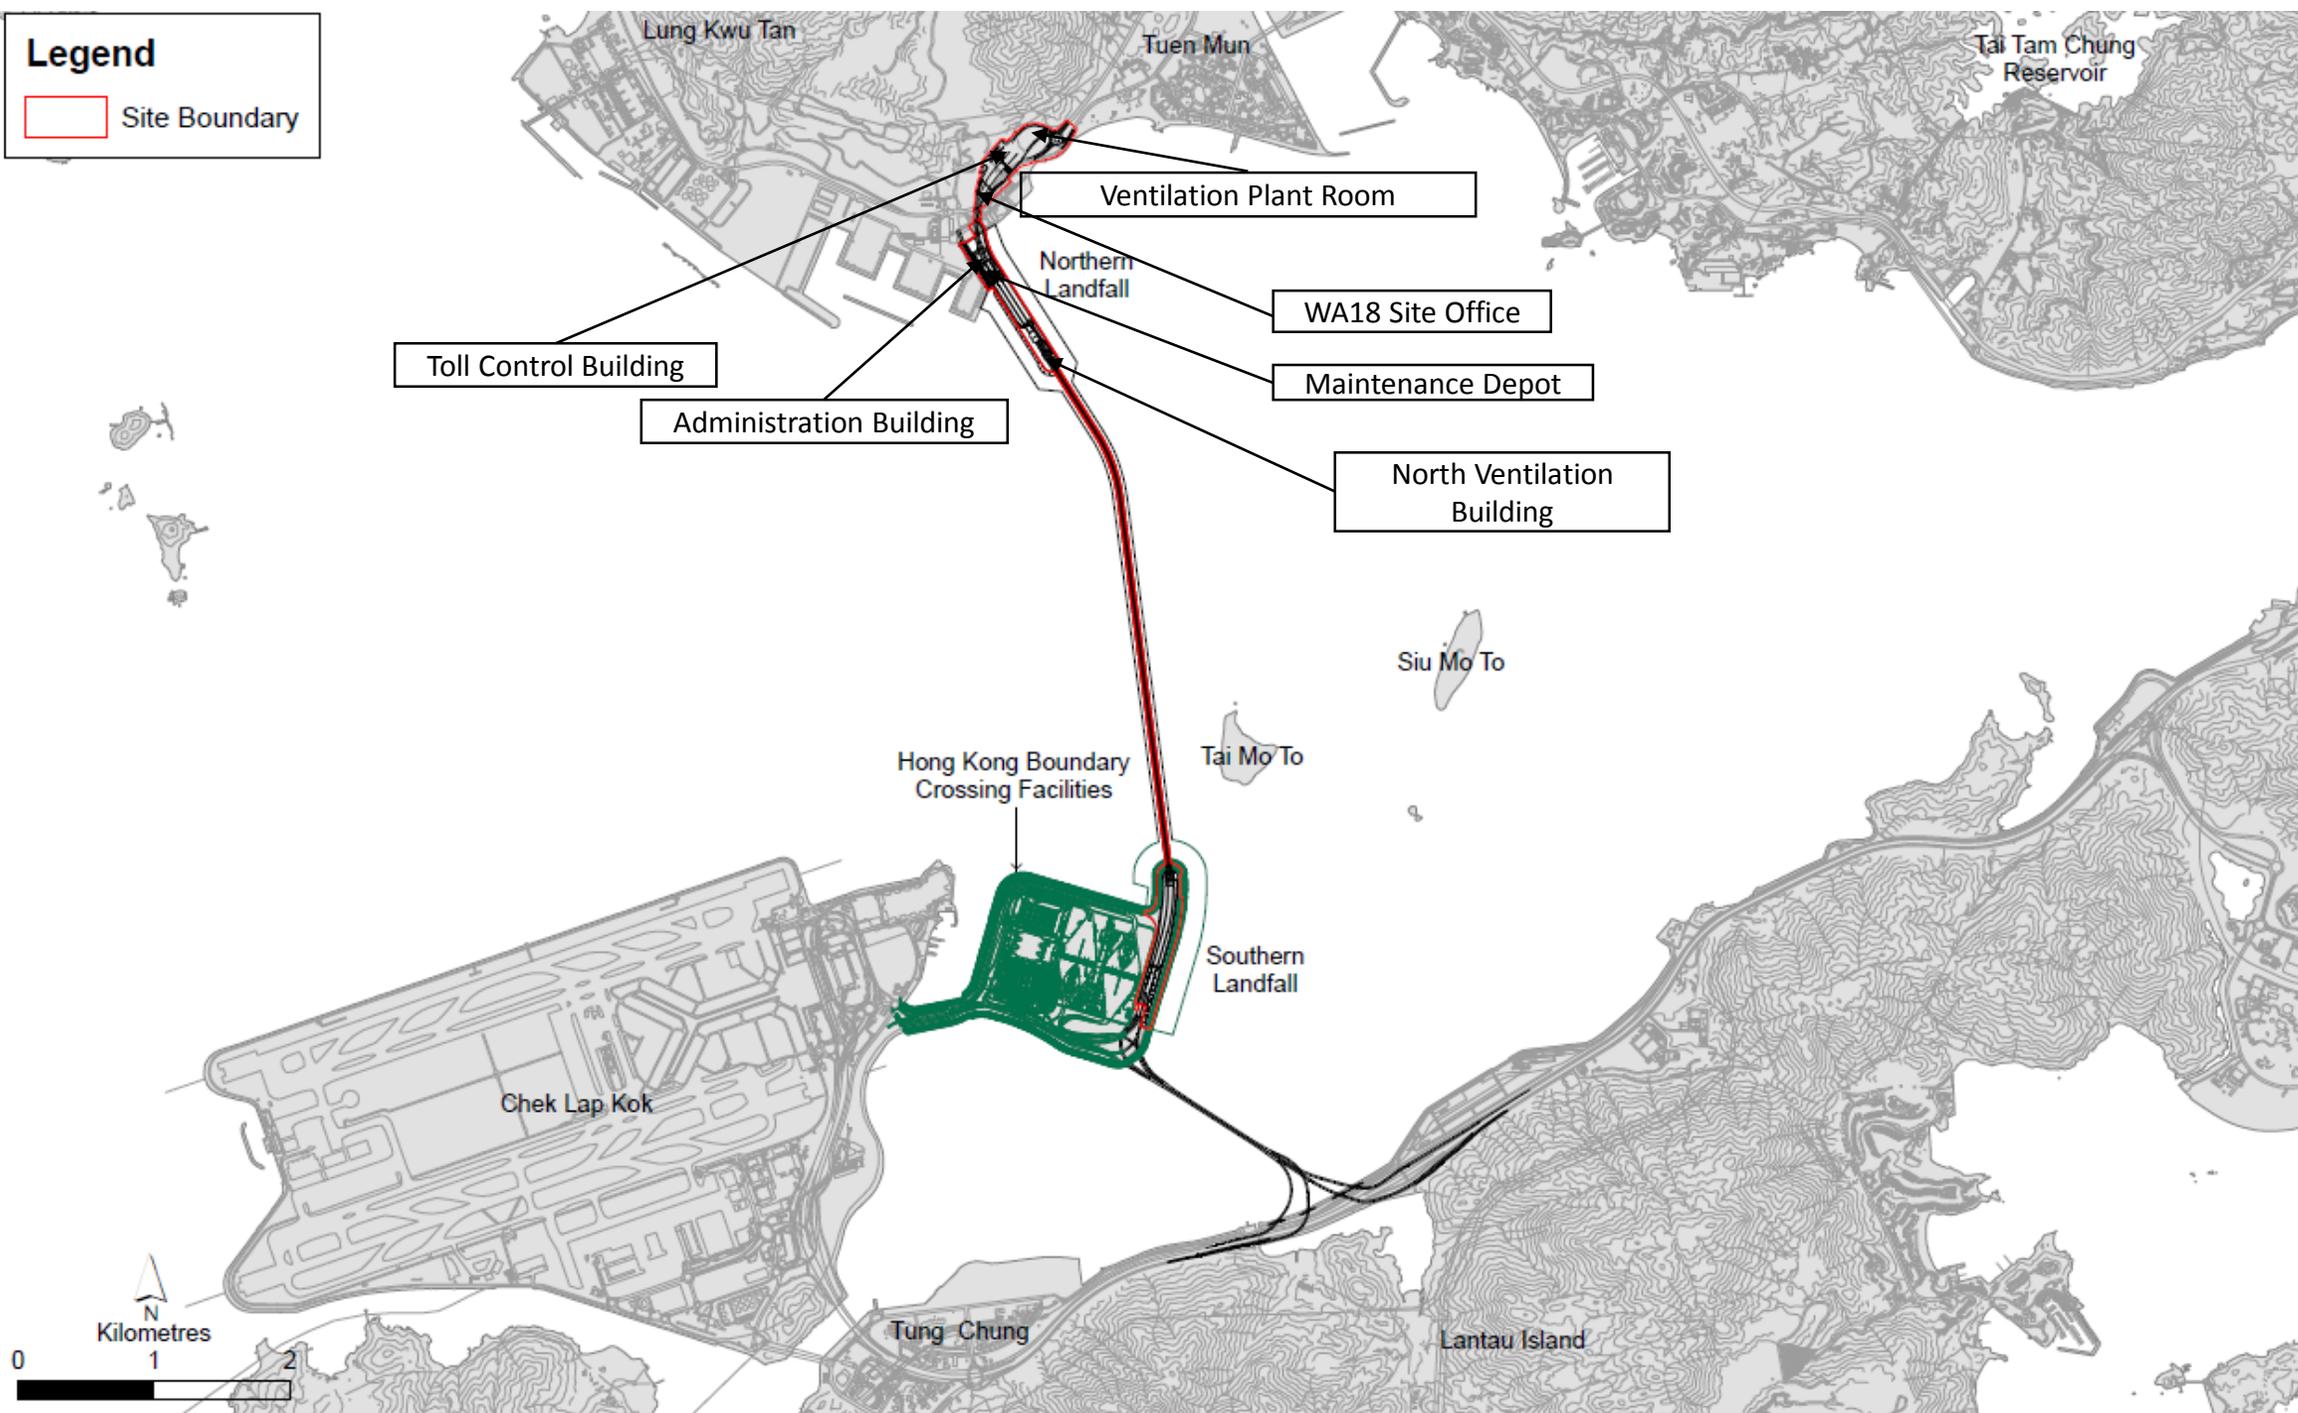
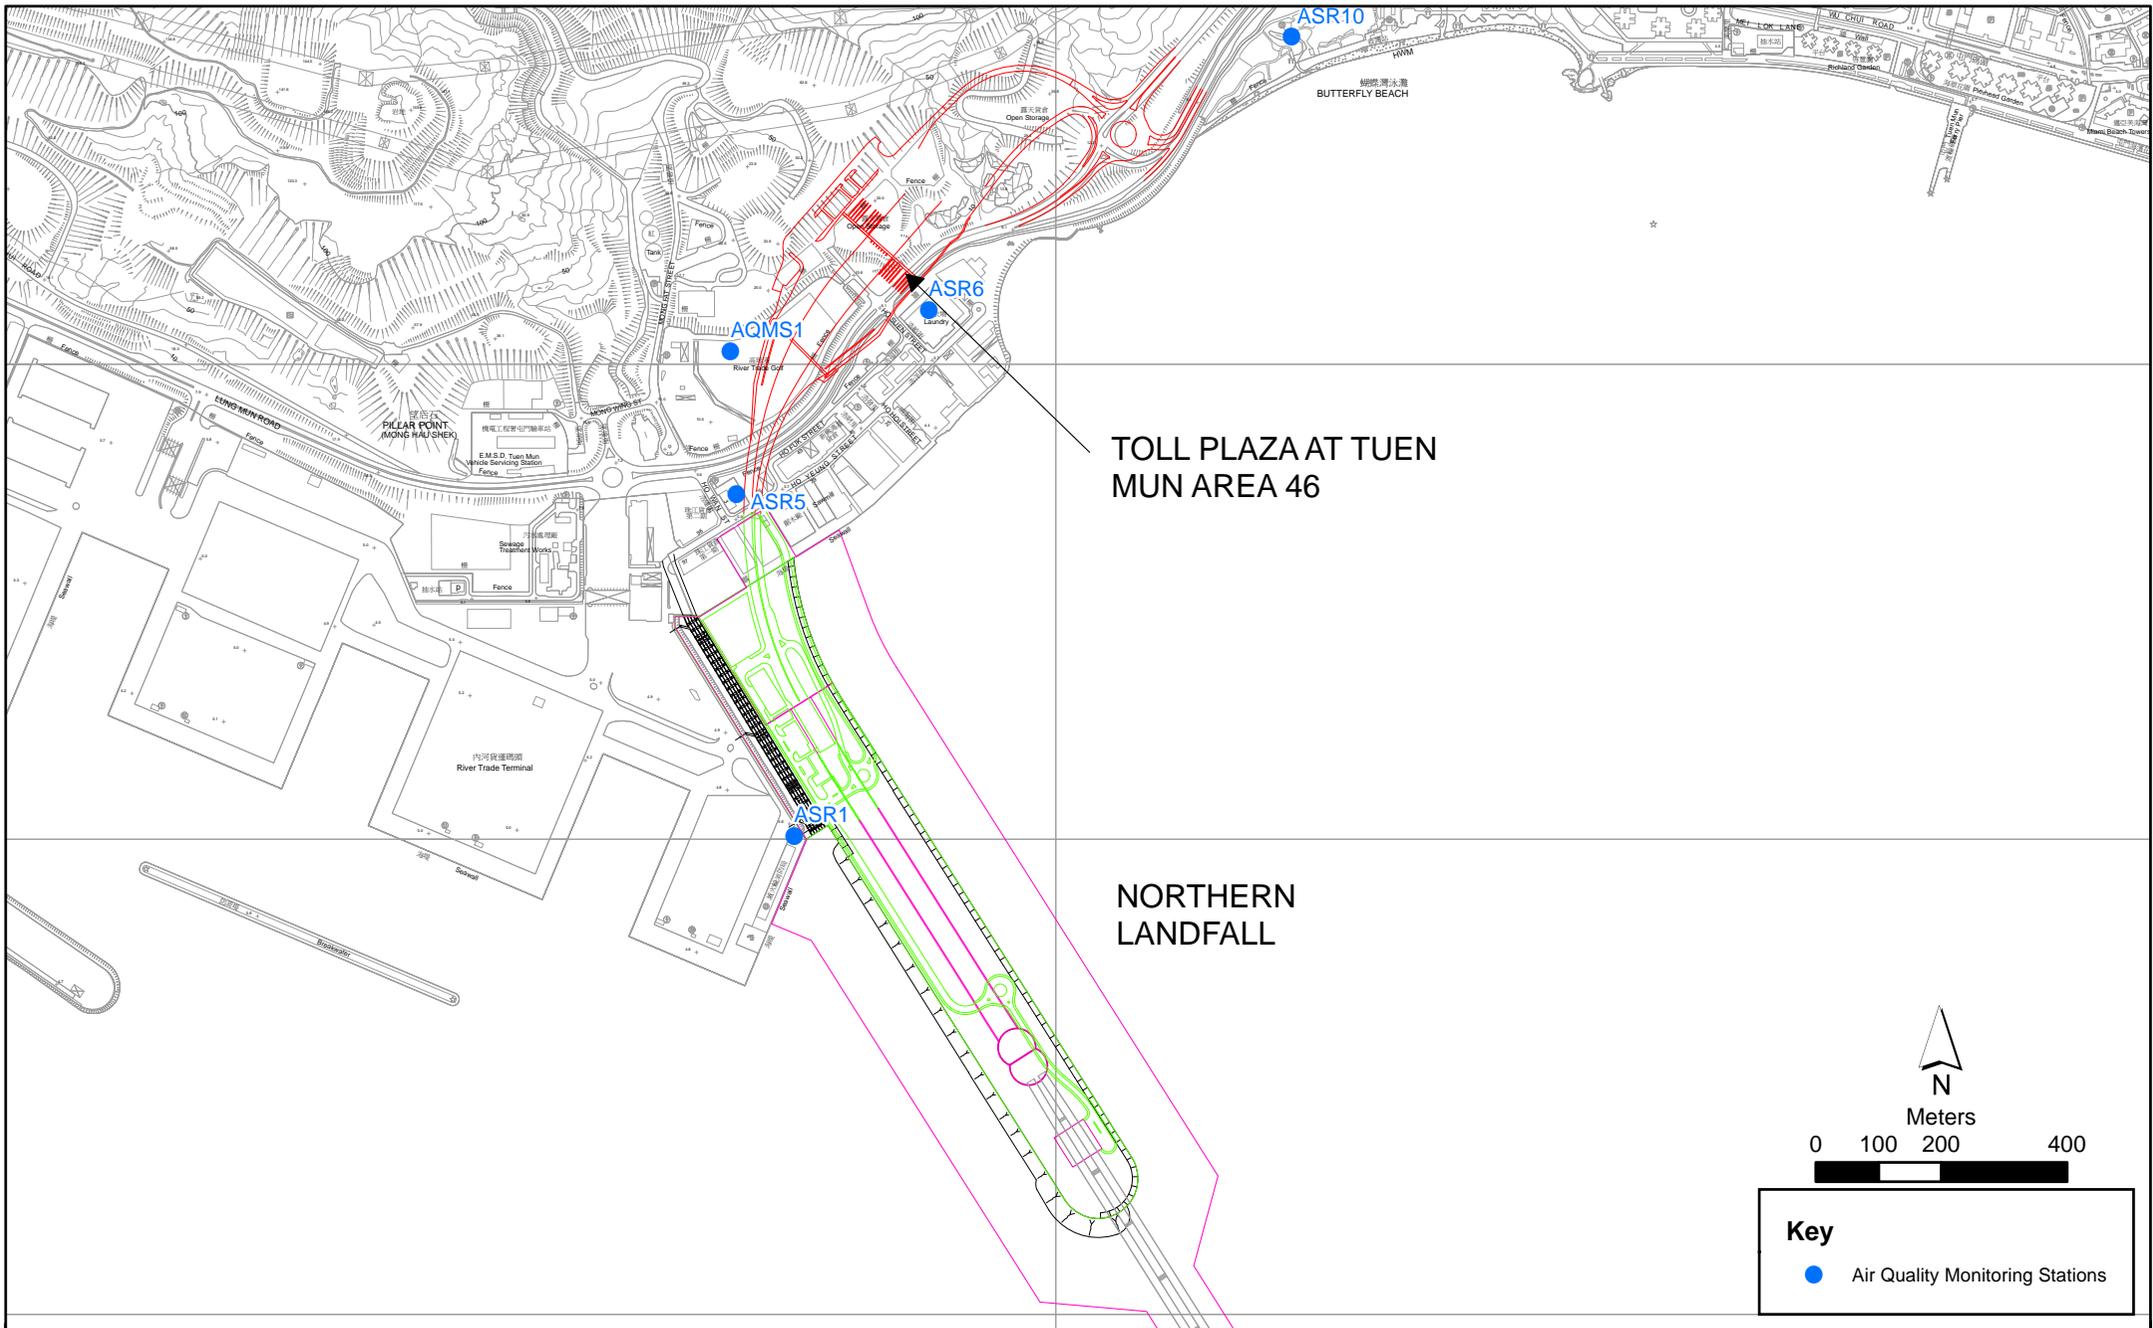
Figure 2.1

Air Quality Monitoring Stations for the Enhanced TSP Monitoring
 (Source: Adopted from Contract No. HY/2012/08 Tuen Mun-Chek Lap Kok Link -
 Northern Connection Sub-sea Tunnel Section)

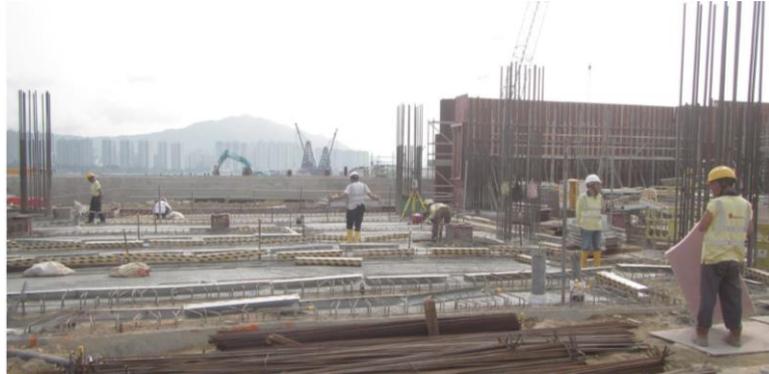
Photo 1 - Building structure was conducted at works area of Administration Building and Maintenance

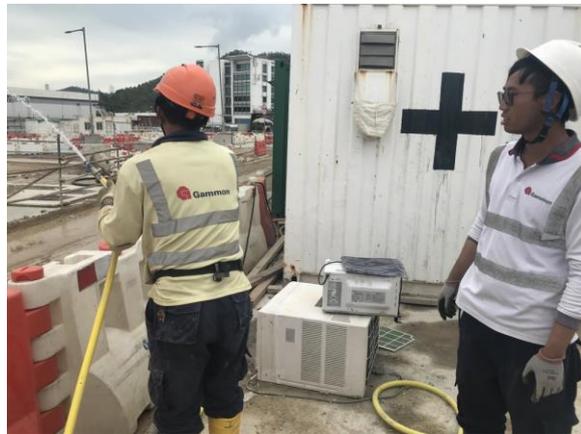
Photo 2- Watering of unpaved roads near Administration Building and Maintenance Depot

| Actions Taken/ To Be Taken | The Contractor has been reminded to ensure all dust suppression measures are implemented at the site area including water spraying at unpaved road. The ET will monitor for future trends in exceedances. | |

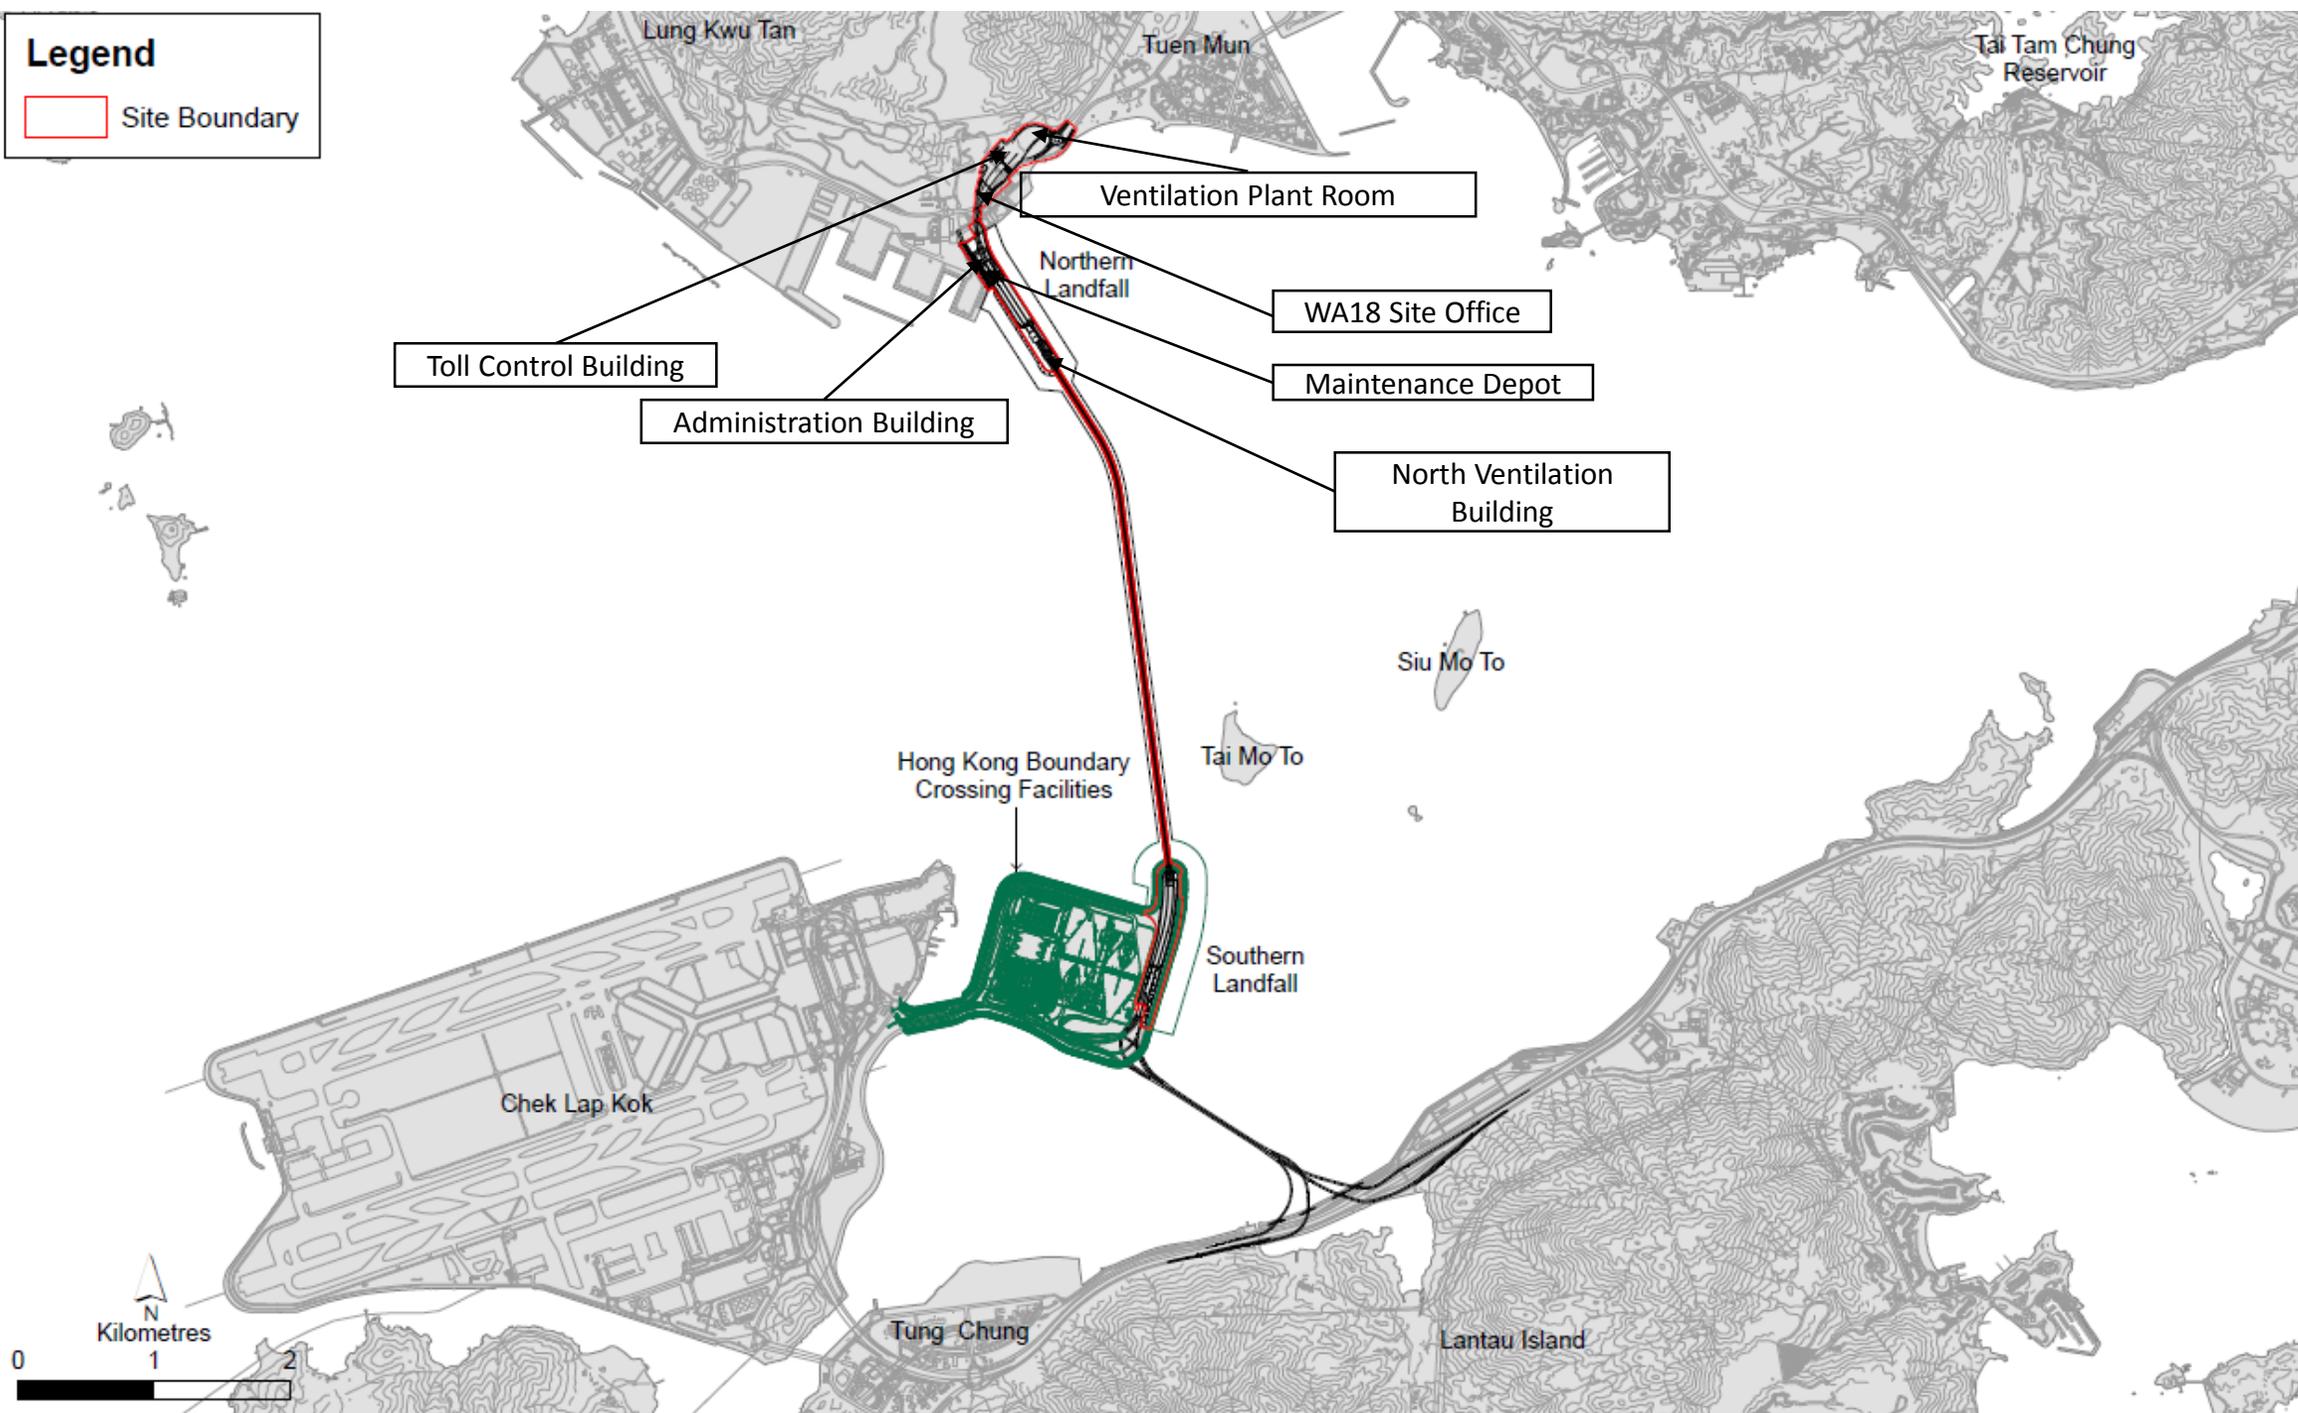
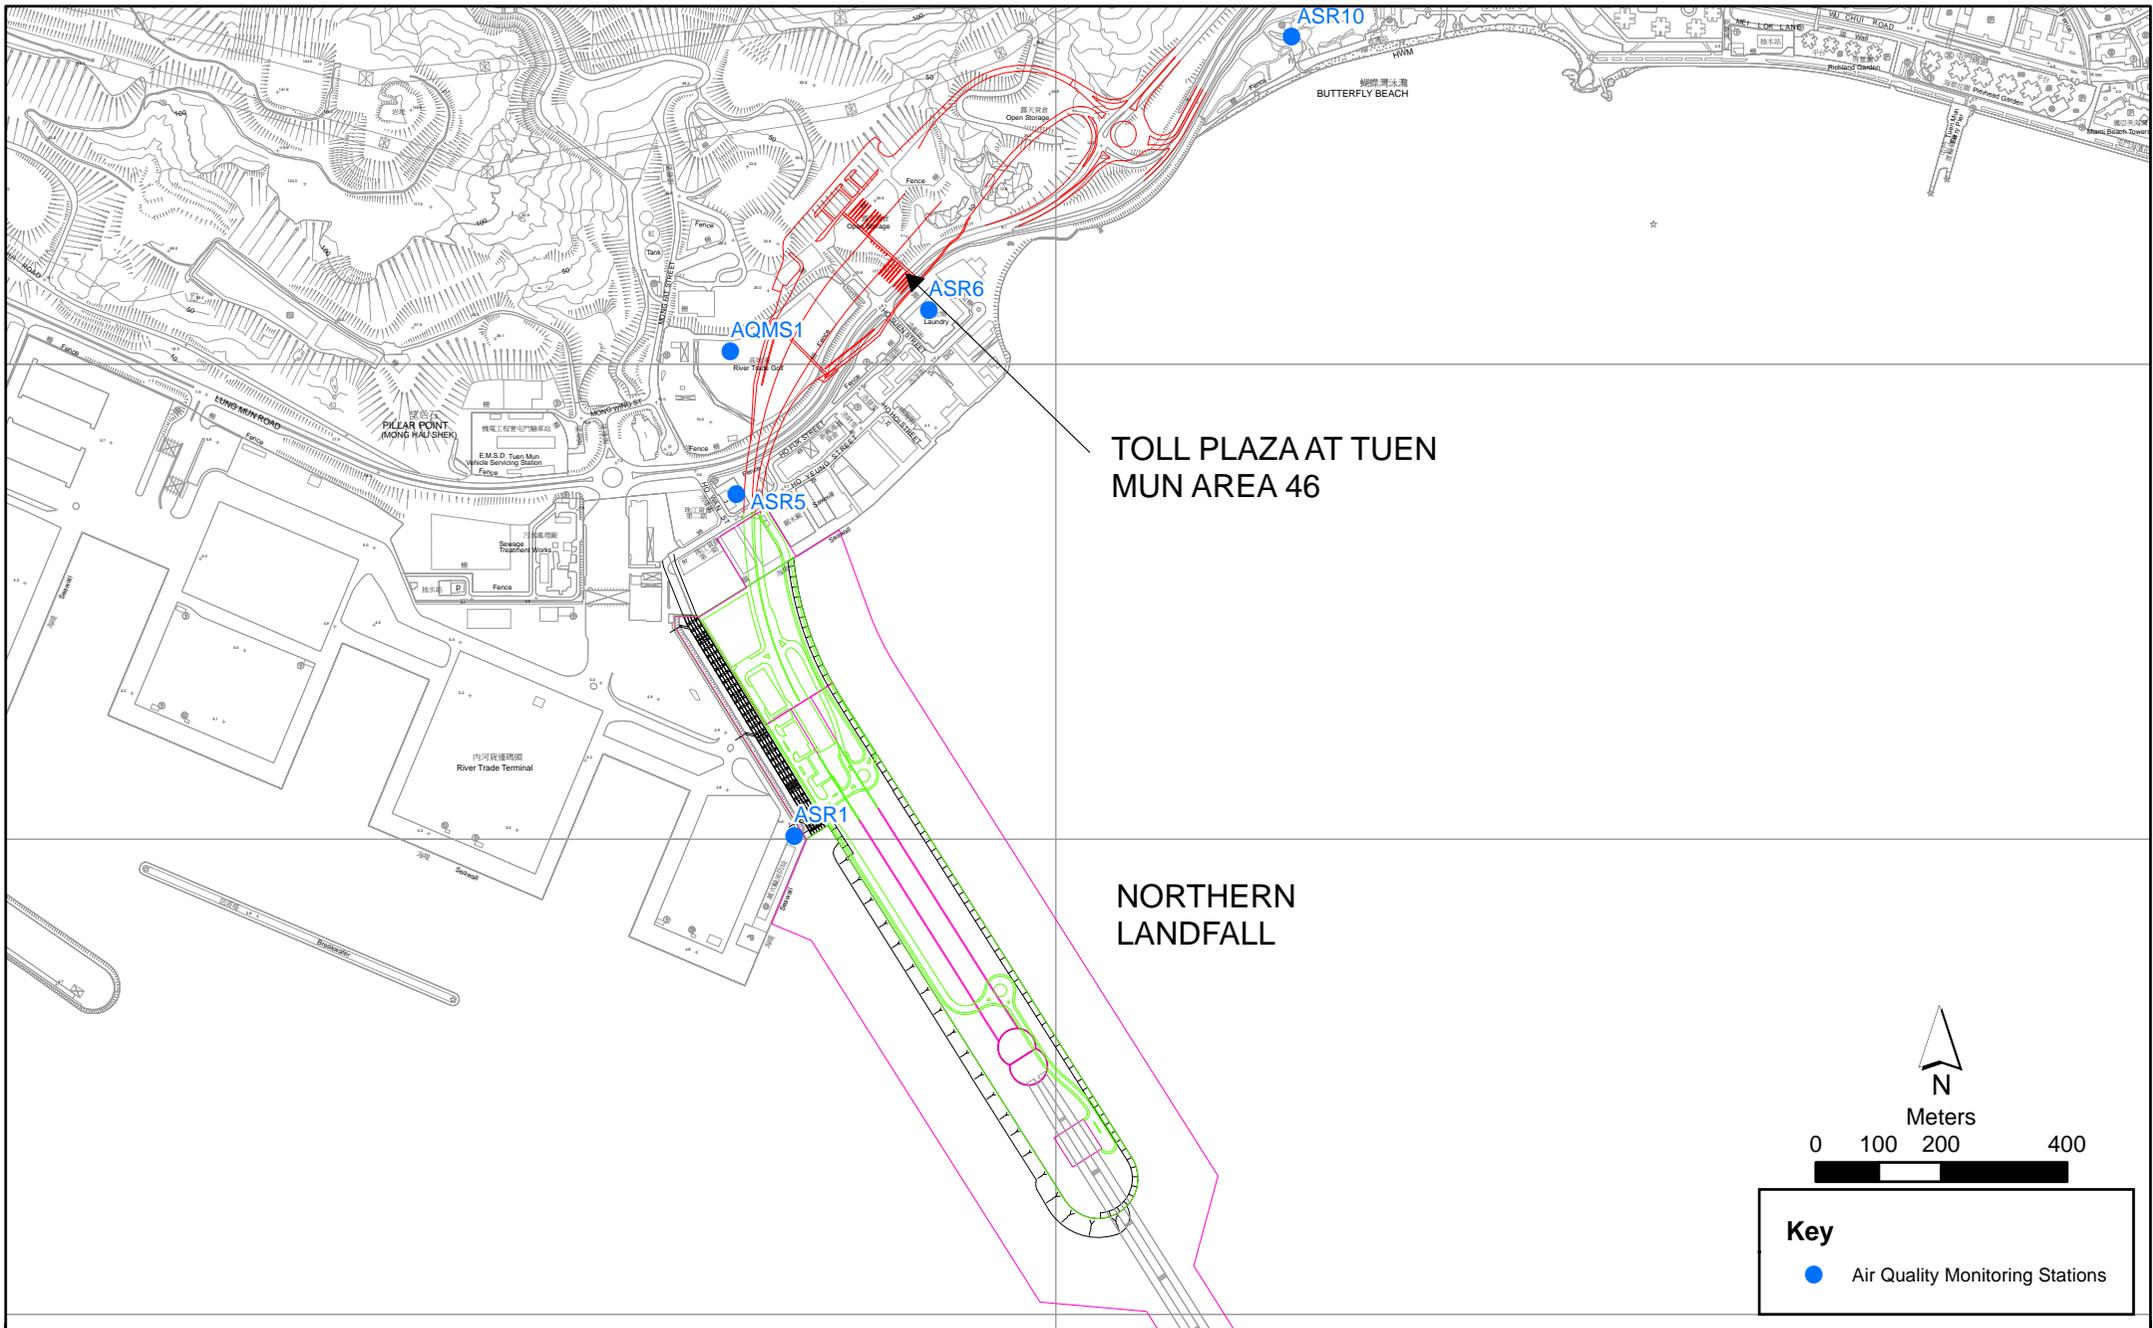
Figure 2.1

Air Quality Monitoring Stations for the Enhanced TSP Monitoring
 (Source: Adopted from Contract No. HY/2012/08 Tuen Mun-Chek Lap Kok Link -
 Northern Connection Sub-sea Tunnel Section)
