Contract No. HY/2010/02

**Hong Kong – Zhuhai – Macao Bridge
Hong Kong Boundary Crossing
Facilities –
Reclamation Works****Quarterly EM&A Report for
March 2013- May 2013**

Version: Rev. 0 Date: Sept 2013

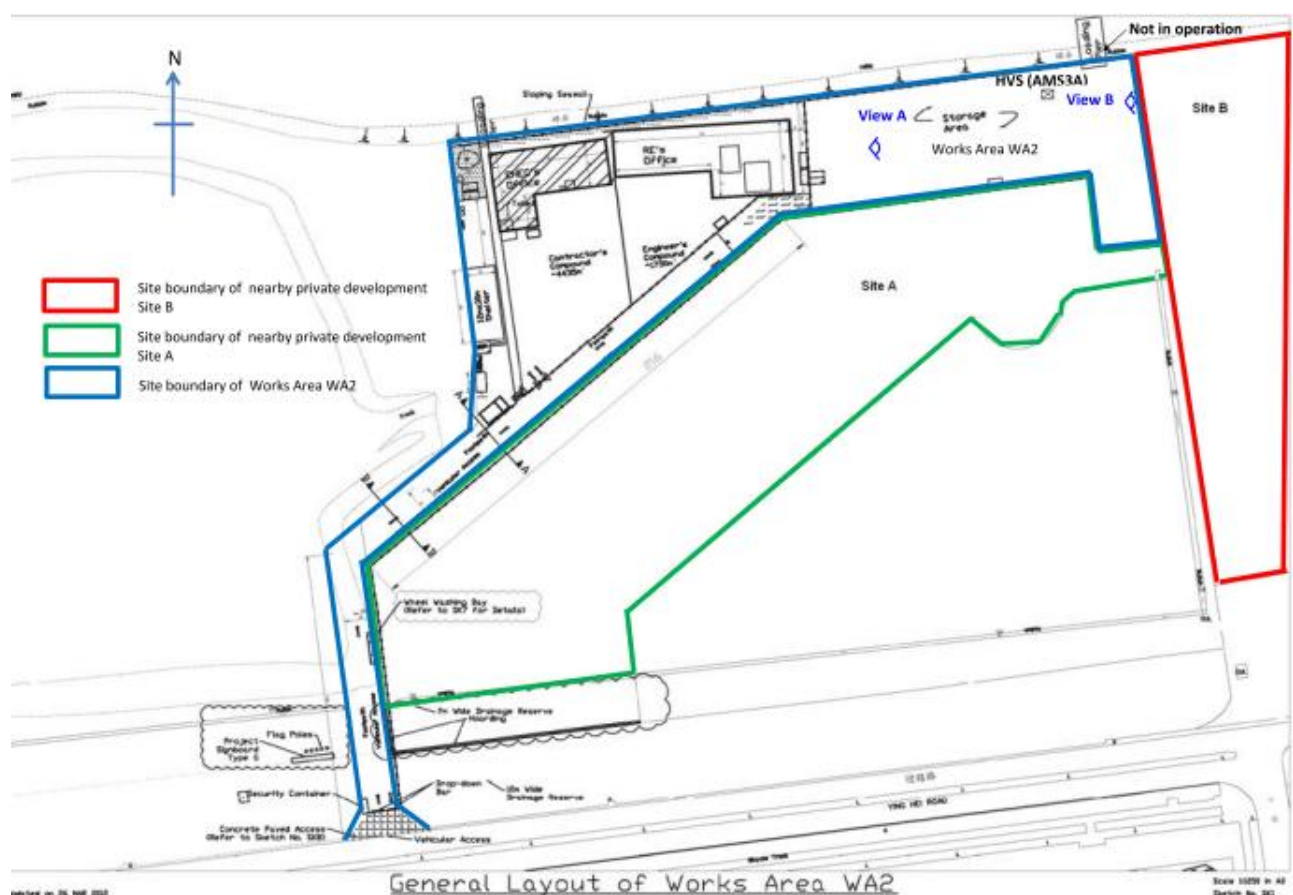
- 3.1.7.3 Please see layout map attached for reference of site conditions

- 3.1.7 For the one (1) 24-hour TSP result exceeded the Limit Level on 04 March 13 at monitoring station AMS3A, according to information provided by the Contractor, land-based construction activity such as transloading and delivery of geotextile and installing sand bags were undertaken at Works Area WA2 during the monitoring period which is unlikely to cause fugitive dust emission.

- 3.1.7.2 Construction activities, like sheet piling and percussive piling, were carrying out by nearby private development project during the course of monitoring, which are close to the monitoring station AMS3A but beyond the site boundary of Works Area WA2. Trucks were observed passing exposed soil surfaces at those construction sites of nearby private development project.

3.1.7.10 The Contractor was recommended to continue implementing existing dust mitigation measures.

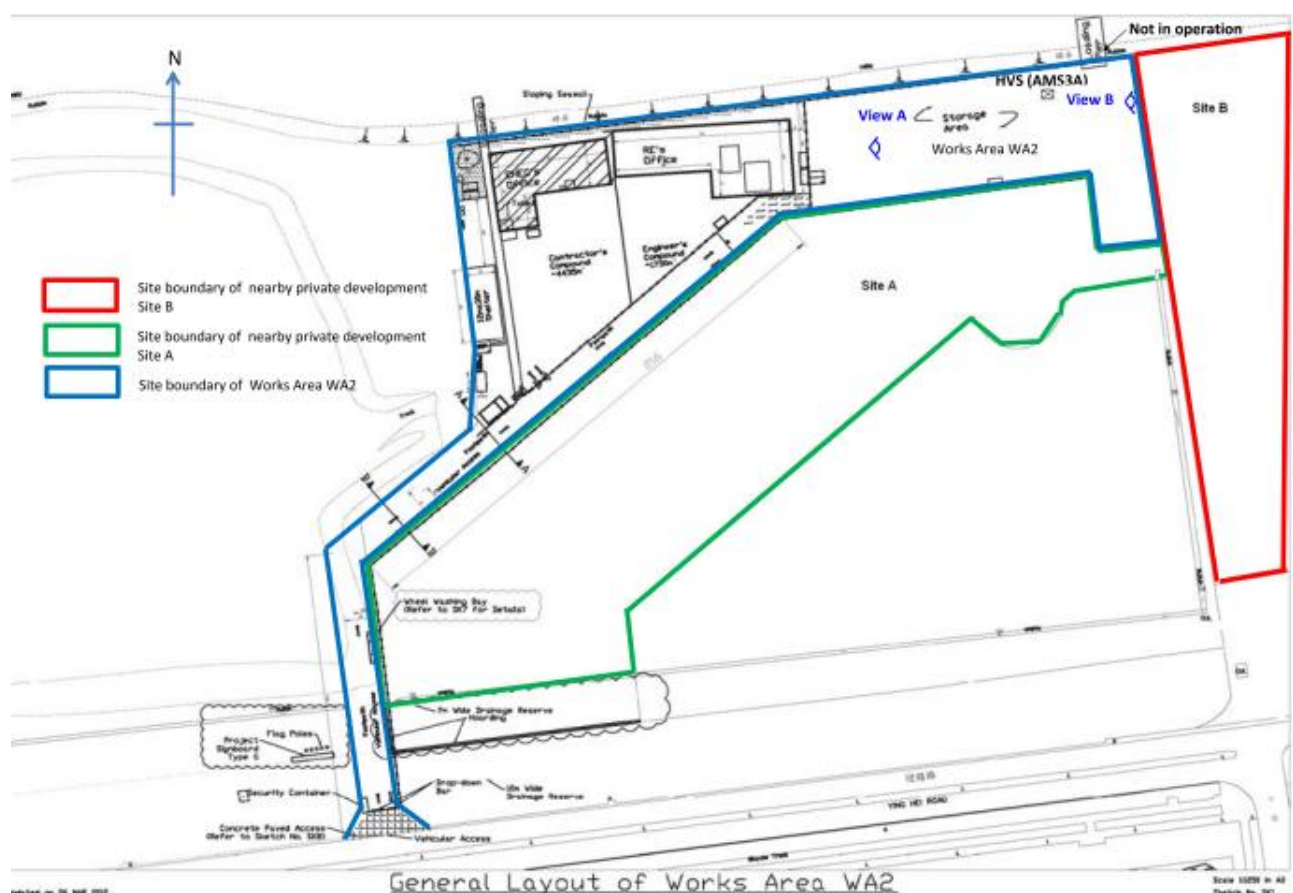
3.1.8.3 Please see layout map attached for reference of site conditions

3.1.8.2 As informed by the Contractor, construction activities like sheet piling and percussive piling, were carrying out by nearby private development project during the course of monitoring, which are close to the monitoring station AMS3A but beyond the site boundary of Works Area WA2. Traffics were observed passing exposed soil surfaces at those construction sites of nearby private development project.

3.1.8.10 The Contractor was recommended to continue implementing existing dust mitigation measures.

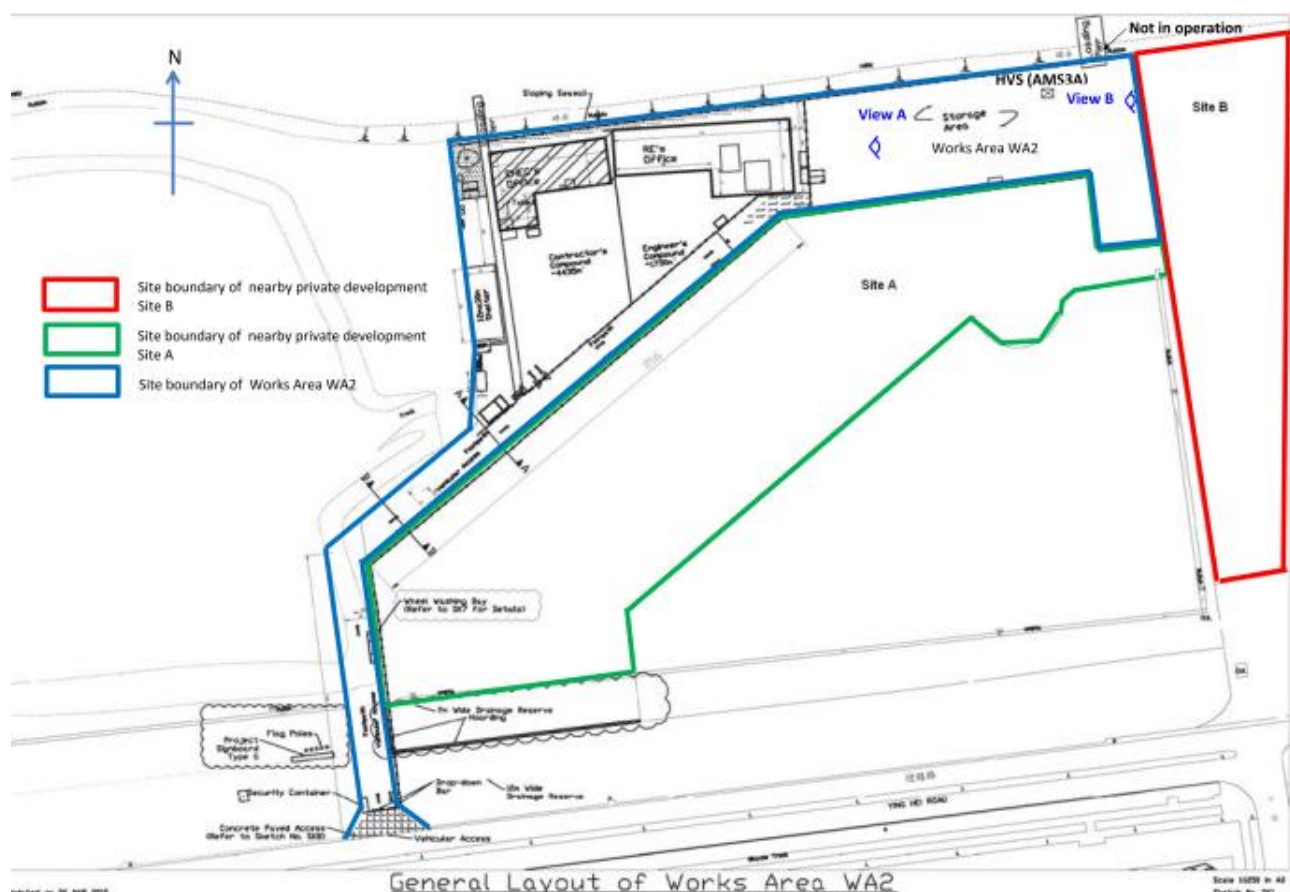
3.1.9.3 Please see layout map attached for reference of site conditions:

3.1.9.2 As informed by the Contractor, construction activities like sheet piling and percussive piling, were carrying out by nearby private development project during the course of monitoring, which are close to the monitoring station AMS3A but beyond the site boundary of Works Area WA2. Traffics were observed passing exposed soil surfaces at those construction sites of nearby private development project.

- 3.1.9.10 The Contractor was recommended to continue implementing existing dust mitigation measures.

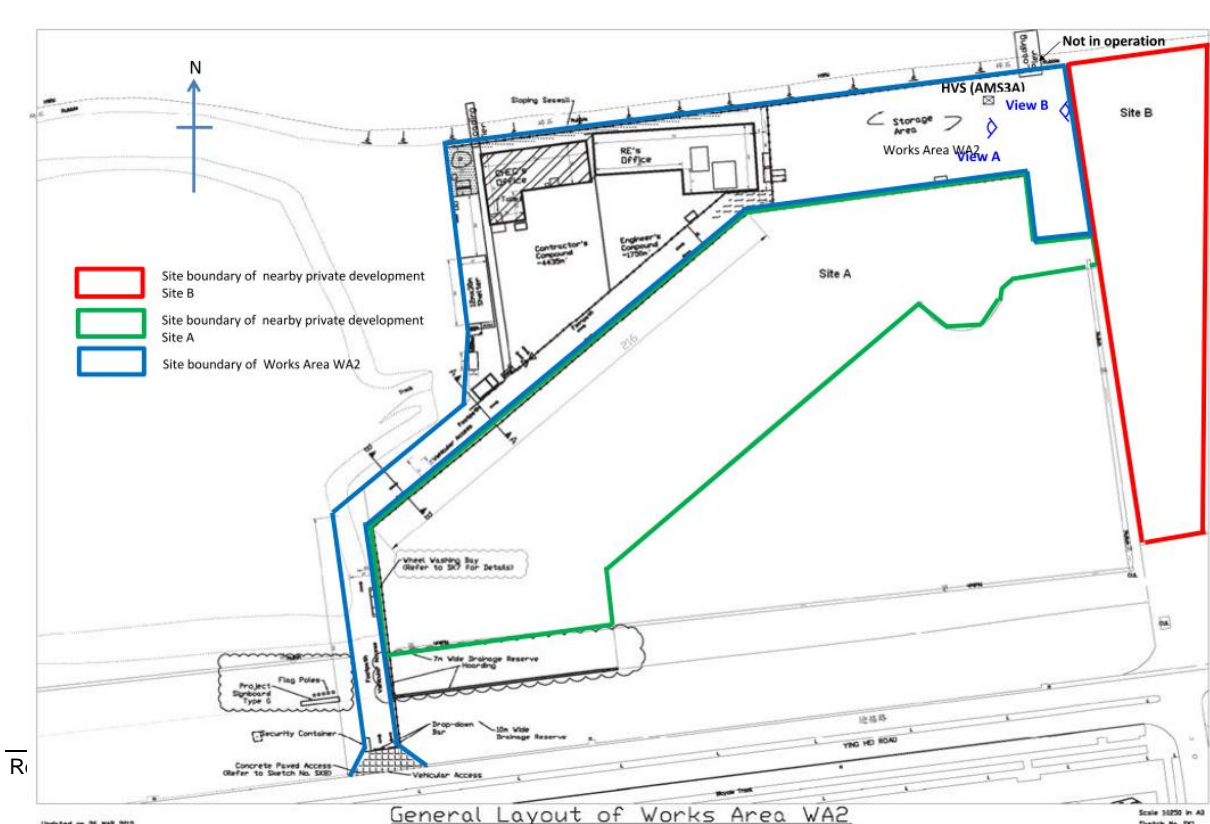
- 3.1.10.2 As informed by the Contractor, construction activities like sheet piling and percussive piling, were carrying out by nearby private development project during the course of monitoring, which are close to the monitoring station AMS3A but beyond the site boundary of Works Area WA2. Traffics were observed passing exposed soil surfaces at those construction sites of nearby private development project. Please also see photo and layout map attached for reference of site conditions.

- 3.1.10.6 The following dust mitigation measures have been implemented at Works Area WA2:
- Works Area WA2's surface was hard-paved, compacted or hydro-seeded

- Vehicle washing facility was provided at vehicle exit points,
 - Measures for preventing fugitive dust emission are provided, e.g. tarpaulin covers.
- 3.1.10.7 Please see layout map attached for reference of site conditions

3.1.10.10 The Contractor was recommended to continue implementing existing dust mitigation measures.

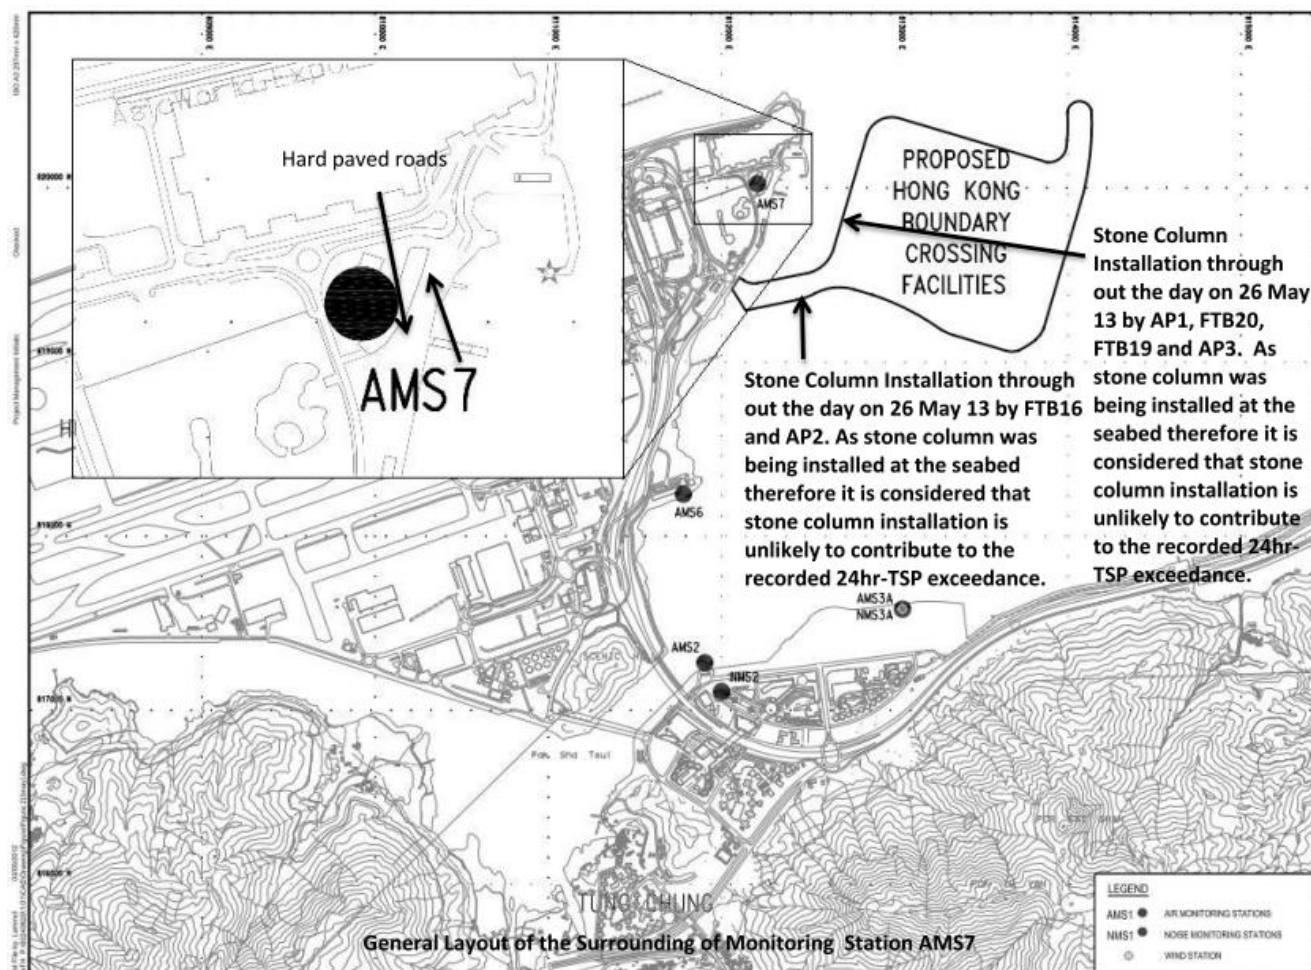
- 3.1.11.5 On the other hand, according to observation made at the monitoring station AMS7, there was no non-project potential cause/activity at the surrounding of monitoring station AMS7 which might potentially contribute to the dust action level exceedance.

- 3.1.11.6 As refer to the wind data collected at wind station at Works Area WA2 during the monitoring period on 13 and 14 April 13 (as attached) southwest winds was prevailing during the monitoring period. Construction works carried out by this Contract is unlikely to cause dust exceedance at AMS7 under southwest prevailing wind direction.

- Excavators and generators were operated by ultra low sulphur diesel (ULSD) to minimize the possibility of air pollution.
- 3.1.11.9 Please see layout map attached for reference of site conditions

3.1.11.12 The Contractor was recommended to continue implementing existing dust mitigation measures.

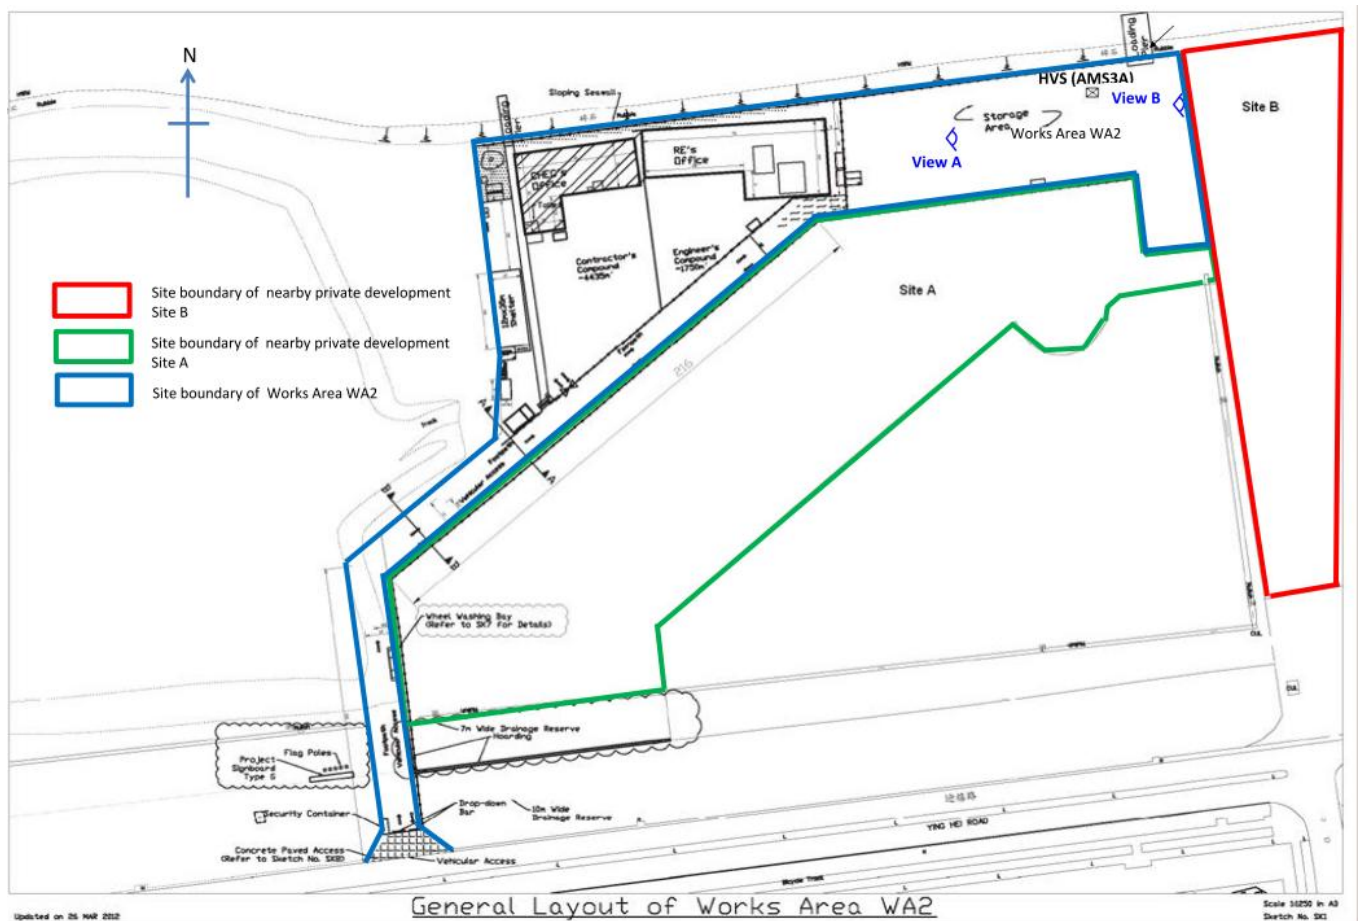
3.1.12.2 As informed by the Contractor, construction activities like sheet piling and percussive piling, were carrying out by nearby private development project during the course of monitoring, which are close to the monitoring station AMS3A but beyond the site boundary of Works Area WA2. Traffics were observed passing exposed soil surfaces at those construction sites of nearby private development project. Please also see photo and layout map attached for reference of site conditions.

- 3.1.12.5 The measured 24-hr TSP values recorded at AMS2 and AMS7 (which are closer to the marine-based works areas) on the same monitoring date were 38 g/m^3 and 54 g/m^3 respectively, which are below the Action and Limit Levels.
- 3.1.12.6 The following dust mitigation measures have been implemented at Works Area WA2:
- Works Area WA2's surface was hard-paved, compacted or hydro-seeded
 - Vehicle washing facility was provided at vehicle exit points,
 - Measures for preventing fugitive dust emission are provided, e.g. tarpaulin covers.
- 3.1.12.7 Conditions of the construction sites near Works Area WA2:
- 3.1.12.8 Please see layout map attached for reference of site conditions

3.1.12.11 The Contractor was recommended to continue implementing existing dust mitigation measures.

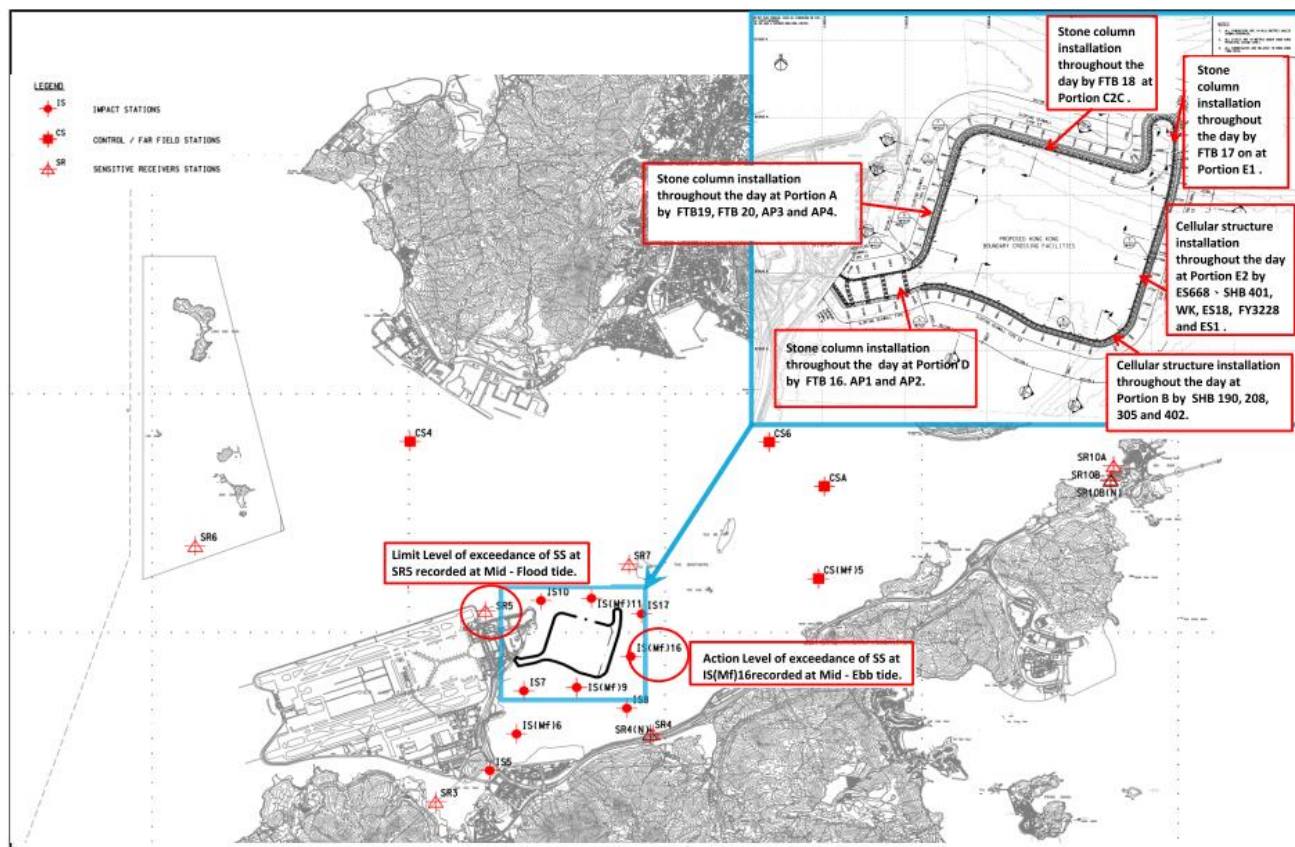
- 3.3.4 One (1) Limit and Action (1) Limit Level exceedance were recorded at during mid flood tide at SR5 and mid ebb tide at IS(Mf)16 respectively on 29 Mar 13. The investigation results show that the action and limit level exceedance were non-project related.

- 3.3.4.1 As informed by the Contractor, stone column installation was carried out throughout the day at Portion D by FTB 16, AP1 and AP2; at Portion A by FTB19, FTB 20, AP3 and AP4; at Portion C2c by FTB 18 and at Portion E1 by FTB 17. Cellular structure installation works was conducted at Portion E2 by ES668, SHB 401, WK, ES18, FY3228 and ES1 and at Portion B by SHB190, 208, 305 and 402..

- 3.3.4.2 Exceedances were not due to marine based construction works of the Project because:
- 3.3.4.3 For exceedance recorded at SR5 during mid flood tide, since monitoring stations IS10 and IS(Mf)11 are considered downstream and closer to the active works than monitoring station SR5 and the Suspended Solids values recorded at IS10 and IS(Mf)11 are all below the Action and Limit Level during same tide on the same day. The water quality noted at downstream of and closer to active works were not adversely affected by active works. Hence it is considered that the exceedance recorded at SR5 are not related to the Project.

- 3.3.4.5 When impact water quality monitoring was carried out during mid ebb and mid flood tide at monitoring location IS(Mf)16 on 29 Mar 13, yellow brown color of sea water was noted but no silty plume was observed to flow from the inside to the outside of the site boundary.

- 3.3.4.7 The exceedances were likely due to local effects in the vicinity of SR5 and IS(Mf)16.
- 3.3.4.8 Floating type silt curtains were provided around the whole works area. In addition, it was noted that the Contractor swiftly rectified the perimeter silt curtain in particular the portions which defects were observed on 28 March 13 to ensure the sediment plume generated by construction activities could be prevented from discharging to areas outside the site boundary.
- 3.3.4.9 The Contractor was reminded to carry out maintenance work once defects were found.
- 3.3.4.10 As informed by the Contractor, maintenance work of the silt curtain was carried out on a daily basis except Sunday and public holiday.

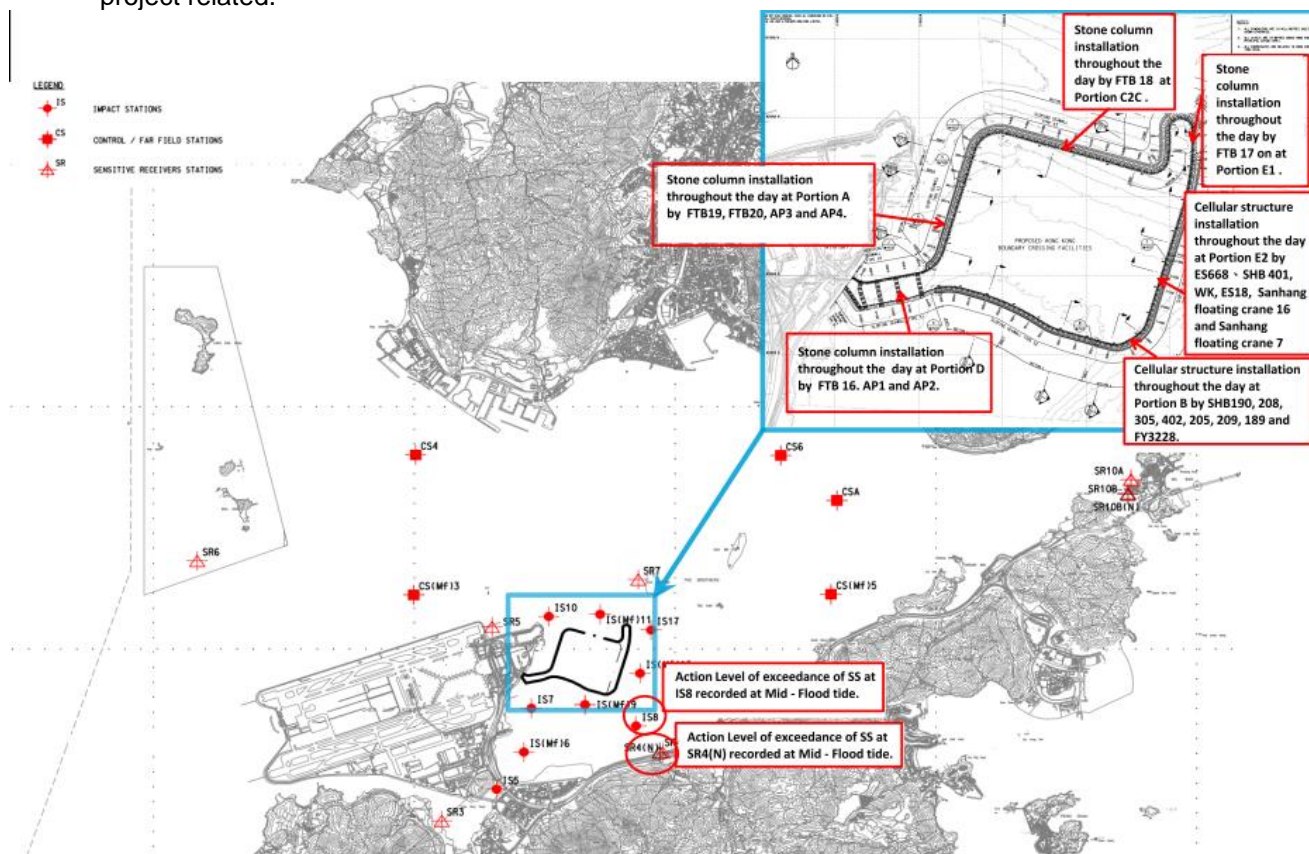
3.3.5.1 For the two (2) Action Level exceedance were recorded at during mid flood tide at IS8 and SR4(N) respectively on 10 April 13. The investigation results show that the action exceedances were non-project related.

3.3.5.2 As informed by the Contractor, stone column installation was carried out throughout the day at Portion D by FTB 16, AP1 and AP2; at Portion A by FTB 19, FTB 20, AP3 and AP4; at Portion C2c by FTB 18 and at Portion E1 by FTB 17. Cellular structure installation works were conducted at Portion E2 by ES668, SHB 401, WK, ES18, Sanhang floating crane 16 and Sanhang floating crane 7 and at Portion B by SHB190, 208, 305, 402, 205, 209, 189 and FY3228.

- 3.3.5.7 The exceedances were likely due to local effects in the vicinity of IS8 and SR4(N).
- 3.3.5.8 Nevertheless, the Contractor was reminded to ensure provision of ongoing maintenance to the silt curtains.
- 3.3.5.9 Maintenance work of the silt curtain was carried out by the Contractor on a daily basis except Sunday and public holiday.
- 3.3.5.10 The investigation results show that the action and limit level exceedance were non-project related.

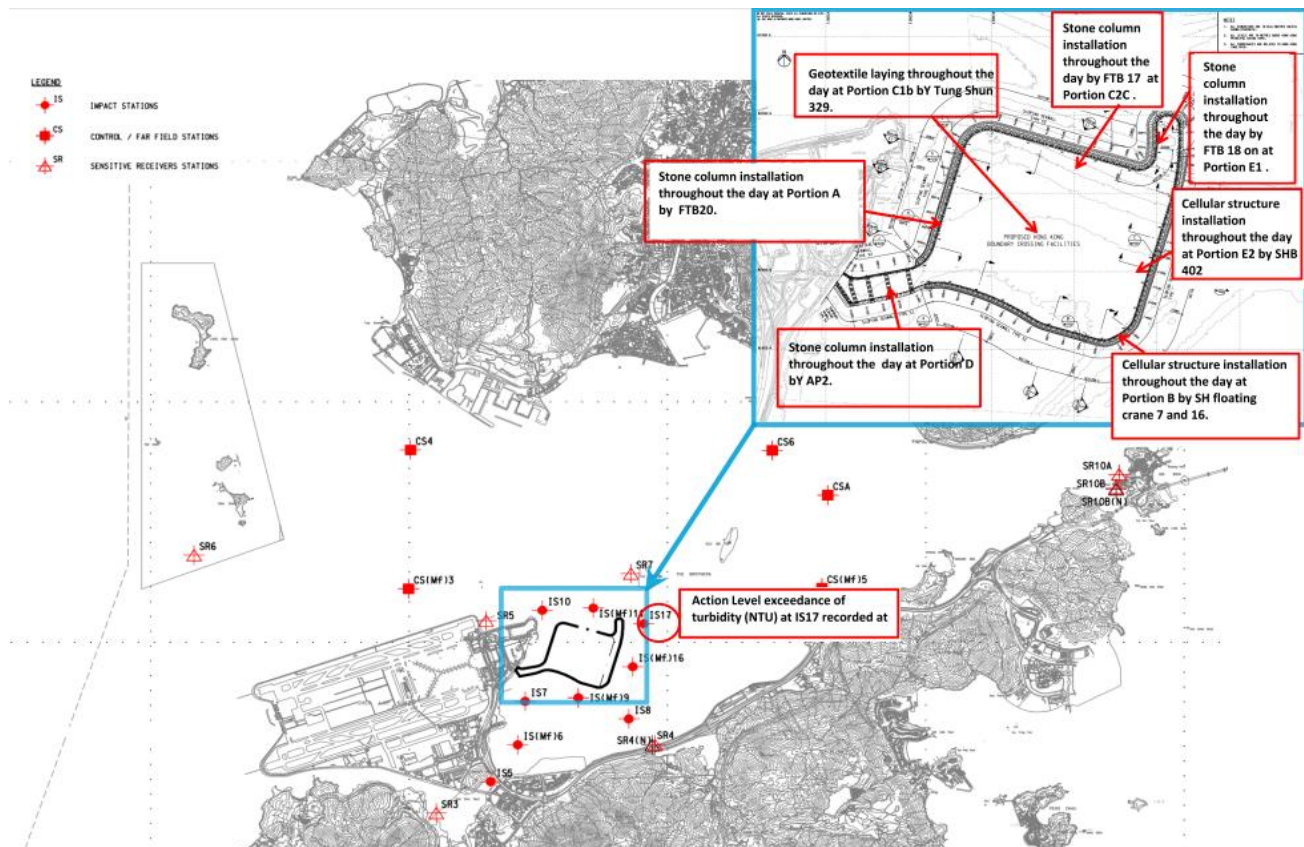
- 3.3.6 For the one (1) Action Level exceedance were recorded at during mid flood tide at IS17 on 29 April 13. The investigation results show that the action exceedances were non-project related.

- 3.3.6.1 Stone column installation was carried out throughout the day at Portion D by AP2 and AP4; at Portion A by FTB 20; at Portion C2c by FTB 17 and at Portion E1 by FTB 18. Cellular structure installation works was conducted at Portion E2 by SHB 402; at Portion B by SH Floating Crane 7 and 16; Geotextile laying at Portion C1b by Tung Shun 329.

- 3.3.6.2 For action level exceedance of depth averaged turbidity (in NTU) recorded at IS17 during mid ebb tide, stone column installations were carried out at almost the same locations on 26, 29 Apr 13 and 1 May 13, but all depth averaged turbidity (in NTU) results recorded at all monitoring location on 26 Apr 13 and 1 May 13 were all below the Action and Limit Level. Which indicates that stone column installation is unlikely to contribute to the action level exceedance recorded at IS17?

- 3.3.6.3 When impact water quality monitoring was carried out during mid ebb at monitoring location IS17 on 29 April 13, no discoloration of sea water was observed and no silty plume were observed to flow from the inside to the outside of the site boundary.

- 3.3.6.7 Maintenance work of the silt curtain was carried out by the Contractor on a daily basis except Sunday and public holiday.

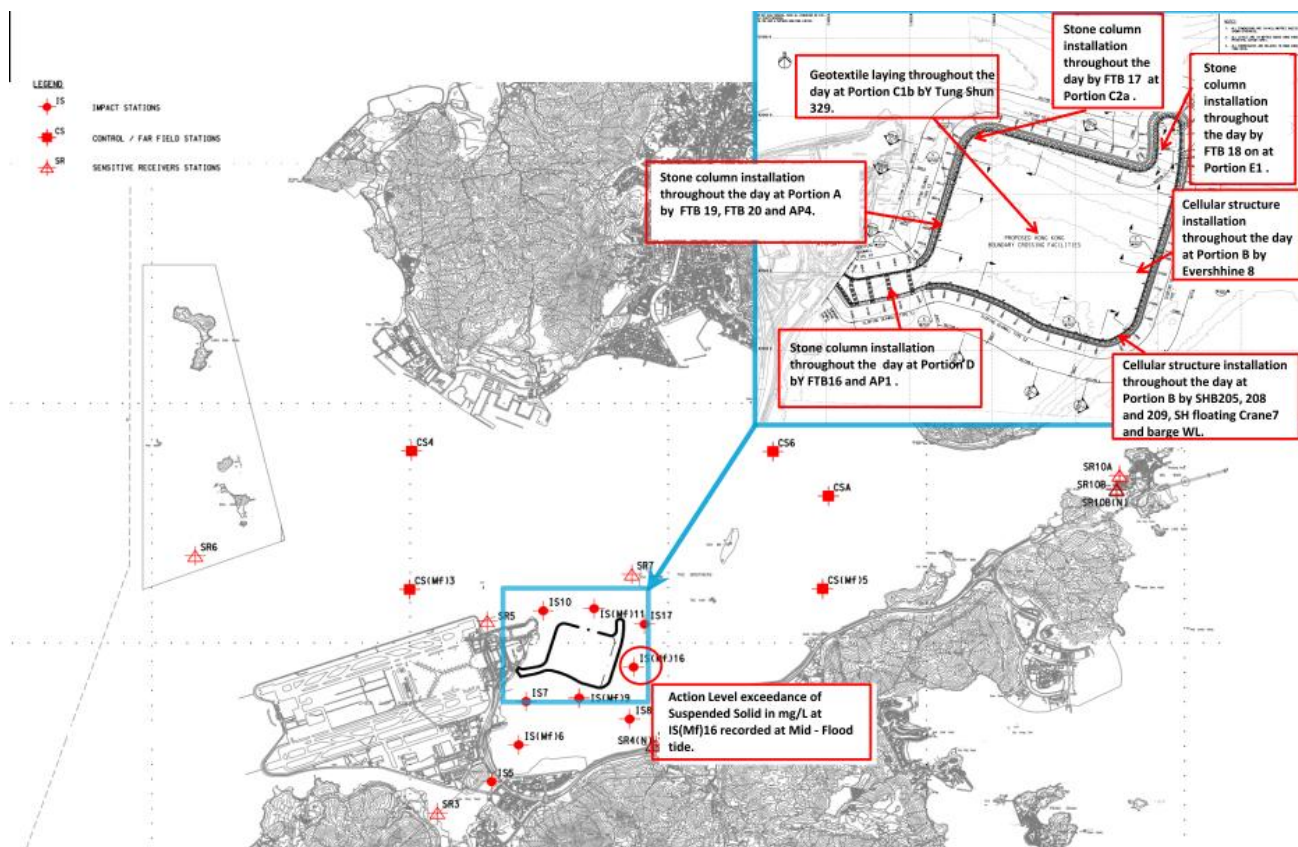
- 3.3.7 For the one (1) Action Level exceedance were recorded at during mid flood tide at IS(Mf)16 on 22 April 13. Stone column installation was carried out throughout the day at Portion D by AP1 and FTB16; at Portion A by FTB 19, 20 and AP4; at Portion C2a by FTB 17 and geotextile laying was carried out throughout the day by Tung Shun 329 at Portion C2a, at Portion E1 by FTB 18. Cellular structure installation works was conducted at Portion B by SHB402, SHB205, SHB208 and SHB209.

- 3.3.7.1 Exceedances were not due to marine based construction works of the Project because:
- 3.3.7.2 For action level exceedance of depth averaged SS (in mg/L) recorded at IS(Mf)16 during mid flood tide, stone column installations were carried out at almost the same locations on 19, 22 and 24 Apr 13, but all depth averaged SS (in mg/L) results recorded at all monitoring location on 19 and 24 Apr 13 were all below the Action and Limit Level. Which indicates that stone column installation is unlikely to contribute to the action level exceedance recorded at IS(Mf)16.

- 3.3.7.3 When impact water quality monitoring was carried out during mid flood tide at monitoring location IS(Mf)16 on 22 April 13, no discoloration of sea water was observed and no silty plume were observed to flow from the inside to the outside of the site boundary.

- 3.3.7.5 Location of monitoring station IS(Mf)16 is considered upstream to active works during mid flood tide and therefore it is unlikely that the elevation of suspended solid is caused by active works.

- 3.3.7.6 The exceedances were likely due to local effects in the vicinity of IS(Mf)16.
- 3.3.7.7 Nevertheless, the Contractor was reminded to ensure provision of ongoing maintenance to the silt curtains. The Contractor was reminded to carry out maintenance work once defects were found.

3.3.7.8 Maintenance work of the silt curtain was carried out by the Contractor on a daily basis except Sunday and public holiday.

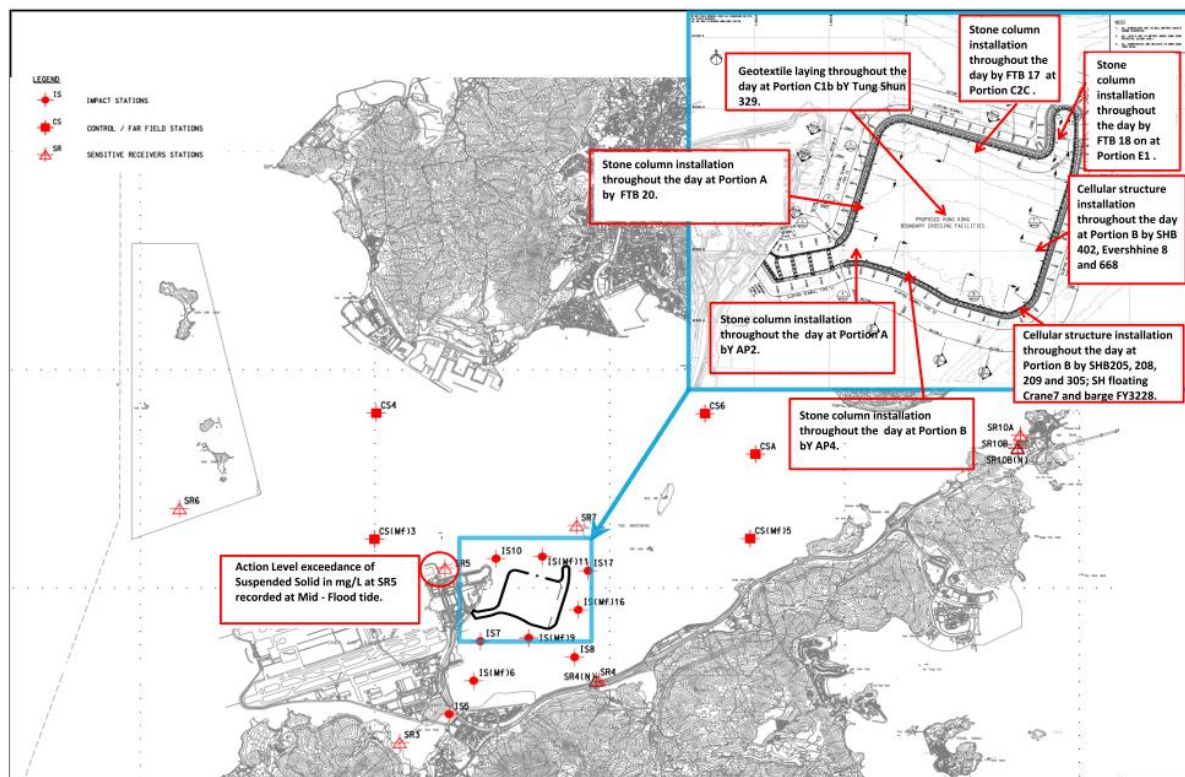
- 3.3.8 For the one (1) Action Level exceedance were recorded at during mid flood tide at SR5 on 26 April 13. Stone column installation was carried out throughout the day at Portion A by AP2 and FTB 20; at Portion B by AP4; at Portion C2c by FTB 17 and at Portion E1 by FTB 18. Cellular structure installation works was conducted at Portion B by SHB 402, Evershine 8 and 668, SHB 205, 208, 209 and 305, SH Floating Crane 7 and FY3228; Geotextile laying at Portion C1b by Tung Shun 329.

3.3.8.1 Exceedance was not due to marine based construction works of the Project because:

3.3.8.2 Impact Stations IS10 and IS(Mf)11 which are considered downstream and closer to the works than Impact Station SR5. Since the Suspended Solids values recorded at IS10 and IS(Mf)11 are all below the Action and Limit Level during same tide on the same day. The water quality noted at downstream of and closer to active works were not adversely affected by active works. Hence it is considered that the exceedance recorded at SR5 are not related to the Project.

3.3.8.6 The Contractor was reminded to carry out maintenance work once defects were found.

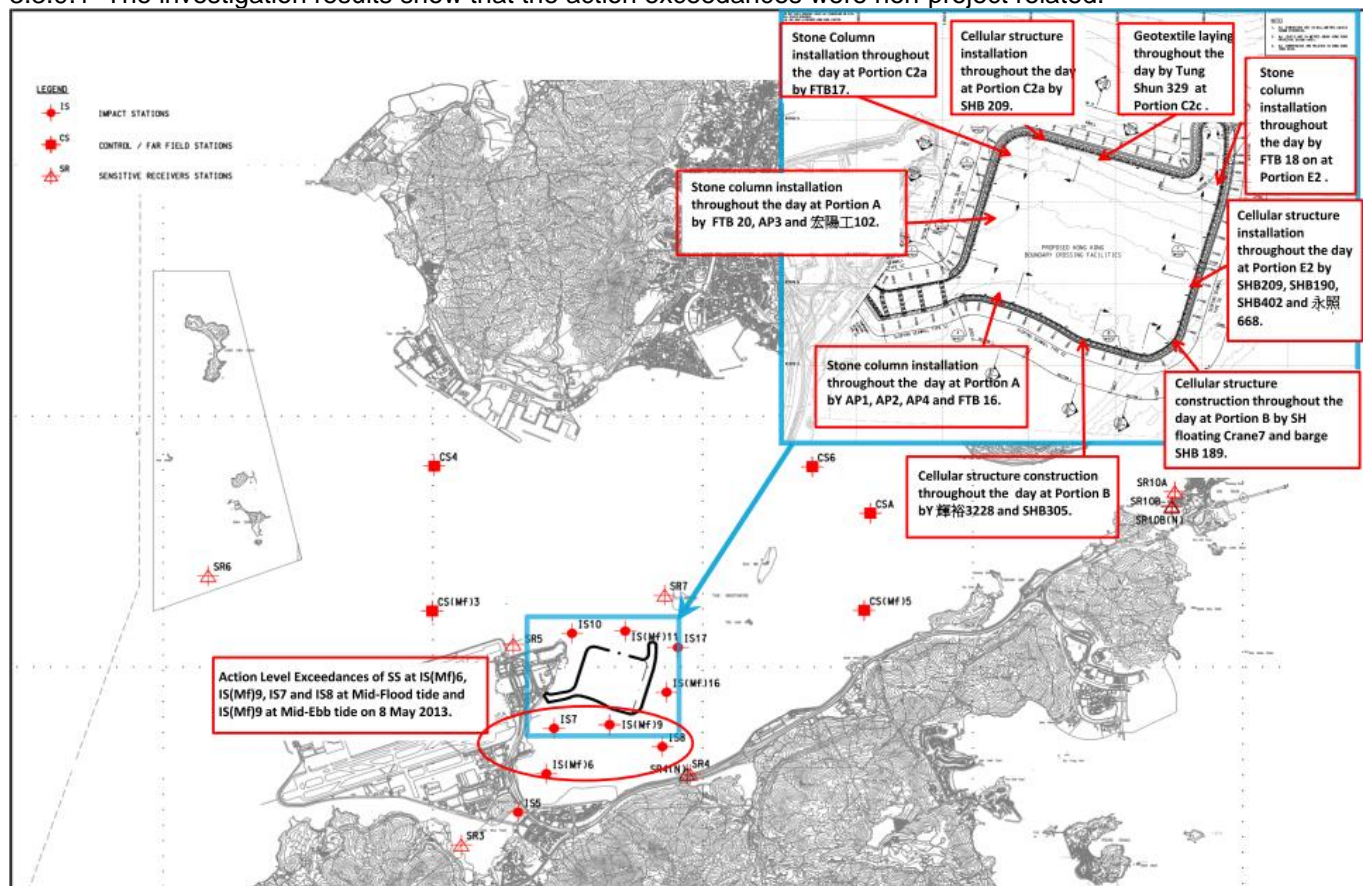
3.3.9 Five (5) Action Level Exceedances of SS at IS(Mf)6, IS(Mf)9, IS7 and IS8 at Mid-Flood tide and IS(Mf)9 at Mid-Ebb tide were recorded on 8 May 2013.

3.3.9.1 The investigation results show that the action exceedances were non-project related.

3.3.9.2 For type, location and duration of works carried out on 8 May 2013, please refer to the above layout map.

3.3.9.6 Strong wind and rough sea condition were experienced during the monitoring period, which is likely to affect the ambient water quality in such shallow water condition.

3.3.9.7 When impact water quality monitoring was carried out at IS(Mf)6, IS(Mf)9, IS7 and IS8 at Mid-Flood tide and IS(Mf)9 at Mid-Ebb tide on 8 May 2013, no silty plume was observed to flow from the inside to the outside of the site boundary.

3.3.9.12 The Contractor was reminded to carry out maintenance work once defects were found.
