China Harbour Engineering Company Limited

Contract No. HY/2010/02

**Hong Kong – Zhuhai – Macao Bridge
Hong Kong Boundary Crossing
Facilities –
Reclamation Works****Quarterly EM&A Report for
December 2013- February 2014**

Version: Rev. 0 Date: 26 June 2014

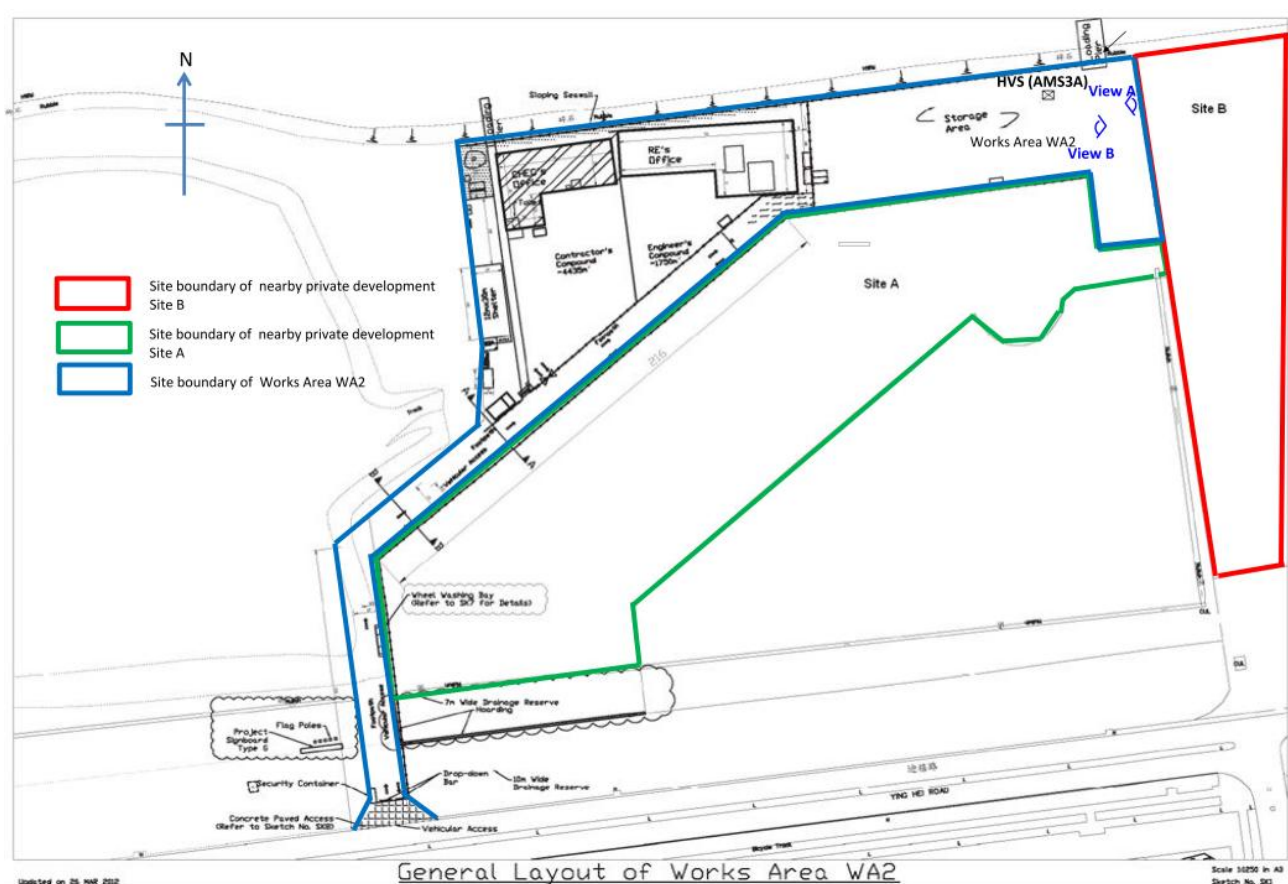
- 3.1.6.3 Photo records shows vehicle parking activities were observed inside an area at construction sites of nearby private development project which are close to the monitoring station AMS3A but beyond the site boundary of Works Area WA2. (Please also see photo and layout map attached for reference of site conditions (View A.))

- 3.1.6.4 As refer to the wind data collected at wind station at Works Area WA2 during the monitoring period on 10 and 11 Dec 13 (as attached) east winds was prevailing during the monitoring period. Traffic activities at construction sites of nearby private development project which are close to the monitoring station AMS3A but beyond the site boundary of Works Area WA 2 may contribute to the measured dust levels at the monitoring station AMS3A.

Conditions of the construction sites near Works Area WA2:

View A: (Parking lot observed at nearby construction site which do not belongs to this Contract):

- 3.1.6.8 The dust exceedance was therefore considered not to be due to the Project works.
- 3.1.6.9 The Contractor was recommended to continue implementing existing dust mitigation measures.

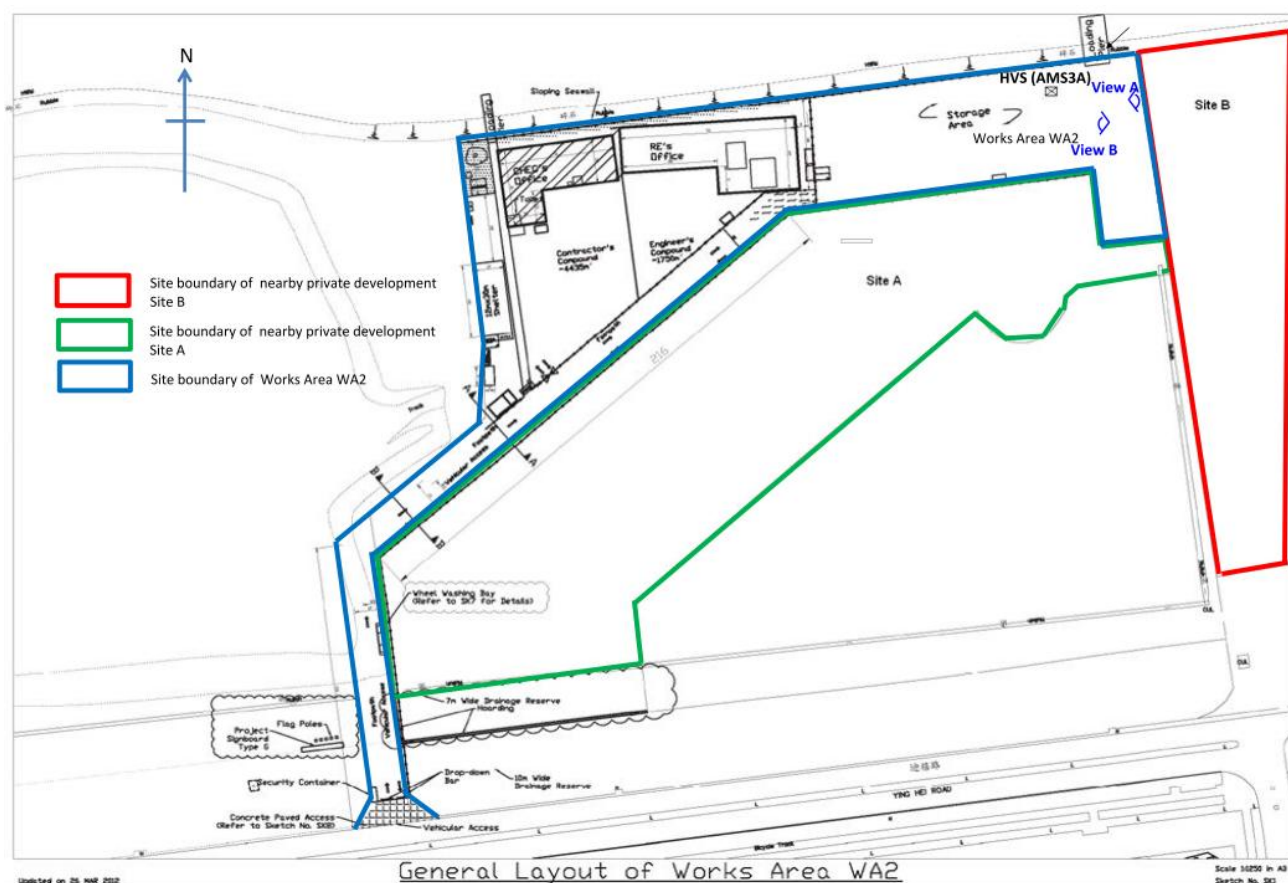
View A (parking lot observed at nearby construction site which do not belongs to this Contract)

- 3.1.10.3 Photo records shows vehicle parking activities were observed inside an area at construction sites of nearby private development project which are close to the monitoring station AMS3A but beyond the site boundary of Works Area WA2. (Please also see photo and layout map attached for reference of site conditions (View A.))

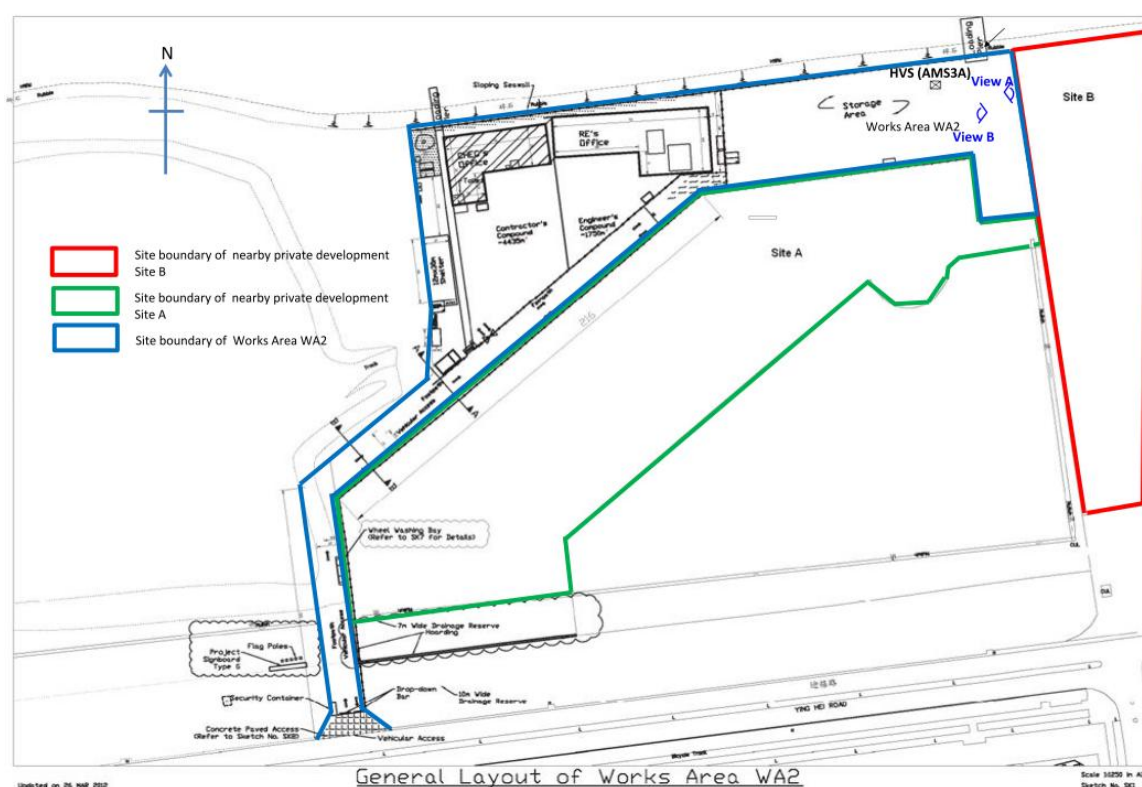
View A (parking lot observed at nearby construction site which do not belongs to this Contract)

- 3.1.12.3 Photo records shows vehicle parking activities were observed inside an area at construction sites of nearby private development project which are close to the monitoring station AMS3A but beyond the site boundary of Works Area WA2. (Please also see photo and layout map attached for reference of site conditions (View A.))

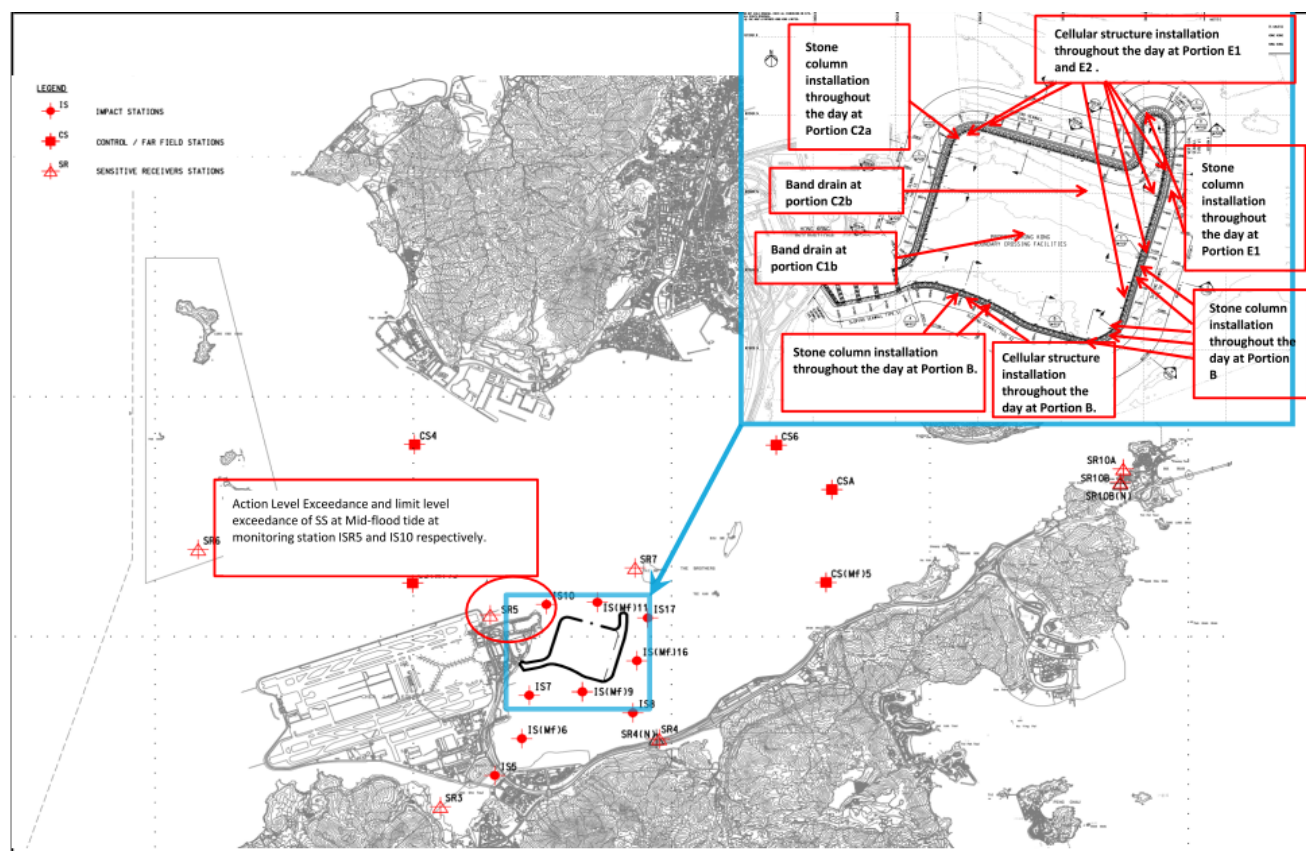
- 3.3.4 One (1) action level exceedances at measured Suspended Solids (mg/L) was recorded on 18 Dec 2013 at monitoring station SR5 at Mid-flood tide and one (1) limit level exceedance at measured Suspended Solids (mg/L) was recorded on 18 Dec 2013 at monitoring station IS10 at Mid-flood tide. For Action Level exceedance at measured Suspended Solids (mg/L), 33.2mg/L were recorded at Monitoring Station SR5. For limit level exceedance at measured Suspended Solids (mg/L), 34.9 mg/L was recorded at Monitoring Station IS10.

- 3.3.4.1 For locations and type of active works carried out on 18 Dec 13, please refer to the above layout map.
- 3.3.4.2 Exceedances recorded at SR5 and IS10 are likely due to marine based construction activities of the Project because:

- 3.3.4.3 With refer to monitoring record, appearance of water was not clear at IS10 and SR5 when compared with the appearance of water at IS(Mf)11 and IS17 during monitoring during Mid-flood tide on 18 Dec 13. This indicates the source of exceedance may not due to works activities at portion E1 and E2 which is directly upstream of IS(Mf)11 and IS17. The relatively turbid water observed at IS10 and SR5 may due to activities at Portion C2a during flood tide.

- 3.3.4.5 With refer to the silt curtain condition on 18 Dec 13, defects of the perimeter silt curtain was observed at northwest of the construction site.

- 2 With refer to the joint site inspection audit conducted on 19 Dec 13, sources of impact is likely due to the turbine activities and/or movement of vessel at shallow water (at near the entrance at southwestern of the Construction site and/or when vessel's propeller was turn on at shallow water). The dispersion of turbid water from the inside of the perimeter silt curtain to the outside of the perimeter silt curtain is potentially due to defects of perimeter silt curtain at certain sections.

3.3.4.9 The exceedances note at IS10 and SR5 on 18 Dec 13 were considered as project related. Although the silt curtain integrity checking record on 4 January 13 shows that the disconnected silt curtain observed on 18 Dec 13 at northwest of HKBCF were rectified, the effectiveness of such rectification will be closely monitored through impact water quality monitoring and inspected through regular site inspection audit. The Contractor was further reminded to ensure provision of ongoing maintenance to the silt curtains and to carry out maintenance work once defects were found.

- 5 The Contractor was reminded to ensure provision of ongoing maintenance to the silt curtains and to carry out maintenance work once defects were found.

- 6 As informed by the Contractor maintenance work for the defects of the northwest part of the perimeter silt curtain was conducted on 4 January 13.
- 7 Monitoring results show no recurrence of exceedance of SS at IS10 and SR5 on 20, 23 and 25 of Dec 2013.

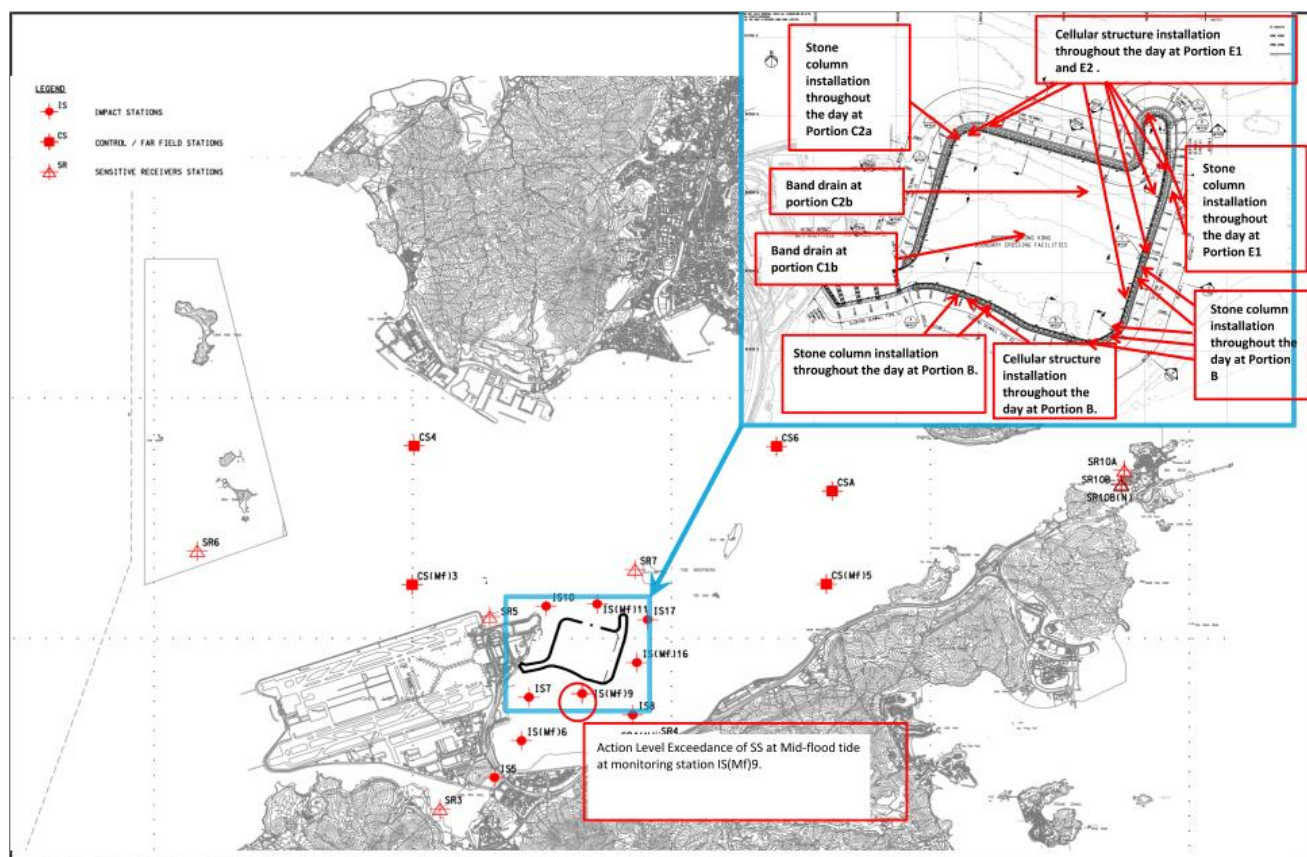
- 3.3.5 One (1) action level exceedances at measured Suspended Solids (mg/L) was recorded on 18 Dec 2013 at monitoring station IS(Mf)9 at Mid-flood tide. For the Action Level exceedances at measured Suspended Solids (mg/L), 23.9 mg/L was recorded at Monitoring Station IS(Mf)9.

- 3.3.5.1 For locations and type of active works carried out on 18 Dec 13, please refer to the above layout map.
- 3.3.5.2 Exceedance recorded at IS(Mf)9 is unlikely due to marine based construction activities of the Project because:

- 3.3.5.3 With refer to the silt curtain condition on 18 Dec 13, no defects of the perimeter silt curtain was observed at south and southeast of the construction site.

- 3.3.5.5 With referred to monitoring record, no turbid water or silt plume was observed when monitoring was conducted IS(Mf)9. (Please refer to the attached photo record for reference of sea condition)

- 3.3.5.6 As such, the exceedance recorded at IS(Mf)9 is considered to be non-project related.
- 3.3.5.7 The Contractor was reminded to ensure provision of ongoing maintenance to the silt curtains and to carry out maintenance work once defects were found.

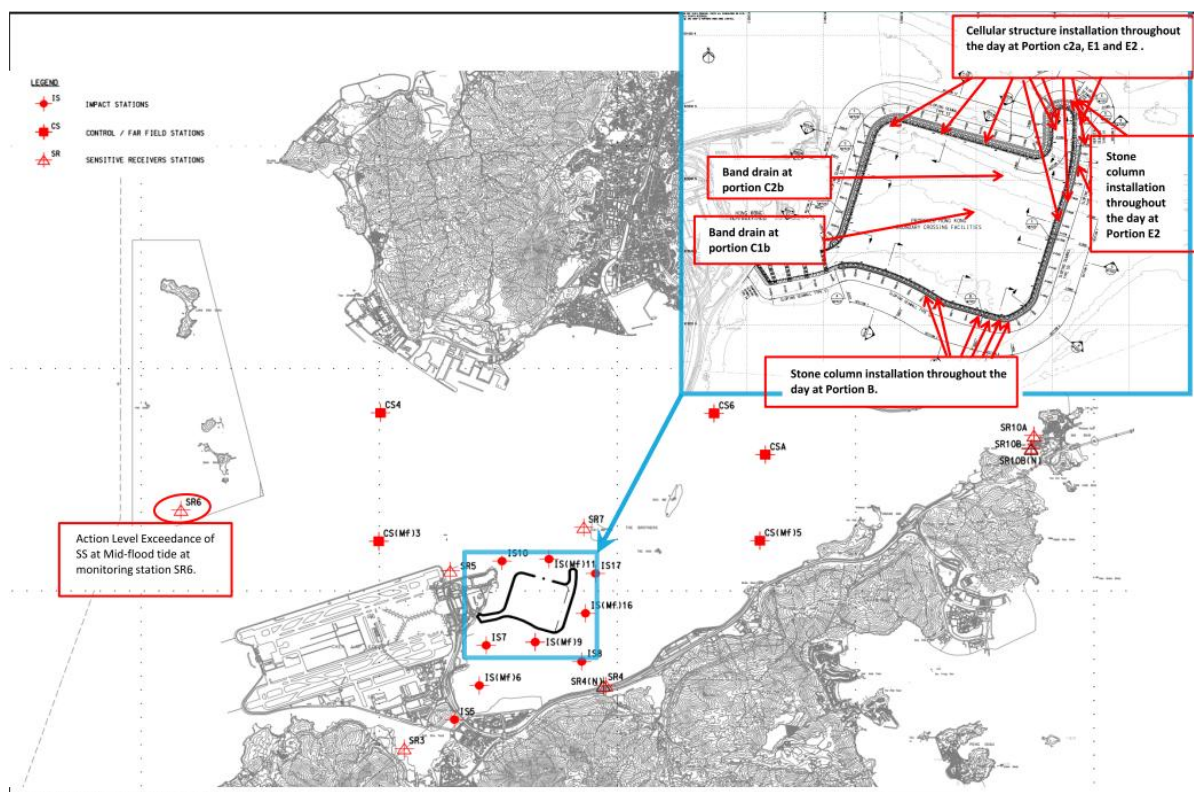
- 3.3.7 One (1) Action Level exceedance at measured Suspended Solids (mg/L) was recorded on 03 Jan 2014 at monitoring station SR6 at Mid-flood tide. For Action Level exceedances at measured Suspended Solids (mg/L), 23.9 mg/L was recorded at Monitoring Station SR6.

- 3.3.7.1 For locations and type of active works carried out on 03 Jan 14, please refer to the above layout map.
- 3.3.7.2 When impact water quality monitoring was carried out during mid flood tide at monitoring location IS10, SR5 and SR6 on 3 Jan 14, no silty plume were observed to flow from the inside to the outside of the northwestern part of the perimeter silt curtain.
- 3.3.7.3 IS10, SR5 (located outside northwest part of the perimeter silt curtain) and IS(Mf)11 (located outside north part of the perimeter silt curtain) which are closer to the active works than monitoring station SR6. Depth Averaged Suspended Solids (SS) values (in mg/L) recorded during the flood tide on the same day at IS10, SR5 and IS(Mf)11 were below the Action and Limit Level which shows that the water quality closer to active works was not adversely affected.

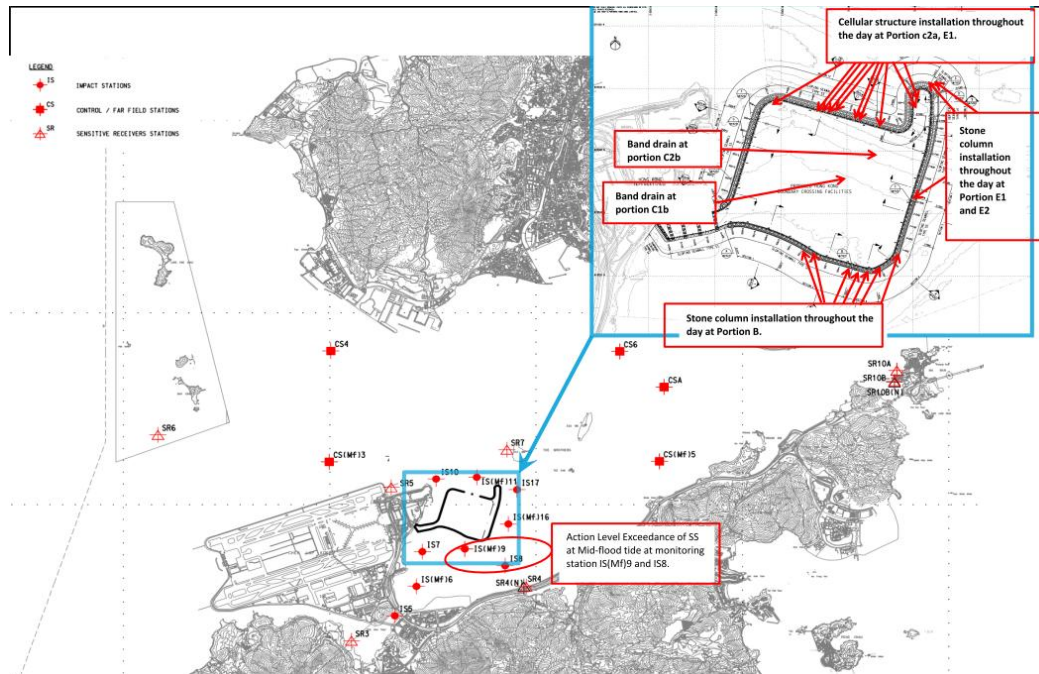
3.3.8 Two (2) action level exceedances at measured Suspended Solids (mg/L) were recorded on 06 Jan 2014 at monitoring station IS(Mf)9 and at monitoring station IS8 at Mid-flood tide. For Action Level exceedance at measured Suspended Solids (mg/L), 24.4mg/L were recorded at Monitoring Station IS(Mf)9 and 25.4mg/L were recorded at Monitoring Station IS8.

3.3.8.1 For works activities carried out on 06 Jan 14, please refer to the attached layout map.

3.3.8.2 The Depth averaged turbidity (in NTU) and depth averaged SS (in mg/L) of nearby monitoring station, such as IS7 and IS(Mf)16 were below the action and limit level, indicating the water quality at area nearby IS(Mf)9 and IS8 was not adversely affected.

3.3.8.3 The turbidity level (in NTU) at IS(Mf)9, IS8, IS7 and IS(Mf)16 were below the action and limit level and no silt plume was observed when monitoring was conducted IS(Mf)9 and IS8, this indicates that the turbidity level (in NTU) at IS(Mf)9, IS8, IS7 and IS(Mf)16 were not adversely affected.

- 3.3.8.4 Also, with refer to the silt curtain condition on 06 Jan 14, no defects of the perimeter silt curtain was observed at south and southeast of the construction site.
- 3.3.8.5 The exceedances were likely due to local effects in the vicinity of IS(Mf)9 and IS8.
- 3.3.8.6 As such, the exceedances recorded at IS(Mf)9 and IS8 are considered non-project related.
- 3.3.8.7 The Contractor was reminded to ensure provision of ongoing maintenance to the silt curtains and to carry out maintenance work once defects were found.
- 3.3.8.8 Maintenance work of the silt curtain was carried out by the Contractor on a daily basis except on Sunday and public holiday.

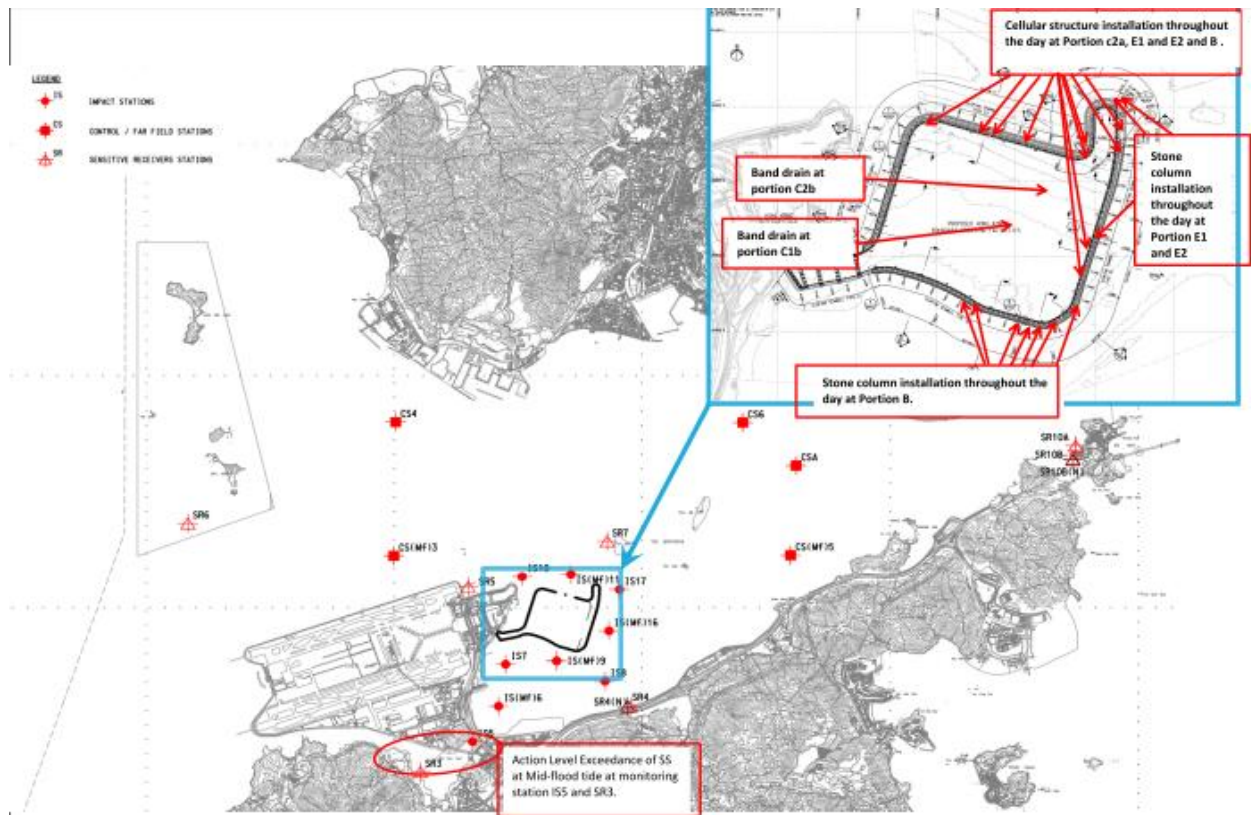
3.3.9 Two (2) action level exceedances at measured Suspended Solids (mg/L) were recorded on 10 Jan 2014 at monitoring station IS5 and at monitoring station SR3 at Mid-flood tide. For Action Level exceedances at measured Suspended Solids (mg/L), 25.1 mg/L was recorded at Monitoring Station IS5 and 24.8 mg/L was recorded at Monitoring Station SR3.

3.3.9.1 For site activities carried out on 10 Jan 14, please refer to the below layout map.

3.3.9.2 Suspended solids values recorded at Impact Station IS(Mf) 6, IS(Mf)9 and IS7 located downstream and closer to active work than SR3 and IS5 were below the Action and Limit Level during the same tide on the same day. As such, active works is unlikely to cause exceedance to IS5 and SR3.

3.3.9.3 Same type of works was carried out at the same locations on 8, 10 and 13 Jan 14 but Suspended Solids values recorded at SR3 and IS5 on 8 and 13 Jan 14 are all below the Action and Limit Level during the same tide on the these days. As such, active works conducted on 10 Jan 14 are unlikely to cause exceedance to IS5 and SR3.

3.3.9.6 The Contractor was reminded to ensure provision of ongoing maintenance to the silt curtains and to carry out maintenance work once defects were found.

3.3.9.7 Maintenance work of the silt curtain was carried out by the Contractor on a daily basis except on Sunday and public holiday.

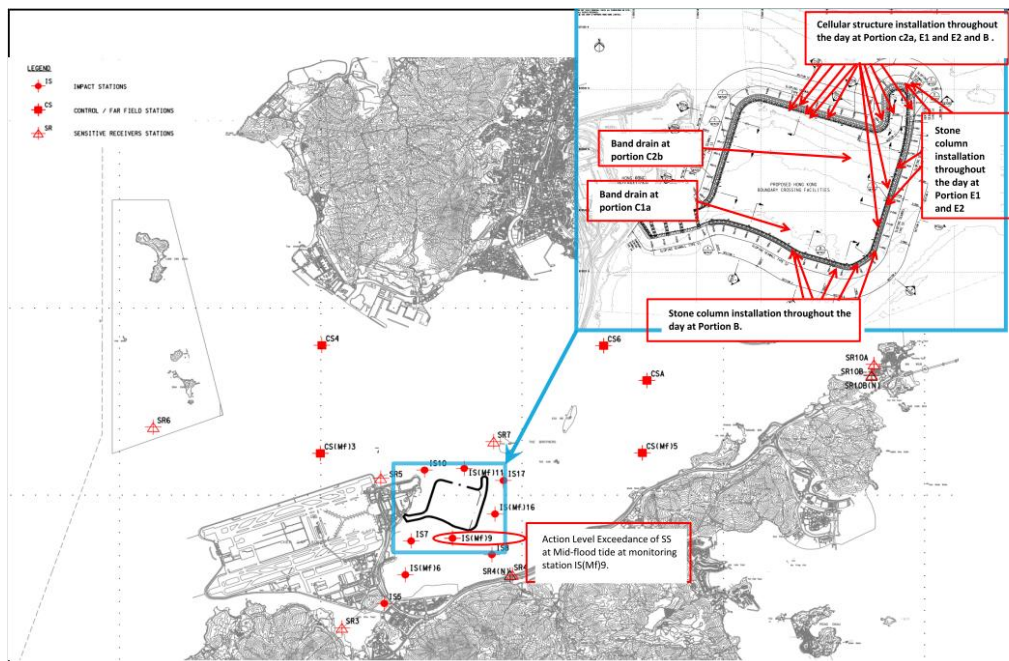
- 3.3.10 One (1) Action Level exceedance at measured Suspended Solids (mg/L) was recorded on 15 Jan 2014 at monitoring station IS(Mf)9 at Mid-flood tide. For the Action Exceedance at measured Suspended Solids (mg/L), 26.6 mg/L was recorded at Monitoring Station IS(Mf)9.

- 3.3.10.1 The Depth averaged turbidity (in NTU) and depth averaged SS (in mg/L) of nearby monitoring station, such as IS8, IS7 and IS(Mf)16 were below the action and limit level, indicating the water quality at area nearby IS(Mf)9 was not adversely affected.

- 3.3.10.2 Since the turbidity level (in NTU) at IS(Mf)9, IS8, IS7 and IS(Mf)16 were below the action and limit level and no silt plume was observed when monitoring was conducted IS(Mf)9, this indicates that the turbidity level (in NTU) at IS(Mf)9, IS8, IS7 and IS(Mf)16 were not adversely affected. Please refer to the photo record attached for sea condition recorded on 15 Jan 14 at southeast vessel entrance of the perimeter silt curtain (near monitoring station IS(Mf)9).

- 3.3.10.3 Also, with refer to the silt curtain condition on 15 Jan 14, no defects of the perimeter silt curtain was observed at south and southeast of the construction site.
- 3.3.10.4 The exceedance was likely due to local effects in the vicinity of IS(Mf)9.
- 3.3.10.5 As such, the action level exceedance recorded at IS(Mf)9 is considered non-project related.
- 3.3.10.6 The Contractor was reminded to ensure provision of ongoing maintenance to the silt curtains and to carry out maintenance work once defects were found.
- 3.3.10.7 The Contractor was reminded that, with reference to EM&A manual Clause 9.1.1, the vessel access opening of the perimeter silt curtain would be formed by two piece of silt-curtain with overlapping length of 150m minimum and a separation distance of about 50m.

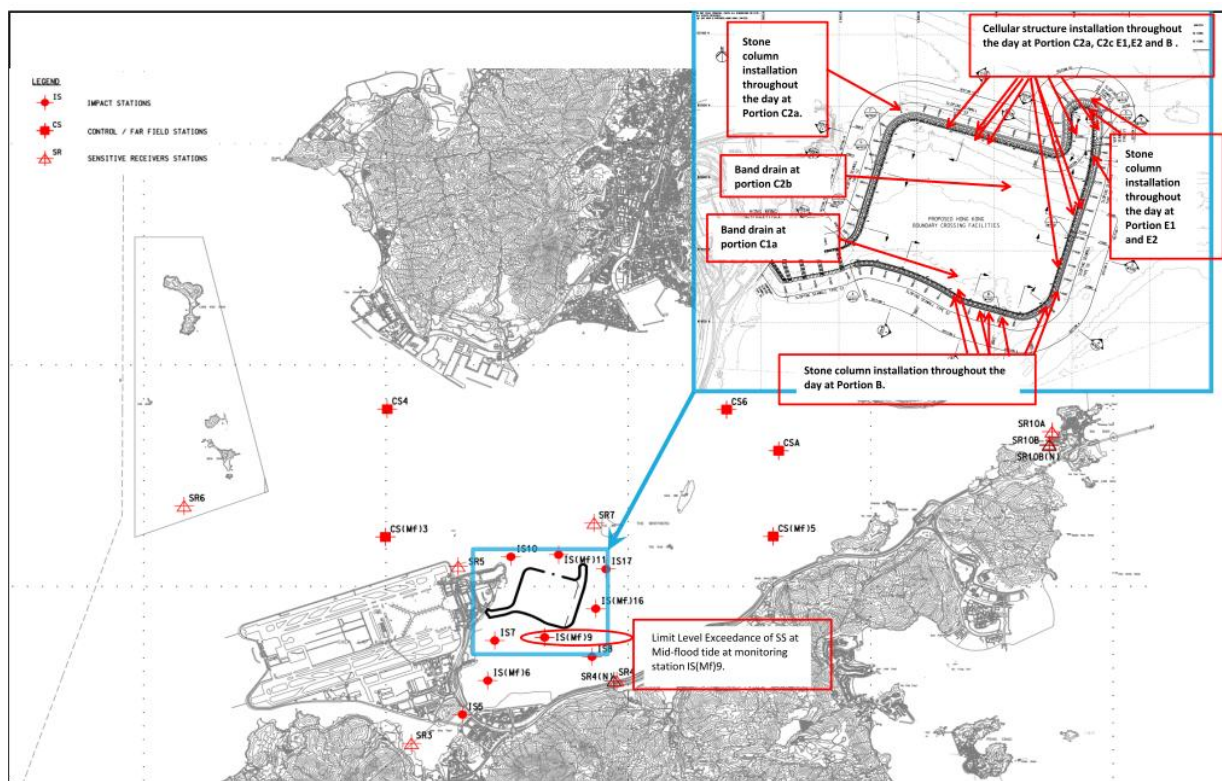
- 3.3.11 One (1) Limit Level exceedance at measured Suspended Solids (mg/L) was recorded on 17 Jan 2014 at monitoring station IS(Mf)9 at Mid-flood tide. For action exceedance at measured Suspended Solids (mg/L), 36.8 mg/L was recorded at Monitoring Station IS(Mf)9.

- 3.3.11.1 The Depth averaged turbidity (in NTU) and depth averaged SS (in mg/L) of nearby monitoring station, such as IS8, IS7 and IS(Mf)16 were below the action and limit level, indicating the water quality at area nearby IS(Mf)9 was not adverse affected.
- 3.3.11.2 Since the turbidity level (in NTU) at IS(Mf)9, IS8, IS7 and IS(Mf)16 were below the action and limit level and no silt plume was observed when monitoring was conducted at IS(Mf)9. Please refer to the photo record below for sea condition near IS(Mf)9 on 17 Jan 14.

- 3.3.11.3 Also, with refer to the silt curtain condition on 17 Jan 14, no defects of the perimeter silt curtain was observed at south and southeast of the construction site.
- 3.3.11.4 The exceedance was likely due to local effects in the vicinity of IS(Mf)9.
- 3.3.11.5 As such, the limit level exceedance recorded at IS(Mf)9 is considered non-project related.
- 3.3.11.6 The Contractor was reminded to ensure provision of ongoing maintenance to the silt curtains and to carry out maintenance work once defects were found.
- 3.3.11.7 Maintenance work of the silt curtain was carried out by the Contractor on a daily basis except on Sunday and public holiday.

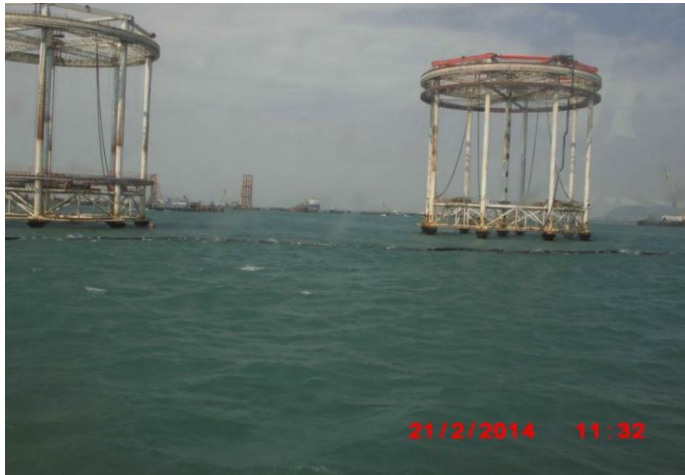
3.3.12.7 With refer to the daily silt curtain integrity checking record of 21 Feb 14, no defects was observed along the part of the perimeter silt curtain located east of HKBCF-reclamation site which is next to IS(Mf)16. For the condition of the perimeter silt curtain condition near monitoring station IS(Mf)16, please refer to the photo record below:

- 3.3.12.8 The exceedance was likely due to local effects in the vicinity of IS(Mf)16.
- 3.3.12.9 The exceedance is considered as non-project related.
- 3.3.12.10 Nevertheless, the Contractor was reminded to ensure provision of ongoing maintenance to the silt curtains and to carry out maintenance work once defects were found.
- 3.3.12.11 Maintenance work of the silt curtain was carried out by the Contractor on a daily basis except on Sunday and public holiday.
- 3.3.13 The graphical plots of the trends of the monitoring results are provided in Appendix G. No specific trend of the monitoring results or existence of persistent pollution source was noted.

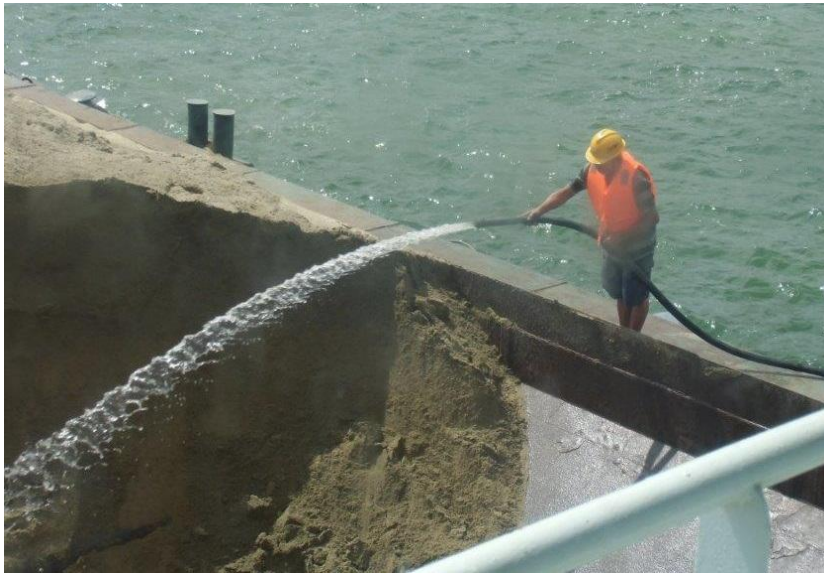
- 7.1.3.5 Photo record shows that watering equipment is provided on pelican barge loaded with sand for watering of sand filling material to keep the sand material wet.

- 7.1.6.1 Site visit was conducted on 9 Jan 14 and it was observed during the site investigation that watering equipment was provided on pelican barge loaded with sand for watering of sand filling material to keep the surface of sand material wet. This is consistent with HyD's reply to Oriental Daily Newspaper that the Contractor would water the sand material to keep the sand material wet to prevent generation of fugitive dust.

- 7.1.3.4 The Contractor was advised to ensure to continue the provision of fugitive dust mitigation measures to barges loaded with filling material such as watering to sand filling material on sand barges to keep the surface of stockpile of filling material wet.

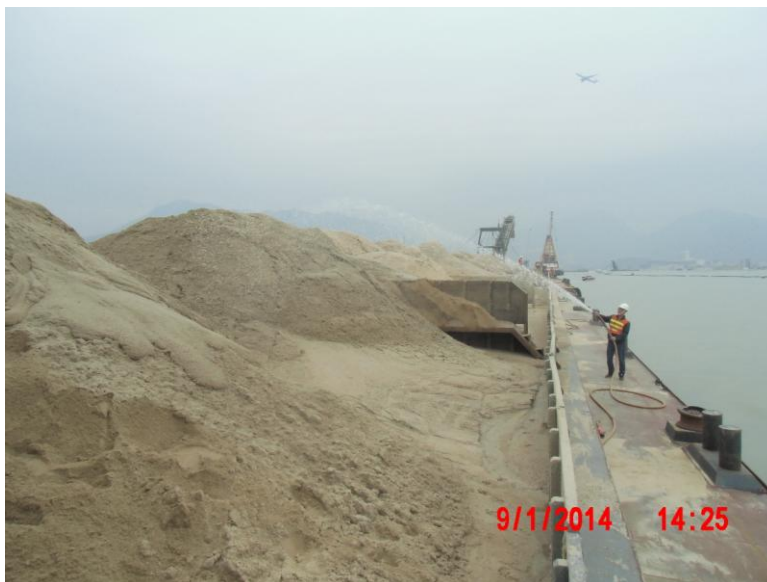
- 7.1.6.2 Photo record shows that watering equipment is provided on pelican barge loaded with sand for watering of sand filling material.
