Notification No.: 20170901DO\_v1

**Works Inspected:** Data collected from water sampling works on 1 September 2017 and the results were issued on 4 September 2017

Monitoring Location: Water Quality Monitoring Station

Parameter: Dissolved Oxygen (DO)/ Suspended Solid (SS)/ Turbidity (TURB)

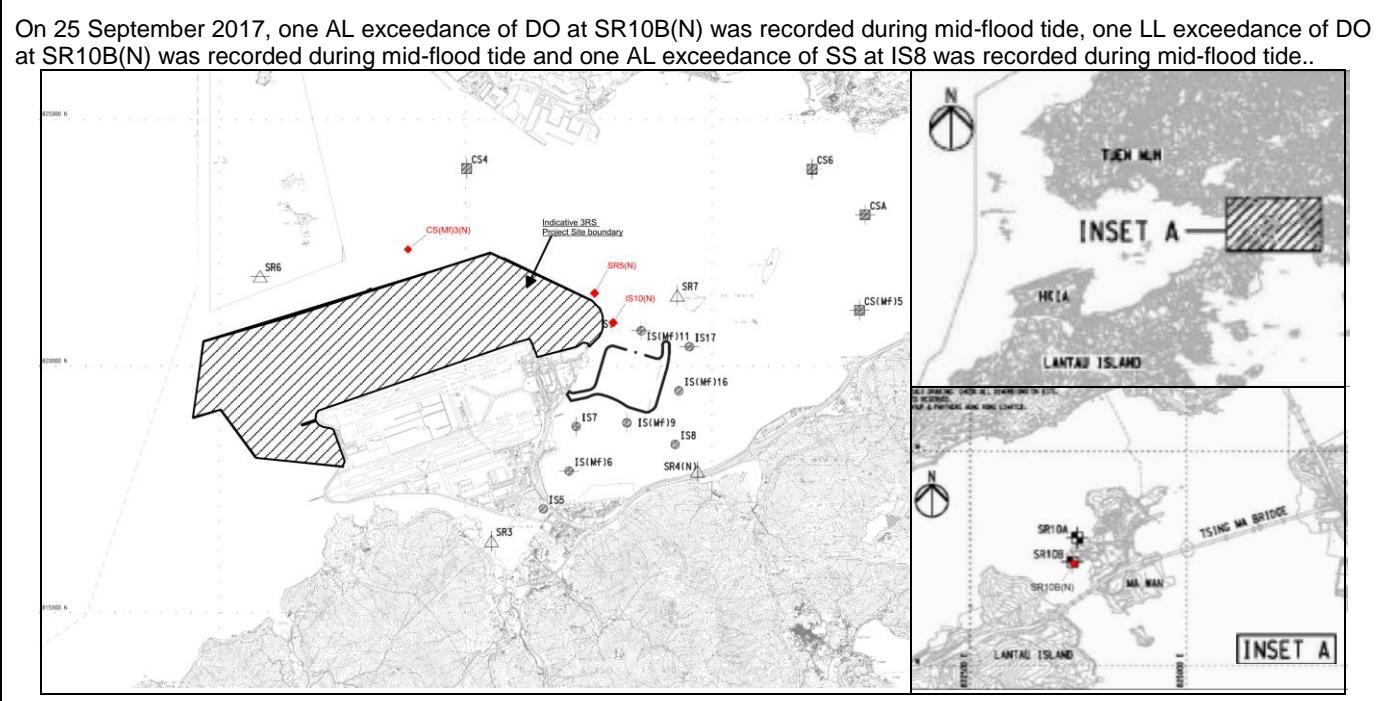
As confirmed by the Contractor, there were no marine transportation and marine-based work on 25 September 2017. No site runoff within the Contract site has been observed. Therefore, it is concluded that the exceedances were not related to the Contract.

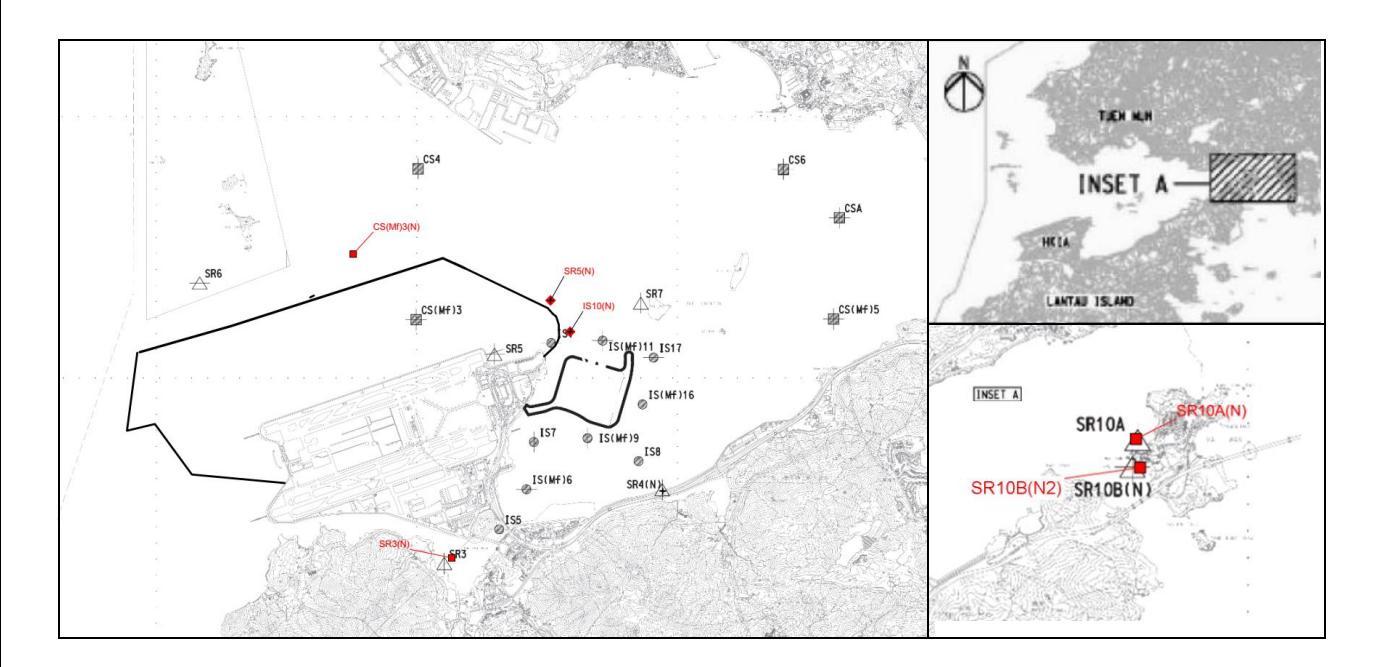
On 22 November 2017, one AL exceedance of SS at SR6 was recorded during mid-ebb tide and one LL exceedance of SS at SR6 was recorded during mid-flood tide.

As confirmed by the Contractor, there was no marine transportation and marine-based work on 22 November 2017. No site runoff within the Contract site has been observed. Therefore, it is concluded that the exceedances were not related to the Contract.
