### Environmental Complaint Form

<b>RECEIPT OF COMPLAINT</b>		<b>Ref: ENPO-C0129</b>
Date:	29 December 2017	
Time:	N/A	
Via:	HyD (ref: CASE#2-4404344922)	
<b>COMPLAINANT</b>		
Name:	N/A	Address: N/A
Contact no.:	N/A	
<b>DETAILS OF COMPLAINT</b>		
Date:	Not specified in complaint	
Time:	Not specified in complaint	
Parameter:	Air Quality and Water Quality      Other (specify): N/A	
Description:	<p>The complaint was about effectiveness of mitigation measures implemented for dust and mud (namely, street washing vehicles and dust collecting vehicles) on East Coast Road to handle dust problems associated with HZMB BCF Island site works, which according to the complainant, was not as effective as they should. Specifically, the complainant said that water spray from street washing vehicles had turned the dust on the road into mud, and furthermore dust was still present on the road despite the use of dust collecting vehicles, causing the problem to persist.</p>

HY/2013/04  
HONG KONG-ZHUHAI-MACAO BRIDGE  
HONG KONG BOUNDARY CROSSING FACILITIES  
- INFRASTRUCTURE WORKS STAGE II  
(SOUTHERN PORTION)

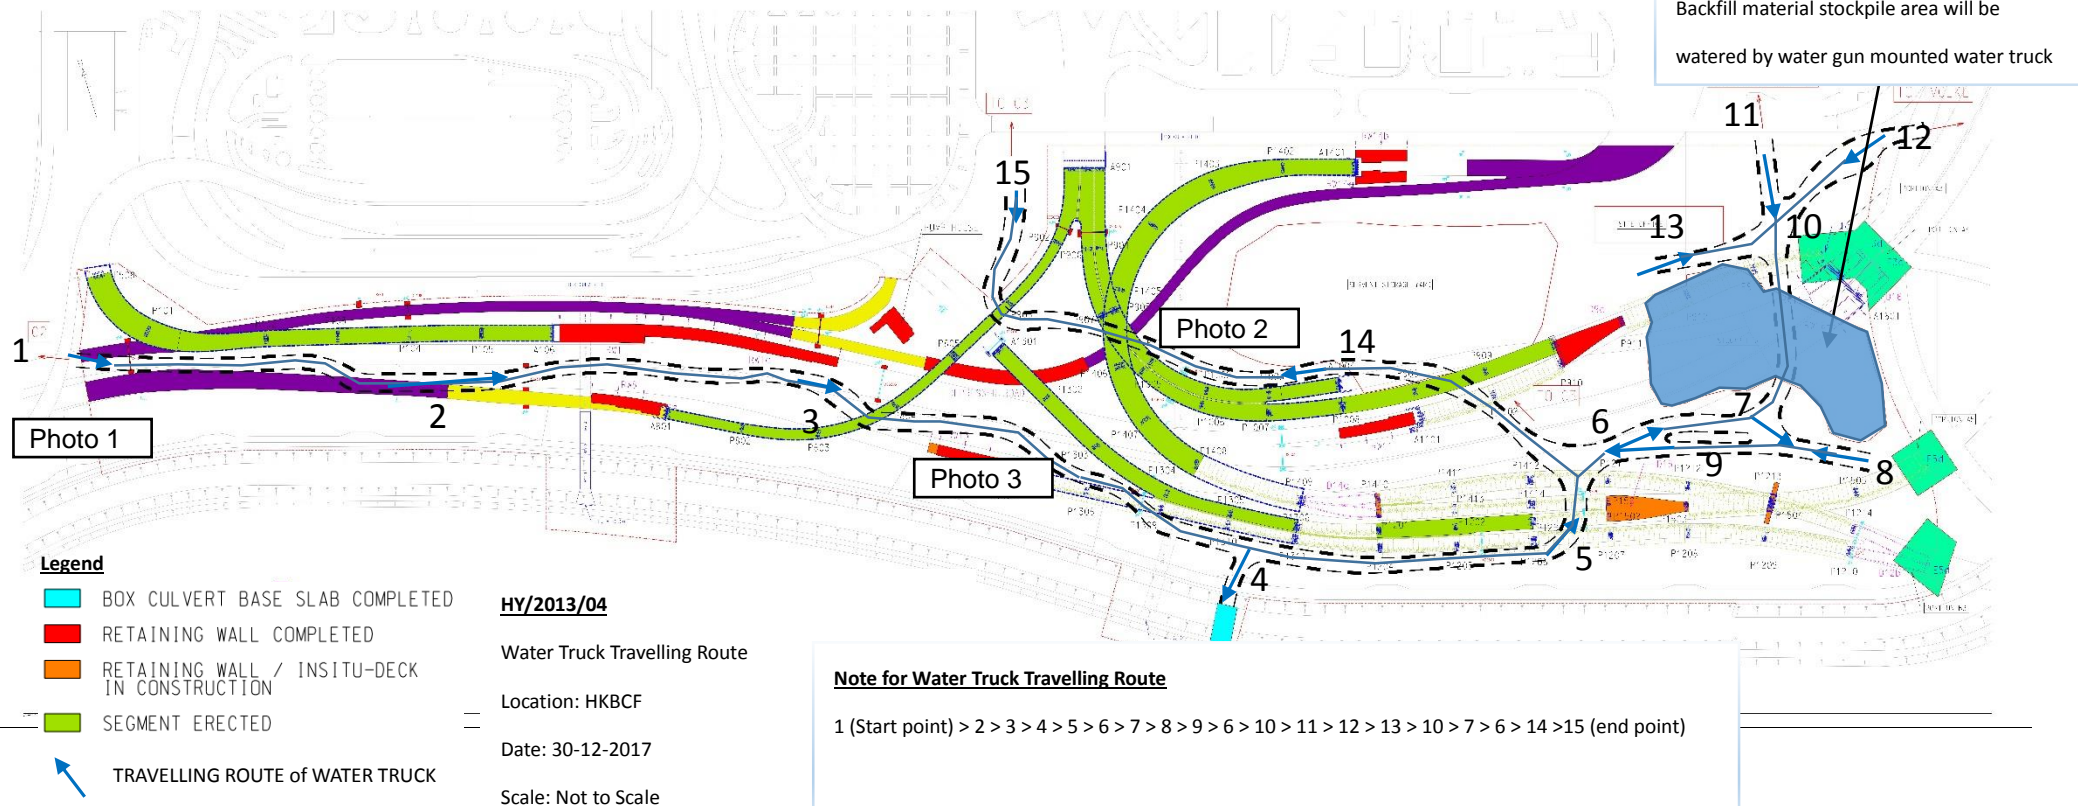
Photos taken on 10 January 2018

1. Water spray provided at HY/2013/04 site boundary for vehicles leaving HY/2013/04 site towards BCF Island site exit. No adverse observation was observed.

3. Haul roads were wetted in the HY/2013/04 site area (between Box Culvert C and Box Culvert D).

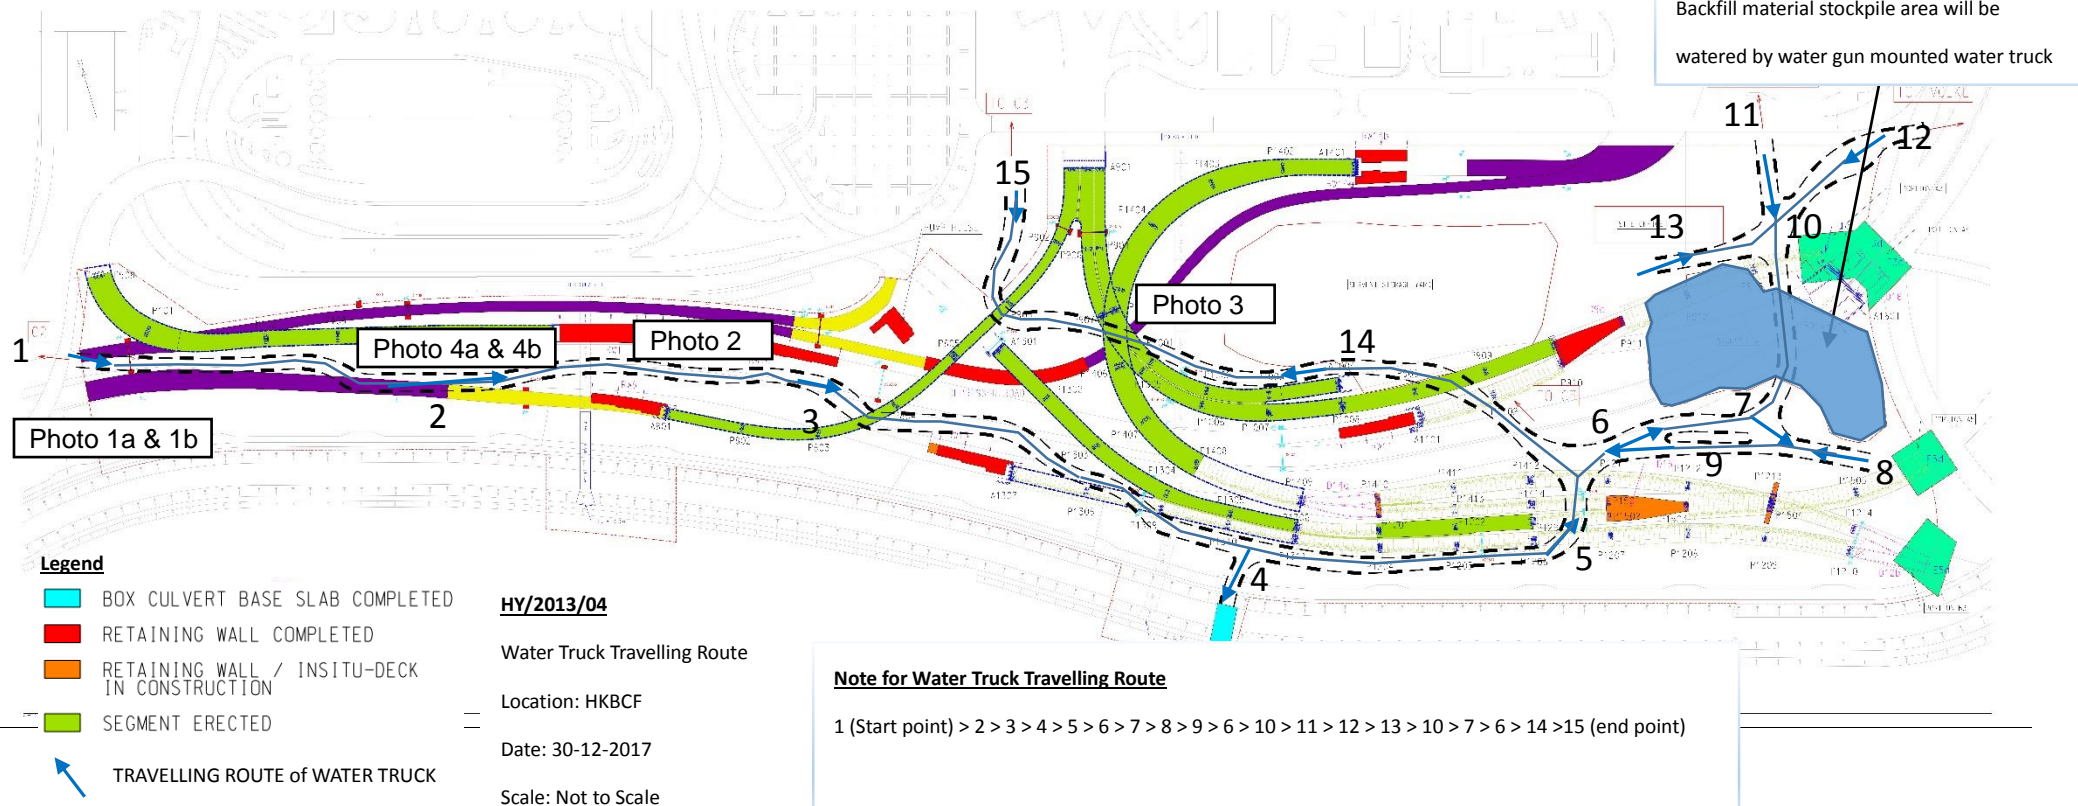
Photos taken on 24 January 2018

1. Water spray provided for haul roads in the HY/2013/04 site area (near Box Culvert C). No fugitive dust generation was observed.

2. Water spray provided for haul roads in the HY/2013/04 site area (near Bridge D13). No fugitive dust generation was observed.

3. Water spray provided for haul roads in the HY/2013/04 site area (near Bridge D10). No fugitive dust generation was observed.

4. Water spray provided for haul roads in the HY/2013/04 site area (near Bridge D9a). No fugitive dust generation was observed.

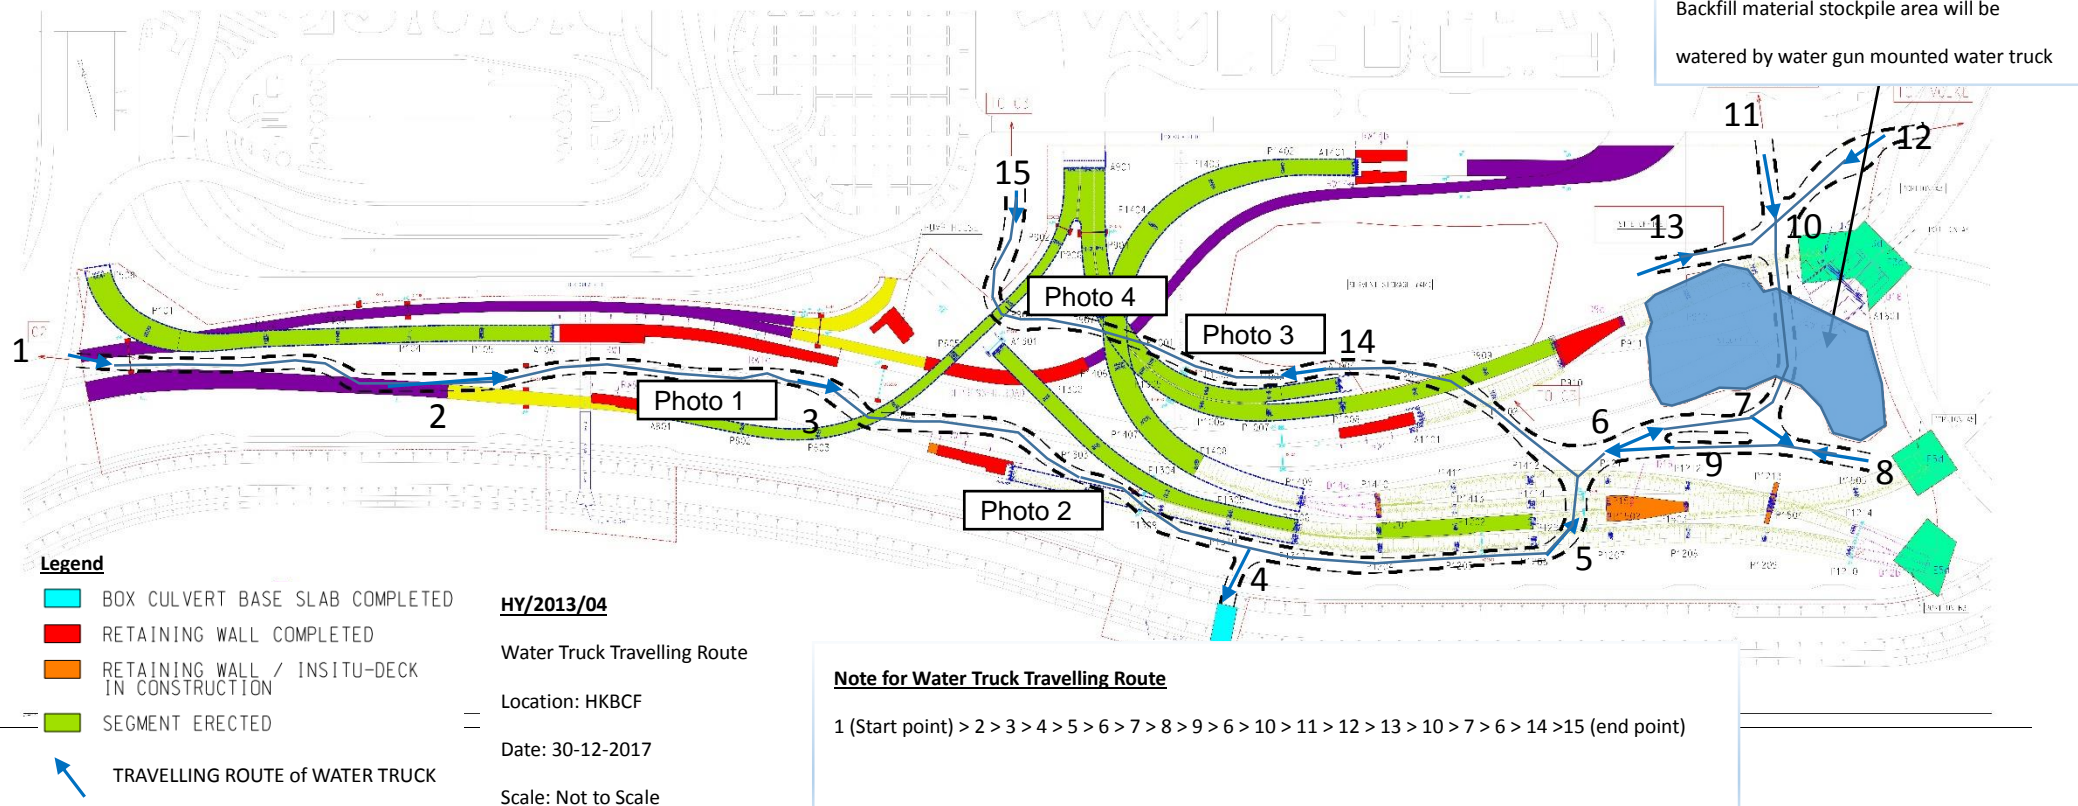
Photos taken on 31 January 2018

1. Wheel wash facility was in operation at HY/2013/04 site boundary for vehicles leaving HY/2013/04 site towards BCF Island site exit. No specific observation referring to air or water quality mitigation measures associated with access roads was observed.

2. Water spray provided for haul roads in the HY/2013/04 site area (near Box Culvert D). No fugitive dust generation was observed.

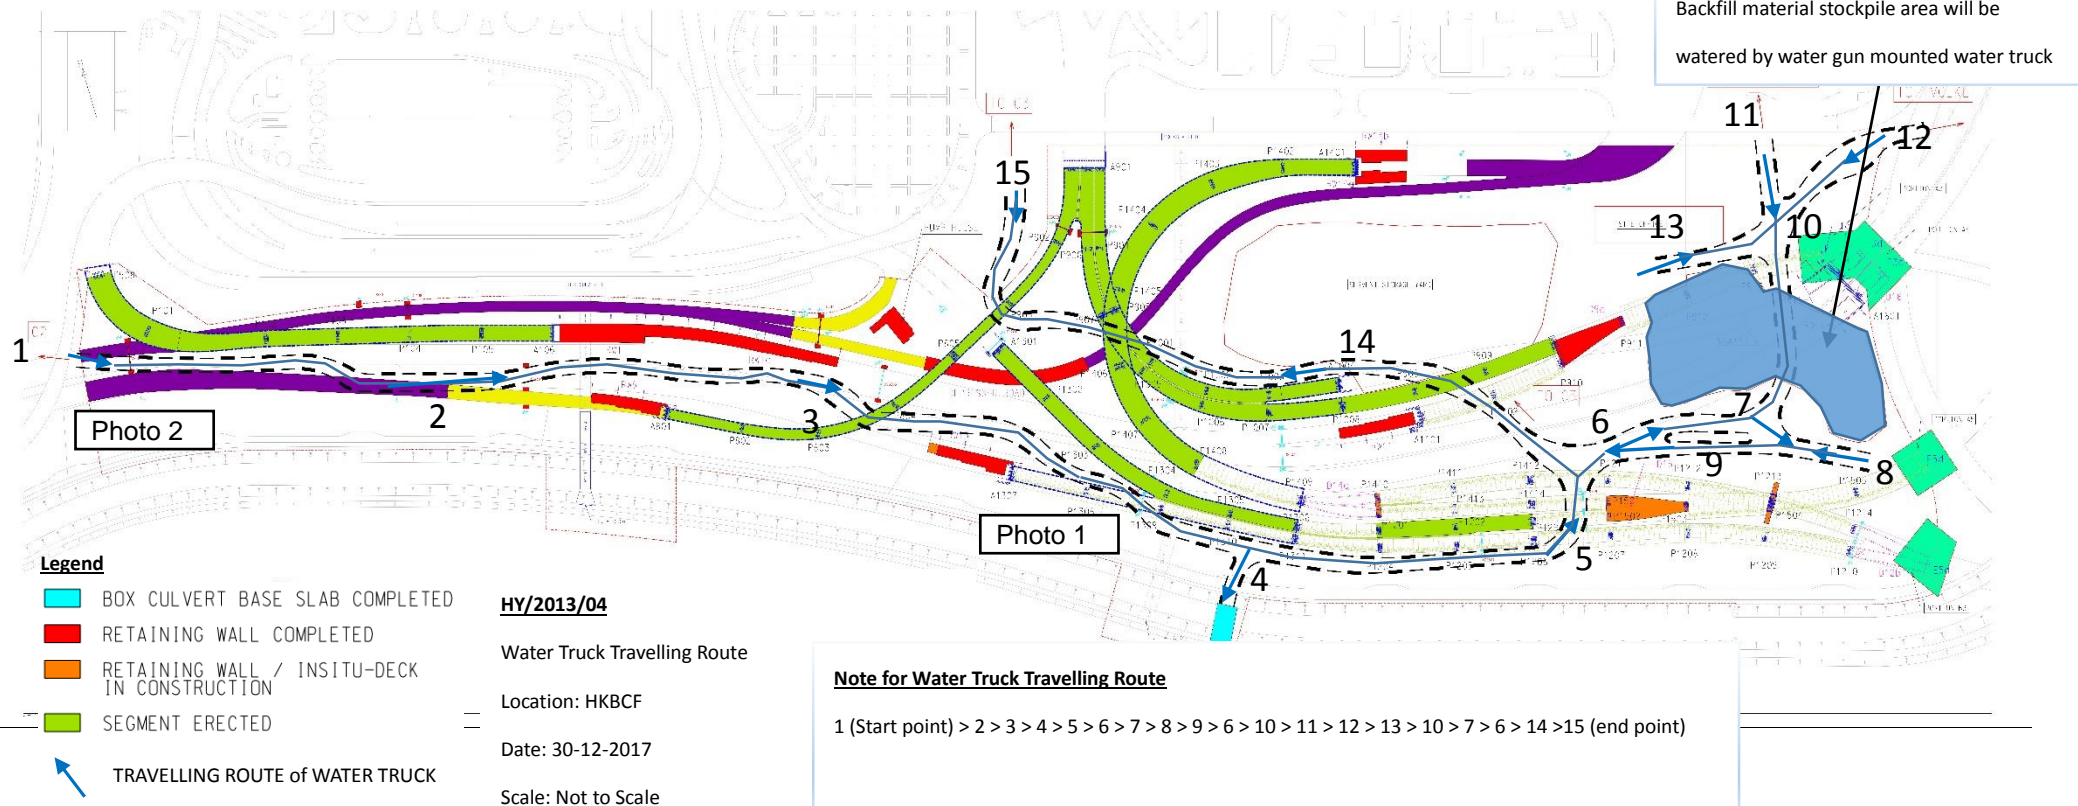
Photos taken on 9 February 2018

1. Haul roads were wetted in the HY/2013/04 site area (between Box Culvert C and Box Culvert D). No specific observation referring to air or water quality mitigation measures associated with access roads was observed.

2. Wheel wash facility was in operation at HY/2013/04 site boundary for vehicles leaving HY/2013/04 site towards BCF Island site exit. No specific observation referring to air or water quality mitigation measures associated with the wheel wash facility was observed.

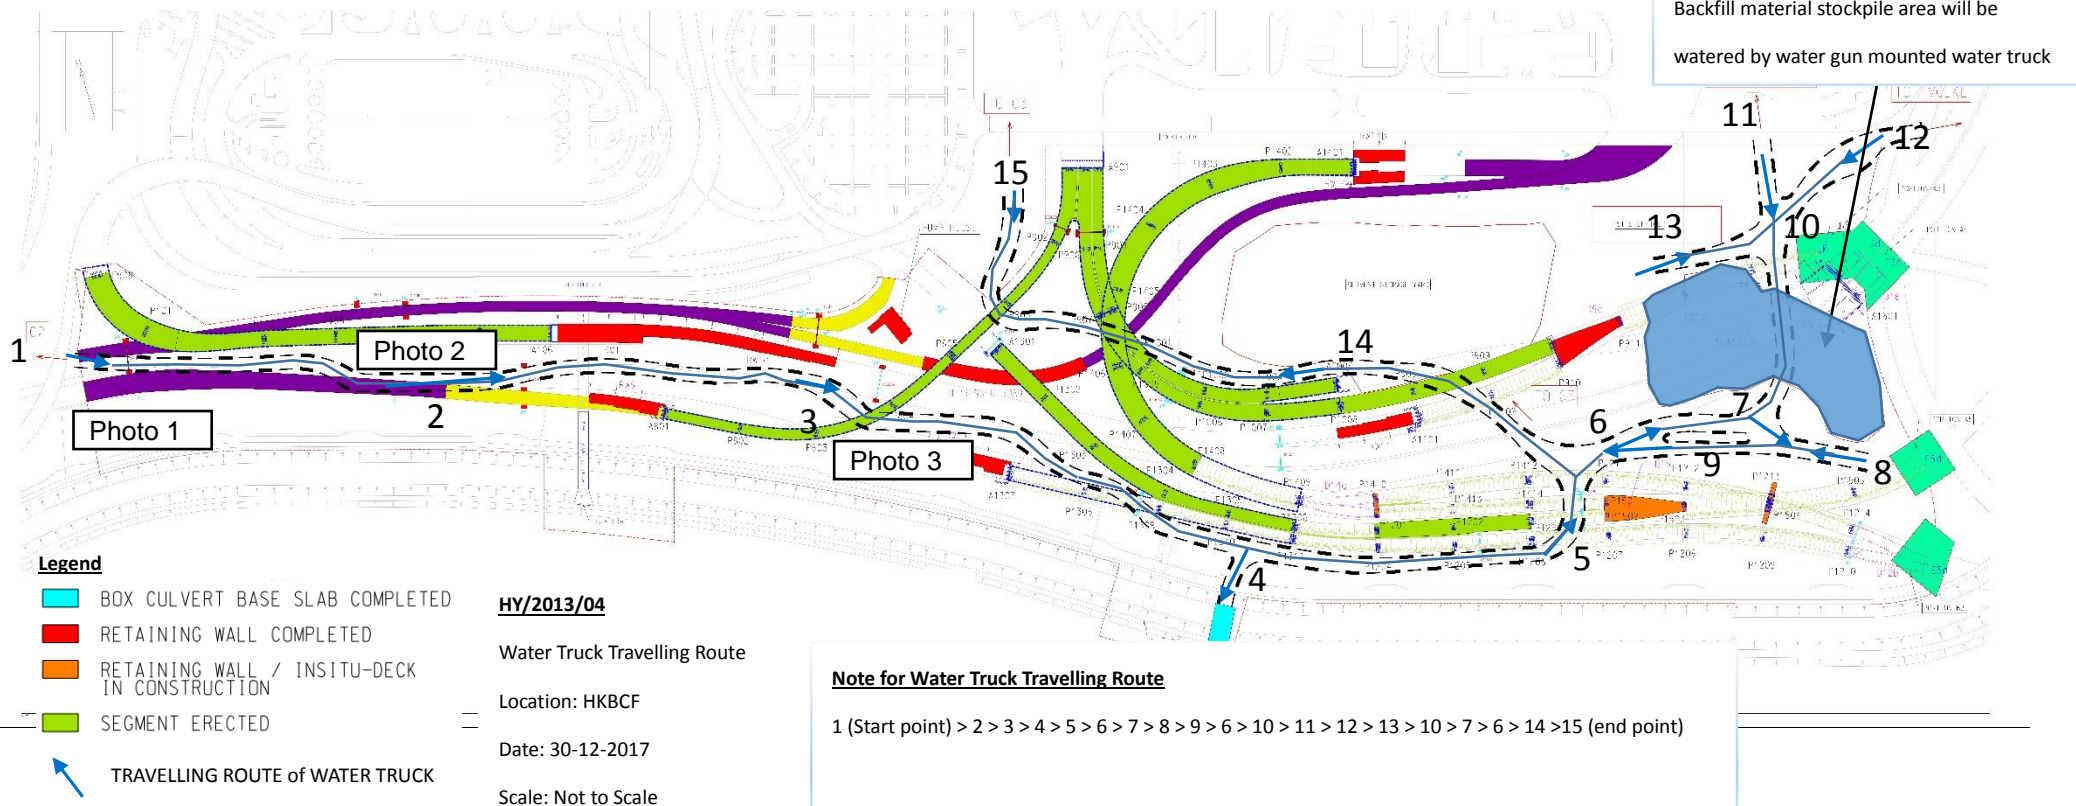
Photos taken on 12 February 2018

1. Wheel wash facility was in operation at HY/2013/04 site boundary for vehicles leaving HY/2013/04 site towards BCF Island site exit. No specific observation referring to air or water quality mitigation measures associated with the wheel wash facility was observed.

3. Haul roads were wetted in the HY/2013/04 site area (between Box Culvert C and Box Culvert D).
