### Environmental Complaint Form

<b>RECEIPT OF COMPLAINT</b>		<b>Ref: ENPO-C0139</b>
Date:	3 October 2018	
Time:	N/A	
Via:	EPD/ENPO	
<b>COMPLAINANT</b>		
Name:	Not specified in complaint	Address: N/A
Contact no.:	N/A	
<b>DETAILS OF COMPLAINT</b>		
Date:	-	
Time:	-	
Parameter:	Air quality	Other (specify): N/A
Description:	The complaint referred to a large amount of dust generated due to lack of water spraying on dirt road at HKBCF Island site. As informed by EPD, the location under complaint was near the exit/entrance of Contract No. HY/2013/04 as advised by the complainant.	
<b>INVESTIGATION RESULT &amp; RESPONSE</b>		
IEC, ER and ET notified on: 3 October 2018		
Result of investigation:		
<p>The relevant mitigation measures for access roads for the HZMB BCF Island site, as required in the EMIS and statutory requirements in the Air Pollution Control (Construction Dust) Regulations and other applicable environmental legislation, are consolidated as follows:</p> <ul style="list-style-type: none"> <li>• Immediately before leaving a construction site, every vehicle shall be washed to remove any dusty materials from its body and wheels and to ensure that no earth, mud or debris is depo

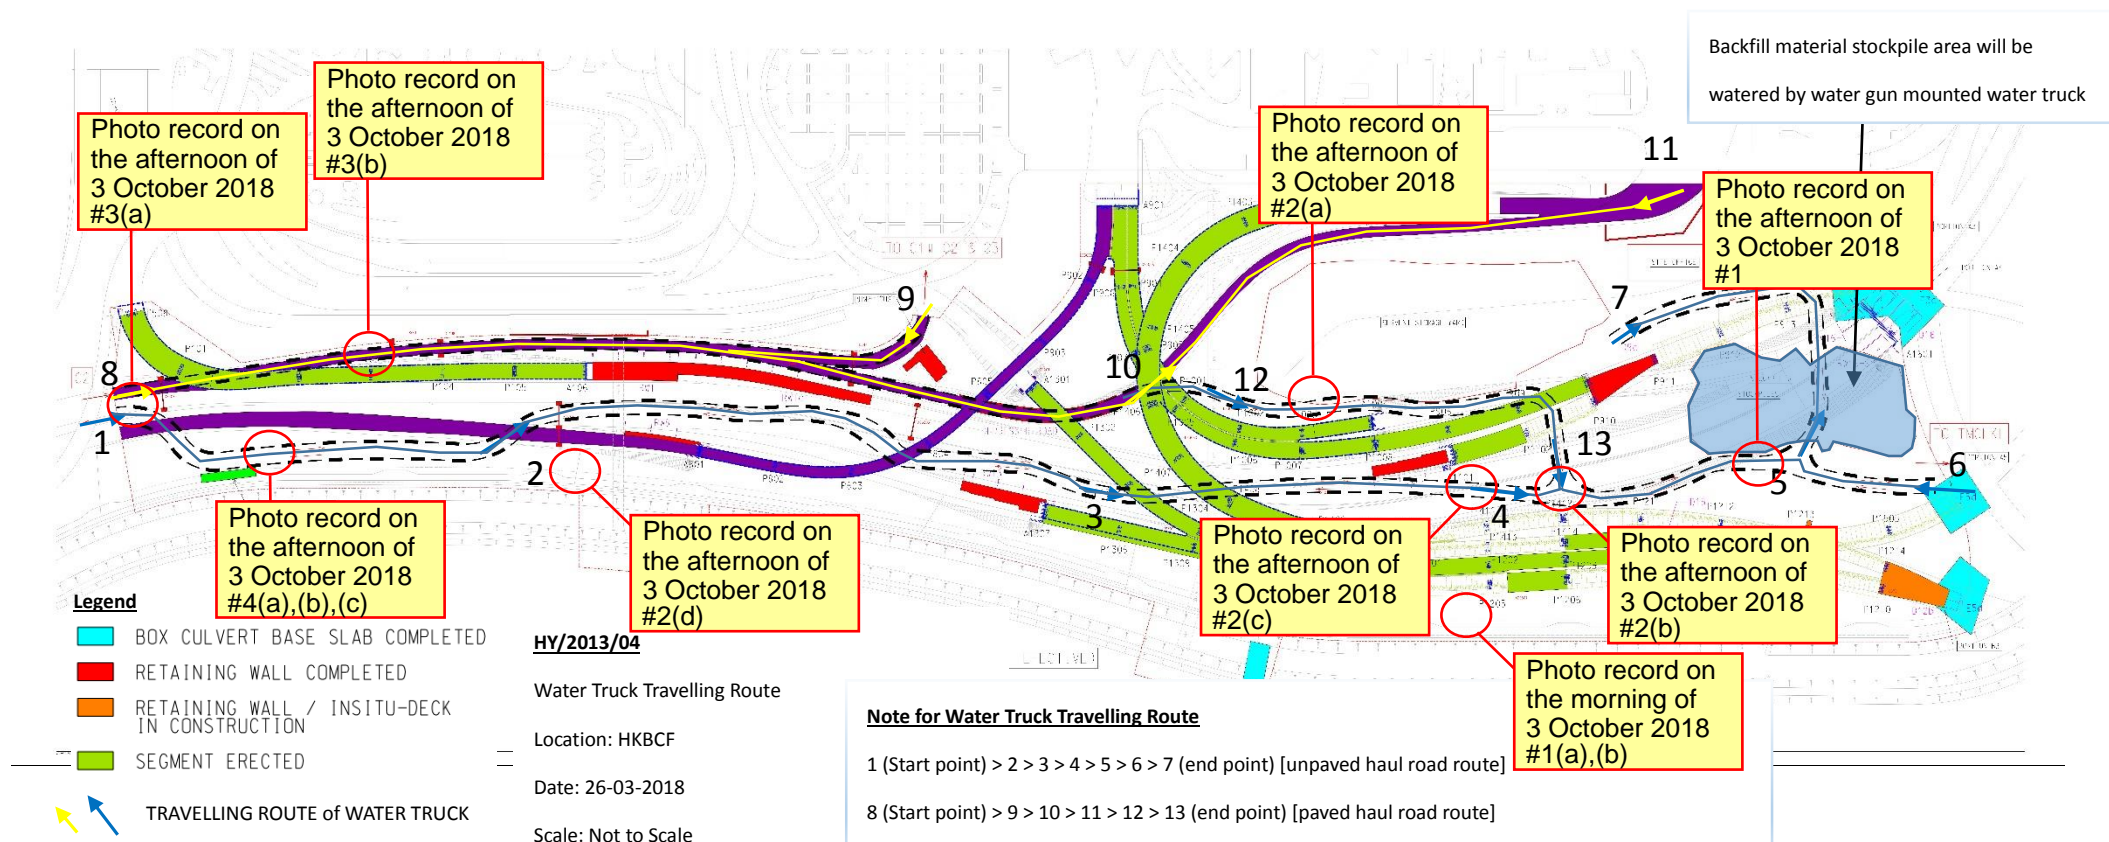
## **Attachment 3**

The Contractor's site watering plan (annotated with locations of the abovementioned photos) and wheel wash facility are presented in **Attachments 3 and 4** respectively.

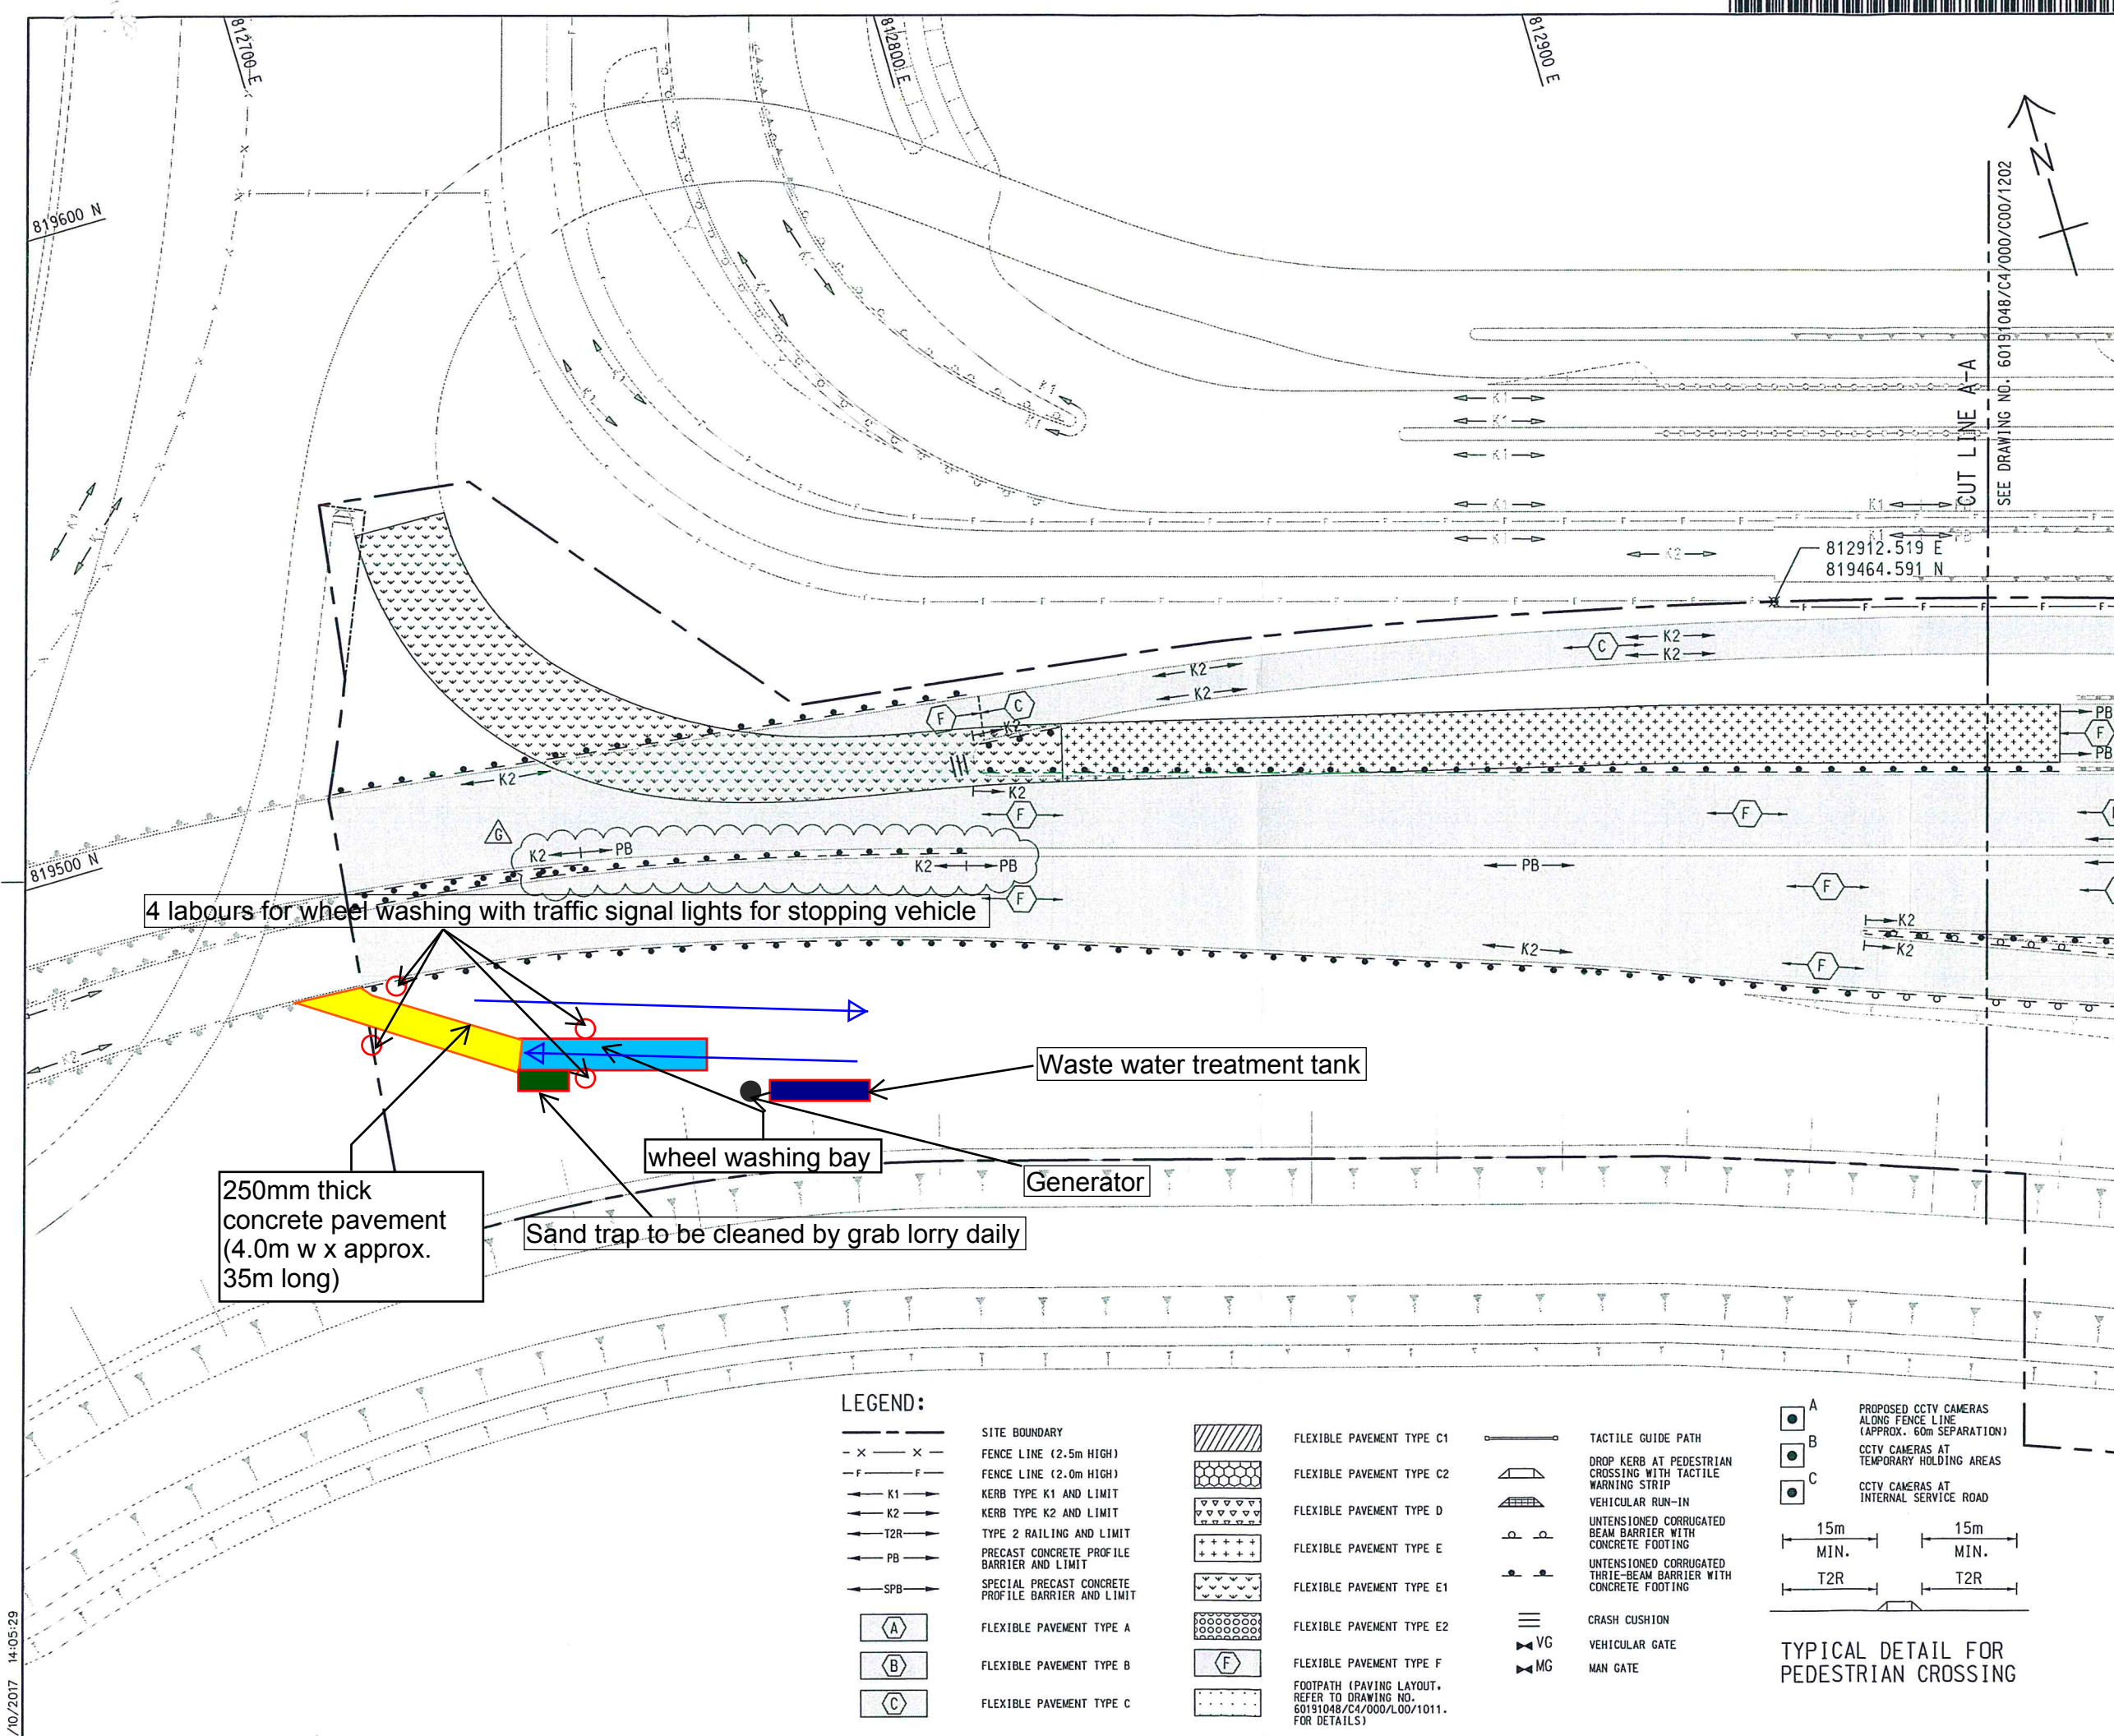
## **Attachment 4**

4. The wheel wash facility at the vehicular exit of HY/2013/04 site boundary was also inspected and found to be operating normally with no fugitive dust observed.
