**Contract No. HY/2011/03 -
Hong Kong- Zhuhai- Macao Bridge
Hong Kong Link Road Section between Scenic Hill and Hong Kong Boundary Crossing Facilities
Notifications of Environmental Quality Limits Exceedances** Notification No.: 278a ver 1

Date of Notification: 13 June 2018

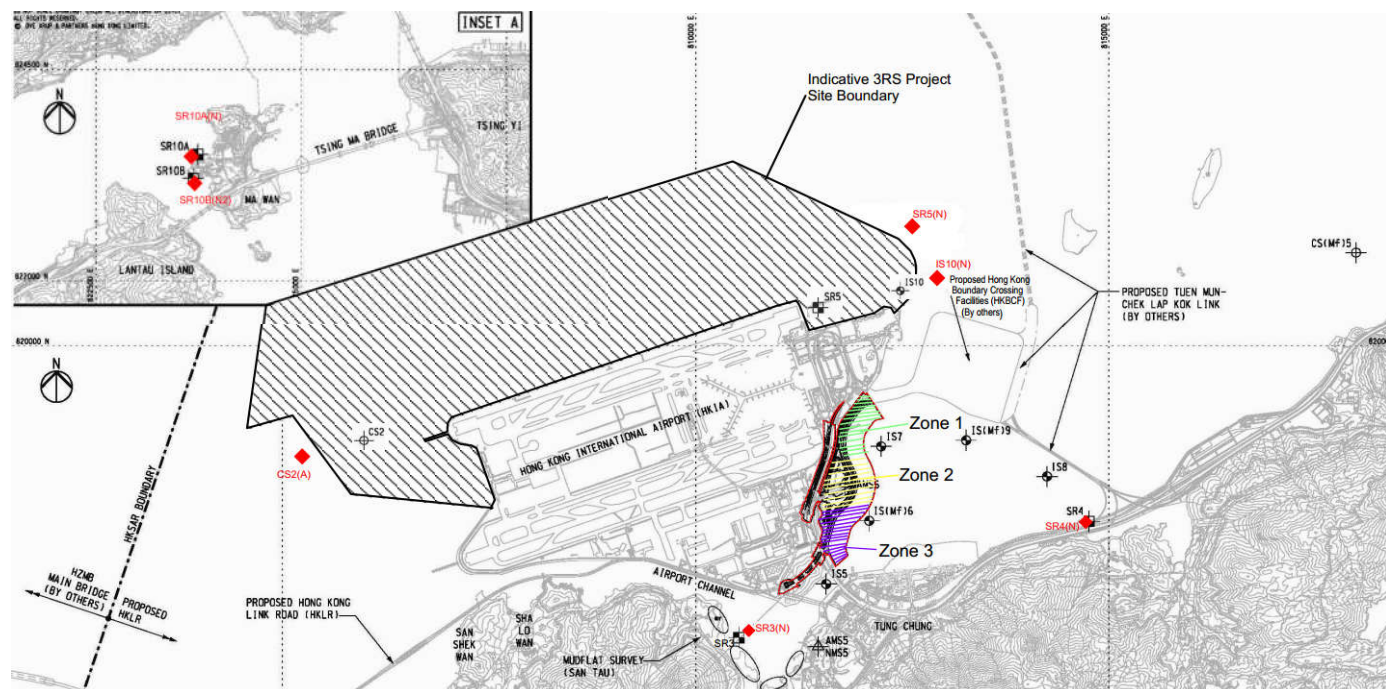
Location Plan:

Contract No. HY/2011/03 - Hong Kong- Zhuhai- Macao Bridge Hong Kong Link Road Section between Scenic Hill and Hong Kong Boundary Crossing Facilities Notifications of Environmental Quality Limits Exceedances Notification No.: 279 ver0																		
Date of Notification: 6 July 2018																		
Works Inspected: Data collected from water sampling works on 29 June 2018 and the test report was issued on 6 July 2018.																		
Monitoring Location: Water Quality Monitoring Stations																		
Parameter: Dissolved Oxygen (DO)/ Suspended Solids (SS) / Turbidity (TURB)																		
Action & Limit Level (AL & LL) / Measured Level:																		
PARAM	STATION	DEPTH	AL (mg/L)	LL (mg/L)	MEASURED AT MID-EBB TIDE (mg/L)	MEASURED AT MID-FLOOD TIDE (mg/L)												
DO	IS5	Bottom	4.7	3.6	4.6	4.9												
<p>Notes:</p> <p><i>Bold Italic</i> means AL exceedances.</p> <p><u><i>Bold Italic with underline</i></u> means LL exceedances.</p> <p>Possible reasons for Action Level Non-compliance:</p> <p>On 29 June 2018, an Action Level exceedance of dissolved oxygen was recorded at station IS5 during the mid-ebb tide. The exceedance has been investigated and is considered unlikely to be related to contract works due to the following reasons:</p> <ol style="list-style-type: none"> 1. According to Contractor's information, there was no marine transportation near station IS5 during sampling period and no marine works were conducted near station IS5 which is located outside the site boundary of HKLR03 Contract. No abnormality or malpractice for the contract works was observed during the sampling exercise. 2. The range of dissolved oxygen for bottom level at station IS5 during the baseline monitoring is shown as below: <table border="1" style="width: 100%; border-collapse: collapse; margin-top: 5px;"> <tr> <th>Station</th> <th>Depth</th> <th colspan="2">Range of Dissolved Oxygen (mg/L) Mid-Ebb Tide</th> <th colspan="2">Range of Dissolved Oxygen (mg/L) Mid-Flood Tide</th> </tr> <tr> <td>IS5</td> <td>Bottom</td> <td>3.3</td> <td>to 8.6</td> <td>2.9</td> <td>to 9.4</td> </tr> </table> <p>On 29 June 2018, the measured value of dissolved oxygen for bottom level at station IS5 during the mid-ebb tide was within the range of the baseline monitoring.</p> <ol style="list-style-type: none"> 3. There were no specific activities recorded during the monitoring period that would cause any significant impact on the monitoring results. As such, the exceedance in DO level is considered to be attributed to other external factors rather than the contract works. 							Station	Depth	Range of Dissolved Oxygen (mg/L) Mid-Ebb Tide		Range of Dissolved Oxygen (mg/L) Mid-Flood Tide		IS5	Bottom	3.3	to 8.6	2.9	to 9.4
Station	Depth	Range of Dissolved Oxygen (mg/L) Mid-Ebb Tide		Range of Dissolved Oxygen (mg/L) Mid-Flood Tide														
IS5	Bottom	3.3	to 8.6	2.9	to 9.4													
<p>Actions taken/ to be taken:</p> <p>As the DO level recorded beyond the water quality criteria was not related to contract works, no immediate actions are considered necessary. However, the Contractor is reminded to ensure the silt curtain is fully maintained throughout the construction works and construction works are under stringer supervision to prevent any water quality impacts to the seawater.</p>

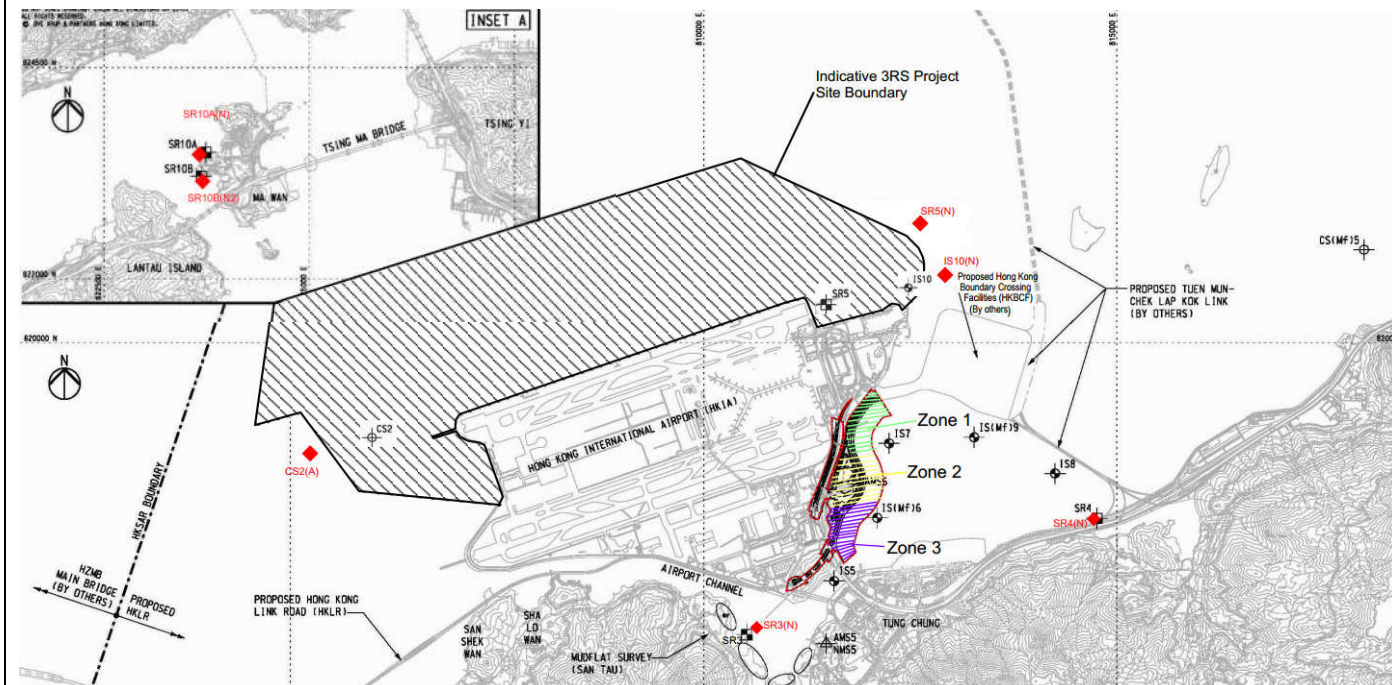
Location Plan:

Possible reasons for Action Level Non-compliance:						
On 6 August 2018, Action Level exceedances of dissolved oxygen were recorded at stations IS10(N) and SR5(N) during mid-ebb tide. The exceedances have been investigated and are considered unlikely to be related to contract works due to the following reasons:						
<ol style="list-style-type: none"> Seawall construction at Zones 2 and 3 were carried out on 6 August 2018. As confirmed by the Contractor, seawall construction at Zones 2 and 3 were carried out within the properly deployed silt curtain as recommended in the EIA Report. According to Contractor's information, there was no marine transportation near IS10(N) and SR5(N) during sampling period and no marine works were conducted near stations IS10(N) and SR5(N) which are located outside the site boundary of HKLR03 Contract. No abnormality or malpractice for the contract works was observed during the sampling exercise. The range of dissolved oxygen for surface and middle level, bottom level at stations IS10 and SR5 during the baseline monitoring is shown as below:

As the DO level recorded beyond the water quality criteria was not related to contract works, no immediate actions are considered necessary. However, the Contractor is reminded to ensure the silt curtain is fully maintained throughout the construction works and construction works are under stringer supervision to prevent any water quality impacts to the seawater.

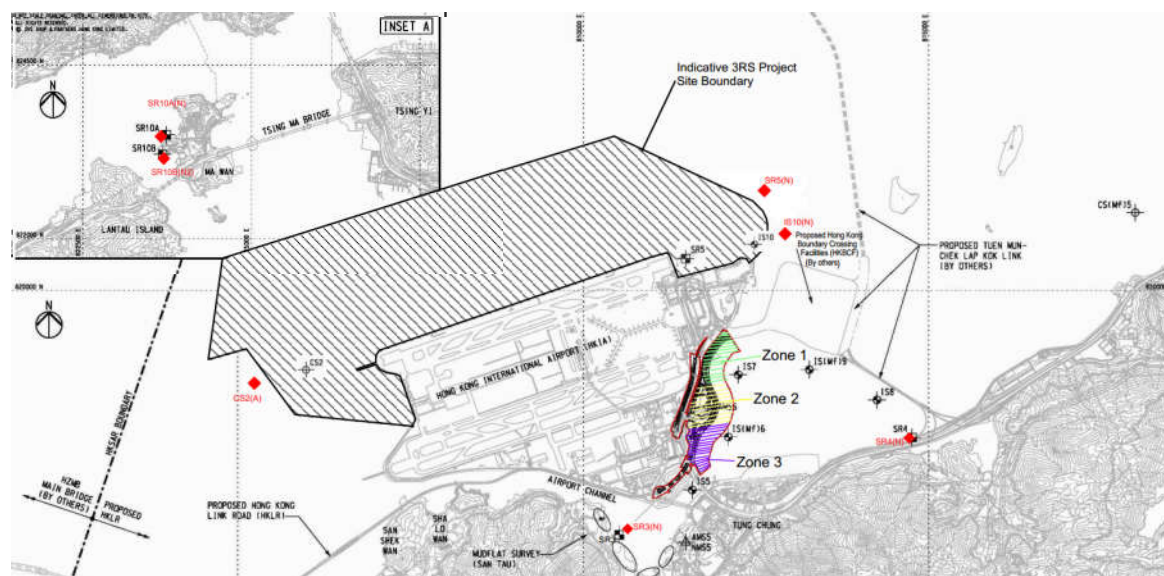
Location Plan:

The measured value for mid-flood tide at station IS8 was within the range of suspended solid for mid-flood tide during baseline monitoring.							
3. During sampling exercise, water appearance was observed moderate (water appearance was observed neither clear nor turbid) at station IS8. There was no marine transportation near station IS8 during sampling period and no marine works were conducted near station IS8 which is located outside the site boundary of HKLR03 Contract. No abnormality or malpractice for the contract works was observed during the sampling exercise.

4. There were no specific activities recorded during the monitoring period that would cause any significant impacts on the monitoring results. As such, the exceedance of suspended solid level is considered to be attributed to other external factors such as sea condition, rather than the contract works.							
Actions taken/ to be taken: As the suspended solid level recorded beyond the water quality criteria was not related to the contract works, no immediate actions are considered necessary. However, the Contractor is reminded to ensure that the silt curtain is fully maintained throughout the construction works and construction works are carried out under stringent supervision to prevent any water quality impacts to the seawater.

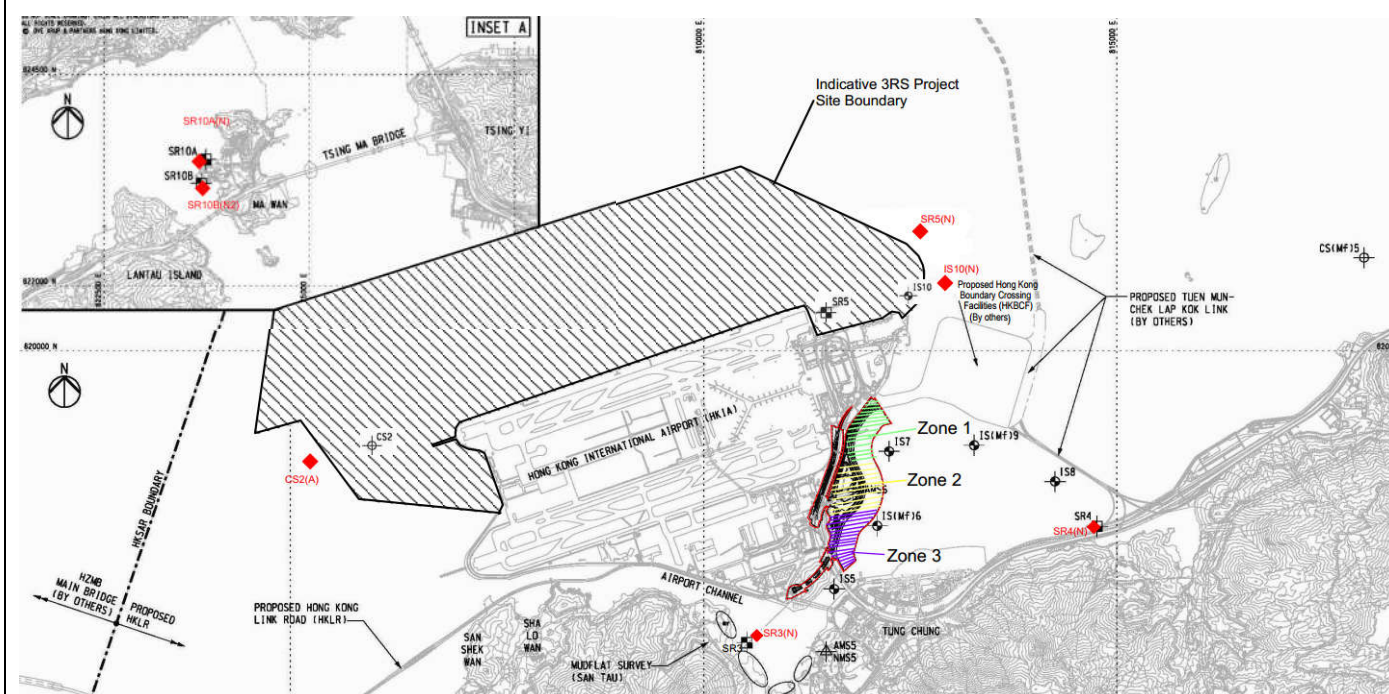
Location Plan:

- Seawall construction at Zones 2 and 3 were carried out on 13 August 2018. As confirmed by the Contractor, seawall construction at Zones 2 and 3 were carried out within the properly deployed silt curtain as recommended in the EIA Report. According to Contractor's information, there was no marine transportation near stations IS10(N), SR5(N), SR10A(N) and SR10B(N2) during sampling period and no marine works were conducted near IS10(N), SR5(N), SR10A(N) and SR10B(N2) which are located outside the site boundary of HKLR03 Contract. No abnormality or malpractice for the contract works was observed during the sampling exercise.
- The range of dissolved oxygen at stations IS10, SR5, SR10A and SR10B during the baseline monitoring is shown as below:

- However, there were no specific activities recorded during the monitoring period that would cause any significant impact on the monitoring results. As such, the exceedances in DO level are considered to be attributed to other external factors rather than the contract works.

As the DO level recorded beyond the water quality criteria was not related to contract works, no immediate actions are considered necessary. However, the Contractor is reminded to ensure the silt curtain is fully maintained throughout the construction works and construction works are under stringer supervision to prevent any water quality impacts to the seawater.
