ENVIRONMENTAL COMPLAINT INVESTIGATION REPORT

Our Reference: 0212330_Complaint LOG_20160519_04

Project	Contract No. HY/2012/08 Tuen Mun - Chek Lap Kok Link - Northern Connection Sub-Sea Tunnel Section	Scale
Drawings	SOUTH VENTILATION SHAFT T R DBW MARINE SET-UP JET GROUTING BARGE - Dust Collector Piping System	No scale
W G	air with small amount of cement particles

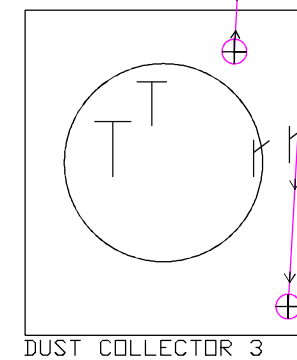
→ → → Cleaned air circuit release out of the
dust collector system to the piping system
(direction - CEMENT BARGE)
→ → → Cleaned air circuit release out of the
dust collector system through the filters
→ → → Air* circuit inside the dust collector
during the sedimentation of cement particles
→ → → Air* circuit going from the dust collector 3
to the dust collector 1

Air pipe line going
to the Cement Barge
