**Ref/Project number** Contract No. HY/2012/08 Tuen Mun–Chek Lap  
Kok Link–Northern Connection Sub-sea Tunnel  
Section

**Subject** Notification of Exceedance for Air Quality  
Impact Monitoring

## CONTRACT NO. HY/2012/08 TUEN MUN – CHEK LAP KOK LINK – NORTHERN CONNECTION SUB-SEA TUNNEL SECTION

### Air Quality Impact Monitoring Notification of Exceedance

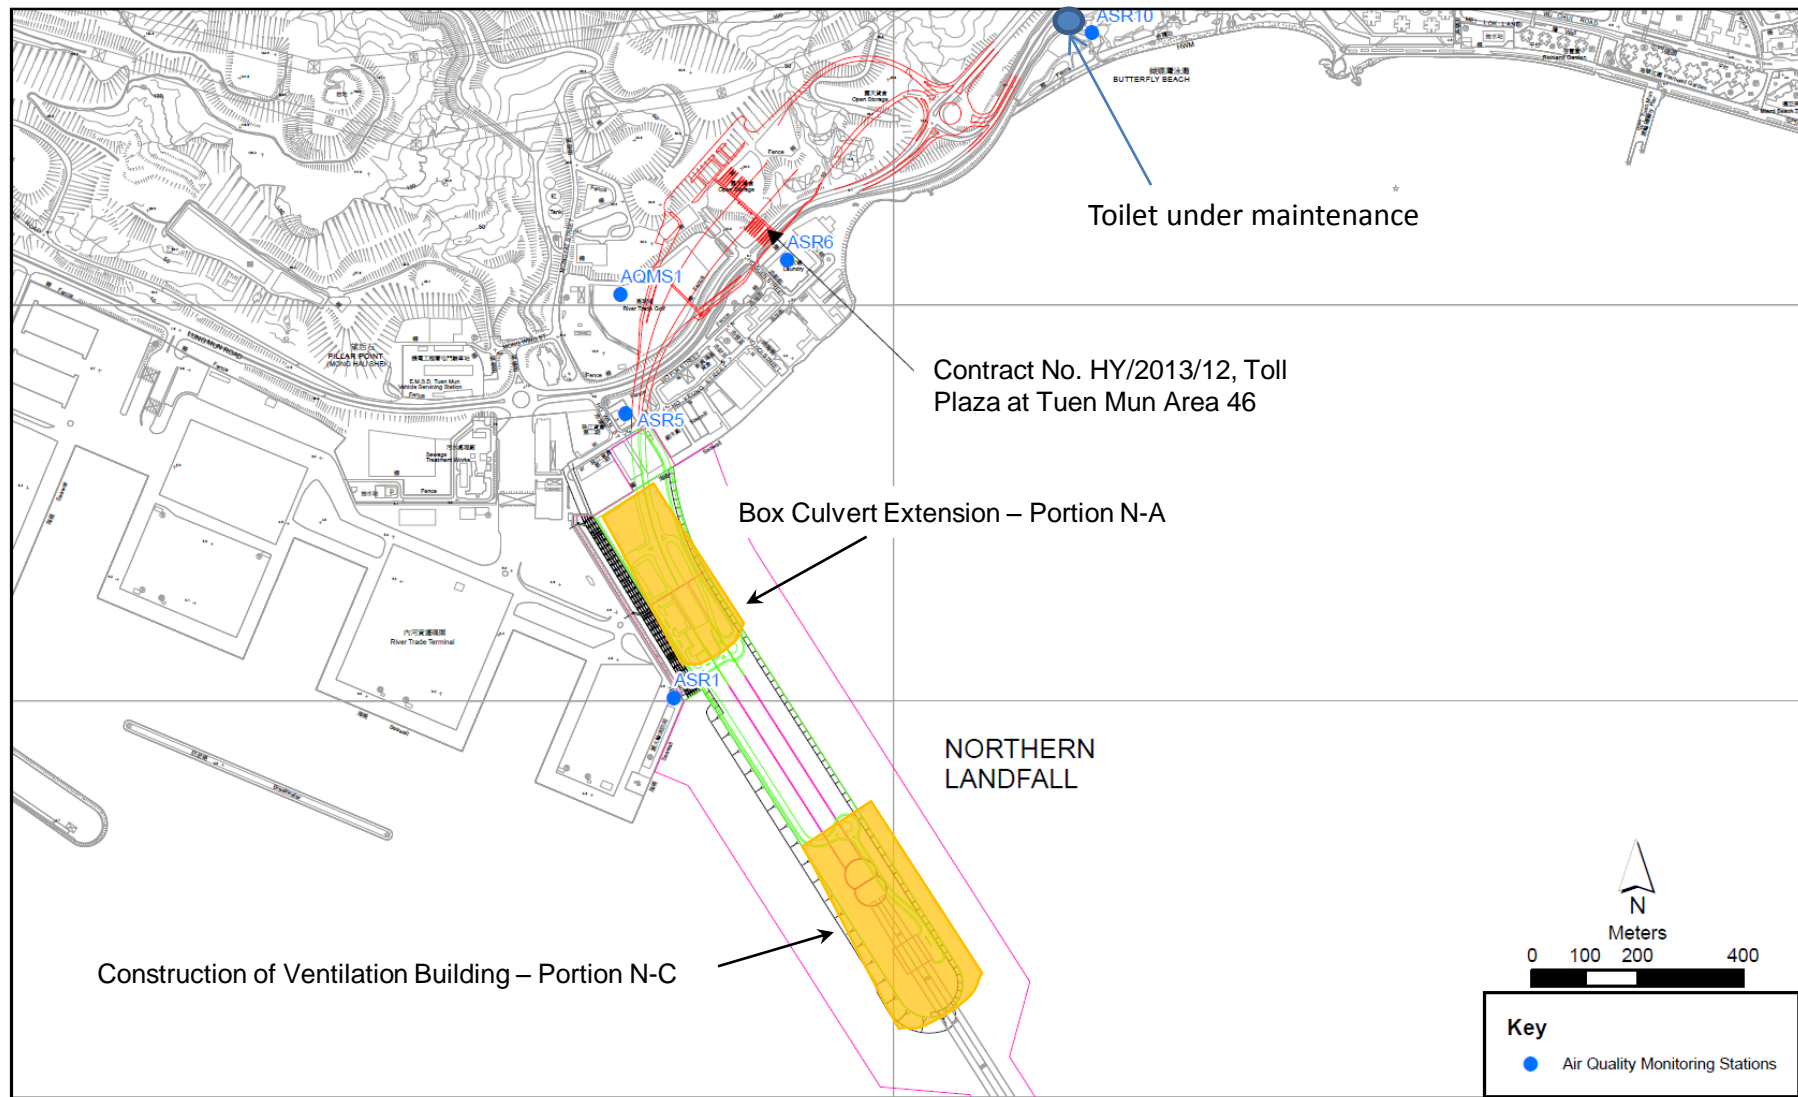
Figure 1

Indicative Construction Works Area on 2 March 2018

<b>Actions Taken/ To Be Taken</b>	<p>According to the photo record on 2 March 2018, the Contractor has properly implemented dust suppression measures on site. Follow up site inspection was carried out on 19 March 2018. Box culvert extension was carried out at Works Area Portion N-A and Construction of Ventilation Building was carried out at Portion N-C. Water spraying was applied to prevent dust. Photo record is provided in Annex A. Photos taken during AQM were also provided. No significant dust impact was observed at ASR1. Dust suppression measures were properly implemented during the site inspections.</p> <p>The Contractor has been reminded to implement the required mitigation measures as per the EP, approved EIA and Updated EM&amp;A Manual including watering to maintain all exposed road surfaces and dust sources wet, use of sprinklers for water spraying, covering the materials having the potential to create dust by clean tarpaulin, use of water truck and watering on all exposed soil within the Project site) throughout the construction period. The Contractor was also reminded to ensure all dust mitigation measures are provided at Portion N-A and Portion N-C, where the construction works are carried out.</p> <p>As occasional exceedances were observed at ASR1, the Contractor has been reminded to enhance their dust mitigation measures at the works area, especially Portion N-A, which is closest to ASR1. Water spraying should be applied more frequently to prevent dust. The Contractor should also ensure that the exposed soil at Portion N-A was covered by tarpaulin sheets.</p>

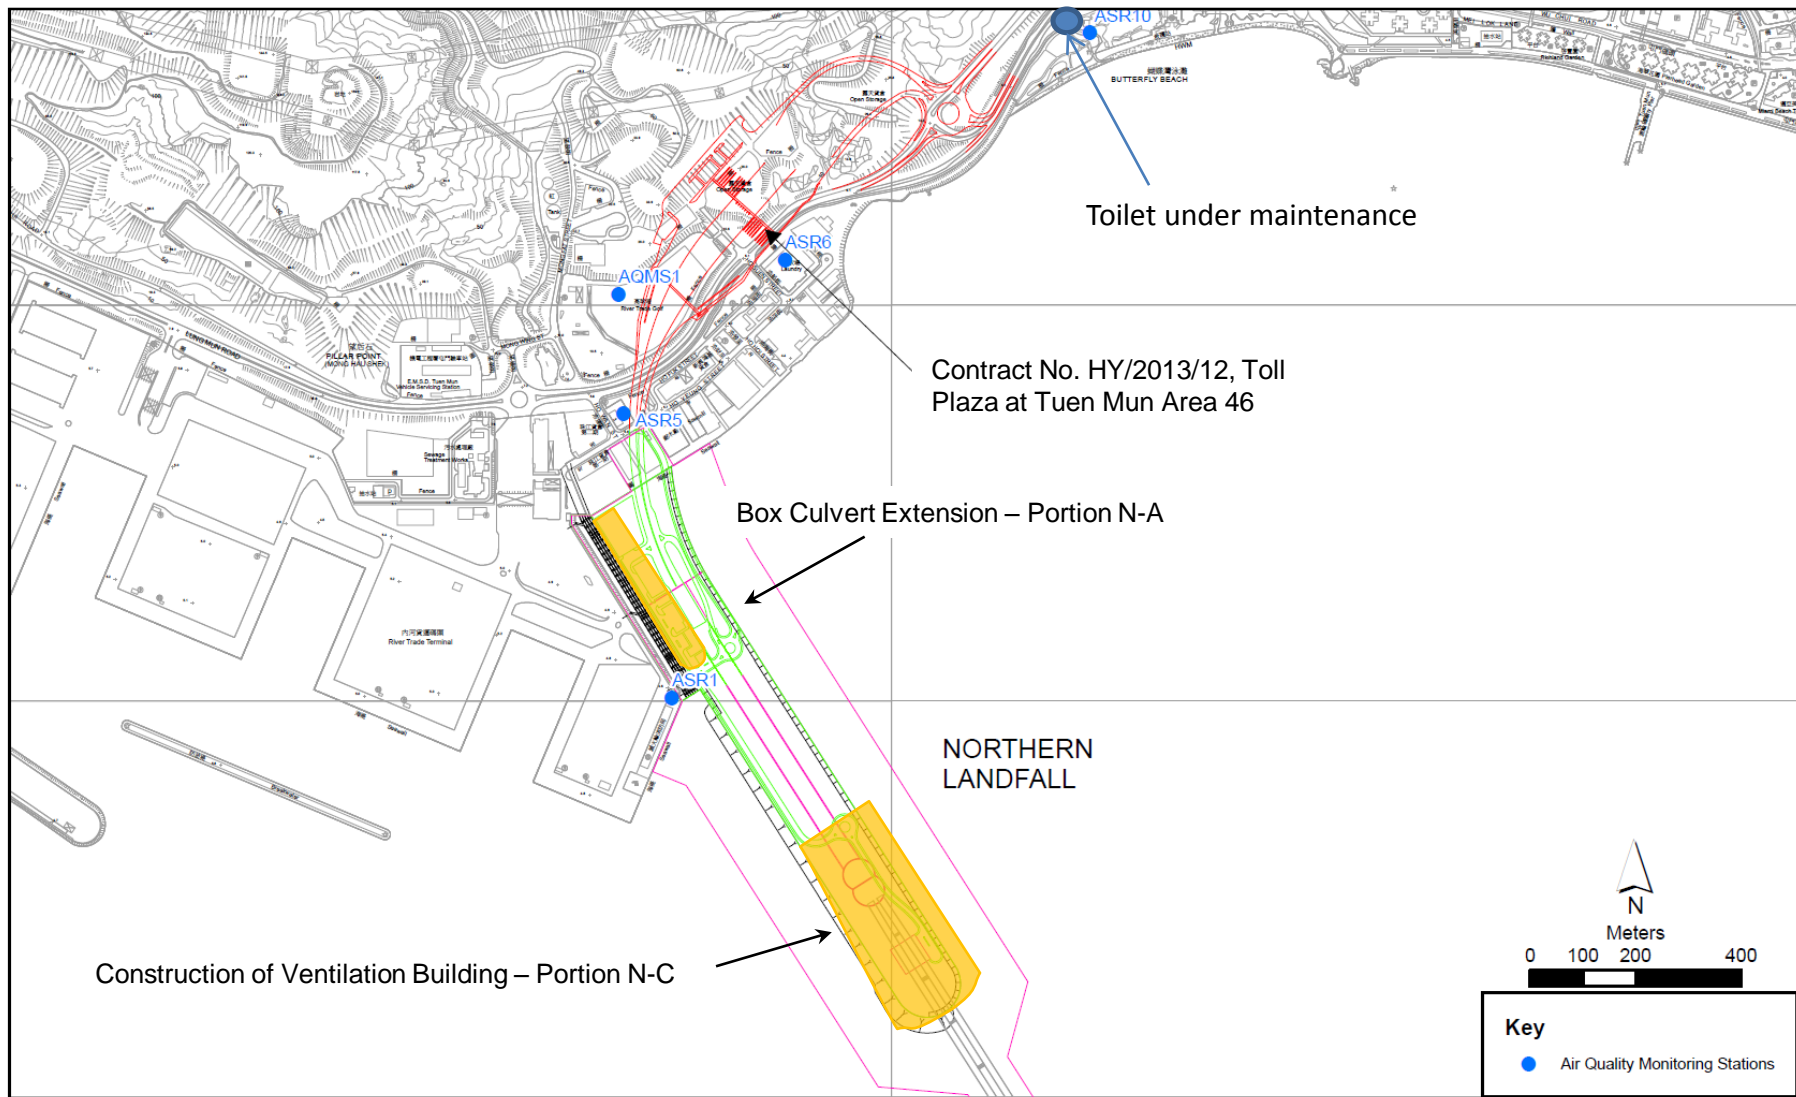
Figure 1

Indicative Construction Works Area on 20 March 2018

<b>Actions Taken/ To Be Taken</b>	<p>Follow up site inspection was carried out on 5 April 2018. Box culvert extension was carried out at Works Area Portion N-A and Construction of Ventilation Building was carried out at Portion N-C. Water spraying was applied to prevent dust. Photo record is provided in Annex A. Photos taken during AQM were also provided. No significant dust impact was observed at ASR1. Dust suppression measures were properly implemented during the site inspections. Based on the above, no additional action is required.</p> <p>The Contractor has been reminded to implement the required mitigation measures as per the EP, approved EIA and Updated EM&amp;A Manual including watering to maintain all exposed road surfaces and dust sources wet, use of sprinklers for water spraying, covering the materials having the potential to create dust by clean tarpaulin, use of water truck and watering on all exposed soil within the Project site) throughout the construction period. The Contractor was also reminded to ensure all dust mitigation measures are provided at Portion N-A and Portion N-C, where the construction works are carried out.</p>
