CONTRACT NO. HY/2012/08

TUEN MUN – CHEK LAP KOK LINK – NORTHERN CONNECTION SUB-SEA TUNNEL SECTION

ENVIRONMENTAL COMPLAINT INVESTIGATION REPORT

Our Reference: 0212330_Complaint LOG_20160519_04

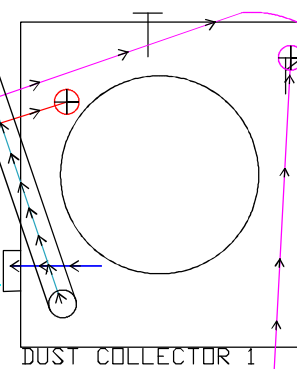
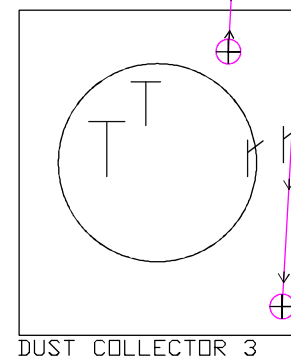
Air pipe line going
to the Cement Barge

Project	Contract No. HY/2012/08 Tuen Mun - Chek Lap Kok Link - Northern Connection Sub-Sea Tunnel Section	Scale
Drawings	SOUTH VENTILATION SHAFT T R DBW MARINE SET-UP JET GROUTING BARGE - Dust Collector Piping System	No scale
W G	air with small amount of cement particles
