Investigation Reports on Action Level or Limit Level Non-compliance

INVESTIGATION REPORT ON
ACTION AND LIMIT LEVEL NON-COMPLIANCE
FOR
CONTRACT NO. HY/2013/03

**Hong Kong Zhuhai Macao Bridge
Hong Kong Boundary Crossing Facilities – Vehicle Clearance Plazas and
Ancillary Buildings and Facilities**

Report No. Ref.: 0165-15-IR0004

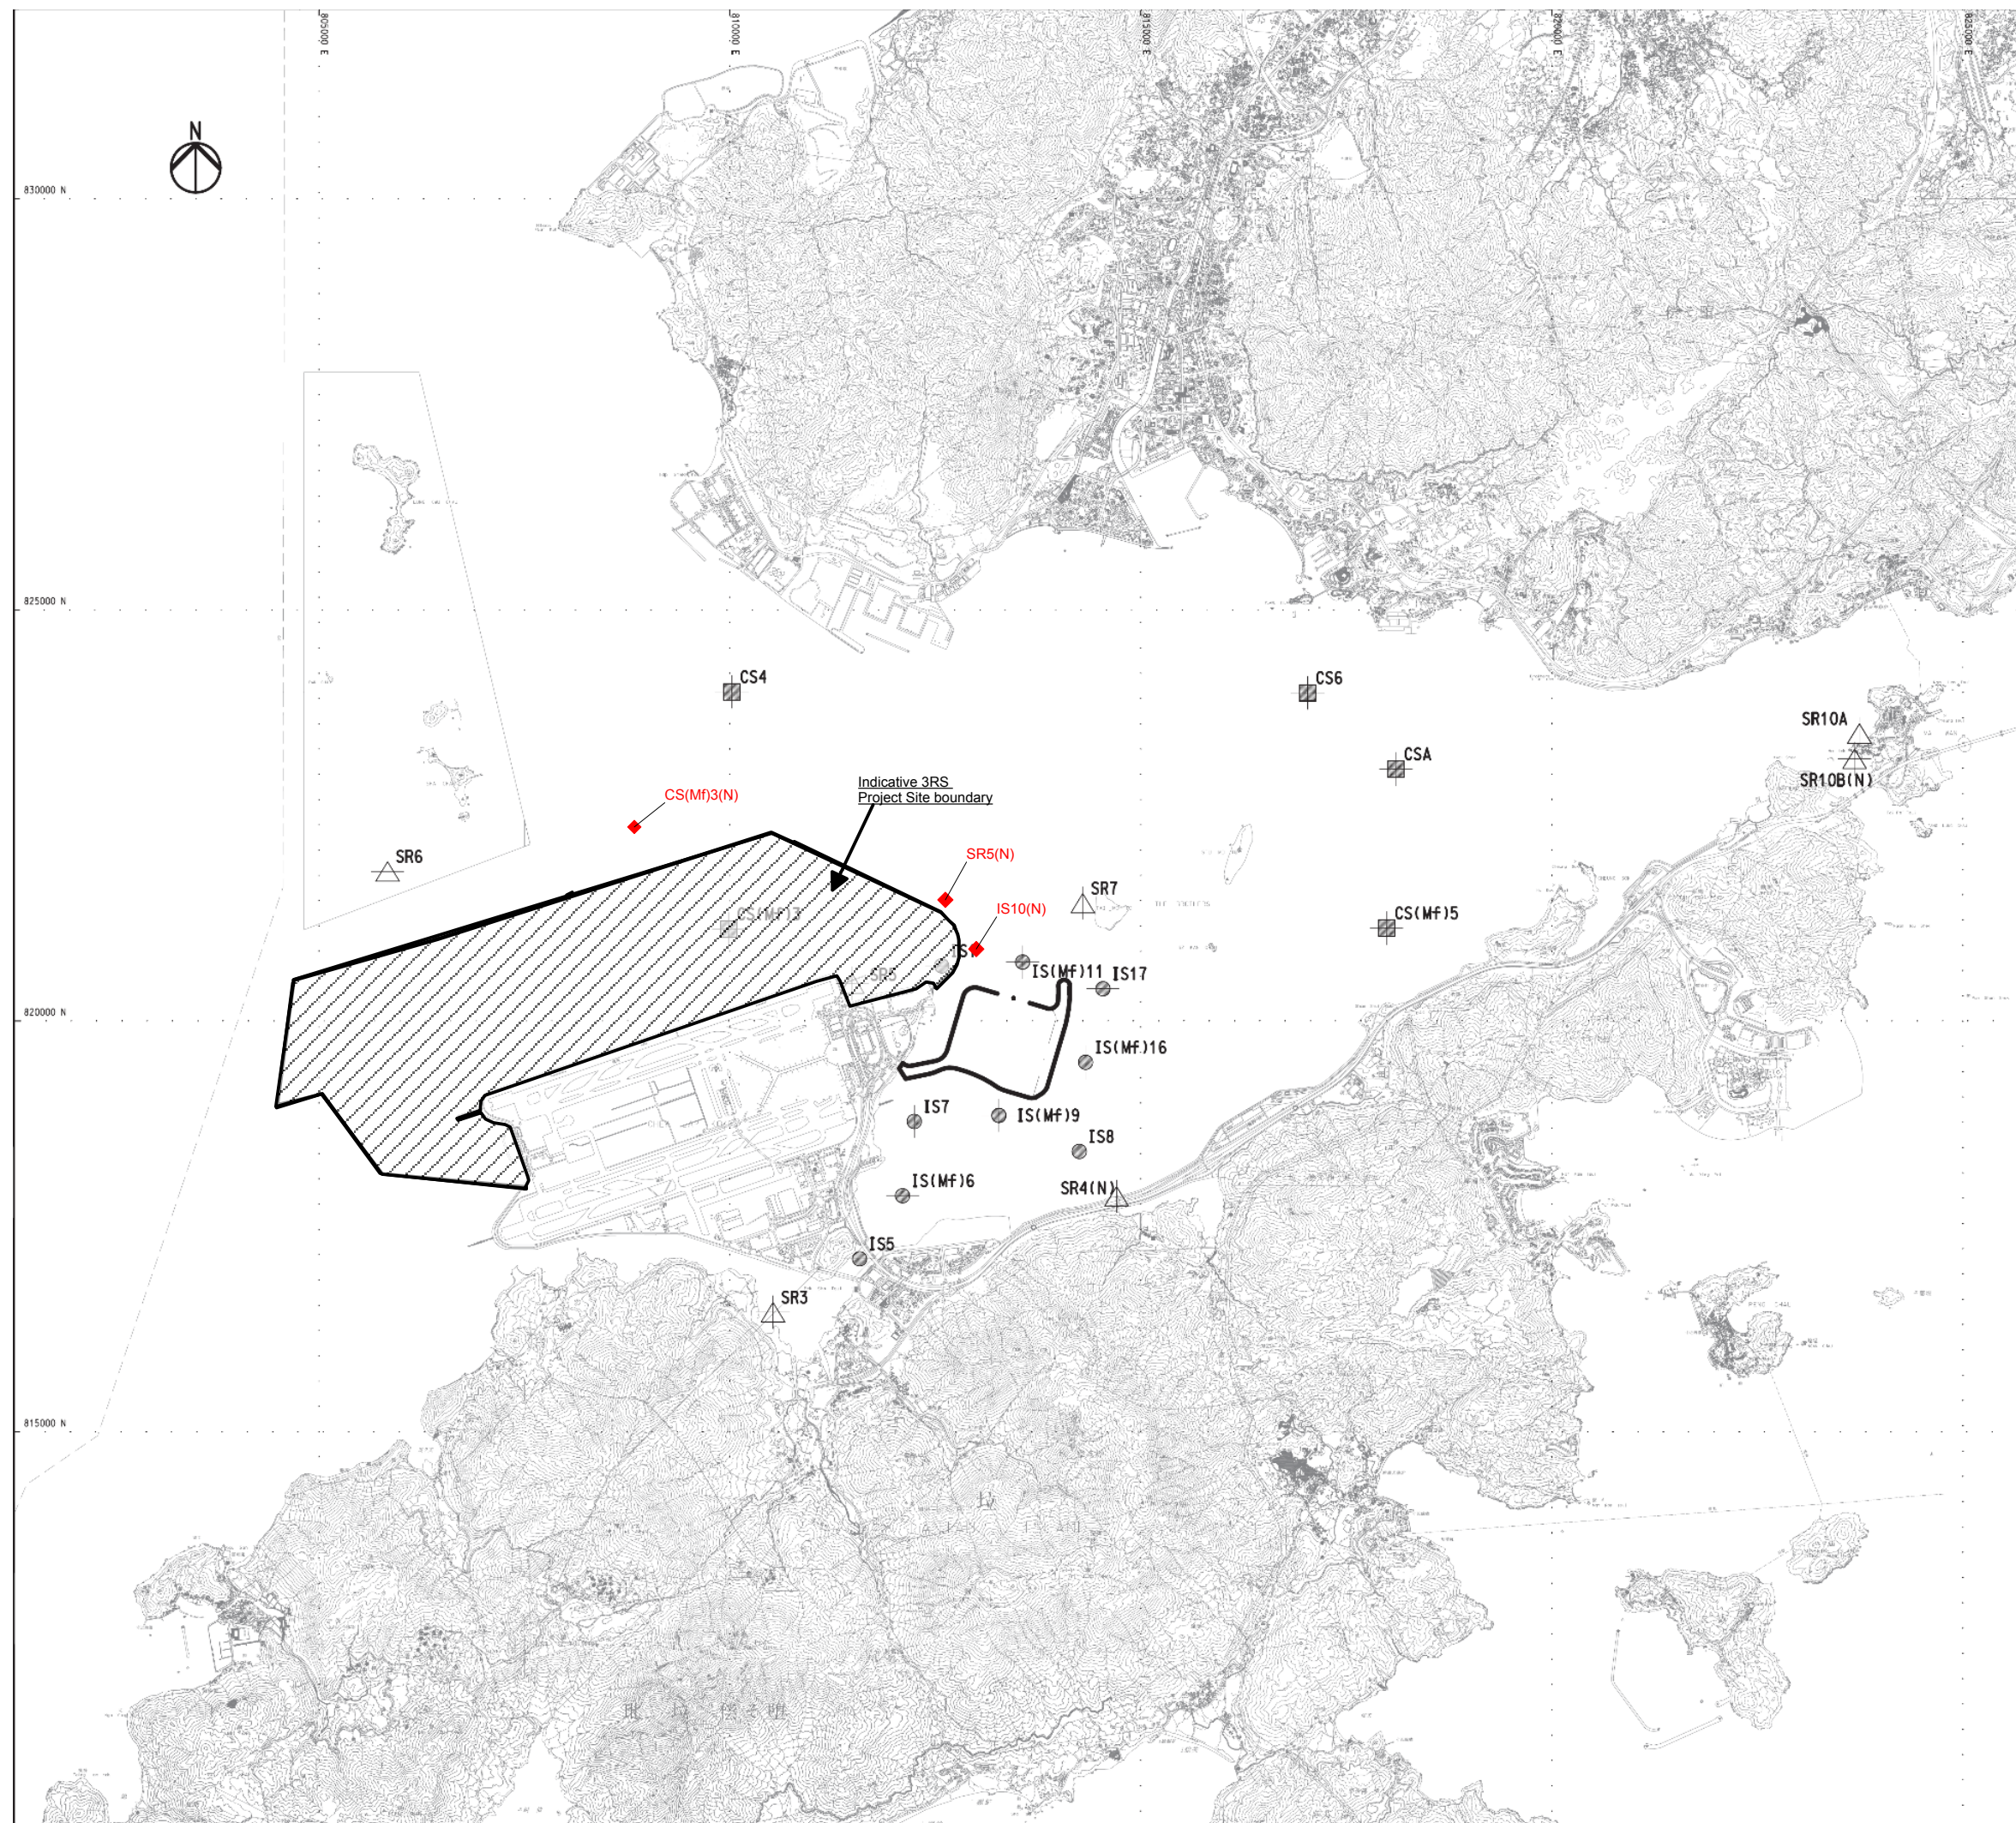
Figure 1

The Location of WQM Stations
